On-scene Investigation / Vehicle to Vehicle
Vehicle defect / Fire
Dynamic Science, Inc. / Case Number: DS02025
2000 Crown Victoria Police Interceptor
California
November, 2002

1. Report No. DS02025		2. Government Accession No.		3. Recipient Catalog No.	
4. Title and Subtitle In-Depth Accident Investigation				5. Report Date	
				6. Performing Organization Report No.

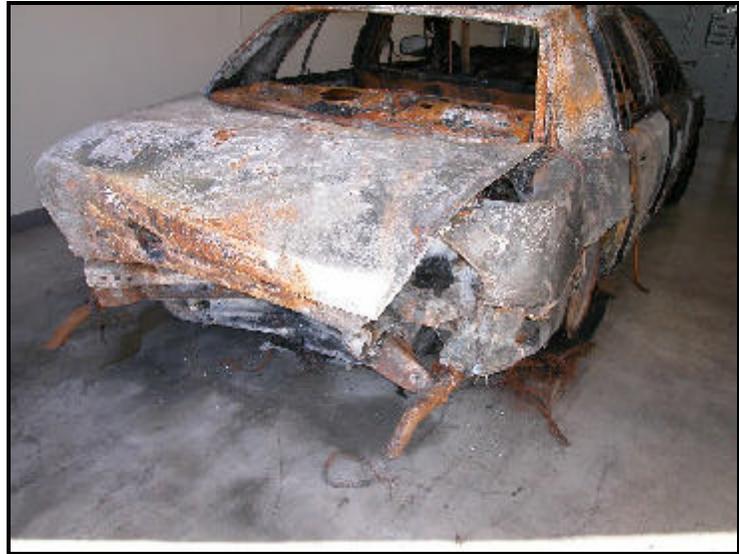
Figure 4. Right rear, case vehicle

The rear 2/3 of the case vehicle was damaged by the fire. The interior was completely gutted. The trunk compartment was badly burned, however, the flares and ammunition were not damaged. This vehicle sustained approximately 118 cm (47 in) of direct contact damage that extended across the middle and right of the vehicle's rear bumper. The rear bumper reinforcement bar was rotated upwards. The residual crush measured along the bar was as follows: C1=16 cm (6 in), C2=41 cm (16 in), C3=69 cm (27 in), C4=69 cm (27 in), C5=54 cm (21 in), C6=50 cm (20 in). The maximum crush was located 6 cm (2 in) right of C3 and measured 75 cm (30 in). The principle direction of force was within the 6 o'clock sector and was an estimated 180 degrees. The damaged components (from the crash) included the bumper fascia and reinforcement bar, trunk lid, and rear fenders. There was a 10 cm (4 in) reduction of the right wheelbase. Both front doors remained closed and operational. The rear doors were locked and could not be opened. The controls to unlock the rear doors are in the front of the vehicle and were not operating at the time of the inspection. It does appear, however, that the right rear door would have been jammed shut due to the impact.

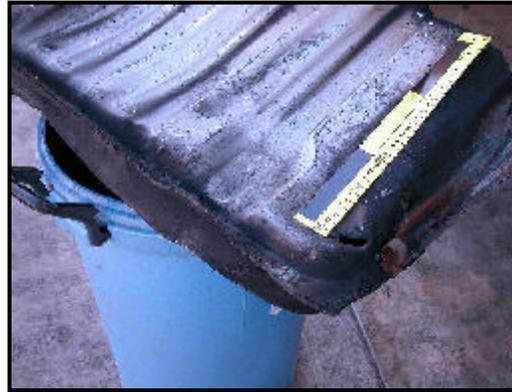
Shortly after the vehicle came to rest it caught on fire. The fire was a result of fuel leakage from two punctures to the right side of the fuel tank. The puncture to the front of the tank was 2.4 cm (0.9 in) wide. It was located 9.0 cm (3.5 in) from the bottom of the tank and 2.4 cm (0.9 in) from the right side. The puncture to the rear of the tank was 3 cm (1.2 in) wide. It was located 7.7 cm (3.0 in) from the bottom of the tank and 2.0 cm (0.8 in) from the right side. The punctures occurred as the wrecking bar was forced forward. The blade end of the bar penetrated the front of the trunk, penetrated the back of the fuel tank, and then penetrated the front of the fuel tank. As restitution took place, the bar was drawn backward—leaving the front puncture open. Fuel flowed out of the two holes—primarily the front hole and began pooling on the ground. DSI estimates that the fuel would have flowed out of the tank at a rate of between 15 and 19 liters (4 and 5 gallons) per minute. At this point, the gasoline ignited. The ignition source is not known for sure, but it was likely related to sparks from dragging metal components. There were no indications of any crash related damage to the fuel lines or the tank filler pipe.

Figure 8. Puncture to back of fuel tank

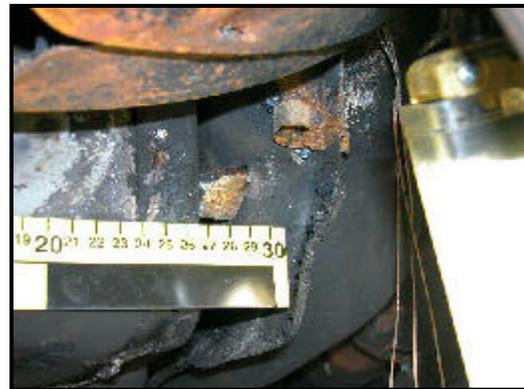
Figure 9. Shows wrecking bar exiting trunk (left) and penetrating back of fuel tank (right).

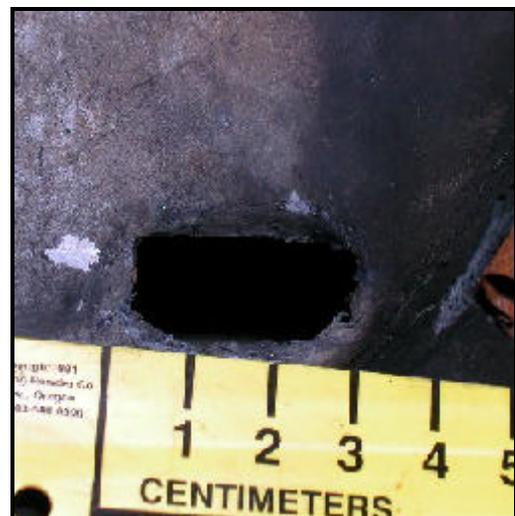
Figure 10. Close up of puncture to back of fuel tank(entry)

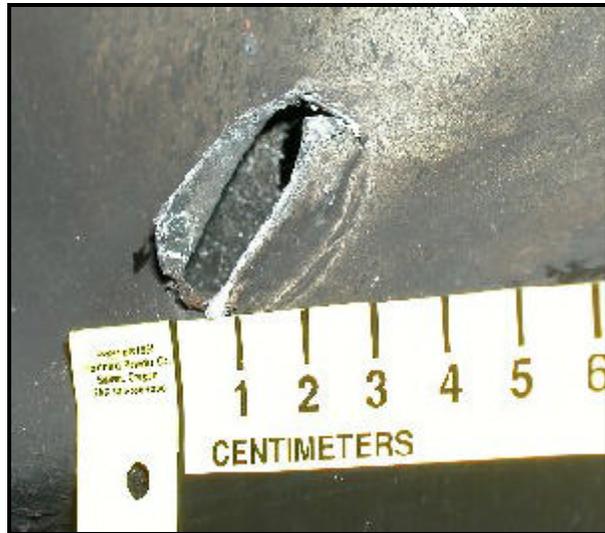
Figure 11. Puncture to front of fuel tank (exit)

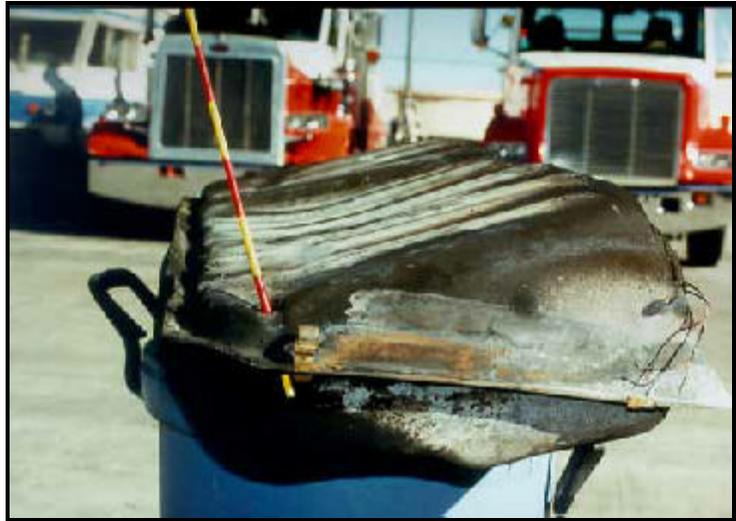
Figure 14. Side view of fuel tank showing entry and exit points

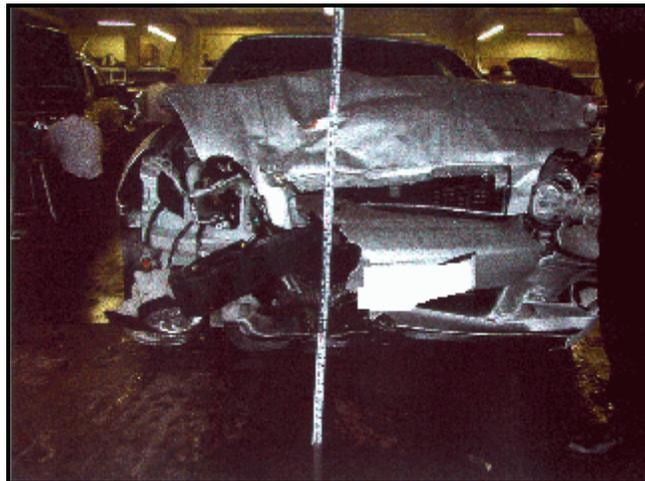
The other vehicle sustained 117 cm (46 in) of direct contact damage beginning at the right front bumper corner. The residual crush measured along the exposed areas of the reinforcement bar was as follows: C1=10 cm (4 in), C2=13 cm (5 in), C3=24 cm (9 in), C4=23 cm (9 in), C5=9 cm (3 in), C6=0 cm (0 in). The maximum crush was located at C3. The principle direction of force was within the 12 o'clock sector and was an estimated 0 degrees.

Figure 17. Front, other vehicle (Sonata)

The damaged components included the bumper fascia and reinforcement bar, hood, grille, and radiator. There was no glazing damage and all doors remained closed and operational.

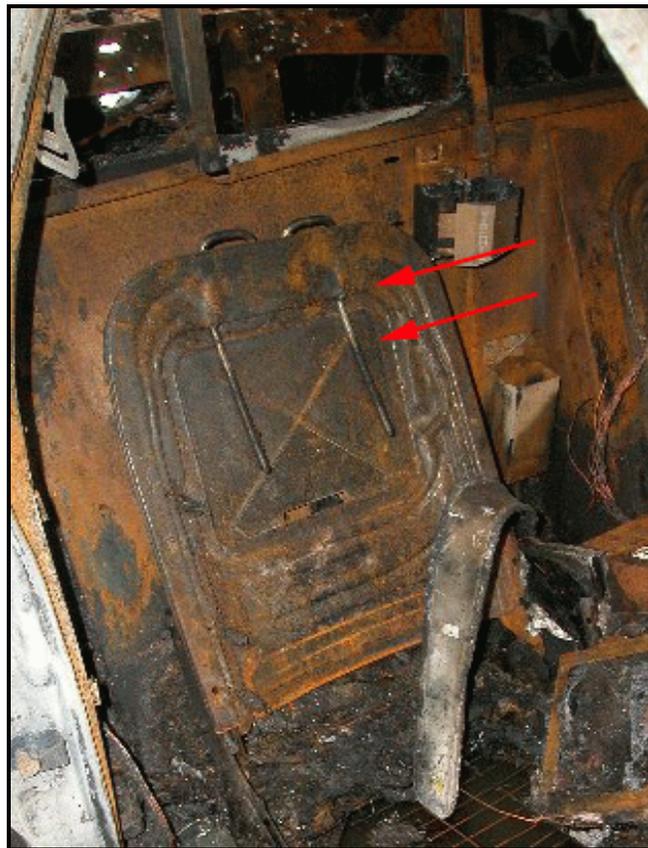
The 33-year-old male front right passenger of the case vehicle was seated in a normal, upright fashion. The bucket seat was slightly reclined; its track position is not known. He was wearing the available 3-point lap and shoulder belt. At impact, he responded to the 180-degree direction of force by moving rearward and engaged the head restraint with the back of his head—causing the concussive injury and neck strain.

Figure 19. Front right seat—head restraint was in up position during the fire
