**VERIDIAN REMOTE ADULT AIR BAG RELATED FATALITY
INVESTIGATION
VERIDIAN CASE NO. CA02-026
VEHICLE: 1994 GEO PRIZM
LOCATION: MASSACHUSETTS
CRASH DATE: DECEMBER 1995**

**VERIDIAN REMOTE ADULT AIR BAG RELATED FATALITY
INVESTIGATION**

VERIDIAN CASE NO. CA02-026

VEHICLE: 1994 GEO PRIZM

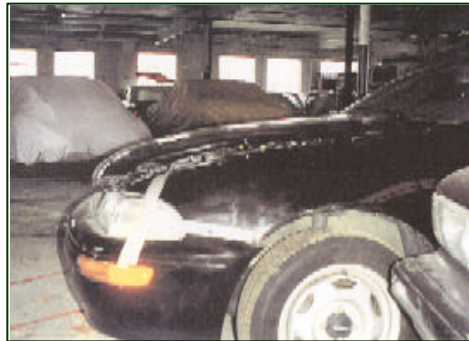
Figure 1. Lateral view of the frontal plane of the Geo Prizm.

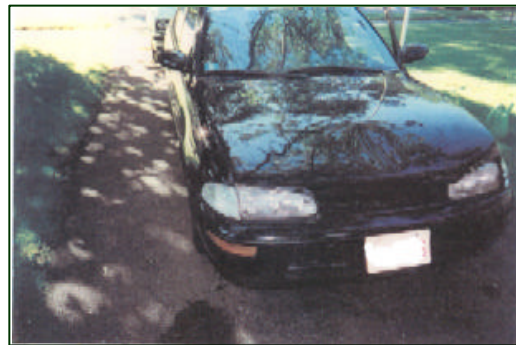
Based on the supplied images of the vehicles, it appeared that the full frontal area of the Geo Prizm impacted the rear center and right areas of the Cadillac in a front-to-rear impact configuration. The resultant directions of force were 12 o'clock for the Geo and 6 o'clock for the struck Cadillac. The impact resulted in a longitudinal deceleration that was sufficient to deploy the Geo's frontal air bag system. Crush profiles could not be estimated, therefore, a WinSMASH reconstruction of the damage data was not performed. Based on SCI experience, the Geo sustained an estimated longitudinal delta V of 13-19 km/h (8-12 mph). **Figure 2** is a frontal view of the Geo Prizm's damage.

Figure 2. Frontal view of the damage of the Geo Prizm.

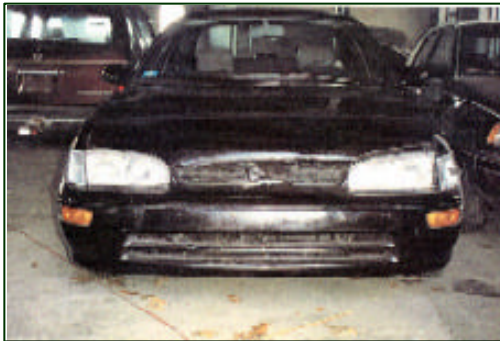
The exterior damage to the Geo Prizm was rated as moderate. The direct contact damage on the bumper fascia began at the midpoint of the right headlamp lens and extended laterally to the left corner. The bumper fascia was abraded and scuffed. The mid aspect of the hood edge was dented from engagement against the rear of the Cadillac. The left aspect of the hood edge was crush rearward approximately 2.5 cm (1.0”) over the left headlamp lens. The left turn signal lens appeared to be fractured and the left fender was deformed forward of the tire. The bumper fascia contact probably resulted in crush to the bumper beam, however, the fascia returned to its pre-crash position, thus concealing any underlying damage. There appeared to be minimal crush at the level of the upper radiator support panel. The Collision Deformation Classification (CDC) for this crash event was 12-FDEW-1. The police report noted an estimated damage repair cost of \$2,000. **Figures 3 and 4** are frontal views of the Prizm’s crash related damage.

Figure 3. Frontal view of the Prizm.

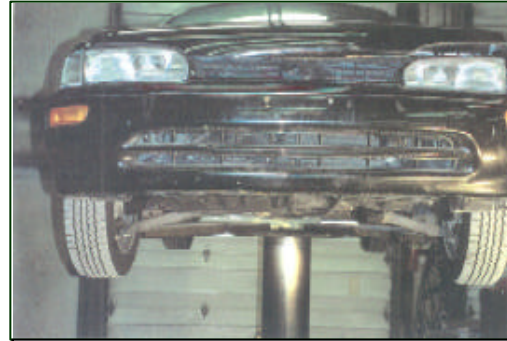
Figure 4. Additional view of the Prizm’s frontal damage.

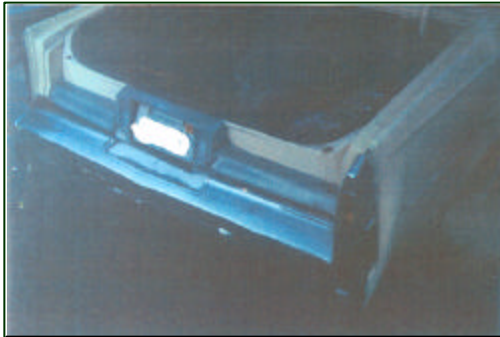
The back plane of the Cadillac sustained moderate damage as a result of the crash sequence with the Geo Prizm. The direct contact damage to the rear of the Cadillac appeared to be distributed across the bumper (**Figure 5**). Both vertical bumper extensions that housed the taillight assemblies were deflected outward as a result of the crash. There was no apparent crush to the mid aspect of the bumper. The right corner aspect of the bumper was displaced forward which resulted in induced buckling to the right quarter panel (**Figure 6**). The CDC for this damage was 06-BZEW-1.

Figure 5. Rear view of the struck Cadillac.

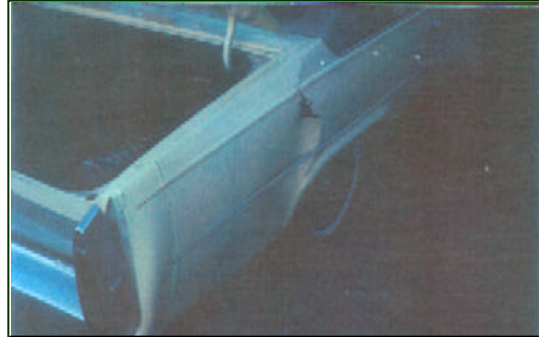
Figure 6. Induced buckling of the right rear quarter panel.

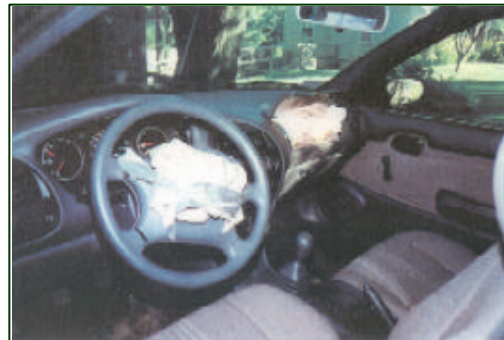
The left aspect of the steering wheel rim was deflected forward. A gap was visible between the spokes and the air bag module/hub cover. It was unknown if there was compression of the energy absorbing steering column (**Figure 7**).

The Geo Prizm was equipped with a frontal air bag system for the driver and right passenger positions. The system deployed as a result of the front-to-rear crash event with the Cadillac (**Figure 7**). The frontal air bag system consisted of a driver air bag module that was housed within the four-spoke steering wheel rim, a mid mount passenger air bag in the right instrument panel, two crash sensors that were mounted on the front frame rails, inboard of the fenders, and the Diagnostic Energy Reserve Module (DERM) that was located under the front right instrument panel.

Figure 7. Deployed frontal air bag system in the Geo Prizm.

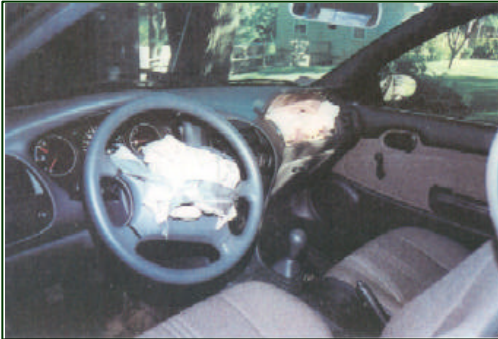
Figure 8. View of the deployed front left air bag and the deformation to the steering wheel rim.

Immediately prior to the crash, the driver of the struck Cadillac stated to the investigating officer that he did not hear skid marks indicative of heavy pre-crash braking. The driver of the Geo may have braked without locking the tires of the Geo Prism. The frontal area of the Geo impacted the rear of the Cadillac resulting in deployment of the Geo's frontal air bag system (**Figure 8**).

The driver's forward motion in response to the frontal crash forces, in combination with air bag expansion, resulted in forward displacement of the left aspect of the steering wheel rim. This was evidence by a separation between the wheel rim and the air bag

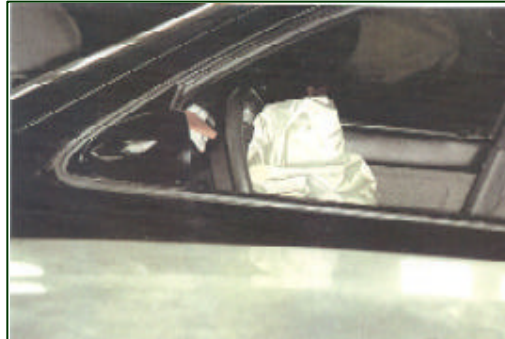
Figure 9. Lateral view of the deployed front left air bag.

At deployment, the driver of the Geo was positioned in close proximity to the steering wheel (**Figure 9**) due to a forward seated position, or forward displacement due to possible pre-crash braking or a response to the frontal crash forces with a delayed air bag deployment. The driver's air bag expanded against the driver's chest as evidenced by the abrasions across her breasts and sternum. The initial deployment of the air bag compressed the chest, resulting in anterolateral rib fractures 1-7 on the left and 1-8 on the right side, a fractured sternum, and bilateral clavicle fractures. Additionally, air bag deployment produced two lacerations of the right ventricle, a laceration of the pericardial sac, and multiple superficial liver lacerations. As the air bag continued to expand, the bag membrane contacted the underside of the driver's chin, producing a 12.7x2.5 cm (5.0x2.5") band-like abrasion with blistering. There were no cervical spine injuries documented in the autopsy report.

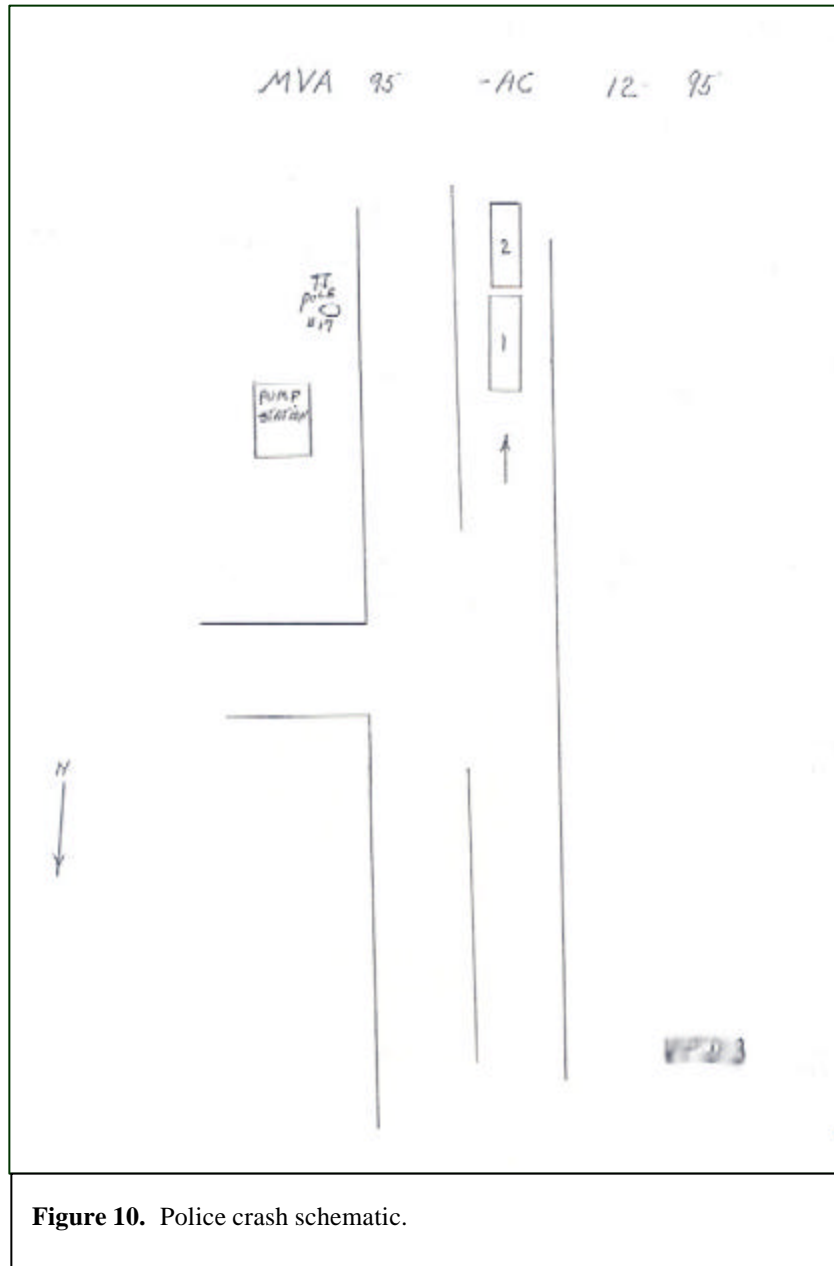
Figure 10. Police crash schematic.

The 49-year old male driver of the Cadillac was traveling in a southerly direction on the two-lane road. He stated to the investigating officer that traffic was moving at a constant speed estimated at 32-40 km/h (20-25 mph). The 60-year old female driver of the Geo Prizm was traveling in a southbound direction, following the Cadillac. The investigating officer noted on his report that the sun was in view of southbound traffic. It was unknown if this contributed to the causation of the crash. The Cadillac driver reported that he did not hear the sound of brakes prior to the crash, indicating avoidance action by the Prizm driver. The Prizm was not equipped with anti-lock brakes. The crash schematic is attached as **Figure 10** on Page 7 of this report.
