On-Site Advanced Occupant Protection Systems Investigation
Dynamic Science, Inc. / Case Number: DS02-027
2002 GMC Envoy 4x2 Four-door Sport Utility Vehicle
California
July, 2002

Dynamic Science, Inc.
Crash Investigation
Case Number: DS02-027

Investigation Type:	On-Site Advanced Occupant Protection Systems
Crash Location:	California
Crash Date:	July, 2002
Notification Date:	November 19, 2002
Field Work Completed:	April 2, 2003

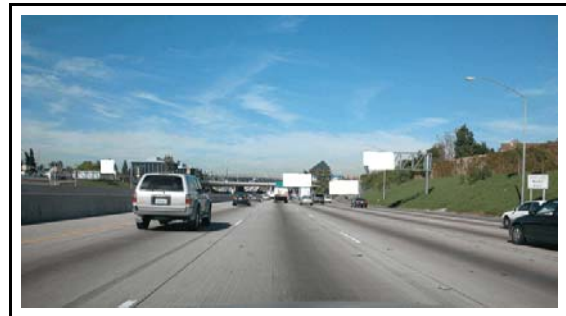
Figure 1. Direction of travel both vehicles (north)

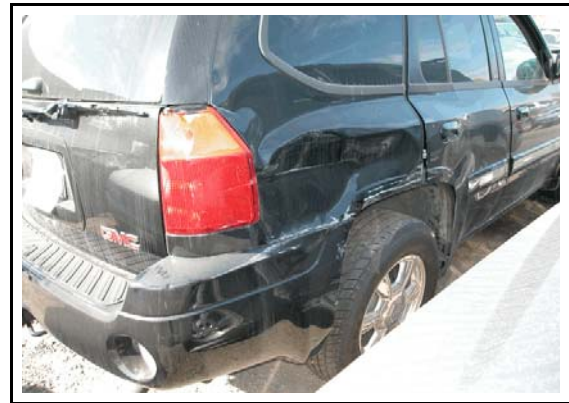
Figure 2. Damage right side case vehicle (impact 1)

The sideswipe impact (1) with the other vehicle resulted in minor right rear damage to the case vehicle. The direct/induced damage began at the rear right bumper corner and extended forward 199.0 cm (78.3 in). A crush deformation code of 04RZEW1 was assigned to the damage.

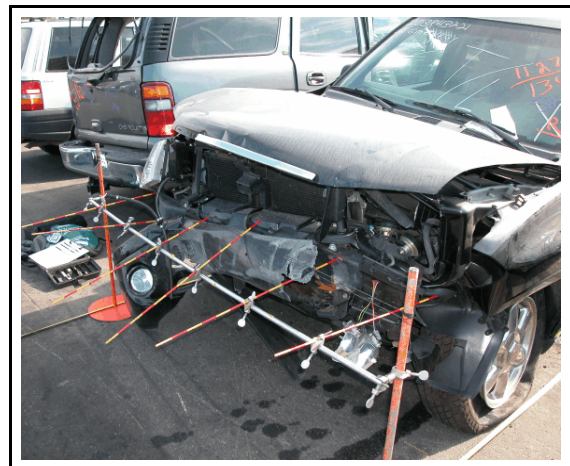
The impact (2) with the concrete divider wall resulted in moderate damage to the front of the case vehicle. The direct damage began at the front right bumper corner and extended across the entire front end. Six crush measurements were taken along the metal bumper backing bar and were as follows: C1=28.0 cm (11.0 in), C2=24.0 cm (9.5 in), C3=16.0 cm (6.3 in), C4=9.0 cm (3.5 in), C5=3.0 cm (1.2 in), C6=5.0 cm (2.0 in). Maximum crush was located at C1. A crush deformation code of 01FDEW2 was assigned to the damage. The principal direction of force was within the 01 o'clock sector and was an estimated 20 degrees. The impact energy was managed by the forward structures of the vehicle.

Figure 3. Front left damage case vehicle (impact 2).

The damaged components included the upper and lower radiator supports and the metal bumper backing that was crushed rearward. The front bumper fascia was partially broken away. The left front wheel was displaced rearward and the left wheelbase was shortened by 7.8 cm (3.1 in). The front left tire was de-beaded from the rim.

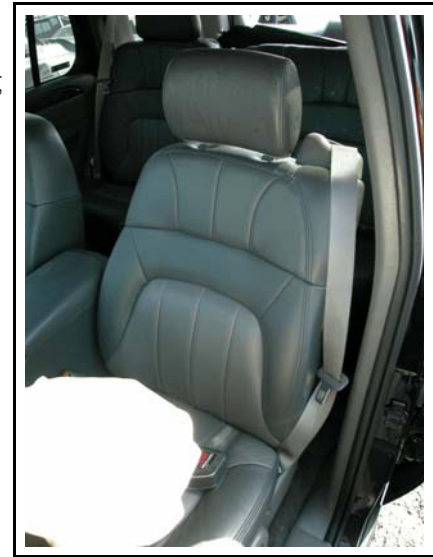
The case vehicle was configured with integrated manual 3-point continuous loop lap and shoulder safety belts with sliding latch plates for the front seat positions. The driver's safety belt was configured with a belt-sensitive emergency locking retractor (ELR) and the front right passenger's safety belt was configured with a belt-sensitive switchable/automatic locking retractor (ALR). The driver's latch plate had abrasions that were consistent with historical usage. The plastic part of the latch plate, where the safety seat belt webbing looped through, also exhibited abrading which is consistent with usage of the safety belt at the time of the crash. Data downloaded from the SDM also indicated that the driver's belt switch circuit status was "buckled" at deployment. The front right occupant's latch plate also had abrasions that were consistent with historical usage.

Figure 4. Driver's integrated lap and shoulder belt.

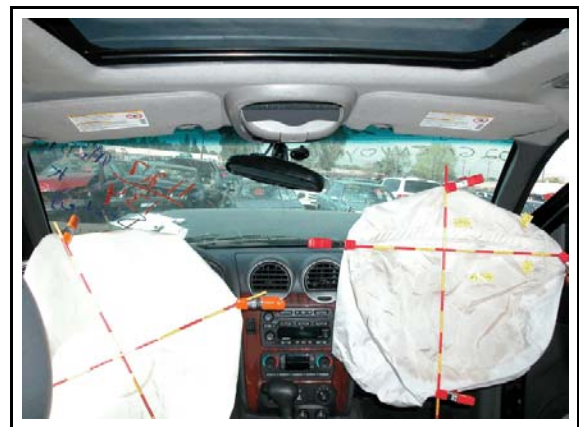
The case vehicle was equipped with dual stage driver and front right passenger air bags. The driver's air bag module was located in the center hub of the steering wheel rim. The dual module cover flaps opened with a vertically oriented flap tear seam (I-configuration). The left and right flaps each measured 11.5 cm (4.5 in) high by 8.0 cm (3.1 in) wide. There were no indications of any damage to the module cover flaps. The diameter of the deflated circular air bag was 69.0 cm (27.2 in). It was equipped with two internal tether straps and two vent ports at the 11 and 01 o'clock positions. There were no indications of any damage or

Figure 5. Deployed front air bags.

occupant contact to driver's air bag. Primarily about the left half of the front of the air bag and the lower half of the back of the air bag coffee was splattered. There were eleven vertical folds and thirteen horizontal folds.

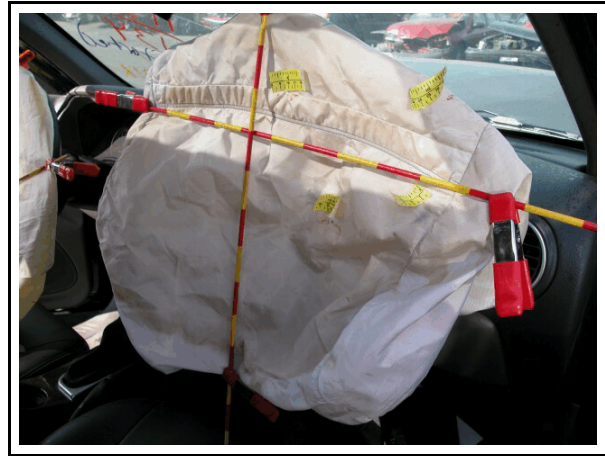
The front right passenger's air bag was a mid instrument panel mount with a single module cover flap. The module cover measured 13.0 cm (5.1 in) high by 33.0 cm (13.0 in) wide. The deflated air bag was vaguely rectangular in shape with a height of approximately 43.0 cm (16.9 in) and a width of approximately 49.0 cm (19.3 in). There was a single tether sewn across the entire top of the air bag. There were two vent ports at the 02 and 10 o'clock positions. There were no indications of any damage to the front right passenger air bag or module cover flap. On the front of the upper right quadrant was what appeared to be a lipstick transfer. There were also two red colored transfers to the mid-top and back right of the air bag. Both were similar in color and appearance to the lipstick transfer. The driver however indicated that there were no other occupants or cargo in the vehicle at the time of the crash. There were no indications of any damage to the module cover flaps, but the module cover was splattered with coffee and the air bag was soaked in coffee.

Figure 6. Front right passenger's air bag

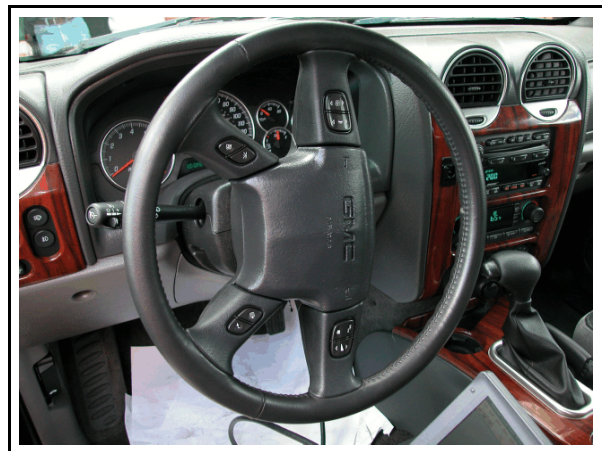
As noted earlier in this report, the data in the SDM was downloaded after the vehicle had been repaired and sold to a private party. The air bag module covers for both frontal air bags had been replaced, but the air bags had not been replaced. There was a digital message displayed after the vehicle's ignition was turned to the "ON" position that indicated that the air bags needed to be serviced. The private party was aware that the air bags had not been replaced and choose to buy the vehicle in this condition because it made the vehicle affordable.

Figure 7. Repaired driver's air bag
