**GENERAL DYNAMICS ON-SITE AMBULANCE CRASH INVESTIGATION
CASE NO: CA02-028
VEHICLE: 1999 FORD E-350 SUPER DUTY VAN CHASSIS W/WHEELED
COACH TYPE III AMBULANCE BODY
LOCATION: NEW JERSEY
CRASH DATE: JULY 2002**

Contract No. DTNH22-01-C-17002

<p>1. <i>Report No.</i> CA02-028</p>	<p>2. <i>Government Accession No.</i></p>	<p>3. <i>Recipient's Catalog No.</i></p>	
<p>4. <i>Title and Subtitle</i> General Dynamics On-Site Ambulance Crash Investigation Vehicle: 1999 Ford E-350 Chassis Location: State of New Jersey</p>		<p>5. <i>Report Date:</i> October 2004</p>	
		<p>6. <i>Performing Organization Code</i></p>	
<p>7. <i>Author(s)</i> Crash Data Research Center</p>		<p>8. <i>Performing Organization Report No.</i></p>	
<p>9. <i>Performing Organization Name and Address</i> Transportation Sciences Crash Data Research Center Advanced Engineering Services A General Dynamics Company P.O. Box 400 Buffalo, New York 14225</p>		<p>10. <i>Work Unit No.</i> C00410.0000.0049</p>	
		<p>11. <i>Contract or Grant No.</i> DTNH22-01-C-17002</p>	
<p>12. <i>Sponsoring Agency Name and Address</i> U.S. Department of Transportation National Highway Traffic Safety Administration Washington, D.C. 20590</p>		<p>13. <i

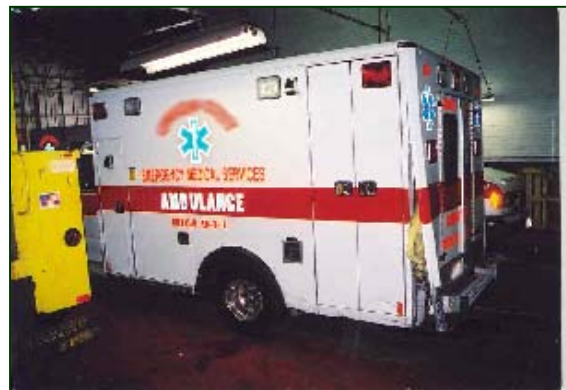
The left exterior side of the patient compartment contained four compartments (**Figure 3**). The forward compartment housed the oxygen cylinders. This compartment was accessed by a forward hinged door that was 41.9 cm (16.5") in width and 151.1 cm (59.5") in height. Internally, the compartment was equipped with two floor mounts that were 11.4 cm

Figure 3. Left side view of the patient compartment.

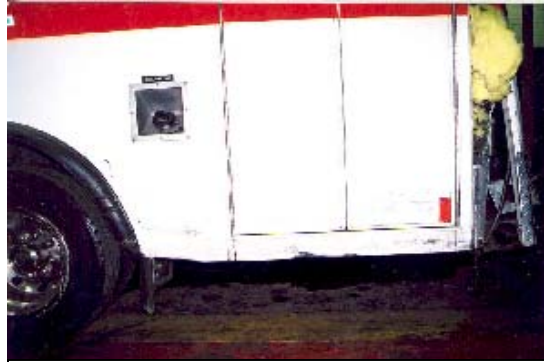
The ambulance sustained minor severity damage as a result of the initial impact with the Ford Crown Victoria taxicab. The taxicab struck the left rear aspect of the patient compartment (**Figure 11**). The damage began on the left rear chrome wheel, 21.6 cm

(8.5") forward of the axle position and extended rearward onto the rubber fender flare, lower portion of the patient compartment aft of the axle, corner post, terminating at the left corner of the aluminum rear bumper. The direct damage length measured 219.7 cm (86.5"). There was no measurable crush to this contact area. The damage to the wheel consisted of an abrasive pattern to the chrome surface with minimal deflection of the wheel bead. The lower aspect of the patient compartment, aft of the axle, was scratched with superficial isolated dents. The bottom aspect of the left rear corner post of the patient compartment was snagged by the Ford as the ambulance continued forward. The snagging deflected the corner post 19.3 cm (7.6") rearward at the bottom corner and separated the full height of the post from the side and rear sheet metal body panels. The Collision Deformation Classification (CDC) for this impact was 10-LBEW-1.

Figure 11. Left side damage from the initial impact with the taxicab.

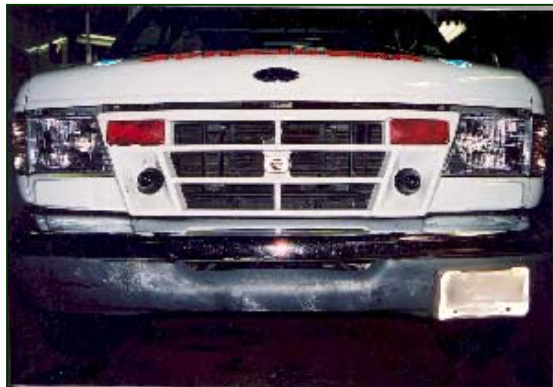
The frontal area of the ambulance sustained minor severity damage from the secondary impact with the parked 1991 Dodge Caravan. Subtle white paint transfers were noted to the top surface of the front bumper (**Figure 12**). These transfers began 11.4 cm (4.5") left of center and extended laterally 27.9 cm (11.0"), ending 16.5 cm (6.5') right of the vehicle's centerline. The composite lower bumper fascia panel was abraded. These abrasions were both vertically and diagonally oriented and began 61 cm (24") left of center of the license plate and extended 125.7 cm (49.5") to the right. A horizontally oriented black rubber-type scuffmark was present on the lower bumper fascia and appeared to be underlying the abrasions. This transfer began 78.7 cm (31.0") left of center and extended 162.6 cm (64.0") laterally. There was no residual crush to the front bumper. There was no contact evidence or damage to the grille or hood face. The CDC for this damage was 12-FDLW-1.

Figure 12. Frontal damage from the impact with the parked Dodge Caravan.

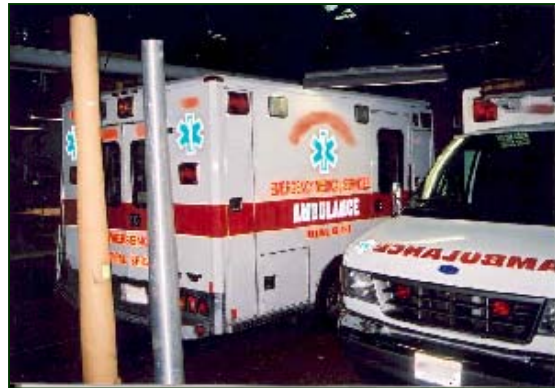
The right side of the ambulance sustained minor severity damage as a result of the overturn (**Figure 13**). The damage began on the protruding lug nut caps for the right front wheel. These caps protruded 3.5 cm (1.375”) outboard of the hub of the wheel and 10.2 cm (4.0”) outboard of the wheel rim bead. Three of the caps were deformed from the ground contact. The diamond plated aluminum running board that extended below the right side sill of the cab was abraded. The damage began on the forward corner post of the patient compartment and extended the full length of the body. The damage consisted of isolated dents and abrasions with asphalt embedded into the protruding door and compartment hinges (**Figures 14 and 15**). This damage began 204.0 cm (80.3”) forward of the right rear axle location and extended 172.2 cm (67.8”) rearward to the rear corner post. This rollover damage also extended vertically 219.1 cm (86.5”), covering the full height of the patient compartment. The right door and all storage compartments remained closed during the rollover and remained operational post-crash. The CDC for this overturn event was 00-RDAO-1

Figure 13. Overall view of the right side damage to the patient compartment.

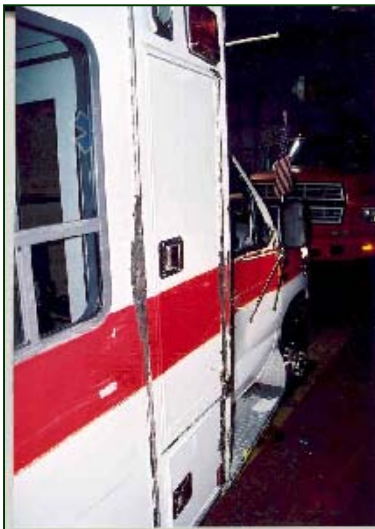
Figure 14. Asphalt embedded into the aft side of the door hinges.

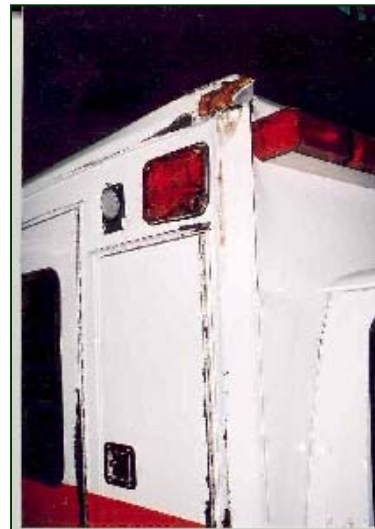
Figure 15. Close-up view of the rollover damage to the top forward corner of the patient compartment.

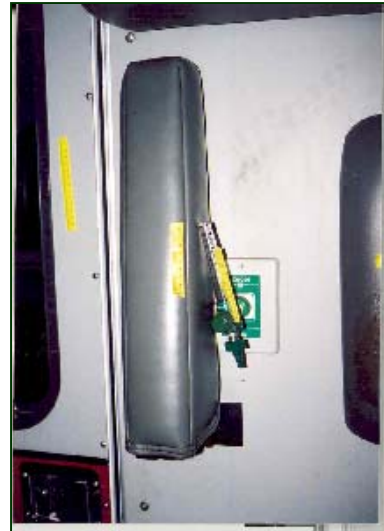
The patient compartment of the ambulance unit sustained minor damage as a result of occupant contact. This contact damage did not occur during the crash, but occurred post-crash as the EMT unbuckled his manual lap belt system and fell onto the right side wall of the patient compartment. The oxygen valve that was mounted to the right side wall forward of the bench seat was rotated/deflected into the fold down armrest from contact by the EMT (**Figure 16**). The valve was not damaged and there was no release of oxygen from the valve. This contact resulted in an abrasion to the right face of the EMT. As he came to rest, blood from the abrasion was transferred onto the forward aspect of the padded backrest for the bench seat. The patient was restrained in the center position of the bench seat and did not contact interior components other than the seat back rest. All interior compartments remained closed and were not damaged by the crash forces or occupant contact.

Figure 16. Displaced oxygen valve.

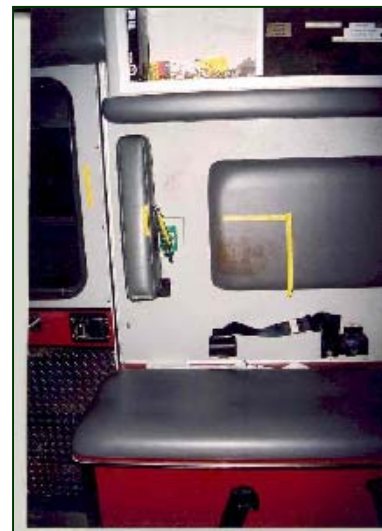
As the vehicle came to rest, the EMT unbuckled his lap belt and fell across the patient compartment, contacting the fold-down armrest on the right wall of the compartment and the oxygen valve located adjacent to the armrest. This contact resulted in an abrasion to the right of his face. As a result of this abrasion, the EMT bled. He then rolled onto the padded seat back of the patient compartment adjacent to the patient. This resulted in a blood transfer to the padded backrest (**Figure 19**).

Figure 19. EMT contact to the right side interior and oxygen valve.

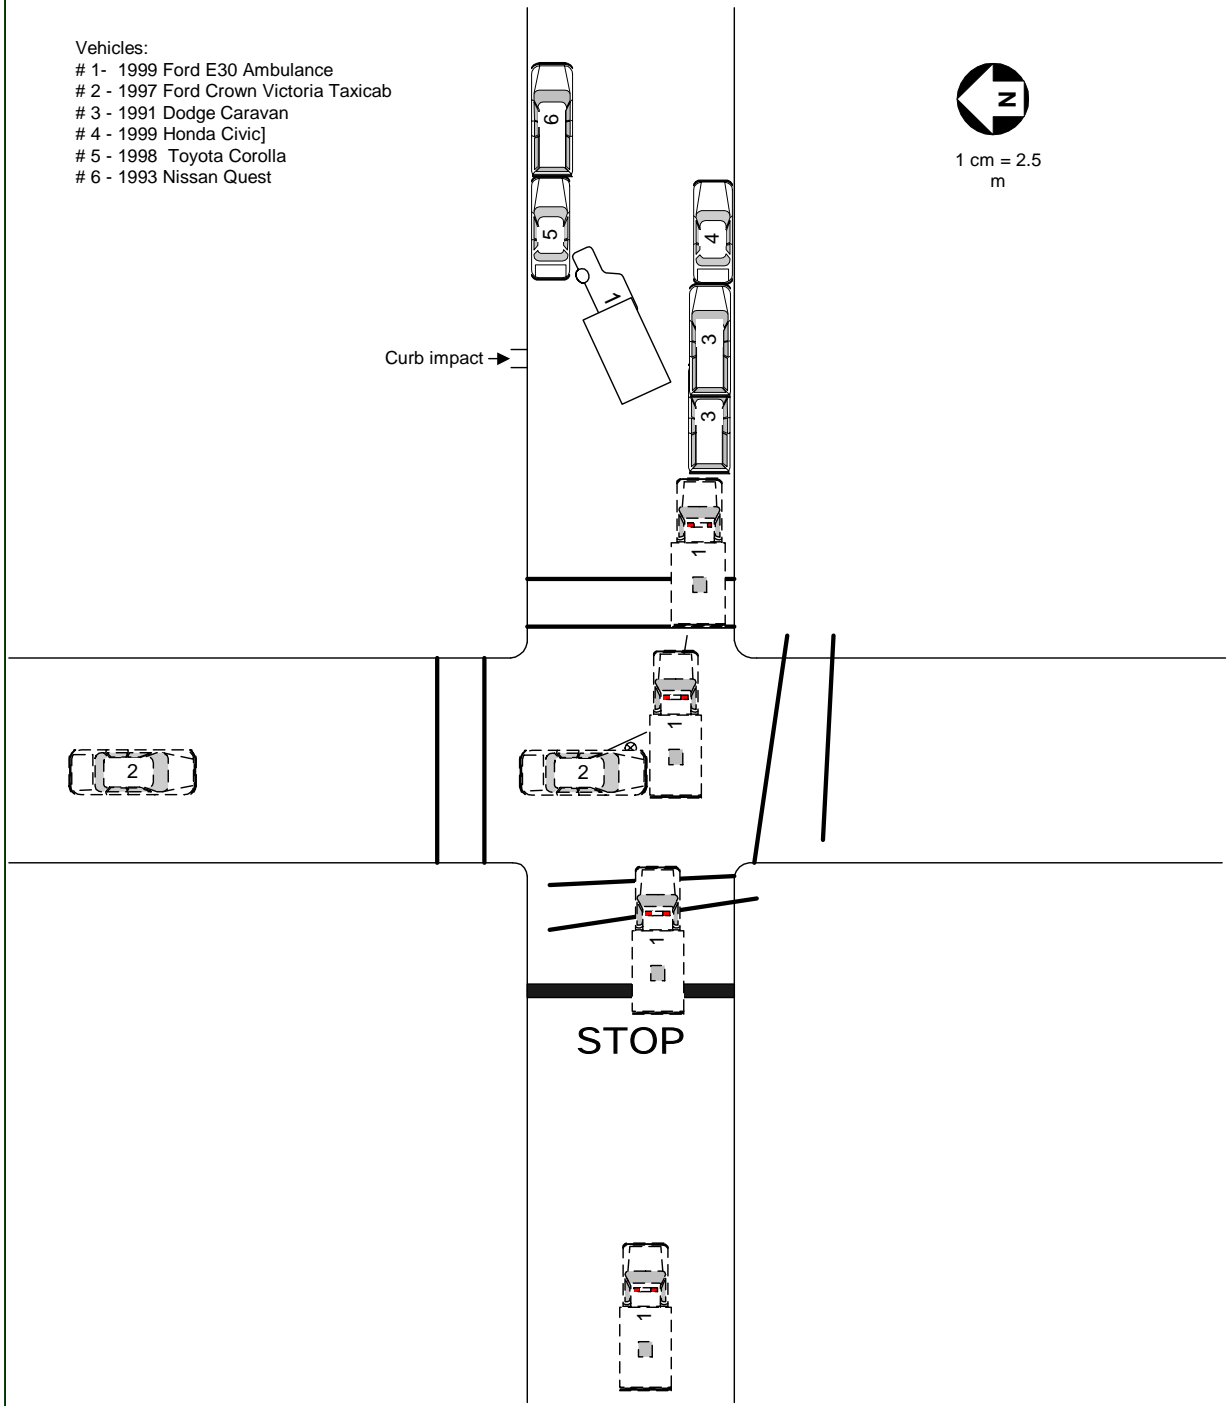
Figure 21. Crash Schematic

The frontal area of the taxicab impacted the left rear aspect of the patient compartment of the ambulance. The impact produced sideswipe-type damage to the ambulance. The resultant directions of force were within the 11 o'clock sector for the ambulance and most likely within the 2 o'clock sector for the striking taxicab. Although the ambulance experienced a longitudinal crash pulse, the pulse was not sufficient to deploy the vehicle's frontal air bag system or fire the safety belt buckle pretensioners. The damage to the patient compartment involved isolated dents, superficial abrasions, transfers on the rub strips, and dents and abrasions to the left rear hubcap and chrome wheel, and snagging of the left rear corner post.
