On-scene Investigation / Vehicle to Object  
Dynamic Science, Inc. / Case Number: DS02028  
2001 Subaru Outback station wagon  
Colorado  
October, 2002

1. Report No. DS02028		2. Government Accession No.		3. Recipient Catalog No.	
4. Title and Subtitle In-Depth Accident Investigation				5. Report Date	
				6. Performing Organization Report No.

**Dynamic Science, Inc.**  
**Accident Investigation**  
**Case Number: DS02028**

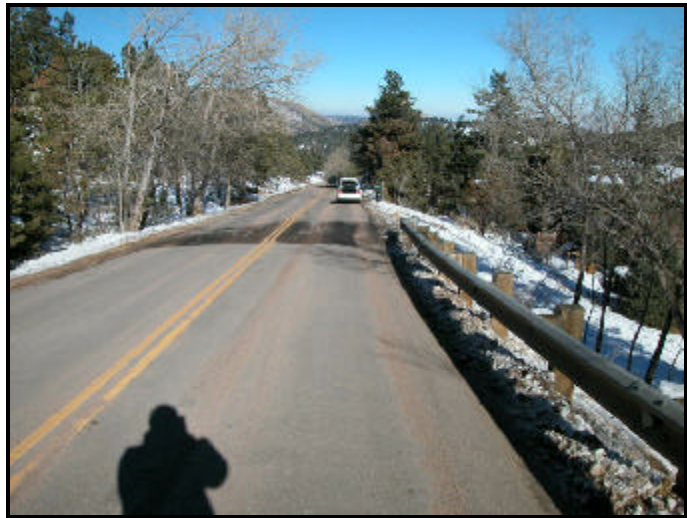
**Figure 1.** Approach to area of impact (North)

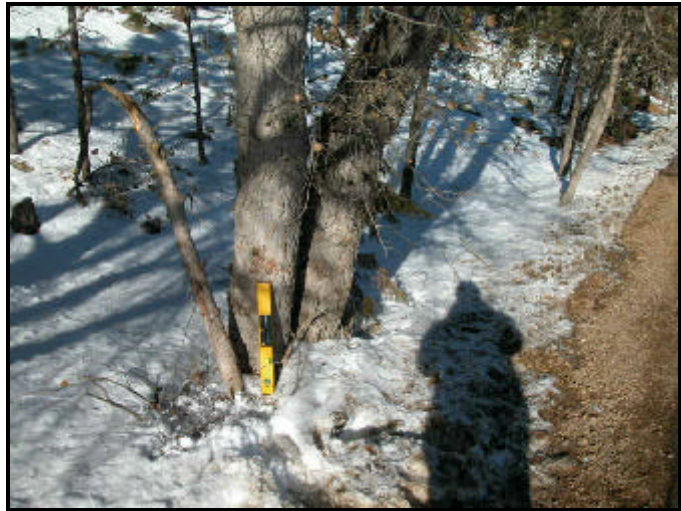
The driver was traveling northbound around the left hand curve. As the vehicle entered the straight portion of the roadway the driver braked and lost control of her vehicle. The case vehicle began a slight counter clockwise yaw. As the vehicle went to the left it departed the roadway on the left side and struck the trees with its front end (12FDEW3).

**Figure 2.** Tree impact

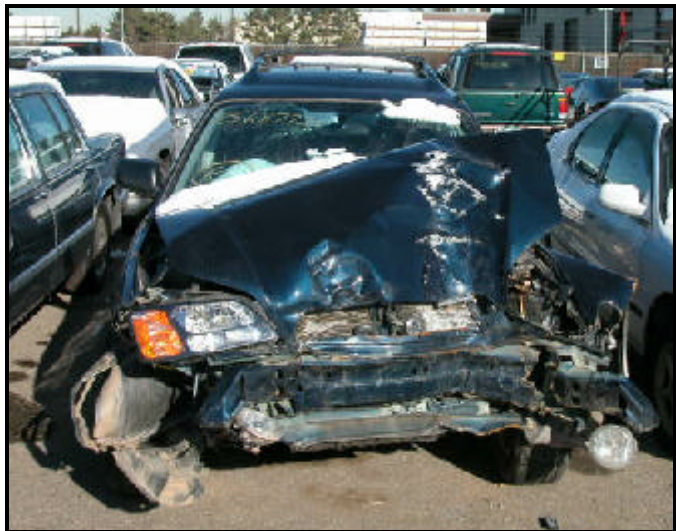
The case vehicle sustained front end damage and was towed from the scene. It was later declared a total loss by the insurance company.

**Figure 3.** Front of vehicle

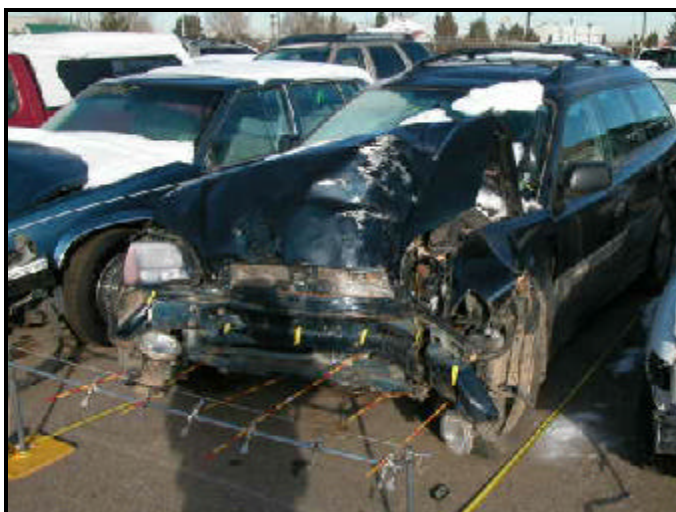
**Figure 5.** Front left, case vehicle

The case vehicle sustained 74 cm (29 in) of direct contact across the front. The residual crush measured along the bumper reinforcement bar was as follows: C1=22 cm (9 in), C2=45 cm (18 in), C3=53 cm (21 in), C4=43 cm (17 in), C5=31 cm (12 in), C6=8 cm (3 in). The maximum crush was located between C2 and C3 and measured 60 cm (24 in). The principle direction of force was within the 12 o'clock sector and was an estimated 10 degrees. The damaged components included the bumper fascia and reinforcement bar, the grille, hood, and the upper and lower radiator supports. The wheelbase was shortened by 1 cm (0.4 in) on the left side. There was glazing damage to the right side of the windshield from the deploying passenger air bag. There was no intrusion.

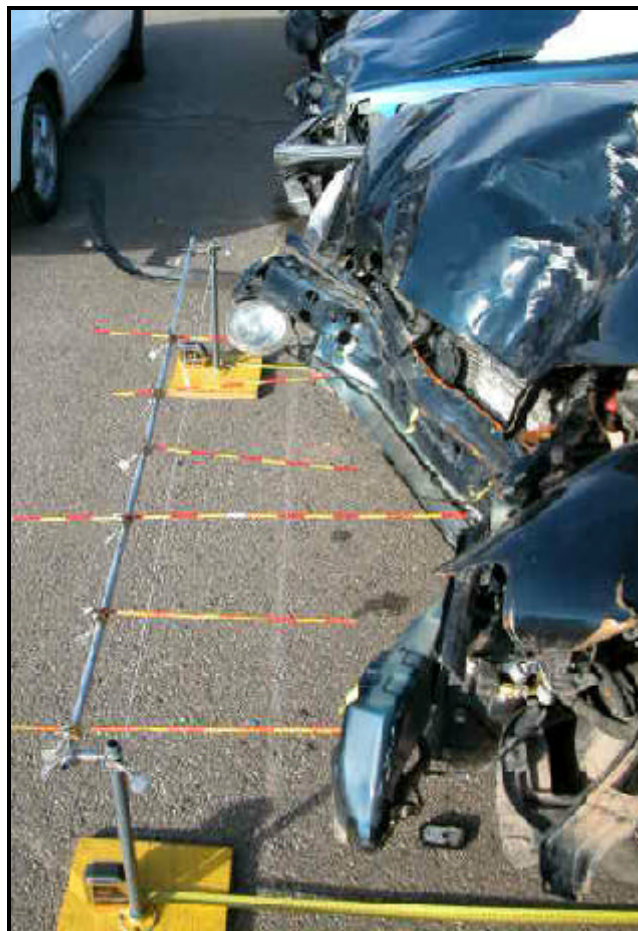
**Figure 6.** Left view of case vehicle showing depth of crush

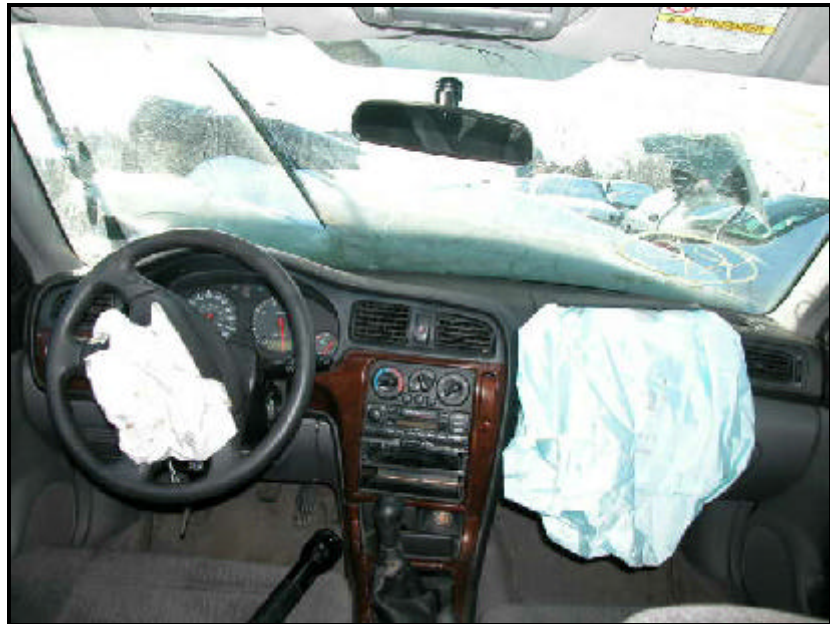
**Figure 7.** Driver's and front right passenger air bag

The supplemental restraint system for the case vehicle consisted of dual stage driver and front right passenger air bags that deployed as a result of the crash. It is not known if this was a first or second stage deployment. The driver air bag was designed in the typical manner and located in the center hub of the steering wheel. The module cover opened in an H-configuration. There was no contact evidence on the cover flap. The air bag measured 55 cm (21.6 in) in its deflated state. There was a single tether and two vent ports that were located at the 3 and 9 o'clock positions. There was no

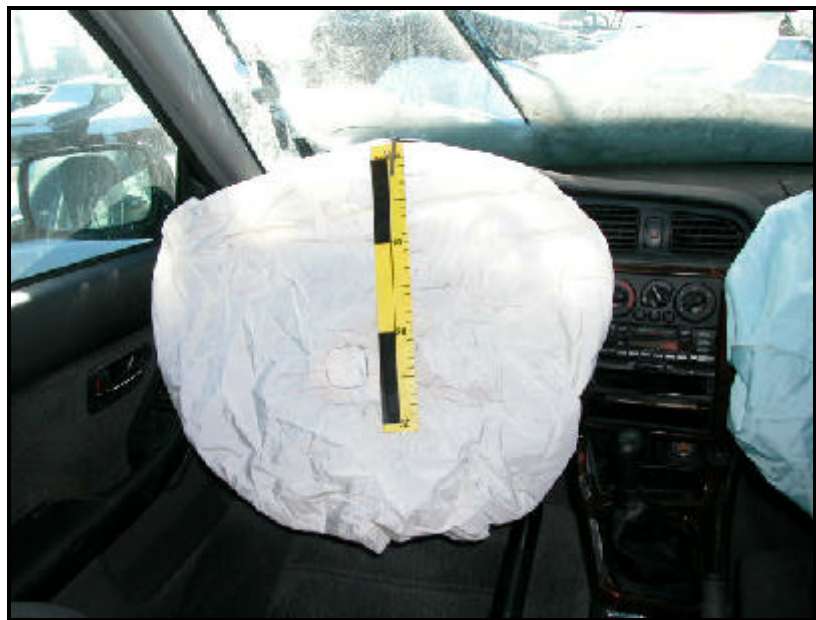
**Figure 8.** Driver's air bag

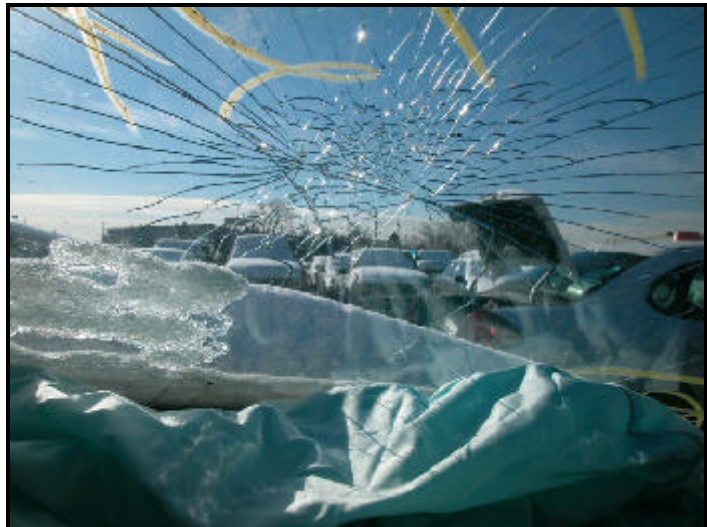
**Figure 9.** Air bag contact to windshield

contact evidence on the face of the air bag. The front right passenger air bag was located at the top of the right instrument panel. The H-configuration module cover measured 26 cm (10 in) wide by 9 cm (4 in) high on the top and 4 cm (1 in) high on the bottom. The passenger air bag measured 66 cm (26 in) wide by 55 cm (22 in) high with a maximum deployed excursion of 55 cm (22 in). The air bag was vented at the 3 and 9 o'clock positions. There was no occupant contact evidence on either the air bag or the module covers. The deploying passenger air bag did fracture the windshield on the right side. There was evidence of bag contact to the windshield.

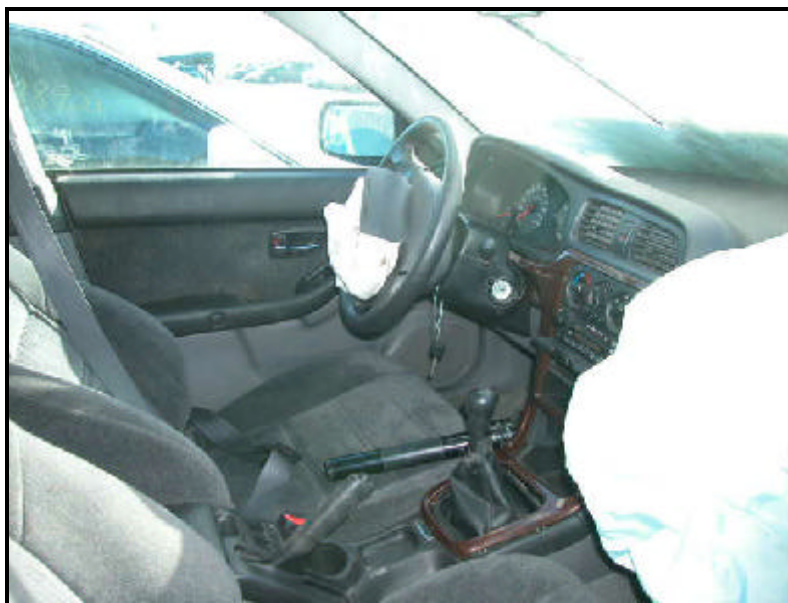
The 33-year-old female driver of the case vehicle was seated in a normal, upright fashion. She was wearing the available 3-point lap and shoulder belt. The fabric-covered bucket seat had been adjusted to the forward most position. Both hands were on the steering wheel. She was steering to the left, so the right hand was higher than the left. Her right foot was on the brake, and the left was on the floorboard. Upon impact, both front seat belt retractor pretensioners fired and the frontal air bags deployed. The driver responded to the 12 o'clock direction of force by exhibiting a forward trajectory and loading the pretensioned and locked manual restraint system. The driver's face contacted the deployed air bag. Her lower body loaded the seat belt—causing bilateral contusions to her hips. During the subsequent rotation, the driver's right leg contacted and dislodged the center console trim panel. This contact did not result in any injury.

Figure 10. Driver's seat

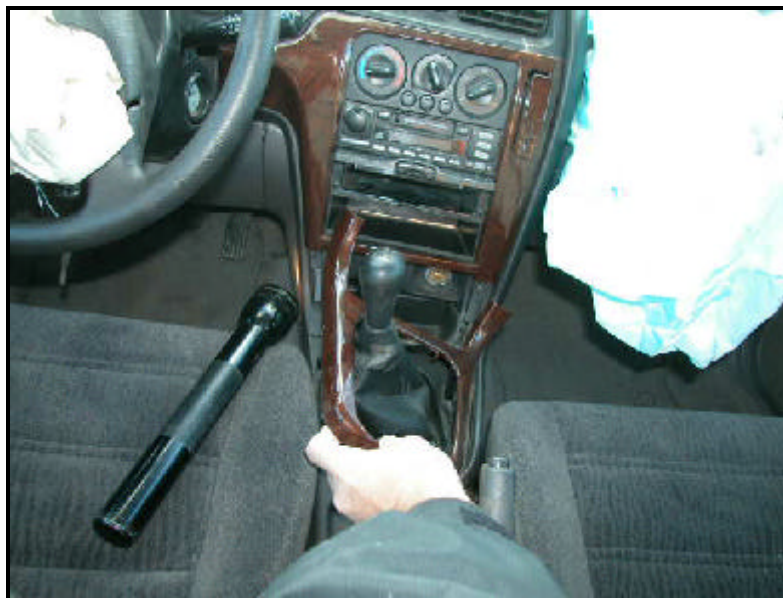
Figure 11. Displaced console trim

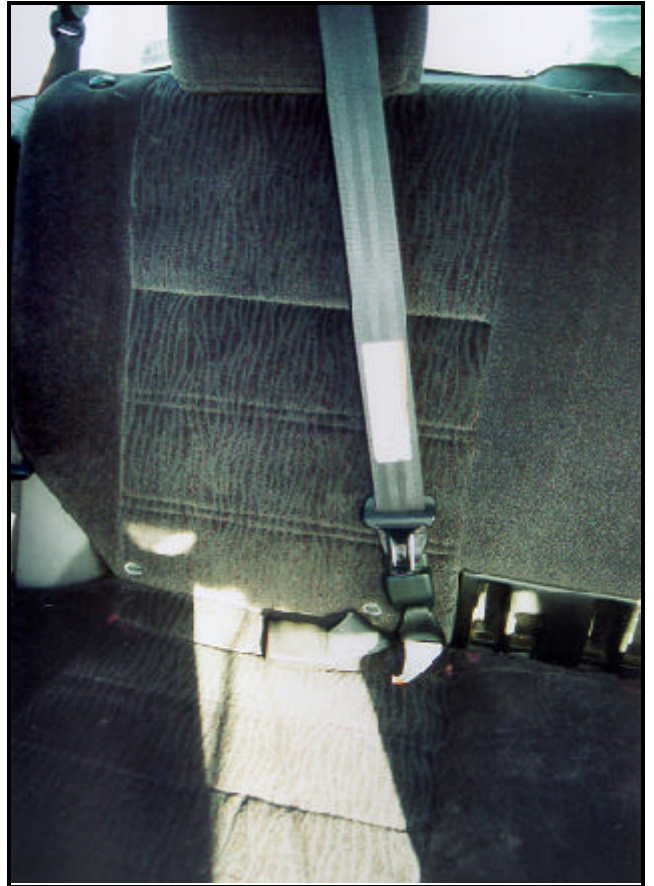
The 9-year-old female right rear seat occupant was seated in a normal, upright fashion. She was wearing the available 3-point lap and shoulder belt. Upon impact, this occupant responded to the 12 o'clock direction of force by exhibiting a forward trajectory and loaded the manual restraint system. Her lower body loaded the seat belt—causing bilateral contusions to her hips. There were no indications of any contacts to any surfaces in the rear seating area.

**Figure 12.** Right rear seating area
