Advanced Occupant Protection System Investigation / Vehicle to Vehicle
Dynamic Science, Inc. / Case Number: DS02029
2003 GMC Safari van
Washington
October, 2002

1. Report No. DS02029		2. Government Accession No.		3. Recipient Catalog No.	
4. Title and Subtitle Advanced Occupant Protection System Investigation				5. Report Date January 16, 2004

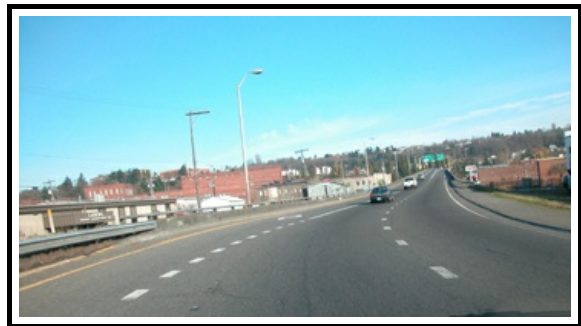
Figure 1. Direction of travel towards POI (east)

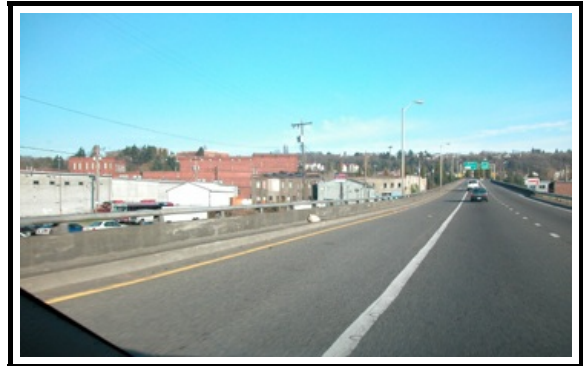
Figure 2. Area of impact

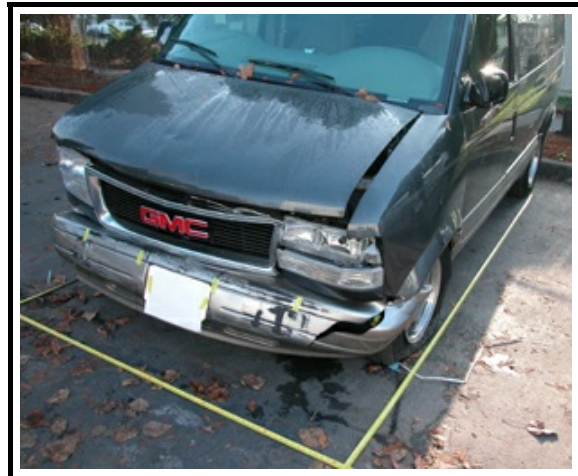
Figure 3. Exterior frontal damage to case vehicle

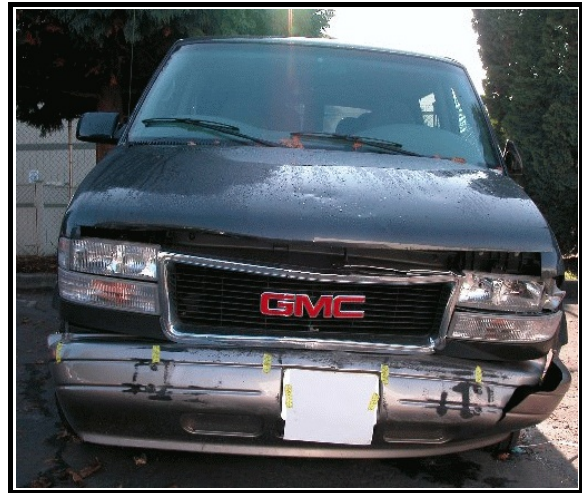
Damage Description:	Moderate front end damage to bumper, grille, radiator and hood. Bumper slightly shifted to left. Towed from the scene due to damage.	
CDC:	12FLWN3 (Event 1) 12FDEW2 (Event 2)	
Delta V:	Total	20.0 km/h (12.4 mph)
	Longitudinal	-19.7 km/h (-12.2 mph)
	Latitudinal	-3.5 km/h (-2.2 mph)
	Energy	32,376 joules (23,879 ft-lbs)

During impact 1 with the concrete wall, the case vehicle sustained 170 cm (67 in) of direct and induced contact damage that extended across the entire frontal end width of the vehicle. The impact energy was managed by the forward structures of the vehicle. The damaged components included the bumper fascia and reinforcement bar, upper and lower radiator supports, the grille area, and the hood. Six crush measurements were documented at the bumper level: C1= 19 cm (8 in), C2= 18 cm (7 in), C3= 16 cm (6 in), C4= 12 cm (5 in), C5= 2 cm (1 in), C6= 0 cm (0 in). A Collision Deformation Classification of 12FDEW2 was assigned to the damage. The principal direction of force was within the 12 o'clock sector and was an estimated 10 degrees. There was no reduction of the right side wheelbase, but there was a reduction of the left side wheelbase which measured 9 cm (4 in). All doors remained closed and operational, and there was no glazing damage.

Figure 4. Frontal damage to case vehicle

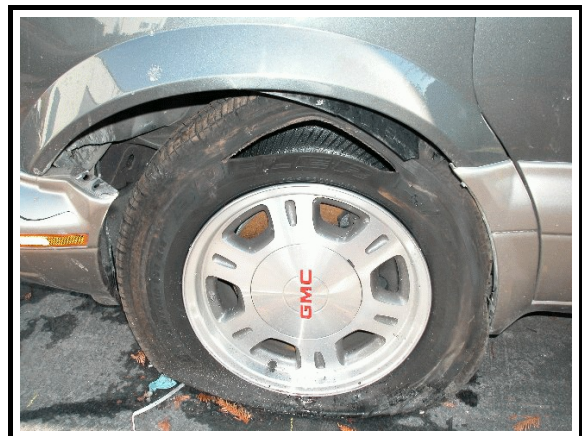
Figure 5. Damage to front left tire

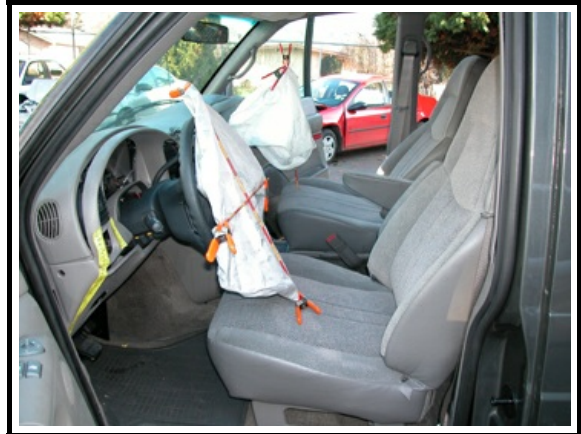
The driver's manual restraint system consisted of a continuous loop 3-point lap and shoulder safety belt with the sliding latch plate and an adjustable shoulder belt upper anchorage (full up position). The emergency locking retractor was located in the B-pillar. The front right seat was equipped with 3-point manual lap and shoulder safety belt which consisted of continuous loop belt webbing with a sliding latch plate and switchable automatic/emergency locking retractor. The two rear bench seat outboard positions were equipped with 3-point lap and shoulder safety belts which consisted of continuous loop belt webbing with a locking latch plate and emergency locking retractors. The two rear bench middle positions were equipped with manual 2-point lap safety belt which consisted of continuous loop belt webbing with a locking latch plate. Only the driver's restraint exhibited evidence of historical use in the form of minor scratching to the latch plate. Faint frictional abrasions were identified on the latch plate's plastic surface, but are not associated to with this deployment event. As indicated earlier, the Deployment Event recorded by SDM reports that the driver's belt switch circuit status was "UNBUCKLED". The instrument panel (knee bolster covering) was uniformly deformed by contact with both of the driver's knees, a good indication that the driver was not wearing the lap and shoulder safety belt.

Figure 6. Driver's seat area

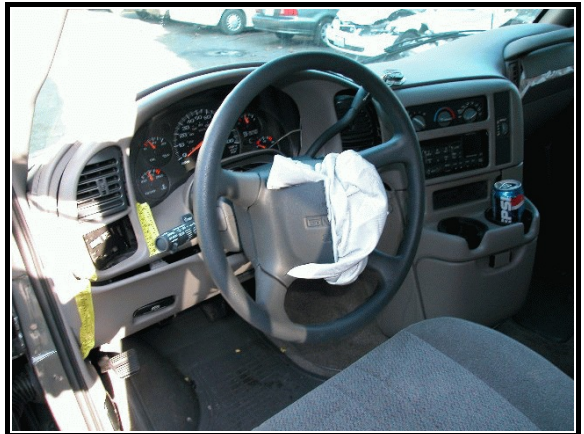
Interior damage to the 2003 GMC Safari was minimal and was attributed to occupant contacts and the air bag deployments. The plastic cover beneath the left instrument panel was dislodged by the driver's knees. The left lower air vent was pushed into the instrument panel by the driver's knee. Both front air bags deployed.

Figure 7. Knee bolster contacts

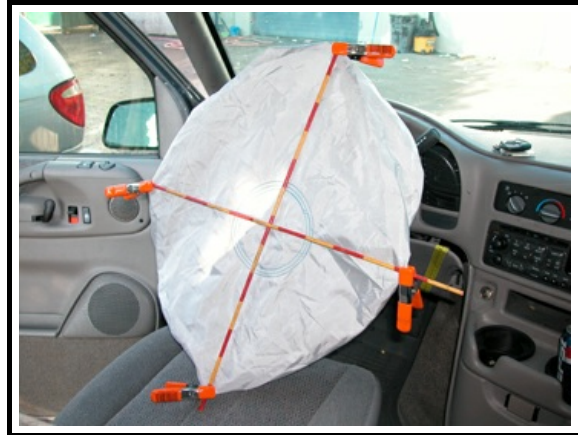
The case vehicle was equipped with redesigned (reduced force) driver and front right passenger air bags. The driver air bag module was located in the center hub of the steering wheel rim with a vertically oriented flap tear seam (I-configuration). The diameter of the deflated circular air bag was 62 cm (24 in). It was equipped with two internal tether straps and had two vent ports (11 and 01 o'clock positions). The maximum deflated air bag excursion measured approximately 20 cm (8 in). There were no indications of any damage to driver's air bag or the module cover flaps. On the face of the lower right quadrant of the air bag, there were vinyl transfers to the membrane from expansion within the module. There were nine horizontal folds and seven vertical folds. There was no occupant contact evidence on the air bag.

Figure 8. Driver's air bag

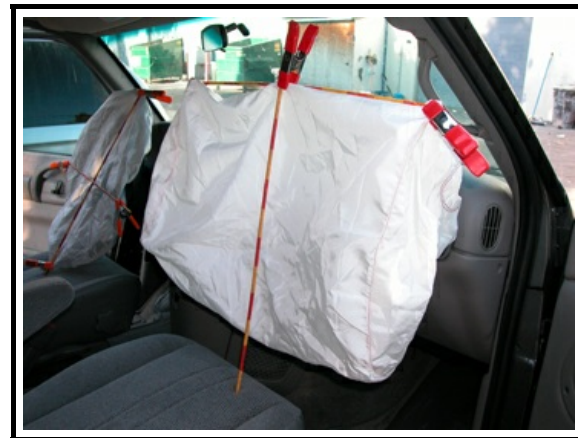
The front right passenger air bag was a mid instrument panel mount with dual symmetrical module cover flaps. The deflated air bag was rectangular in shape with a height of approximately 53 cm (21 in) and a width of approximately 56 cm (22 in). The maximum deflated air bag excursion measured approximately 53 cm (21 in). The air bag was untethered and had two vent ports (02 and 10 o'clock positions). There were no indications of any damage to front right passenger air bag or the dual module cover flaps. There was faint evidence of vinyl transfer to the membrane from expansion within the module to the middle face of the air bag. There were six vertical folds on the air bag face.

Figure 9. Front right passenger's air bag

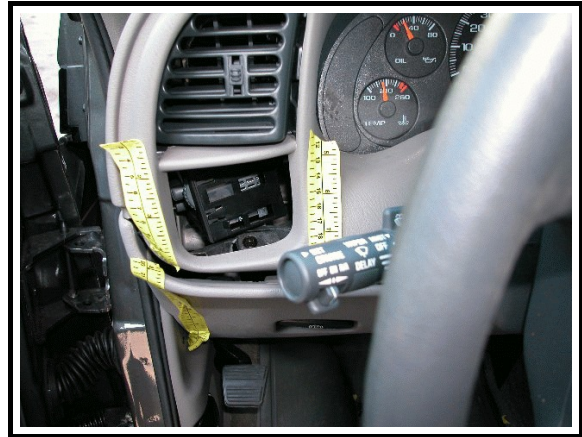
Figure 10. Close up of left knee contact

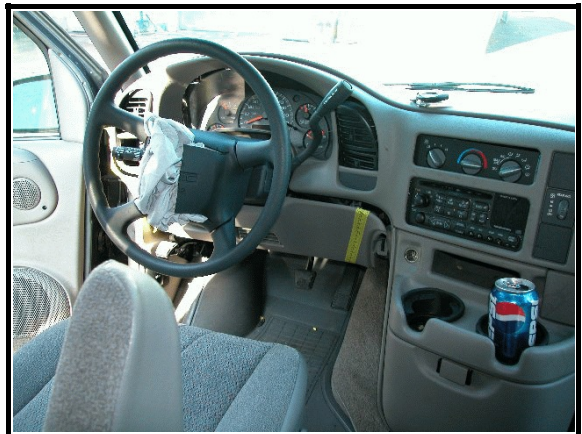
Figure 11. Driver's air bag and right knee contact
