**VERIDIAN ON-SITE SIDE IMPACT OCCUPANT PROTECTION
INVESTIGATION**

VERIDIAN CASE NO. CA02-030

VEHICLE - 2001 BMW 740i

CRASH DATE - JULY, 2002

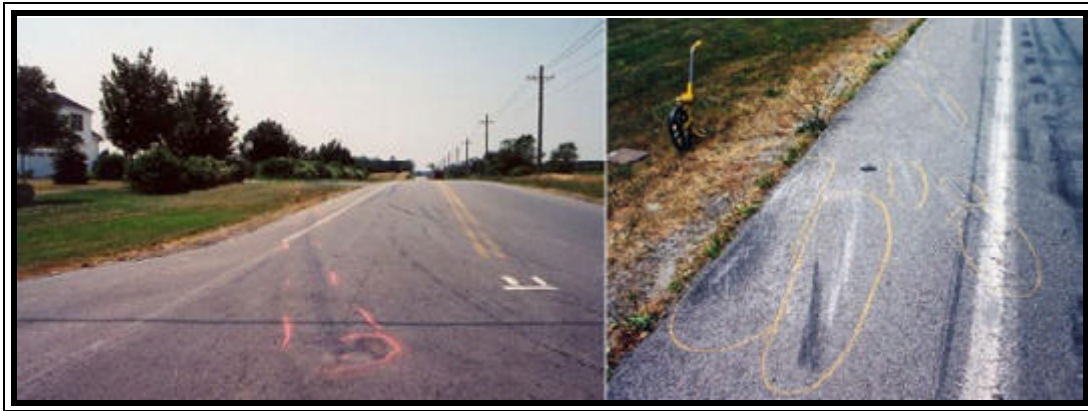
rotated clockwise 50 degrees and began its post-impact trajectory into the southwest sector of the intersection (**Figure 3**). The vehicle began to move laterally as the left side wheels dug into the asphalt surface. The BMW was tipped (*leaning*) slightly to the left as it exited the south pavement edge and traversed an adjacent grassy area. The left side wheels began digging into the soft soil as the BMW continued 15.4 meters (50.5 feet) in a southwesterly direction across a shallow ditch and residential lawn. This tripping mechanism initiated a three quarter turn left side rollover (“*tripover*”) resulting in moderate top damage. This trajectory was evidenced by the extensive physical evidence documented at the crash site. The 2001 BMW came to rest (on its right side) adjacent to a residential driveway off the south pavement edge of the east/westbound lanes facing northwest.

Figure 3. Southwest post-impact trajectory and pavement gouging for the 2001 BMW 740il.

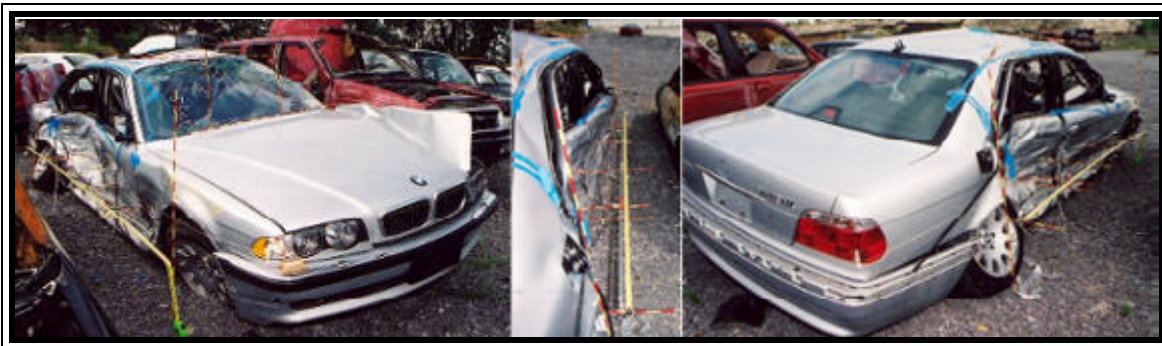
The 2001 BMW 740il sustained moderate right side surface damage as a result of the impact with the 1990 Dodge Shadow (**Figure 4**). The direct contact damage began at the right rear axle and extended 290.0 cm (114.2 in) forward. The combined direct and induced damage length (Field L) also began at the right rear axle and extended 306.0 cm (120.5 in) forward. Six crush measurements were documented at the level of the mid-door: C1= 0, C2= 30.0 cm (11.8 in), C3= 27.0 cm (10.6 in), C4= 14.0 cm (5.5 in), C5= 10.0 cm (3.9 in), C6= 0. A maximum crush value of 33.0 cm (13.0 in) was identified 13.0 cm (5.1 in) forward of the C2 position. The Collision Deformation Classification (CDC) assigned for this initial impact to the BMW was 01-RYEW-3 with a principal direction of force of (+)40 degrees. White paint transfers were noted along the direct contact damage which extended vertically to the upper door area. The right side doors were jammed as the tempered glazings were disintegrated. The right rear wheel/tire was restricted by sheet metal displacement and partially deflated. Induced contact damage produced buckling along the right roof and side rail areas. Reduction in the right side wheelbase measured 7.0 cm (2.8 in).

Figure 4. Right side surface damage to the 2001 BMW 740il 4-door sedan from the initial impact.

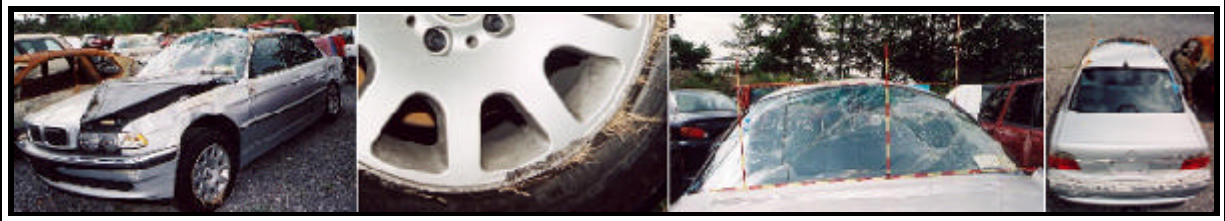
Direct contact damage was also identified along the top and (left/right) side surfaces of the vehicle and attributed to the rollover (**Figure 5**). A maximum crush value of 8.0 cm (3.1 in) was documented along the left roof side rail. Distinct directional striations in the deformation allowed for accurate separation of impact damage for correct assignment of CDC's. The CDC assigned to this secondary impact to the BMW was 00-TDDO-2. Extensive scratches and indentations were documented along both side rails and support pillar areas. Additional roof displacement was attributed to the rollover with buckling identified along the mid-sections and the roof tempered glazing disintegrated. The windshield was fractured in multiple locations from exterior impact forces (only) as the backlight remained undamaged. The exterior roof structure was meticulously analyzed for evidence of occupant ejection, however, none was identified. The left side leading edge of the hood was deformed upward during the rollover with no direct contact damage identified to the remainder of the hood surface or trunk hatch. The rear bumper

fascia separated from the vehicle during the crash sequence. Heavy deposits of grass, soil, and asphalt were noted in the left side wheels, as the edges of the rim were scarred from bituminous pavement interaction during the initial stages of the tripping mechanism. Additional scarring, asphalt and soil deposits were noted in the right front wheel, however, none was identified on the right rear.

Figure 5. Rollover damage to the 2001 BMW 740il 4-door sedan.

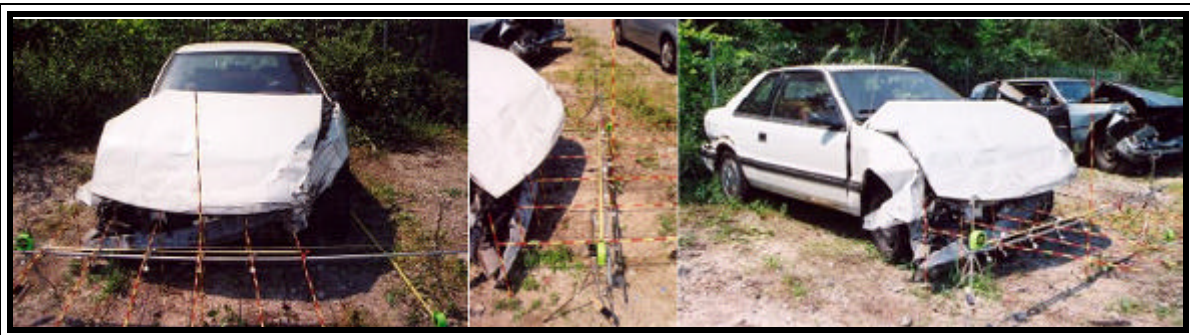
The 1990 Dodge Shadow 2-door hatchback sustained moderate frontal damage as a result of the impact with the 2001 BMW 740il (**Figure 6**). The direct contact damage encompassed the entire front end width resulting in a combined direct and induced damage length (Field L) of 130.0 cm (51.2 in). Six crush measurements were documented at the level of the reinforcement bar (*bumper fascia separation*): C1= 34.0 (13.4 in), C2= 33.0 cm (13.0 in), C3= 36.0 cm (14.2 in), C4= 36.0 cm (14.2 in), C5= 34.0 cm (13.4 in), C6= 33.0 cm (13.0 in). The CDC assigned for this impact to the Dodge was 70-FDEW-2 with a principal direction of force of (-)50 degrees {principal direction of force incremented by 70 to reflect 13.0 cm (5.1 in) of lateral shifting of the end structure to the right}. Light colored paint transfers were identified along the direct contact damage. Black rubber transfers were documented on the leading edge of the hood which was also deformed up and rearward from engagement against the side surface of the BMW. Direct damage was also noted to the left fender and attributed to spinout contact following vehicle maximum engagement. The right fender was displaced rearward and to the right, which restricted the right front wheel/tire (not deflated). Induced contact damage produced minor roof buckling at the right B-pillar. Pre-existing fractures were noted to the mid-windshield as none were attributed to *this* crash. In addition, pre-existing damage was found on the right rear quarter panel with heavy rust deposits. Reduction in the right side wheelbase measured 7.5 cm (3.0 in) while elongation of the left side wheelbase measured 2.0 cm (0.8 in). All tempered glazings remained undamaged. It should be noted that a small leak was identified on the master brake cylinder, which resulted in somewhat “soft” brakes.

Figure 6. Frontal damage to the 1990 Dodge Shadow 2-door hatchback.

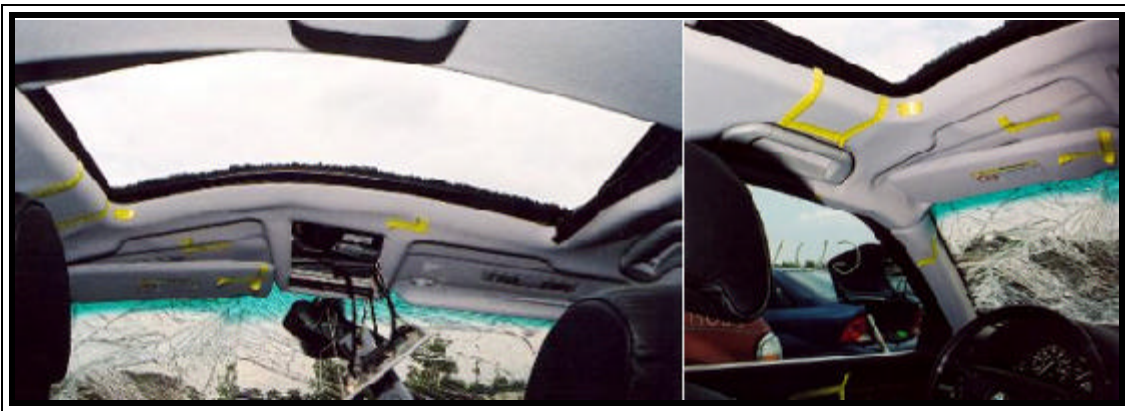
Interior damage to the 2001 BMW was moderate and attributed to component intrusions and occupant contact. Scuff marks were documented on the left roof and side rail, door panel, knee bolster, and center console. The roofliner was abraded in several areas, however, no distinct evidence of ejection was identified (**Figure 7**). Multiple indentations, blue scuff and scratch marks were documented on the right front door panel. Distinct strands of gray and black hair were noted to the left of the (disintegrated) roof glazing, adjacent to the left roof side rail. An elongated scratch mark was documented along the windshield header which began at the right sunvisor and extended into the driver space. The rear view mirror was out-of-place, but, along with the vanity mirrors, remained undamaged. This contact pattern was a clear indication of (right to left) occupant movement within the vehicle during the rollover, and confirmed the lack of belt use by the child passenger.

Figure 7. Contact evidence along the interior roof structure of the 2001 BMW 740iL 4-door sedan.

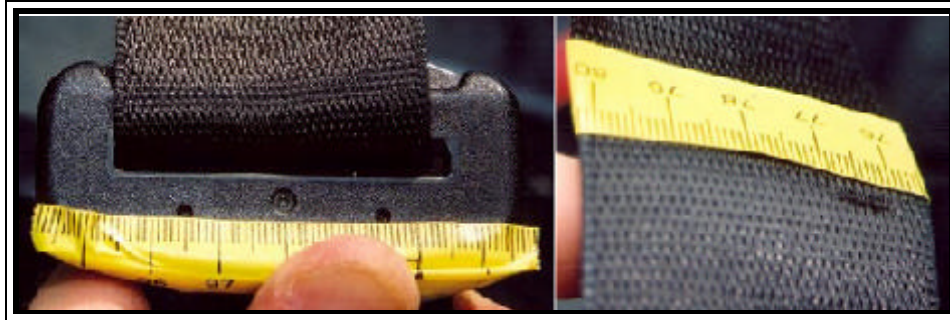
The interior of the BMW consisted of a five passenger seating configuration with front bucket and a rear bench seat. The driver 3-point manual lap and shoulder belt system consisted of a continuous loop belt webbing with a sliding latchplate and a dual mode retractor (inertial lock/belt sensitive). Dimpling was documented on the shoulder portion of the driver restraint and attributed to latchplate loading (**Figure 8**). Light abrading was also identified on the driver D-ring and latchplate webbing sleeve. The driver retractor was noted to be still operable with the shoulder webbing shortened by the pretensioner

Figure 8. Loading evidence on the BMW driver restraint.

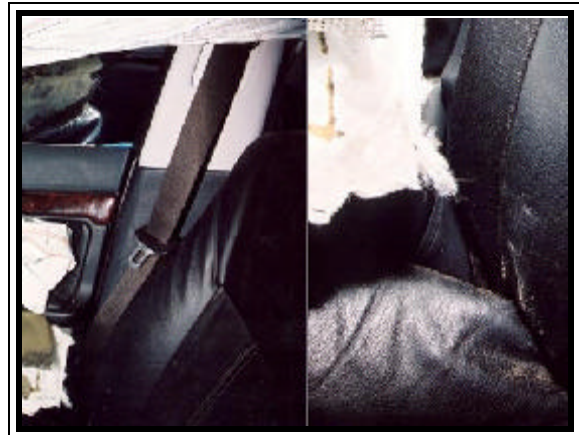
Figure 9. BMW front right restraint restricted in the stowed position by lateral component intrusions.

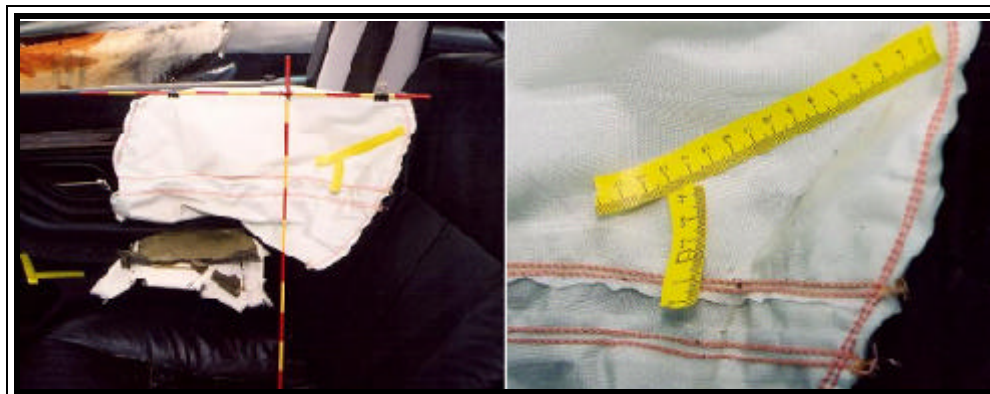
The 2001 BMW 740il was equipped with door mounted side impact air bags for the front seated positions. The right front side impact air bag deployed as a result of the initial impact with the Dodge Shadow (**Figure 10**) and was identified by the Autoliv part number: >PA6.6/Si< with a bar coded lot number of: 0314860035438939. The air bag modules were housed in the door panel above the armrest [42.5 cm (16.7 in) above floor level or 14.3 cm (5.6 in) above the level of the seat cushion] with a single cover flap design hinged at the lower aspect. The flap was trapezoidal in shape and measured 25.0 cm (9.8 in) in width along the top portion, 15.0 cm (5.9 in) in width along the lower portion, and 11.5 cm (4.5 in) in height. No contact evidence was identified on the exterior surface of the module cover flap, however, a pronounced smudge mark was documented along the aft (inboard) portion of the air bag face. The air bag was rectangular in

shape and measured 46.0 cm (18.1 in) in width and 32.0 cm (12.6 in) in height in its deflated state. The bag was tethered by a horizontal stitch pattern which extended across the face of the membrane. No vent ports were present. The side impact air bag sensors were located in the front door cavities.

Figure 10. 2001 BMW 740il deployed right front side impact air bag (thorax).

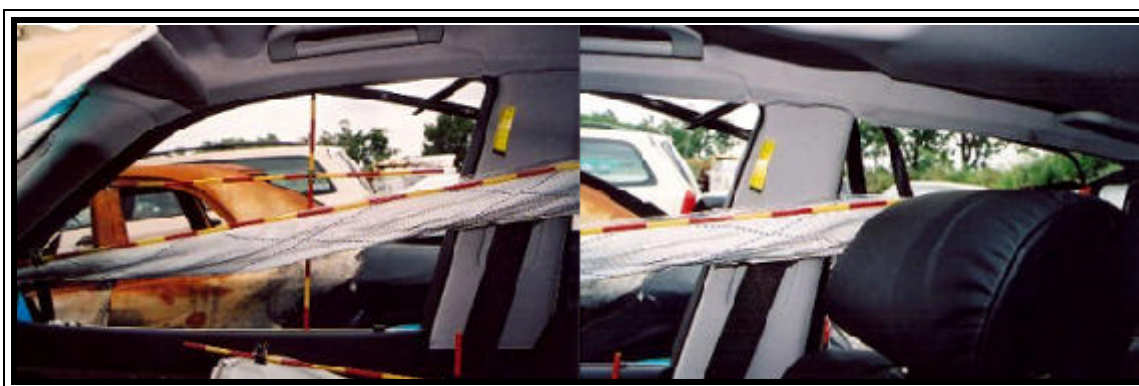
The BMW was also equipped with a head protection air bag for the outboard seated positions. The right side head protection air bag also deployed as a result of the initial impact with the Dodge (**Figure 11**) and was identified by the Autoliv part number: 857001 4260 4N with a bar coded lot number of: ASG 01B0111A00490. The head air bag was housed between the interior roof headliner and structural roof side rail with a horizontal seam measuring 146.0 cm (57.5 in) in length (separation of the headliner versus an actual flap). Inflation was achieved by the use of a cold gas (stored) inflator located in the C-pillar. The air bag measured 7.0 cm (2.8 in) in diameter and 105.0 cm (41.3 in) in length in its deflated state. The air bag was tethered by two external straps connected to the left A-pillar and left rear roof side rail. The front outboard restraint systems also included retractor pretensioners mounted in the lower B-pillars. The activation of both front restraint pretensioners reduced the slack in both the lap and shoulder belt webbing.

Figure 11. 2001 BMW 740il deployed right side head protection air bag.

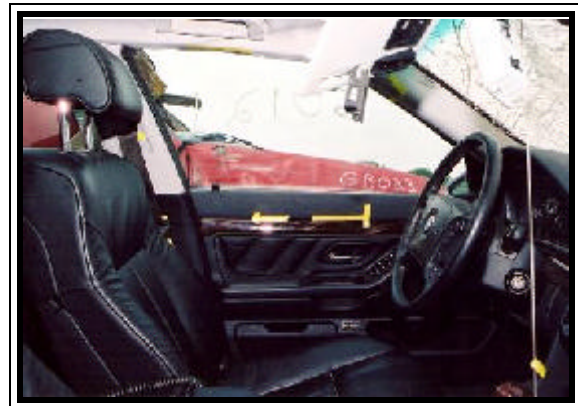
Figure 12. 2001 BMW 740il driver contact evidence.

At impact with the 1990 Dodge Shadow, the BMW driver initiated a forward and slightly lateral trajectory in response to the 1 o'clock impact force and loaded the manual restraint, knee bolster, and center console. This kinematic response was evidenced by the scuff marks documented on these components, however, no specific injury was reported as a result. At this point, the BMW driver initiated movement to the left in response to the vehicle's post-impact clockwise rotational trajectory. As the vehicle tripped into the left side rollover, he loaded the door panel (**Figure 12**) as his head may have "grazed" the roofliner, evidenced by the scuff marks identified just above the armrest and hair strands noted to the left roof area. Following the crash, he exited the vehicle under his own power (port unknown). The BMW driver complained to police (and the surrogate later) of unspecified neck/shoulder pain, however, he refused subsequent transport to a local medical facility for diagnosis and possible treatment. Use of the available 3-point manual lap and shoulder belt system minimized driver movement during the crash, thus reducing the risk of potential serious injury.

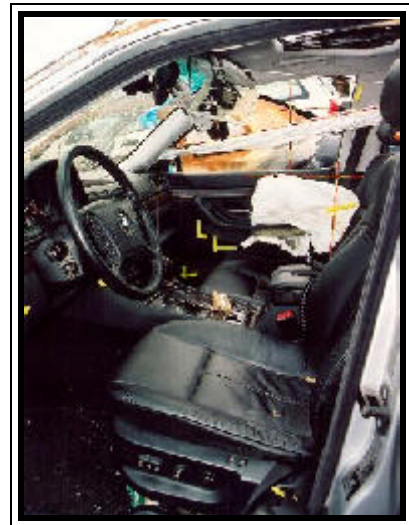
At impact with the 1990 Dodge Shadow, the child passenger of the BMW initiated a lateral and slightly forward trajectory in response to the 1 o'clock impact force and loaded the deployed side impact occupant protection system (head and thorax) and door panel. Bag interaction was confirmed by the light abrading and smudge marks documented on the inboard surface of the membrane. Distinct indentations and scuff marks clearly placed the lower extremities against the door panel during this kinematic response (**Figure 13**), however, the lack of official injury data prohibits an exact analysis of injury sources related to this impact or the subsequent rollover.

Figure 13. Lateral view of the 2001 BMW 740il front right passenger contact evidence.
