On Site Certified Advanced 208 Complaint Investigation / Vehicle to Object
Dynamic Science, Inc. / Case Number: DS02030
2003 Chevrolet Tahoe K1500 Z71 4WD
Texas
October, 2002

Dynamic Science, Inc.
Crash Investigation
Case Number: DS02030

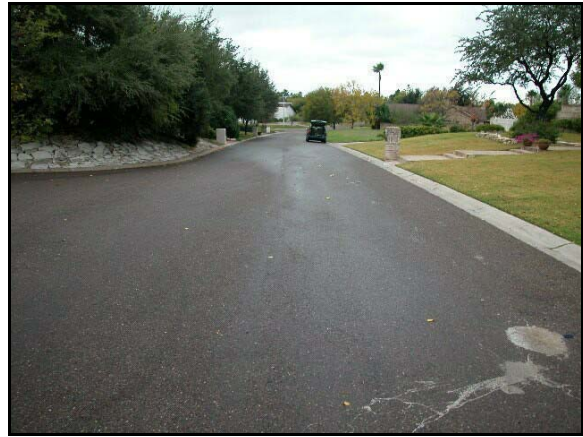
Figure 1. Path to point of impact (west)

The case vehicle was initially traveling eastbound approaching a cul-de-sac. There was a parked vehicle on the north side of the roadway that was parked heading east. The police report indicates that the driver of the case vehicle was unfamiliar with the area and did not realize that the roadway was coming to a dead end. The case vehicle entered the cul-de-sac traveling at a police estimated high rate of speed. The driver made 180 degree turn in the cul-de-sac and headed west. The driver swerved to the left to avoid the parked vehicle on the north side of the roadway. The driver lost control of the vehicle and headed in a south-west direction.

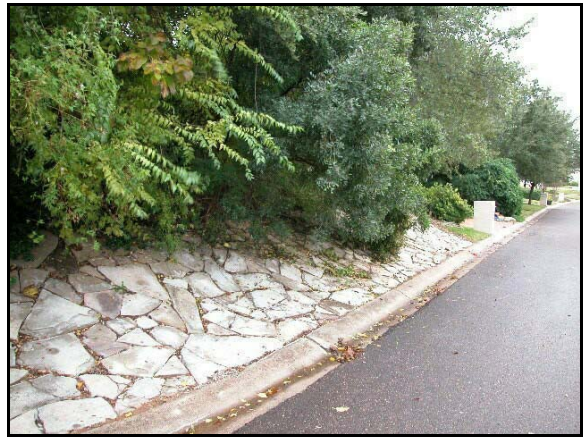
Figure 2. Rain gutter, path to impact with tree (southwest)

The case vehicle “bottomed out” as it went over the rain gutter on the south side of the street, and the Sensing Diagnostic Module (SDM) recorded a non-deployment event. A non deployment event is an event severe enough to “wake up” the sensing algorithm but not severe enough to deploy the air bags. The SDM downloaded non-deployment data indicates that five seconds prior to algorithm enable (AE), the case vehicle was traveling at 24 km/h (15 mph), and accelerating. The brake switch circuit status was in the “OFF” position. The case vehicle continued moving forward off the roadway in a southwest direction and traveled up the positive 5% grade embankment while going through shrubs. The case vehicle struck a tree with its front left bumper (32FYEW1). The driver’s and front right passenger’s air bags deployed at this time. The total velocity change for the case vehicle as calculated by the barrier algorithm of the WinSmash collision model was 19 km/h (12 mph). The longitudinal and lateral delta V components were -19 km/h (-12 mph) and 0 km/h (0 mph), respectively. The results fit the collision model but appear low. The SDM recorded a deployment event with a maximum forward velocity change of -26.26 km/h (-16.32 mph) at the 172.5 ms mark. The SDM data also indicates that the case vehicle was traveling at a maximum speed of 39 km/h (24 mph) with the brake switch circuit status in the “OFF”, two seconds prior to AE.

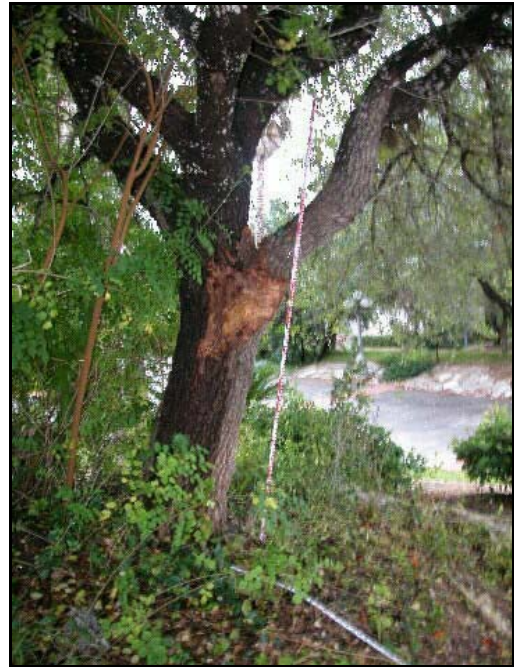
Figure 3. Impact with tree

The case vehicle came to final rest at the point of impact with the tree and its front end in contact with the tree heading southwest.

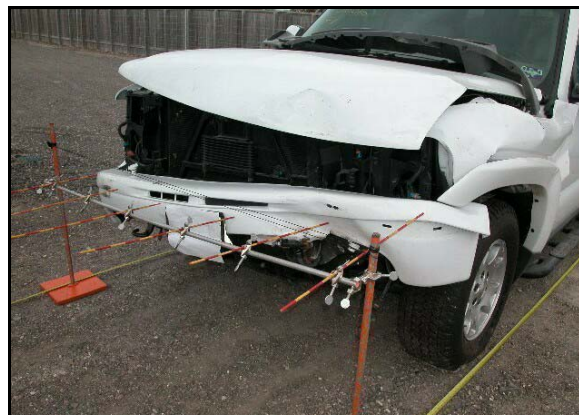
Figure 4. Front exterior damage to case vehicle

Damage Description: During impact with the tree, the case vehicle sustained 174 cm (69 in) of direct and induced contact damage that began at the front left bumper corner. The direct damage began 13 cm (6 in) from the front left bumper corner and extended laterally to the right 50 cm (20 in). The impact energy was managed by the forward structures of the vehicle. The damaged components included the bumper fascia and reinforcement bar, the lower radiator supports, the grille area, the hood, and both front fenders. Six crush measurements were documented at the bumper level: C1= 16 cm (6 in), C2= 24 cm (9 in), C3= 12 cm (5 in), C4= 5 cm (2 in), C5= 0 cm (0 in), C6= 0 cm (0 in). A Collision Deformation Classification (CDC) of 32FYEW1 was assigned to the damage. The principal direction of force was within the 12 o'clock sector and was an estimated 0 degrees. The left front wheel was displaced rearward and restricted. There was a 4 cm (2 in) reduction of the left side wheelbase. All doors remained closed and operational. The case vehicle was towed from the scene due to damage, and was subsequently declared a total loss by the insurance company and sold as a salvage vehicle.

CDC: 32FYEW1

Delta V:	Total	19.0 km/h (11.8 mph)
	Longitudinal	-19.0 km/h (-11.8 mph)
	Latitudinal	0.0 km/h (0.0 mph)
	Energy	34,205 joules (25,228 ft-lbs)

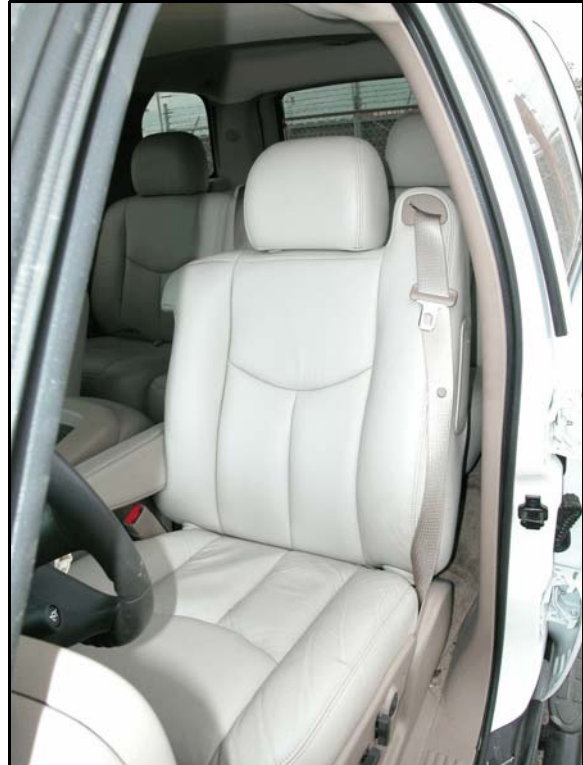
Figure 5. Driver's seat

There are manual seat integrated three-point lap and shoulder safety seat belts present for the two front seating positions. The driver's seat position was equipped with emergency locking retractor and a sliding latch plate. The metal latch plate was scratched, indicating historical usage, but there was no evidence of loading to the seat belt webbing that can be associated to the crash forces. The downloaded SDM data indicated that the driver's seat belt was unbuckled. The front right seat position was equipped with a switchable retractor (Emergency Locking Retractor-Automatic Locking Retractor) and sliding latch plate. The metal latch plate was scratched, indicating historical usage, but there was no evidence of loading to the seat belt webbing that can be associated to the crash forces.

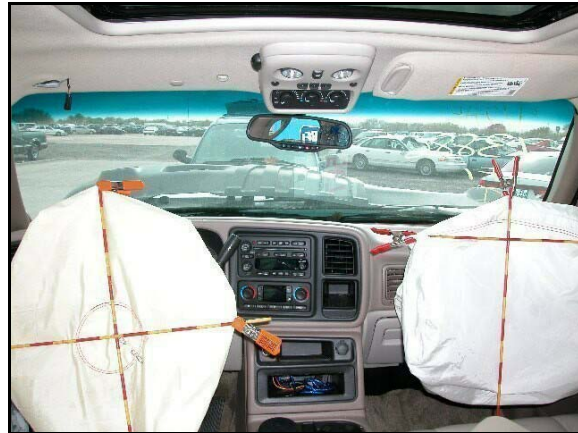
Figure 6. Frontal air bags in case vehicle

This vehicle is equipped with an advanced occupant protection system certified to comply with the Advanced Air Bag portion of FMVSS No. 208. The system consists of the SDM, dual-level (dual stage) driver and front right passenger air bags, a front right passenger sensing system, seat back mounted side air bags at both front seat positions, and a driver's seat belt latch usage detector. The case vehicle is also equipped with OnStar. The OnStar system can be activated by a button on the rear view mirror. It is not known at this time if the driver of the case vehicle communicated with the OnStar service center after the crash.

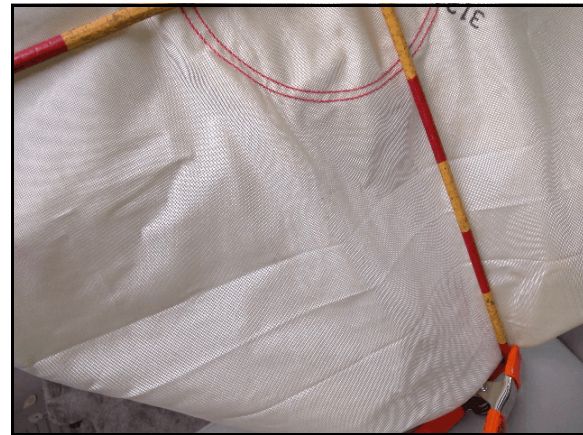
Figure 7. Driver skin transfer to air bag

The driver's air bag deployed at impact with the tree. The driver's air bag module was located in the center hub of the steering wheel rim and had two module cover flaps. The flaps opened in a designed I-configuration. Both module cover flaps measured 8 cm (3 in) by 12 cm (5 in). There was no occupant contact evidence on the module cover flaps. The diameter of the driver's air bag measured 63 cm (25 in) in its post deflated state. The driver's air bag had a maximum excursion of 20 cm (8 in). It had two vent ports at the 11 and 1 o'clock positions and two tethers sewn to the face of the air bag. There was evidence of driver contact in the form of skin transfer to face of the air bag membrane on the lower left quadrant (Figure 7). There was module cover contact to the lower center quadrant of the face of the air bag membrane and the rear right quadrant of the air bag membrane. The driver's air bag had 11 horizontal and 9 vertical folds.

His upper torso was restricted from extended forward movement due to his likely bracing effort with the steering wheel rim. He contacted the deploying driver's air bag (skin transfer was found on the face of the air bag), although no injury was reported. The driver presumably exited the case vehicle under his own power and did not report any injuries to the police.

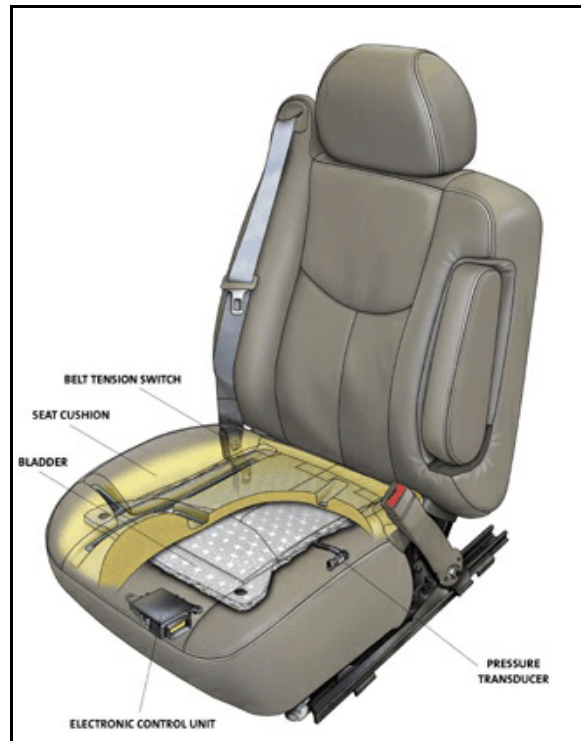
Figure 8. Front right Passenger Sensing System

The case vehicle being equipped with a Passenger Sensing System. The Passenger Sensing System is designed to automatically switch the air bag on or off based on a passenger's weight. The system also uses a sensor in the passenger-side seat belt to measure how much tension is

exerted by the seat belt when it is being cinched down, another means of determining what may be on the seat. There is an indicator on the rear-view mirror that alerts vehicle occupants to the status of the system at all times. If the light reads “Passenger Air Bag ON,” the air bag is programmed to deploy in a frontal crash of sufficient severity. If it reads “Passenger Air Bag OFF,” the system has suppressed the air bag because it determined either that there is no occupant on the front passenger seat, or that a rear-facing infant seat, a forward-facing child restraint, a booster seat or a smaller person, such as a child who has outgrown child restraints, is present.

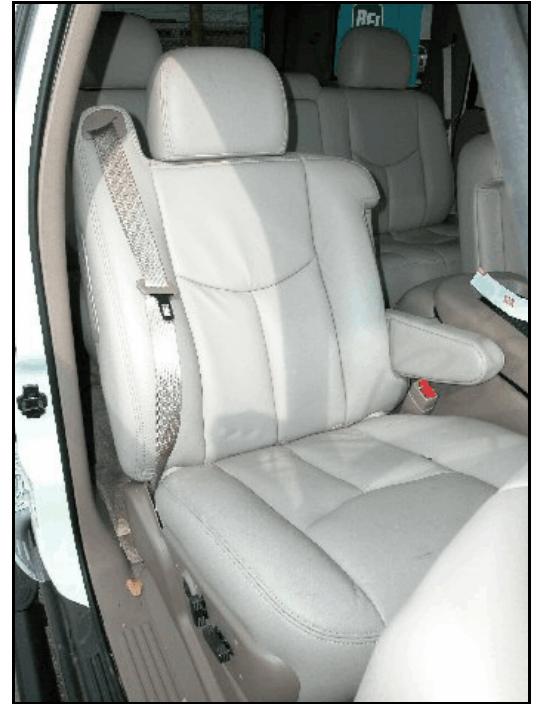
Figure 9. Front right seat

The 28-year-old male front right passenger (height and weight unknown) was unrestrained and was seated in a presumed normal upright facing forward position. The sliding latch plate revealed surface scratches and striations which suggest regular usage of the lap and shoulder belt. The belt webbing however, showed no evidence of belt loading. The leather covered bucket seat was adjusted to between the middle and rear most seat track position. The adjustable head restraint was in the full down position. In response to the 12 o'clock impact force, the unrestrained front right passenger moved straight forward. He likely contacted the deploying front right passenger's air bag, although there was no evidence of occupant contact to the air bag nor any related injuries. He presumably exited the case vehicle under his own power and did not report any injuries to the police.

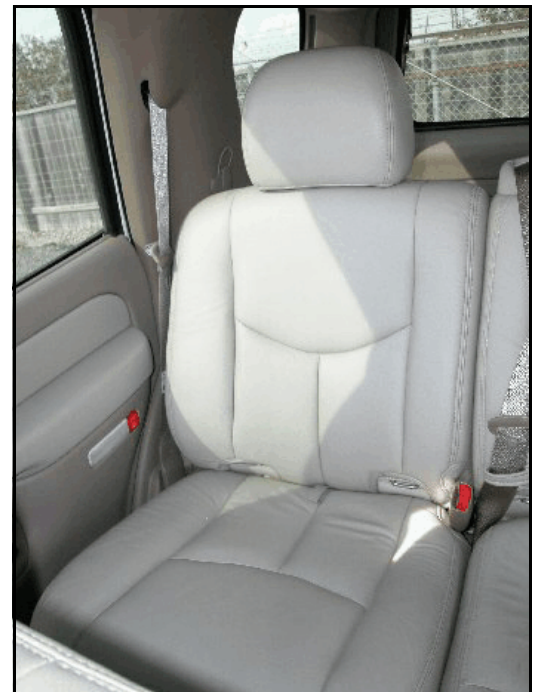
Figure 10. Rear right seat

The 29-year-old male rear right passenger (height and weight unknown) was unrestrained and was seated in a presumed normal upright facing forward position. The sliding latch plate revealed surface scratches and striations which suggest regular usage of the lap and shoulder belt. The belt webbing however, showed no evidence of belt loading. He was seated in a leather covered split bench seat with a folding back. The adjustable head restraint was in the full down position. In response to the 12 o'clock impact force, the unrestrained rear right passenger moved straight forward. He likely contacted the front right seat back, although there was no evidence of occupant contact to the seat back nor any reported injuries. He presumably exited the case vehicle under his own power and did not report any injuries to the police.

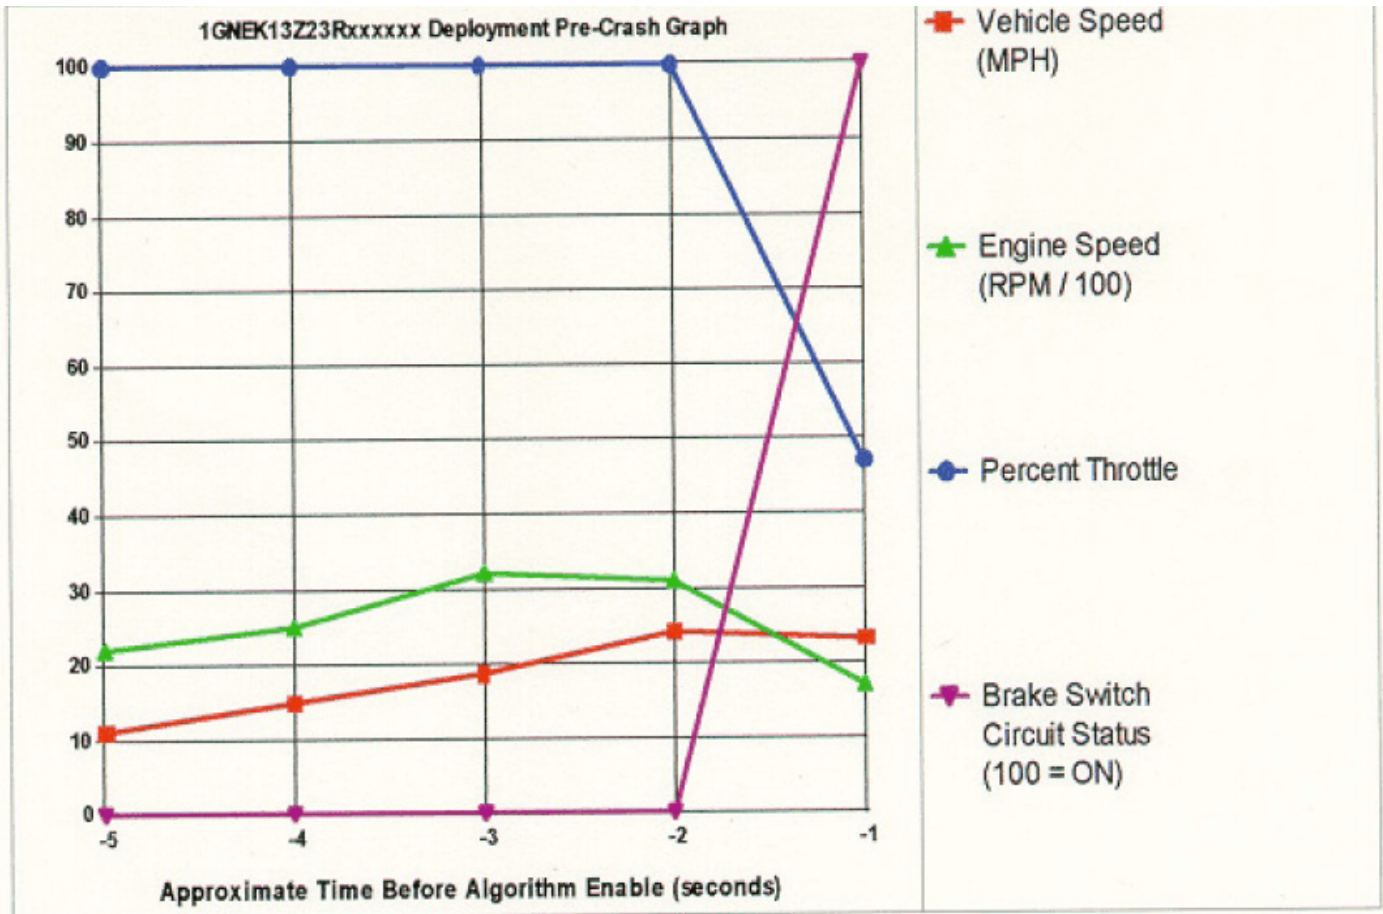
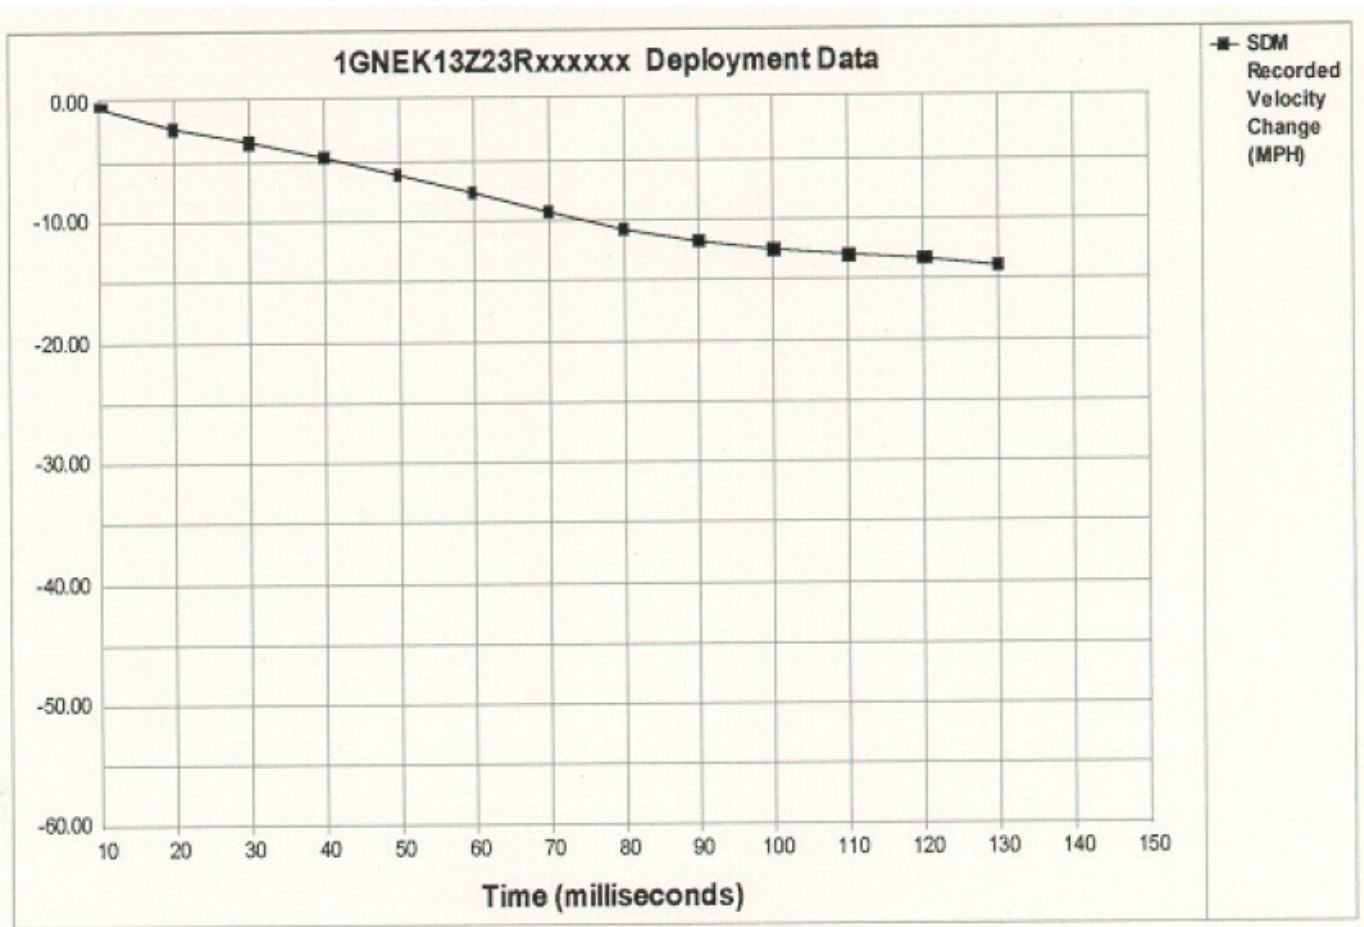
System Status At Deployment

Seconds Before AE	Vehicle Speed (MPH)	Engine Speed (RPM)	Percent Throttle	Brake Switch Circuit Status
-5	11	2240	100	OFF
-4	15	2496	100	OFF
-3	19	3200	100	OFF
-2	24	3072	100	OFF
-1	23	1664	47	ON

Time (milliseconds)	10	20	30	40	50	60	70	80	90	100	110	120	130	140	150
Recorded Velocity Change (MPH)	-0.62	-2.17	-3.41	-4.65	-6.20	-7.75	-9.30	-10.85	-11.78	-12.40	-13.02	-13.33	-13.95	N/A	N/A

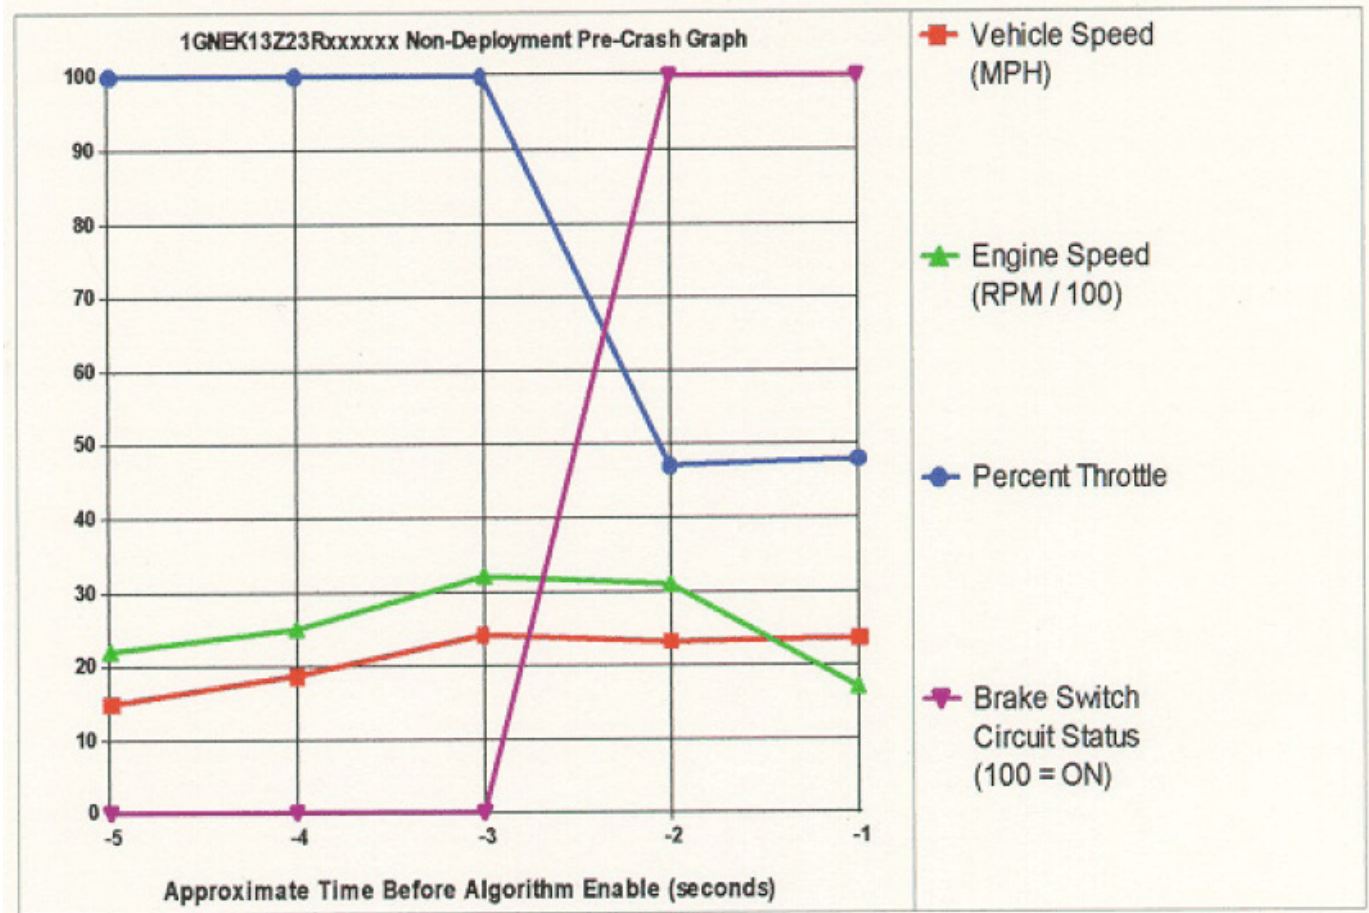
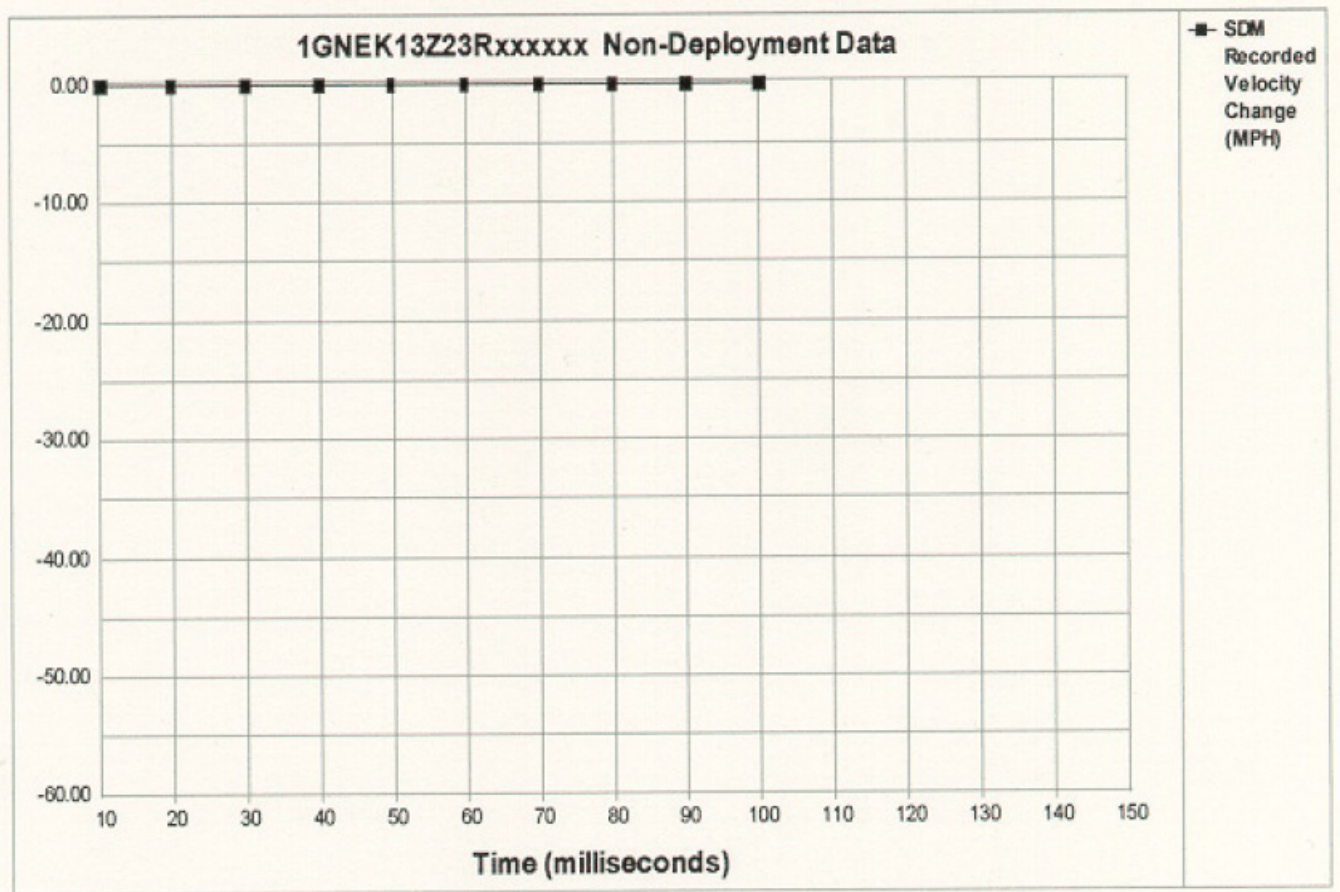
System Status At Non-Deployment

Seconds Before AE	Vehicle Speed (MPH)	Engine Speed (RPM)	Percent Throttle	Brake Switch Circuit Status
-5	15	2240	100	OFF
-4	19	2496	100	OFF
-3	24	3200	100	OFF
-2	23	3072	47	ON
-1	24	1664	48	ON

Time (milliseconds)	10	20	30	40	50	60	70	80	90	100	110	120	130	140	150
Recorded Velocity Change (MPH)	0.00	0.00	0.00	0.00	0.00	0.00	0.00	0.00	0.00	0.00	N/A	N/A	N/A	N/A	N/A
