**VERIDIAN ON-SITE AMBULANCE CRASH INVESTIGATION
SCI TECHNICAL SUMMARY REPORT**

VERIDIAN CASE NO. CA02-033

VEHICLE - 1995 FORD E-350 TYPE III AMBULANCE

CRASH DATE - JULY 2002

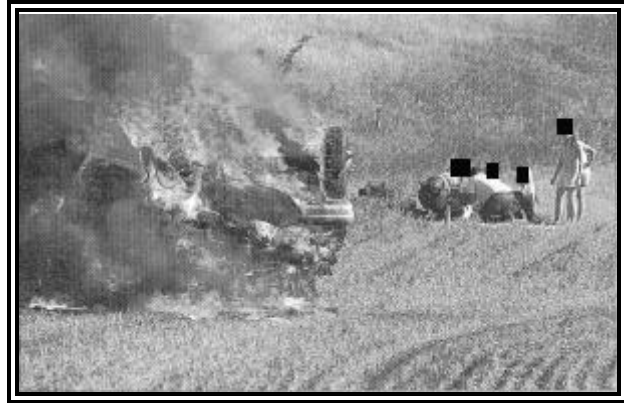
Figure 1. On-scene photograph showing ambulance engulfed in flames

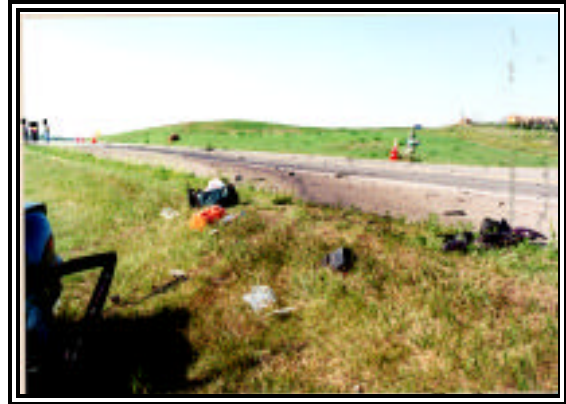
Figure 4. View of vehicle debris on roadway

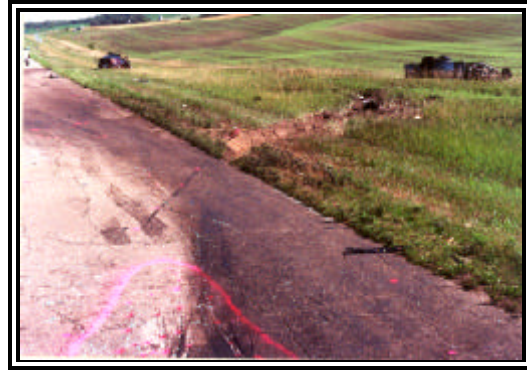
The rear aspect of the ambulance impacted the ground evidenced by large gouges from the rear dual wheels. The ambulance tipped onto the left side and began a rollover down the grassy embankment. The top left corner of the patient compartment created a gouge at the top of the embankment and two linear gouges were present in the ambulance's trajectory along the embankment from the roof side rails of the patient compartment. The ambulance came to rest on its roof facing southeast. Final rest positions are shown in **Figure 6**.

Figure 6. Northeast view showing final rest of both vehicles

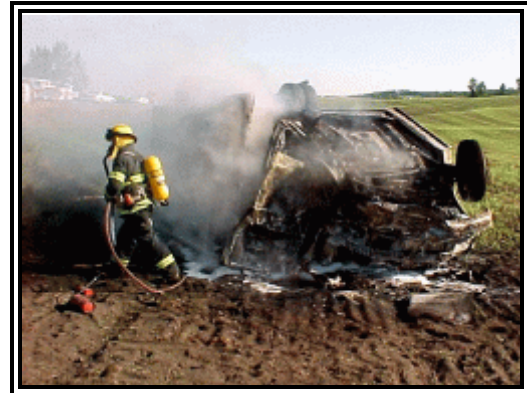
Figure 7. On-scene photograph showing the extent of fire damage

Damage to the ambulance was severe as a result of the fire. The fire appeared to have started in the engine compartment and spread quickly as reported by on-scene personnel and evidenced by **Figure 1** of this report. The fire was fueled by a suspected diesel fuel leak and a crash-induced rupture of the on-board oxygen system, evidenced by the complete burn-through of the compartment housing the cylinder and the melted steel on the top of the displaced cylinder. The fire engulfed the cab after the occupants were removed. As the fire spread to the patient compartment, one of the oxygen tanks discharged which intensified the fire. The exterior and interior of the cab were completely burned. The interior of the patient compartment was burned throughout, and the intensity of the fire resulted in a complete burn-through of left side aspect of the patient compartment (**Figure 15**). The left side hole that resulted from the fire measured 230.5 cm (90.8") and 188.0 (74.0") in height. The left front tire was completely destroyed by the fire and the left rear tires were partially melted. The exterior door and interior diamond-plate walls of the left front cabinet (oxygen cylinder compartment) were completely burned through. The burn hole in the exterior left front cabinet door measured 29.8 cm (11.8") in width and 101.6 cm (40.0") in height. The exterior top aspect and exterior right side aspect of the patient compartment exterior sustained minor fire damage.

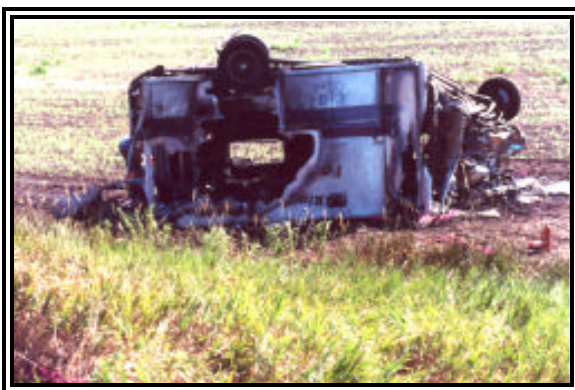
The 1995 Ford E-350 ambulance sustained severe damage as a result of the initial impact with the Chevrolet Cavalier. Due to the nature of the impact with the ditch bank, the damage resulting from the initial impact was partially masked. The impact and pivot of the front left aspect of the ambulance on the ditch bank caused severe frontal damage to the ambulance. The cab was crushed between the weight of the patient compartment and the ditch bank, and the left rear aspect of the cab penetrated the front left aspect of the patient compartment, evidenced in the on-scene photographs (**Figures 9 and 10**). After the ambulance was uprighted, the partial restitution of the cab and frame resulted in the separation between the cab and the patient compartment and understated the static crush measurements. The direct contact damage along the frontal plane began 36.8 cm (14.5") right of center and extended laterally 132.1 cm (52.0") to the front left corner. Abrasions were noted on the bumper from contact with the Cavalier. The grille area and head lamp assemblies were displaced and separated. The combined direct and induced damage involved the entire frontal width of the vehicle and measured 129.5 cm (51.0").

Figure 9. Post-crash view of left side of ambulance

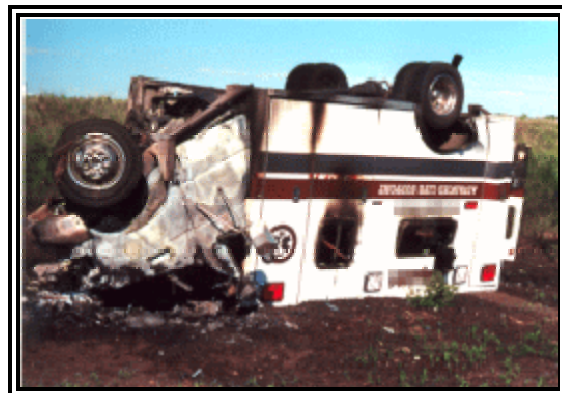
Figure 10. Post-crash view of right side of ambulance

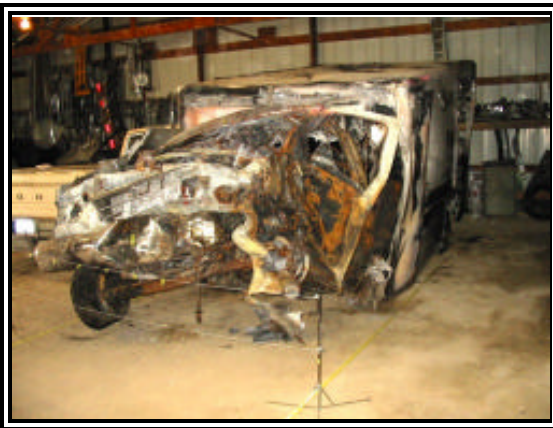
The front left aspect of the cab sustained severe crush, deformation, and lateral shift to the right (**Figure 11**). The centerline of the bumper was located 71.2 cm (28.1") to the right of the centerline of the windshield header (**Figure 12**). The left A-pillar was displaced rearward and inward. The bottom aspect of the left A-pillar was located 24.1 cm (9.5") rear of the top aspect. The entire left front door was twisted approximately 100 degrees in a CW direction and was crushed rearward. The base of the right A-pillar was displaced to the right. The ambulance frame was deformed laterally to the right and vertically upward, more severely on the left side. The upper and lower radiator supports were crushed rearward on the left side and the front axle was displaced rearward on the left side. The left wheelbase was reduced by 48.3 cm (19.0"). Six crush measurements were documented along the front bumper which represented the combined residual damage from the impact with the Cavalier and the impact with the ditch bank and were as follows: C1 = 91.4 cm (36.0"), C2 = 64 cm (26.0"), C3 = 62.2 cm (24.5"), C4 = 19.3 cm (7.6"), C5 = 10.4 cm (4.1"), C6 = 3.8 cm (1.5"). The Collision Deformation Classification (CDC) for the initial impact with the Cavalier was 12-FDEW, but the extent zone was unknown due to masking damage. The CDC for the impact with the ditch bank was 72-FDEW with an unknown extent zone (the CDC was incremented by 60 to denote the lateral shift to the right which resulted from the impact with the ditch bank). The combined damage for both impacts was an extent zone of 6.

Figure 11. View of damaged ambulance after it was uprighted

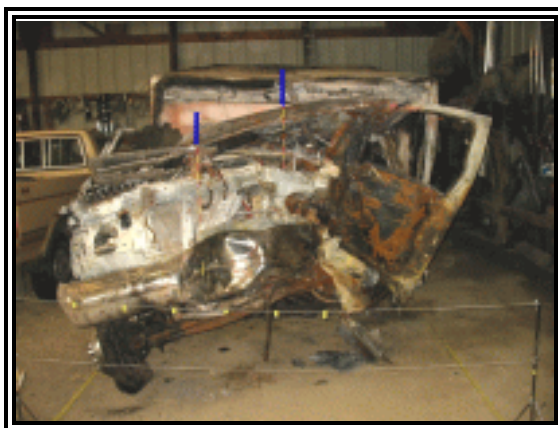
Figure 12. View showing the centerline variance between the windshield header and upper radiator support

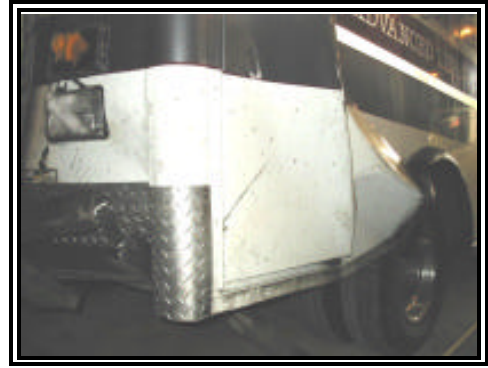
The rear of the ambulance impacted the ground after the impact with the ditch bank and CW rotation. The impact caused both dual wheels to impact the undercarriage and top aspects of the wheel wells. Abrasions and scuffs were present on the interior aspect of the right wheel well from contact with the right rear wheels and tires. The left side wheel well area was destroyed by the fire. The rear diamond plate step was displaced upward and induced buckling was present on the right rear aspect of the patient compartment from contact with the ground and the rear right vertical seam of the patient compartment was separated slightly at the bottom aspect (**Figure 13**). The separation began at the bottom corner and extended 14.0 cm (5.5") vertically. The center flip-up portion of the rear step was separated from the ambulance at the time of the vehicle inspection. The CDC for the undercarriage impact was 00-UBDW-2.

Figure 13. Right rear damage from the ground impact

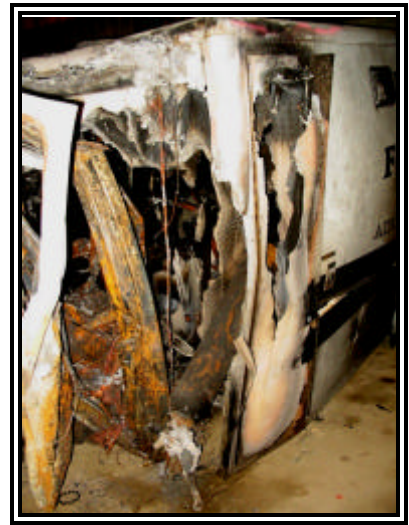
The rollover event resulted in moderate damage to the ambulance. Dirt and grass were present along the entire right side top aspect of the patient compartment along the drip rail. Dirt deposits extended vertically down the right side aspect 64.8 cm (25.5") and pieces of grass were noted in the compartment door frames. Grass and dirt were embedded in the right front wheel. Both side mirror assemblies were separated from the ambulance, and lateral abrasions were present on the right side door and right front fender. The left front diamond plate running board was separated. The right aspect of the roof and windshield header were crushed vertically. The vertical distance between the base of the right A-pillar and the top of the right A-pillar measured 5.1 cm (2.0"). The front right door was buckled outward. Left side separation of the rear aspect of the cab and the forward aspect of the patient compartment measured 13.0 cm (5.1") on top aspect and 24.1 cm (9.5") on the bottom aspect (**Figure 14**).

Figure 14. Left side view showing cab/patient compartment separation

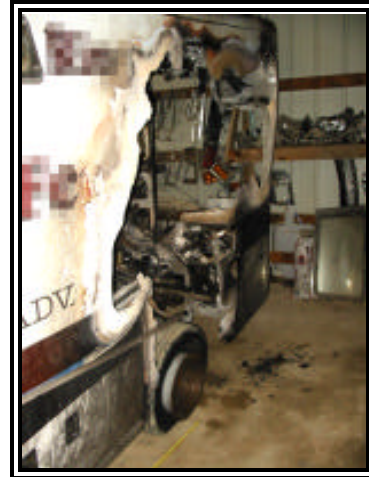
Figure 15. Left side fire damage

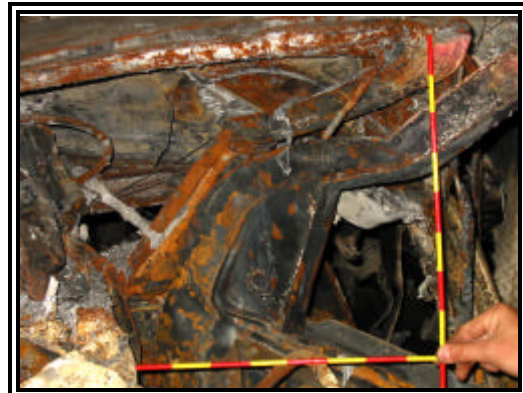
Interior damage to the 1995 Ford E-350 ambulance was severe and was attributed to passenger compartment intrusion and fire damage. The windshield laminate was separated and all glazing had disintegrated as a result of the multiple impacts and fire. Integrity loss through glazing could not be determined due to the masking damage. The integrity of both front doors was compromised due to deformation and distortion of the doors resulting from direct and induced damage. The left front door disengaged from the latch/striker due to the rearward and lateral displacement of the forward aspect and was twisted approximately 100 degrees in a CW direction.

Figure 16. Frontal view of the left A-pillar - Incremented sticks show the lateral displacement of the lower aspect

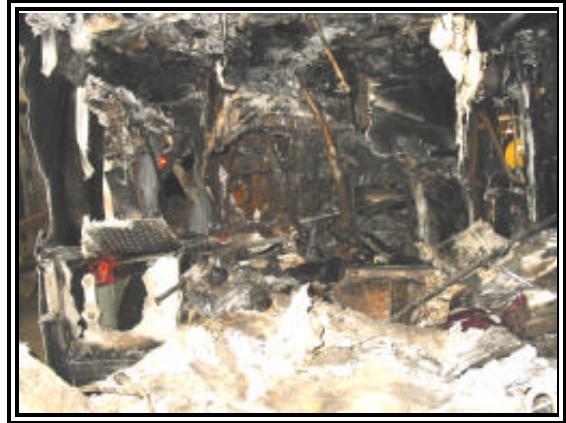
The interior damage to the patient compartment was severe and attributed to fire damage. All interior surfaces were charred (**Figure 17**) and the left side wall of the patient compartment was completely burned through. Based on the exterior post-crash dimensions of the patient compartment, intrusion appeared to be minimal. The glazing of the patient compartment windows had disintegrated as a result of the multiple impacts and fire. Charred and displaced equipment was present on the floor of the patient compartment. The Ferno cot appeared to have been dislodged from the fastener system at some point during the crash sequence. The cot appeared to have been displaced onto the ceiling of the patient compartment adjacent to the longitudinal assist handle. What appeared to be the charred remains of the Ferno cot were on the ceiling of the patient compartment on the left aspect of the assist rail. A charred D-size oxygen cylinder was found in the left rear aspect of the patient compartment, although its original position was not known.

Figure 17. Interior of patient compartment looking forward through the rear door frame

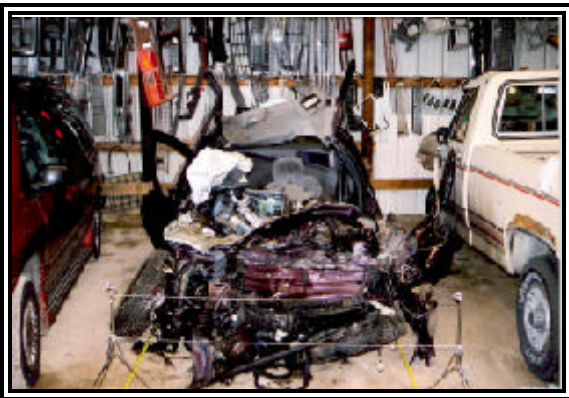
Figures 18 and 19 are the front and left lateral of the Chevrolet, respectively. The vehicle sustained severe frontal damage that extended across the entire 137 cm (54") undeformed frontal end width. The impact damage was biased to the vehicle's right side indicative of the angular head-on impact configuration. The bumper fascia and front body panels separated from the vehicle during the impact exposing the bumper reinforcement bar and forward sub-frame. The bumper reinforcement had separated from the right sub-frame and was cantilevered from the left sub-frame attachment. The separation of the bumper reinforcement precluded measuring the crush profile to this component. The vehicle's crush profile was documented by longitudinal measurements to the deformed locations of the left and right sub-frame, resulting in only two C-locations. The residual crush of the sub-frame was as follows: C1=12.7 cm (5.0"), C2=15.7 cm (6.2"). The residual crush underestimated the severity of the impact. The Collision Deformation Classification (CDC) of the frontal impact was 12-FDEW-1.

Figure 18: Front view of the Chevrolet

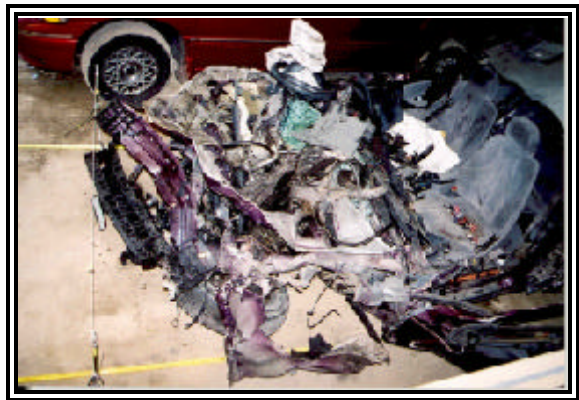
Figure 19: Left lateral view

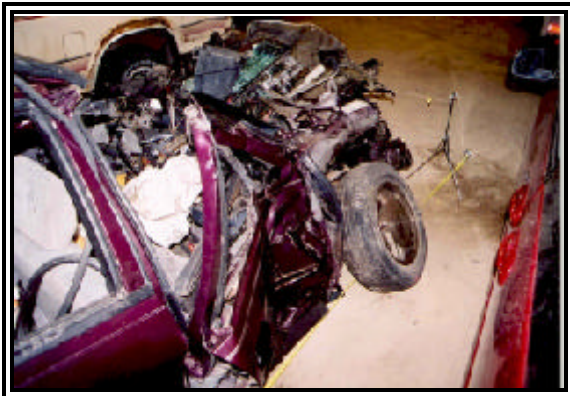
The A-pillars were cut and the roof was retracted during the driver extrication. The windshield was fractured in multiple locations. The right front door buckled approximately 20 cm (8") rear of the A-hinge pillar, **Figure 20**, as a result of its compression into the right B-pillar. The right front door and right rear doors were jammed shut. The location of the right B-pillar measured 5 cm (2") rearward compared to the left B-pillar location. The right wheelbase measurement was foreshortened 13 cm (5"). The left front door was jammed shut by the impact and then pried open during the extrication of the driver. The left rear door was operational but restricted. The damage to the left front suspension precluded a meaningful measurement of the left wheelbase. The floor pan appeared to have twisted (deformed) CCW. Referring to **Figure 20**, note that the right front seat back contacts the right B-pillar as a result of the floor pan deformation.

Figure 20: Right side view

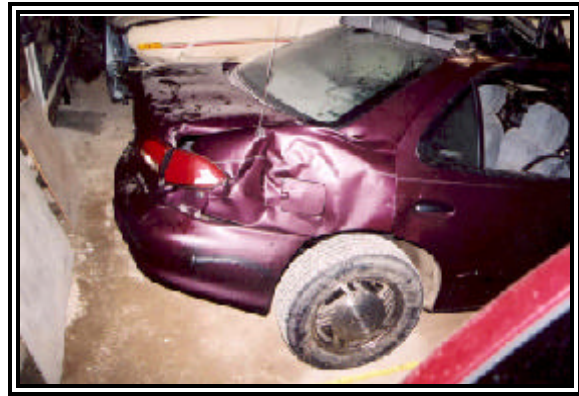
A 66 cm (26") region of the right rear quarter panel was damaged as a result of a secondary side slap, **Figure 21**. This contact pattern began 74 cm (29") rear of the right rear axle and ended 8 cm (3") rear of that axle location. The lateral displacement of the quarterpanel collapsed the trunk space. The maximum displacement measured 41 cm (16"). Immediately aft of the right rear wheel opening, an arcing scuff and abrasion was identified on the lower fascia. This damage pattern was associated to direct contact with the left rear tire and rim of the ambulance. The CDC of this contact was 03-RBEW-3.

Figure 21: Side slap damage

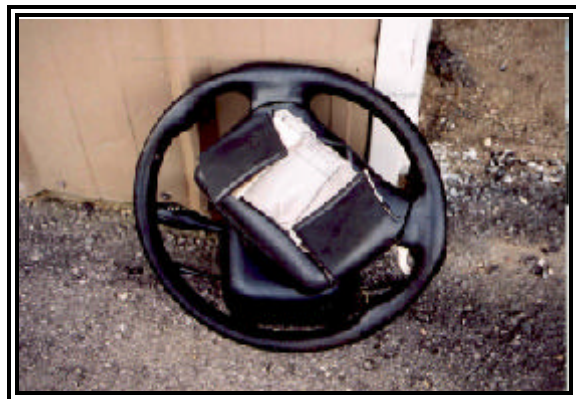
The steering wheel was found separated from the steering column upon initial inspection. The casting that comprised the tilt mechanism fractured above the upper steering column knuckle. It was reported by the fire department personnel that the steering wheel separation occurred during the extrication process. The two-spoke steering wheel rim was deformed throughout its unsupported upper sector, **Figure 22**. The maximum deformation measured approximately 8.9 cm (3.5") in the 12 o'clock sector. The steering wheel rim was rotated approximately 160 counterclockwise relative to the column. There was complete separation of the left and right shear capsules indicative of driver loading.

Figure 22: View of the deformed steering wheel rim

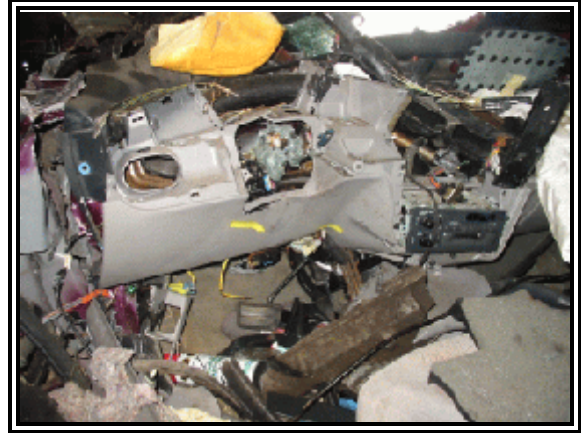
The left bolster exhibited two contacts related to the driver's lower extremities (**Figure 23**). A left lower extremity contacted the bolster 8.3 cm (3.3") left of the steering column center line evidenced by a 5 cm (2") scuff. The right lower extremity pocketed into the right aspect of the bolster 15 cm (6") right of the steering column center line. The metal backer panel behind the bolster was deformed in this region.

Figure 23: Left forward interior

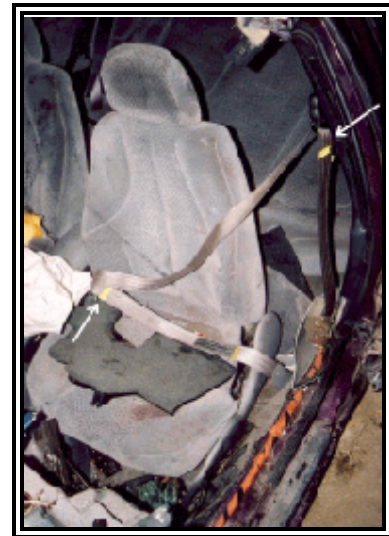
The webbing of the driver's restraint was extended from the retractor upon initial inspection and the retractor was locked. Examination of the latch plate revealed historical usage marks consistent with the vehicle's age. The cinch bar of the latch plate was fractured due to an overload. A section of the webbing, in the area of the latch plate when the restraint was buckled, was abraded and stressed over a 13 cm (5") length. This stressed webbing section began 66 cm (26") above the outboard anchor. A 2.5 cm (1.0") abrasion in the torso section of the webbing from frictional contact with the D-ring was located 152 cm (60") above the anchor point. All the evidence identified during the inspection indicated the driver was restrained at the time of the crash. The driver's manual restraint is shown in **Figure 24**.

Figure 24: Driver's restraint
