**GENERAL DYNAMICS REMOTE SIDE IMPACT AIR BAG INFLATABLE
OCCUPANT PROTECTION INVESTIGATION**

GENERAL DYNAMICS CASE NO. – CA02-036

SUBJECT VEHICLE – 1999 PORSCHE 911 CARRERA

CRASH DATE – APRIL 1999

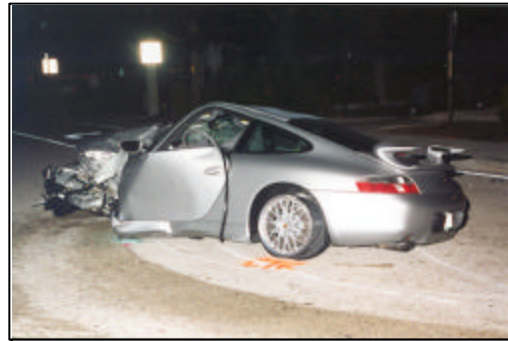
Figure 1. Final rest position of the 1999 Porsche 911 Carrera.

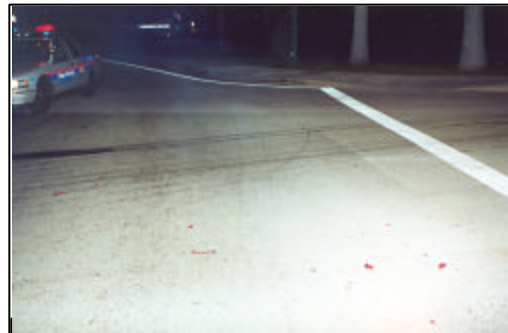
The 42-year old unrestrained male driver of the Porsche was traveling in a westerly direction on the two-lane road. He was attempting to negotiate a left curve in a posted 48 km/h (30 mph) speed zone. The vehicle broke traction and drifted to the right in a slight counterclockwise (CCW) yaw as evidenced by the right side tires marks on the asphalt road surface. The police computed a speed of 98 km/h (61 mph) based on the critical curve tire scuffmarks noted in **Figure 2**. The Porsche drifted across the mouth of the intersection and into the curb at the northwest quadrant of the intersection (**Figure 2**).

Figure 2. Westbound approach to the curb impacts. Note the pre-impact tire mark(s).

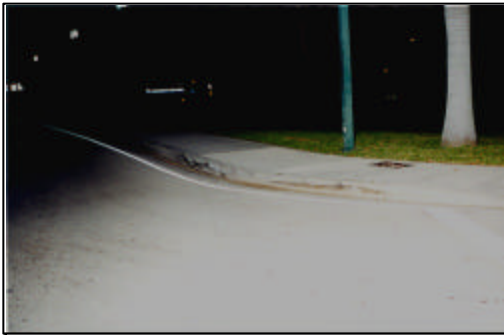
The right front wheel of the Porsche impacted the barrier curb resulting in an air out and de-beading of the tire from the alloy wheel. Due to the low profile of the tires, the alloy wheel engaged the curb, which fractured the wheel (**Figure 3**). The vehicle continued its forward trajectory and mounted the curb. The right sill of the Porsche impacted the curb followed by a right rear tire/wheel impact to the curb. The latter tire/wheel impact fractured the alloy wheel and de-beaded the low profile tire.

Figure 3. Initial curb right side curb impacts.

The initial impact involved the right front tire and wheel against the barrier curb. The damage consisted of a fracture to the wheel rim bead area and the air out and de-beading of the front right tire.

The second impact involved the right sill area of the Porsche as the vehicle impacted and overrode the barrier curb. The damage consisted of abrasions and slight deformation to the lower sill.

The third impact was to the Porsche's right rear wheel impacting the curb. The damage consisted of a fracture to the outer edge of the alloy wheel and the de-beading of the tire.

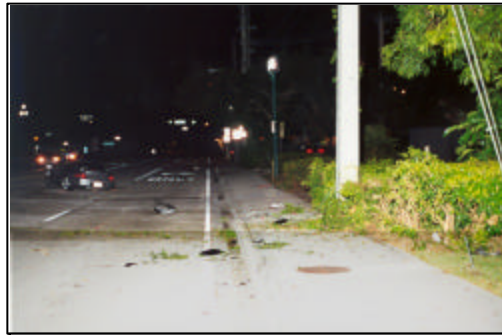
Figure 4. Area of impact with guy wire, hedge and concrete utility pole.

Based on the trajectory of the vehicle, the front right aspect of the Porsche impacted a cable guy wire that snagged the vehicle and induced a rapid clockwise (CCW) rotation. The damage to the vehicle from this impact was masked by a subsequent pole impact and separation of the bumper fascia. In addition, the available police photographs for this remote investigation did not document the guy wire impact damage. The guy wire fractured under tension during this impact event.

The Porsche rotated rapidly approximately 90 degrees in a CW direction. During this rotation, the inboard aspect of the left front wheel impacted and mounted the barrier curb. The vehicle's center of gravity continued in a westerly direction as the left front fender area impacted a hedge and the left front fender/tire/wheel area impacted a square concrete utility pole (**Figure 4**). This impact resulted in severe damage to the left front area.

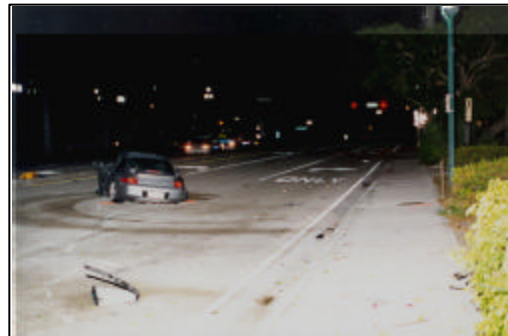
Figure 5. Post-crash spin-out and final rest of the Porsche.

its center of gravity continued in a westerly direction. The physical evidence at the crash scene suggested the vehicle rotated approximately 225 degrees from the pole impact to final rest (**Figure 5**). The unrestrained driver of the Porsche was ejected from the left front door window opening onto the concrete sidewalk, west of the struck pole. The Porsche came to rest on the center westbound lane, facing in a southwesterly direction.

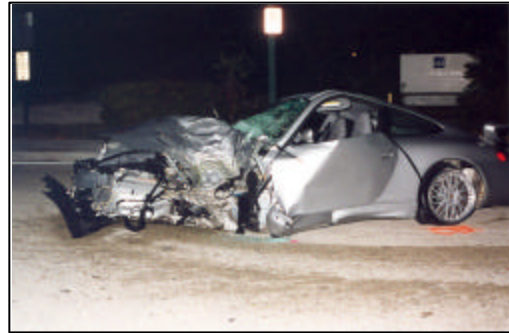
The seventh and most significant impact to the Porsche involved the left front side area contacting the square concrete utility pole (**Figure 6**). The damage from this event consisted of a fractured left front axle, extensive lateral deformation of the left front fender, hood, left frame rail, lateral and longitudinal displacement of the A-pillar, induced deformation of the front left door, fractured windshield, and shattered front left glazing. The Collision Deformation Classifications (CDC) for this multiple event crash is identified in the following **Table 1**.

Figure 6. Left side damage to the Porsche.

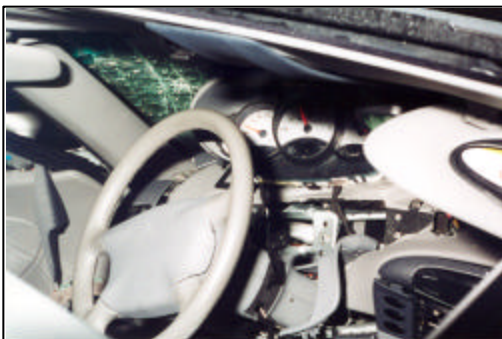
The 1999 Porsche 911 Carrera sustained severe interior damage as a result of intrusion and occupant contacts. The most significant intrusion appeared to be the vertical and longitudinal displacement of the left side instrument panel (**Figure 7**). Other intrusions include longitudinal displacement of the left toe pan, lateral displacement of the left side-kick panel forward of the A-pillar, and vertical and longitudinal displacement of the steering assembly.

Figure 7. Vertical and longitudinal intrusion of the left instrument panel.

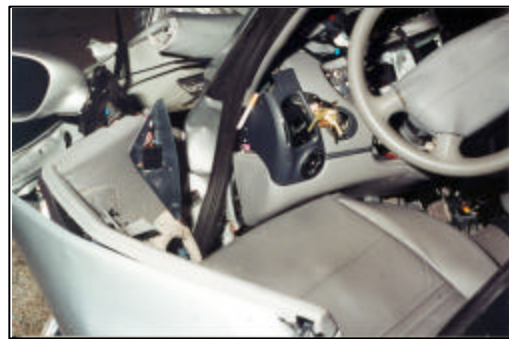
Figure 8. Driver's left leg contact to instrument panel mounting bracket.

The driver's lower left leg contacted the edge of the intruding mounting bracket for the left instrument panel (**Figure 8**). A tissue transfer and body fluid evidenced the contact point. The driver's left hip and torso loaded the left side door panel, which resulted in outward bowing of the door panel. The front right occupant contacted and loaded the center console with his left hip and left thigh, displacing the center console laterally left. It appeared from the photographs that the console was also fractured from occupant loading.

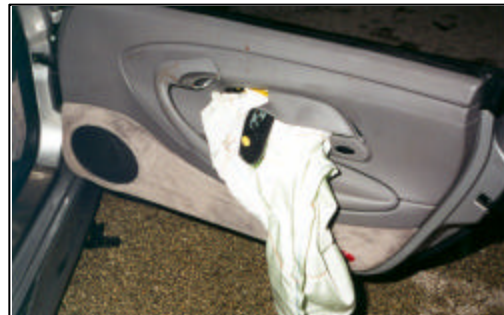
The 1999 Porsche 911 Carrera was equipped with door mounted side impact air bags for the front seat positions. The sensors for the side impact air bags were located on the driver and passenger side rocker panels. Although the Porsche sustained a significant left side impact, the front left door side impact air bag did not deploy. The front right door panel mounted air bag did deploy. The police images of the deployed side impact air bag depict a large bag (**Figure 9**), typical of providing torso and head protection. There were no lateral impacts to the

Figure 9. Deployed front right side impact air bag.

right side of the vehicle; however, the sill of the Porsche contacted the barrier curb early in the crash sequence. This impact may have resulted in deployment of the bag, or the side impact air bag could have deployed from the rapid CW rotation following the pole impact.

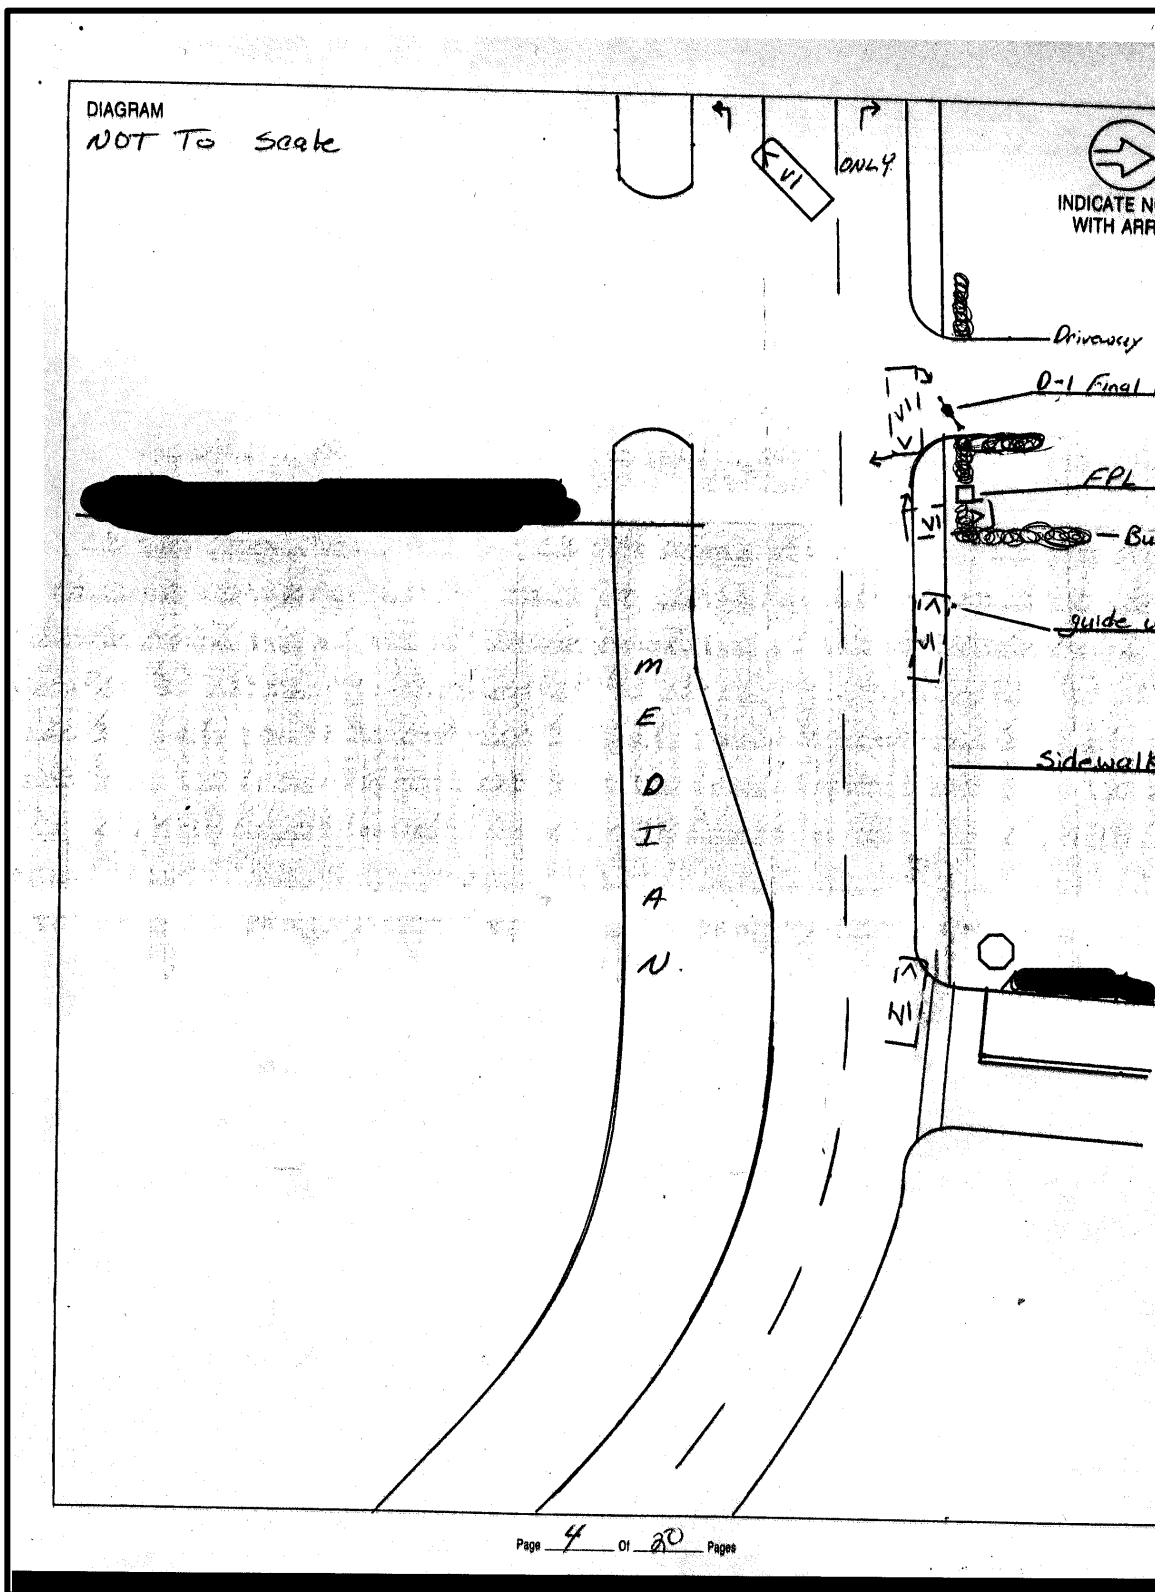
Figure 10: Police Scene Schematic

The crash occurred off-road, at a three-leg “T” intersection of a north/south roadway that intersected an east/west roadway. At the time of the crash, it was dark and the asphalt road surface was dry. There were no adverse weather conditions. The area was illuminated by a series of overhead lights that were positioned outboard of the sidewalk. The east/west roadway was configured with two travel lanes in each direction that were separated by a raised concrete curbed median. The roadway curved left for westbound travel. The east/west roadway was bordered by white fog lines and barrier curbs. The roadside consisted of a sidewalk, light poles, utility poles, and trees. The struck concrete utility pole was located immediately outboard of the concrete sidewalk. The posted speed limit for the east/west roadway was 48 km/h (30 mph). The police scene schematic is included as **Figure 10** of this report.
