ON-SITE ADVANCED OCCUPANT PROTECTION SYSTEM INVESTIGATION

CASE NO: CA02-037

VEHICLE - 2003 PONTIAC BONNEVILLE

LOCATION - PENNSYLVANIA

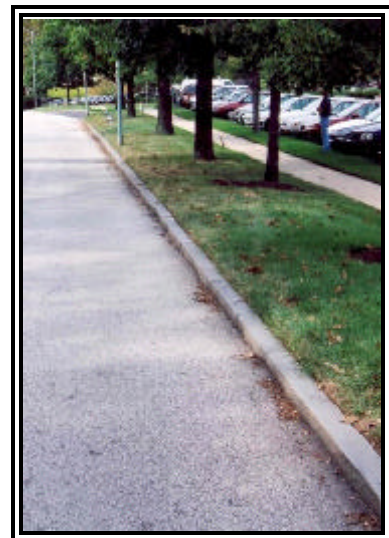
This crash occurred during the nighttime hours in September 2002. At the time of the crash, it was dark and the area of the crash was illuminated by overhead street lights. It was raining and the road surface was wet. **Figure 1** is a trajectory view approaching the crash scene. The crash occurred off the right shoulder of a five lane east/west asphalt road in an urban commercial setting. The traffic way was bordered by 15 cm (6 in) barrier curbs and grass shoulders. A row of deciduous trees was planted parallel to the road and was located approximately 2.1 m (7.0 ft) outboard of the curb. This subject roadway intersected a north/south arterial road approximately 66 m (217 ft) east of the point of impact. The speed limit in the area of the crash was 40 km/h (25 mph).

Figure 1: Westbound trajectory view.

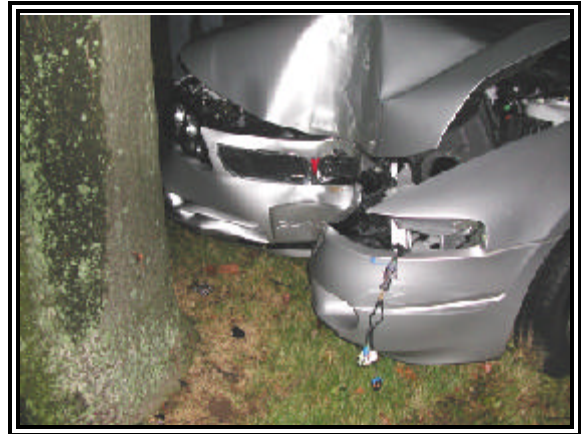
Figure 2: On-scene photograph of the vehicle at final rest.

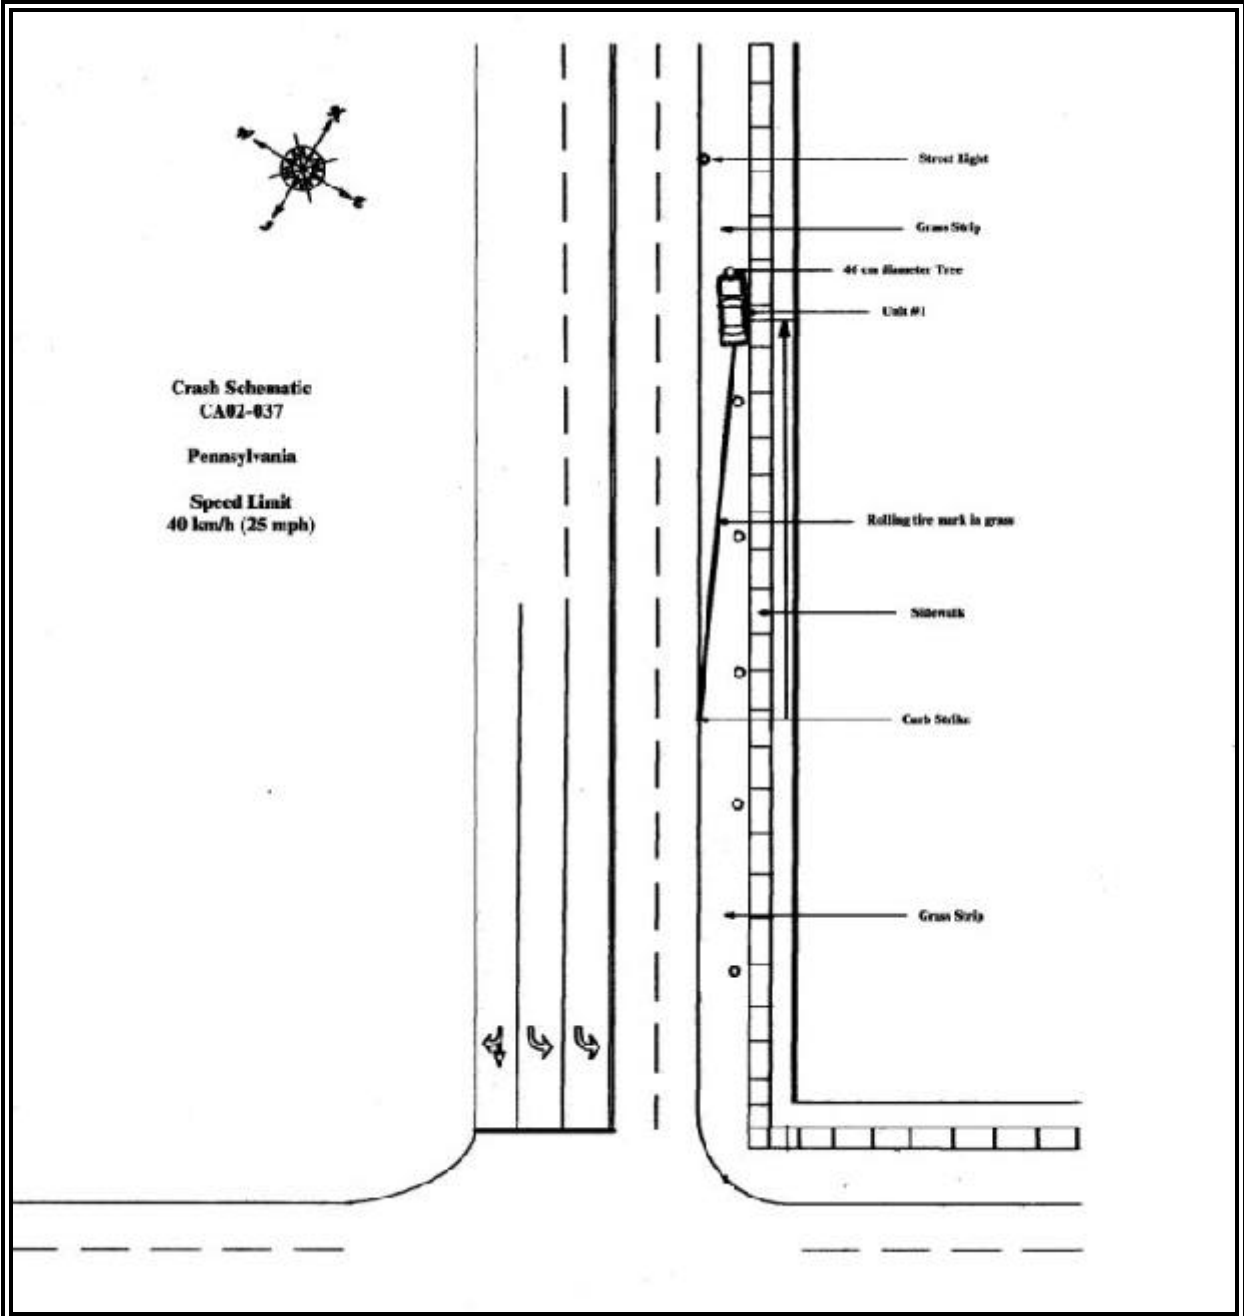
Figure 3: Crash schematic.

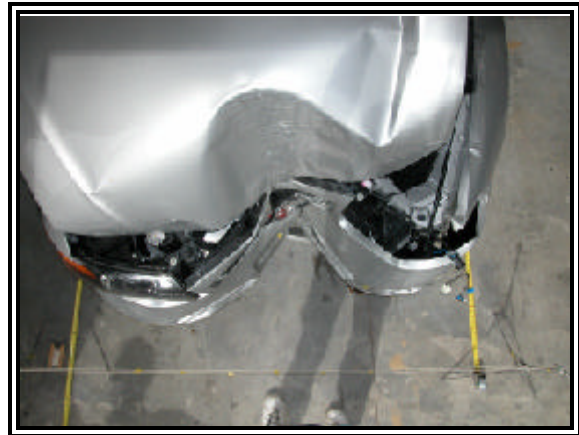
Figure 5 is an overhead view of the frontal damage. The frontal plane of the Pontiac sustained 71.1 cm (28.0 in) of direct contact damage. The direct contact began 22.9 cm (9.0 in) right of center and ended 48.3 cm (19.0 in) left of center. The combined width of the direct and induced damage extended across the vehicle's entire 137 cm (54 in) frontal end width. The impact deformed and collapsed the bumper reinforcement bar rearward into the engine compartment. The maximum crush measured 71.9 cm (28.3 in) and was located 13 cm (5 in) left of the vehicle's centerline. The residual crush profile was as follows: C1 = 5.0 cm (2.0 in), C2 = 22.0 cm (8.7 in), C3 = 62.0 cm (24.4 in), C4 = 47.0 cm (18.5 in), C5 = 21.0 cm (8.3 in), C6 = 1 cm (2.5 in). The longitudinal length of the direct contact on the hood measured 46 cm (18 in). The impact force shifted the left and right fenders rearward into their respective A-pillars. The operation of the left front door was restricted. The left and right wheelbases were reduced 8.6 cm (3.4 in) and 3.0 cm (1.2 in), respectively. The Collision Deformation Classification was 12-FYEW-3. The curb impact punctured the sidewall of the right front tire and abraded the exterior surface of the rim. The CDC of the curb impact was 12-FRWN-3. The total delta V calculated by the Barrier Algorithm of

Figure 5: Overhead view of the frontal damage.

the WINSMASH model was 32.3 km/h (20.1 mph). The longitudinal and lateral components were -32.3 km/h (-20.1 mph) and 0 km/h (0 mph), respectively. The WINSMASH calculation appears to have underestimated the severity of the crash in the opinion of this investigator.

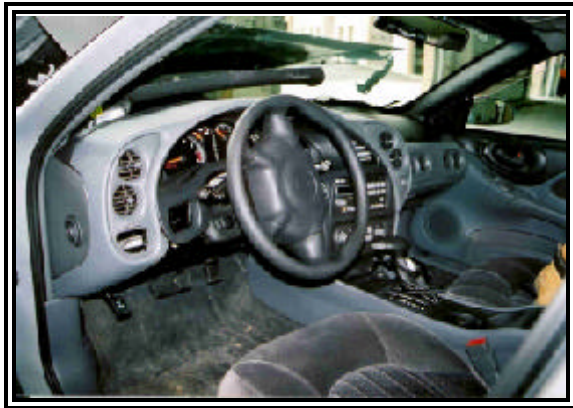
Figure 6 is a view of the driver's interior. There was no interior damage or intrusion attributed to the exterior forces of the crash. The only interior damage was directly associated to the unrestrained driver's interior contacts.

Figure 6: Left interior view.

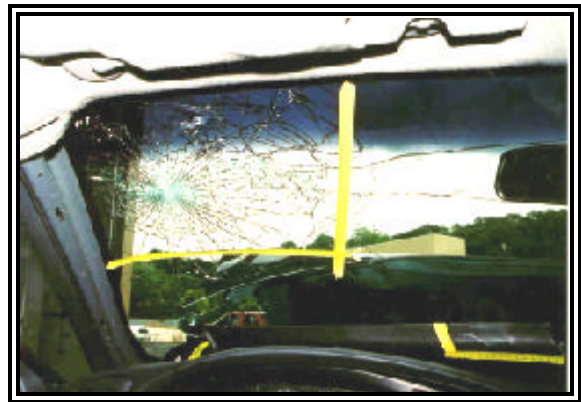
The left upper aspect of the windshield exhibited a fracture pattern consistent with a head contact. The center of the fracture was located 20.3 cm (8.0 in) below the windshield header and (4.8 in) inboard (right) of the left A-pillar. Several strands of black hair were noted within the fracture. A skin oil smear was located directly above the fracture site. The gross overall dimensions of the smear measured 6.4 cm x 30.5 cm (2.5 in x 12.0 in). The trim panel covering the left A-pillar was displaced from its designed position from probable left hand contact. The contact pattern measured 15 cm (6 in) in length and began on the trim panel's upper aspect. There was no deformation to the sheet metal underlying the left A-pillar trim.

Figure 7: Windshield and left A-pillar contact.

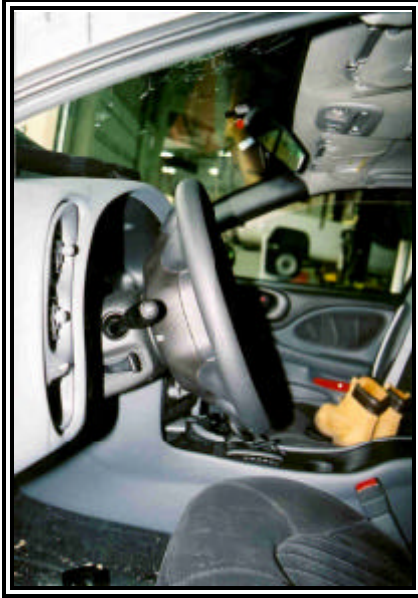
The 4-spoke tilt steering wheel was adjusted to the full up position. The steering wheel was rotated approximately 90 degrees clockwise. There was no steering wheel rim deformation, **Figure 8**. During the crash sequence, the unrestrained driver loaded the plane of the rim and completely separated the steering column from the shear capsules. The column had dropped down and was not attached to the instrument panel, **Figure 9**. The horizontal distance from the top sector of the steering wheel rim to the brow of the instrument panel measured 5 cm (2 in).

Figure 8: Left lateral view of the steering wheel rim.

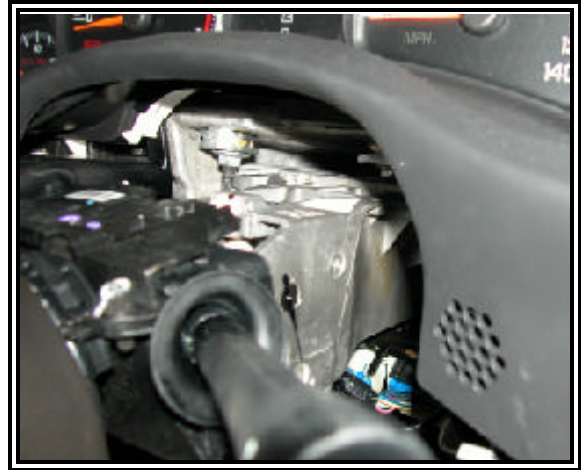
Figure 9: View of the shear capsule separation.

Upon impact, the driver initiated a forward trajectory in response to the 12 o'clock direction of the impact. The driver's chest contacted plane of the steering wheel rim and loaded the steering wheel/column. The driver's inertial loading caused a complete shear capsule separation. The driver's forehead contacted and fractured the left upper aspect of the windshield. This contact resulted in a forehead contusion and the driver was rendered unconscious. His left hand probably contacted the trim panel covering the left A-pillar in a bracing effort. This contact displaced the trim panel. He then rebounded back into his seat where he was found.

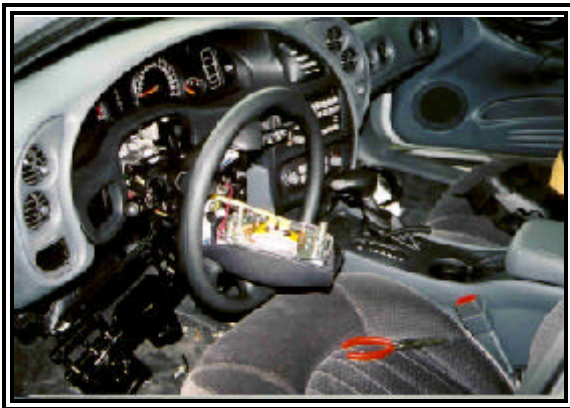
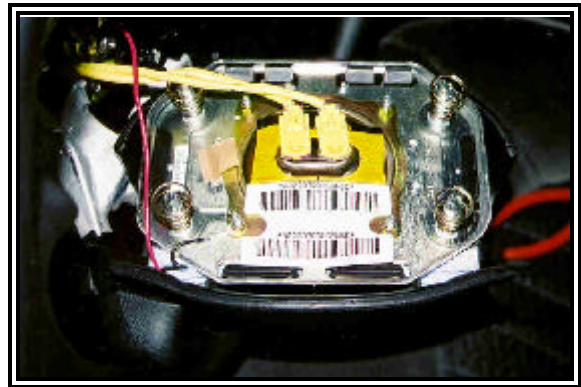
The downloaded data indicated Stage 1 deployments of the driver and front right passenger air bags were commanded 25 milliseconds after the Algorithm Enable (AE). However, the frontal air bags did not deploy. Technical representatives of General Motors have determined that the sensor safing criteria was not met during the crash and prevented the deployment of the frontal air bags.

The driver air bag module was attached to the center hub of the steering wheel. The front right passenger air bag was a top-mount design located in the right aspect of the instrument panel. During the SCI inspection, the driver air bag module was disassembled from the steering wheel hub, **Figures 10 and 11**. All the mechanical and electrical connections on the back side of the module appeared to be intact. There were no obvious assembly problems. The following nomenclature identified the driver air bag module: AB2237Q3UCNSD.

Figure 10: Non-deployed driver air bag.

Figure 11: View of the driver air bag disassembly.
