**CALSPAN ON-SITE CHILD AIR BAG RELATED FATALITY CRASH  
INVESTIGATION**

**CASE NO: CA02-038**

**VEHICLE: 1995 TOYOTA TERCEL**

**LOCATION: SOUTH CAROLINA**

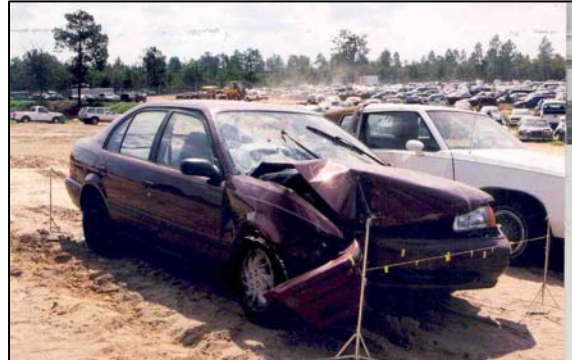
This on-site investigation focused on the injury sources and cause of death of a 3-month old male who was positioned in a rear facing child safety seat (RFCSS) in the front right seat of a 1995 Toyota Tercel (**Figure 1**). The Tercel was equipped with frontal air bags for the driver and front right passenger positions that deployed as a result of a moderate severity frontal crash with a utility pole. The RFCSS was driver reported as secured by the vehicle's 3-point manual lap and shoulder belt system;

**Figure 1 - View of the damaged 1995 Toyota Tercel.**

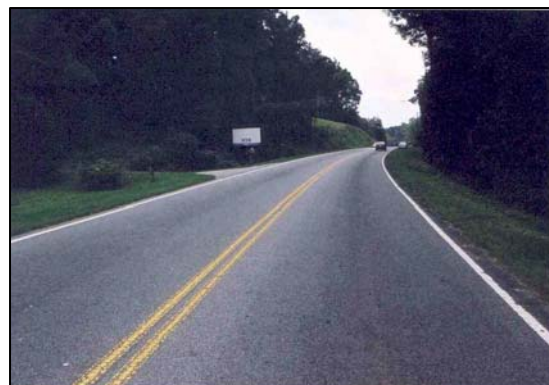
The 18-year old female driver of the 1995 Toyota Tercel had just departed her place of employment and picked up the 3-month old child at a relative’s home. En route to her home, she had traveled approximately 3 km (2 miles) prior to the crash. The driver was traveling southbound on a two-lane curved roadway (**Figure 2**) and reportedly fell asleep as she approached the crash site. As the

**Figure 2 - Southbound approach of the Tercel.**

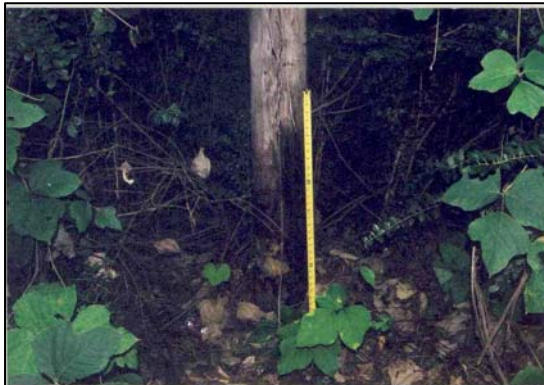
The front right area of the Tercel impacted the utility pole resulting in moderate damage. The direction of force for the impact with the pole was in the 12 o'clock sector and the impact was sufficient to command a deployment of the vehicle's frontal air bag system. The damage algorithm of the WinSMASH program calculated a total delta V of 32 km/h (19.8 mph). The specific longitudinal and lateral components were -32 km/h (-19.8 mph) and 6 km/h (3.7 mph).

**Figure 3 - Impacted utility pole (Event 1).**

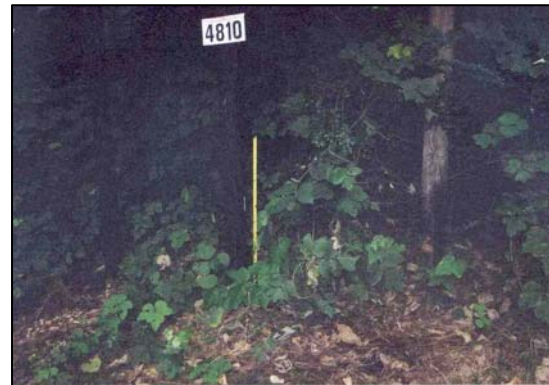
Following the initial impact, the Tercel rotated clockwise approximately 80 degrees and its left side impacted a wooden sign post. The post was designed to hold a roadway advertisement sign in place. The secondary impact resulted in minor damage to the forward aspect of the vehicle's left front door near the A-pillar. The direction of force for this impact was 280 degrees. The damage algorithm of the WinSMASH program calculated a total delta-V of 10 km/h (6.2 mph) for this secondary impact. The specific longitudinal and lateral components were -2 km/h (-1.2 mph) and 10 km/h (6.2 mph). The vehicle came to rest near the second impact and was facing in southwest direction. **Figures 3 and 4** are close-up views of the struck roadside objects.

**Figure 4 - Impacted wooden sign post (Event 2).**

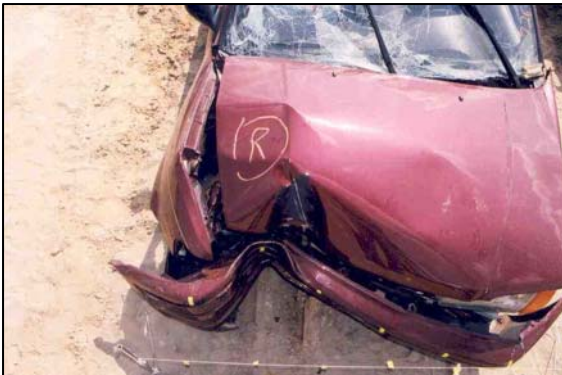
The 1995 Toyota Tercel sustained moderate damage as a result of the impact with the utility pole (**Figure 5**). The direct contact damage began 18 cm (7") right of the vehicle's centerline and extended 20 cm (8") to the right. The combined direct and induced damage encompassed the vehicle's front bumper beam and measured 117 cm (46"). The maximum crush was located at C5, 31 cm (12.4") right of the vehicle's centerline and measured 44 cm (17.5") in depth. The vehicles rebar mounting bracket separated due to lateral right frame rail displacement and the impact compressed the right side wheelbase by 7 cm (2.75"). The Collision Deformation Classification (CDC) for the frontal impact with the utility pole was 12-FREN-3. Six equidistant crush measurements were documented across the front bumper and were as follows: C1 = 3 cm (1.2"), C2 = 13 cm (5.1"), C3 = 24 cm (9.4"), C4 = 35 cm (13.8"), C5 = 44 cm (17.3") and C6 = 16 cm (5.9").

**Figure 5 - Frontal damage to the 1995 Toyota Tercel.**

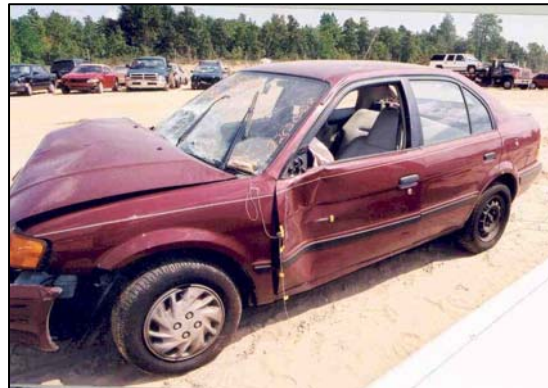
**Figure 6 - Left side damage to the 1995 Toyota Tercel.**

Following the impact with the utility pole, the Tercel rotated clockwise and its left side and impacted a wooden post resulting in minor damage (**Figure 6**). The direct contact damage was concentrated on the forward aspect of front left door near the A-pillar. The direct contact damage began 134 cm (52.8") forward of the left rear axle and extended forward 34 cm (13.4"). The combined direct and induced damage began 94 cm (37") forward of the left rear axle and extended forward 100 cm (39.4"). The maximum crush was located at C5 and was 8 cm (3.1") in depth. The CDC for the left side impact was 09-LPAN-1. Six equidistant measurements were documented along the mid-door level and were as follows: C1 = 0 cm, C2 = 2 cm (0.8"), C3 = 3 cm (1.2"), C4 = 6 cm (2.4"), C5 = 8 cm (3") and C6 = 0 cm.

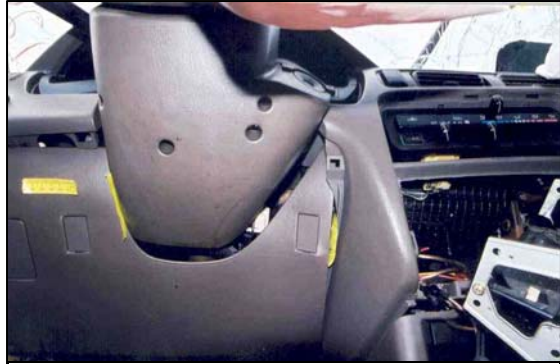
left side of the steering column and onto the top aspect knee bolster. Laterally, the scuffs began 39 cm (15.5") left of the vehicle's centerline and extended left 7 cm (2.75"). Vertically, they began 25 cm (11") below the top of the instrument panel's brow and extended downward 8 cm (3.1"). This contact point was attributed to the driver's left knee. A second prominent scuff was located on the right aspect of the driver's knee bolster in proximity to the driver's right knee. The scuff contained associated fabric embedded within the panel. Laterally, the contact to the right bolster began 15 cm (6") left of the vehicle's centerline and extended left 8 cm (3"). Vertically, the scuff began 28 cm (11") below the instrument panel's brow and extended downward 6 cm (2.4"). **Figure 7** illustrates the damage resulting from the driver's lower extremity contact. Less prominent contact points were located on the front left interior door panel. Although faint, scuffing to the top aspect of the left door attributable to the driver's left shoulder and scuffing to the left armrest attributable to the driver's left hip were documented. Based on the 9 o'clock direction of force of the secondary impact, the trajectory of the driver probably placed her at this location. No discernable contact points to interior components were located in the area front right passenger's seating position. However, loading evidence to the front right air bag was identified and is discussed in greater detail in the Frontal Air Bag section of this report.

**Figure 7 - Contact damage to knee bolster from driver's knees.**

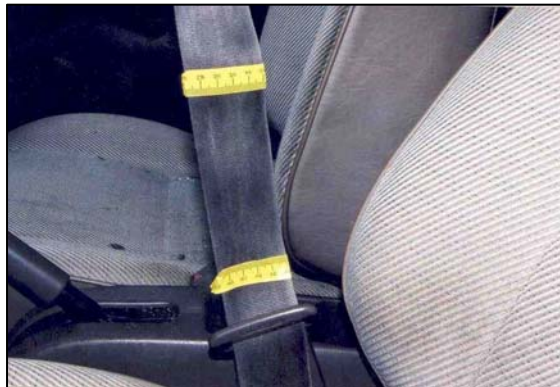
The Tercel was equipped with manual 3-point lap and shoulder belts for the two frontal seating positions. The driver's belt was configured with continuous loop webbing, a sliding latch plate, and a belt sensitive Emergency Locking Retractor (ELR). Frictional abrasions were present on the sliding latch plate housing as a result of occupant loading. The abrasions were located on both surfaces of contact with the belt webbing and were 5 cm (2") in width. The webbing also sustained damage from occupant loading. The loading marks were located 70 – 81 cm (27.5 – 32") above the floor anchor, 15 – 26 cm (5.75 – 10.25") above the stop button (**Figure 8**). The left front webbing was also twisted when stowed reorienting the latch plate to face outside the vehicle.

**Figure 8 - Loading evidence on the driver's belt webbing.**

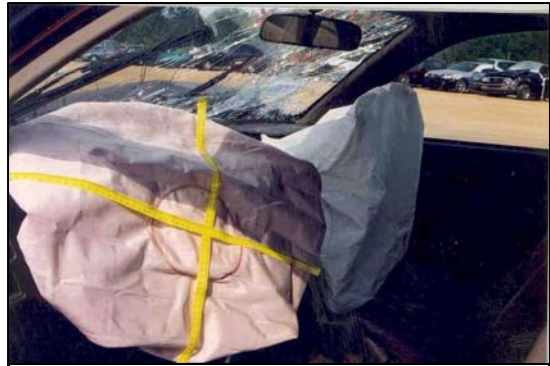
The 1995 Toyota Tercel was equipped with first generation frontal air bags for the driver and front right passenger positions. The driver's air bag (**Figure 9**) deployed from the steering wheel hub through H-configuration module cover flaps. The upper flap measured 13 cm (5.25") in width and 9 cm (3.6") in height. The lower flap measured 13 cm (5.25") in width and 7 cm (2.75") in height. The deployed driver's air bag measured 66 cm (26") in diameter in its deflated state. The air bag was tethered by two 16 cm (6.25") straps with associative tether stitching on the face of the bag.

**Figure 9 - View of driver's air bag.**

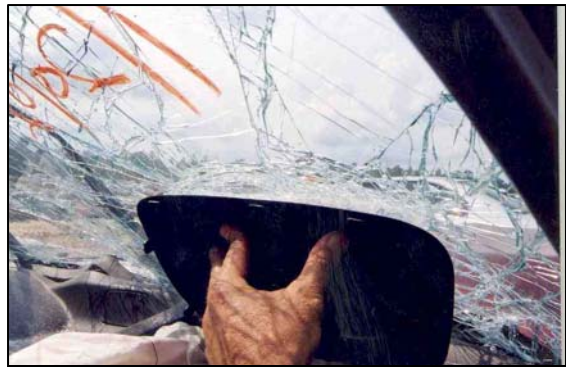
The front right passenger's air bag deployed from a top-mount module configured with a single rectangular cover flap hinged at the forward aspect. The cover flap measured 32 cm (12.75") in width and 22 cm (8.75") in height. The cover flap sustained abrasions due to contact with the laminated windshield (**Figure 10**). The abrasions were to the cover flap's leading edge and were 30 cm (12") in length and 5 cm (2") in height. The deployed front right air bag (**Figure 11**) measured 48 cm in width and 56 in height in its deflated state and had an excursion of 56 cm (22") from the instrument panel and 64 cm (25") from the

**Figure 10 - Front right cover flap and windshield interaction.**

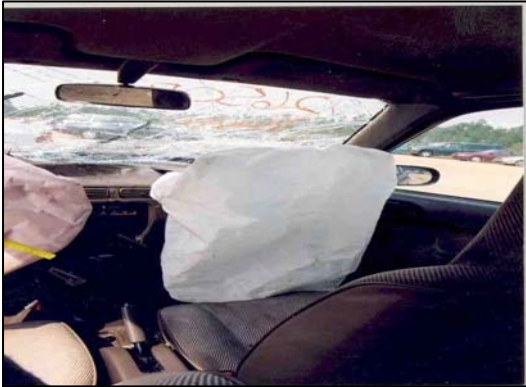
**Figure 11 - View of the right front deployed air bag.**

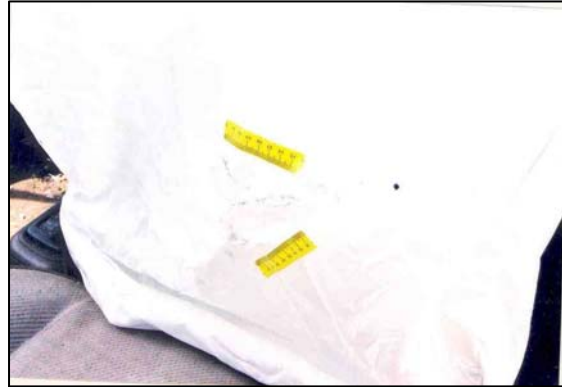
leading edge of the module. The air bag contained no internal tethers. The air bag was vented by two 7 cm (2.75”) ports located in the 3 and 9 o’clock sectors of the air bag. Contact evidence in the form of black scuffs with brown substance transfers were documented on the front right air bag (**Figure 12**). These scuffs were located 5 – 17 cm (2 – 6.5”) right of the air bag’s center and 36 – 43 cm (14 – 17”) below the top horizontal seam. The following nomenclature was stamped on the top of the right front air bag adjacent to the inflator:

**Figure 12 - Close-up of transfer evidence on front right air bag.**

The 3-month old male child was placed within a RFCSS without use of the internal harness. The RFCSS was reportedly secured within the vehicle by the manual 3-point lap and shoulder belt. At impact, the frontal air bag deployed and the child and RFCSS initiated a forward and slightly left trajectory toward the instrument panel. The air bag reportedly expanded against the rear facing RFCSS, displacing the same in a rearward direction. The air bag contained transfer evidence in the form of black scuffs and a brownish material imbedded within the scuff. It is probable the scuff was the result of the air bag expanding against the shell of the RFCSS and the brownish material was possibly a fabric within the RFCSS.
