ON-SITE SIDE IMPACT OCCUPANT PROTECTION INVESTIGATION

VEHICLE: 2000 VOLVO S80

CASE NO: CA02-042

CRASH DATE: SEPTEMBER, 2002

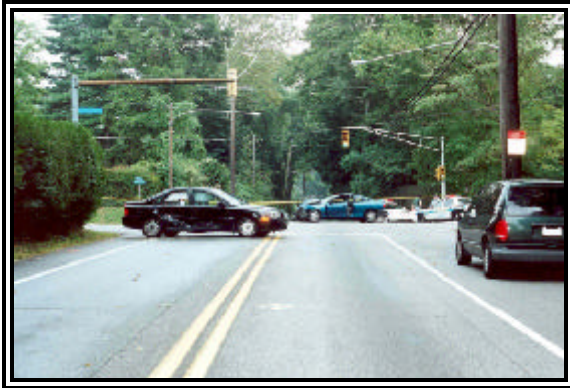
Figure 2: On-scene police photograph looking east.

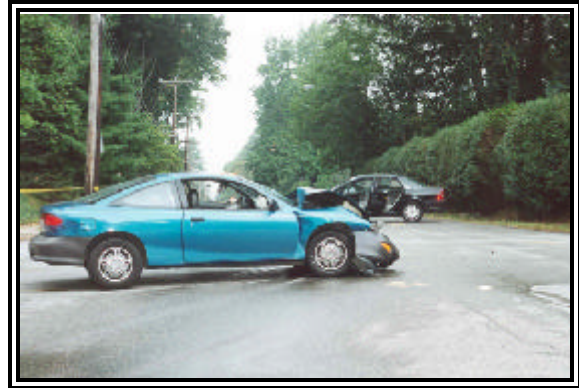
Figure 3: On-scene police photograph looking west.

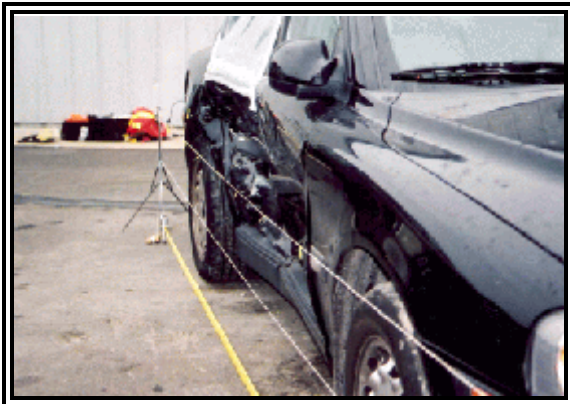
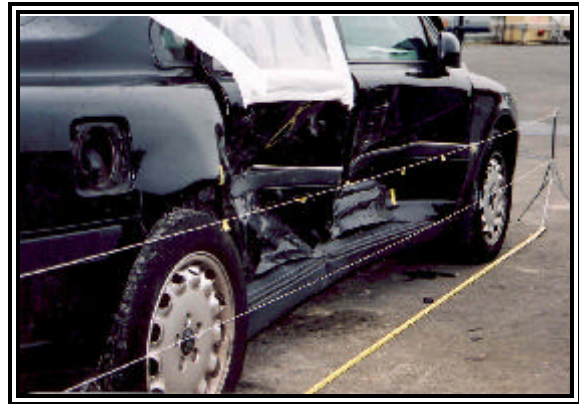
Figures 5 and 6 are the right front and right rear views of the damage. The right side plane of the Volvo sustained a combined 218.7 cm (86.1 in) of direct and induced damage as a result of the impact. The induced damage began 49.3 cm (19.4 in) aft of the right front axle at the leading edge of the right front door. The width of the direct damage measured 174.2 cm (68.6 in) and began 96.3 cm (37.4 in) aft of the right front axle on the center aspect of the right front door. The end of the direct and induced damage was located 81 cm (3.2 in) forward of the right rear axle immediately aft of the right rear door. The door panels were crushed laterally and right rear glazing disintegrated in the impact. The maximum lateral deformation measured 24.4 cm (9.6 in). The residual crush profile was as follows: C1 = 0, C2 = 19.3 cm (7.6 in), C3 = 23.1 cm (9.1 in), C4 = 24.3 cm (9.6 in), C5 = 19.8 cm (7.8 in), C6 = 0. The total delta V calculated by the Damage algorithm of the WINSMASH model was 19.8 km/h (12.3 mph). The longitudinal and lateral delta V components were -12.7 km/h (-7.9 mph) and -15.2 km/h (-9.4 mph), respectively. The principle direction of the impact was within the 2 o'clock sector estimated at 50 degrees. The Collision Deformation Classification was 02-RPEW-2.

Figure 5: Right front close-up of the damage.

Figure 6: Right rear close-up of the damage.

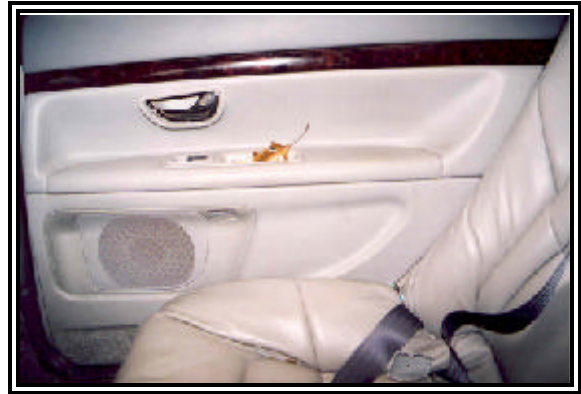
The right front and right rear interior door panels intruded laterally into the occupant compartment and were in contact with outboard aspect of the front right and rear right seat. **Figure 7** is a view of the intrusion and rear right seat compression. The seat cushions were compressed laterally. The intrusion of the central aspect of the right front door measured immediately above the grab handle was 6.1 cm (2.4 in). The right B-pillar intrusion measured at the elevation of the front seat backs was 4.6 cm (1.8 in). The intrusion of the central aspect of the right rear door measured immediately above the grab handle was 5.8 cm (2.3 in).

Figure 7: View of the rear right intrusion and seat compression.

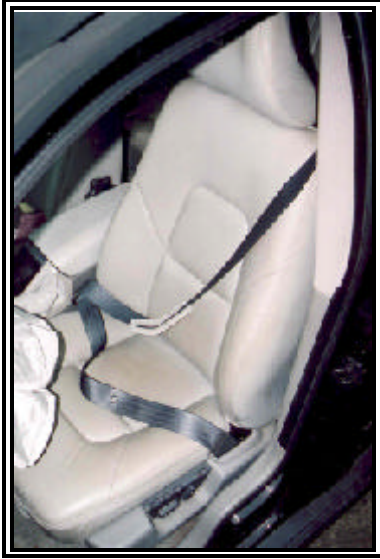
Figure 8: Driver's restraint.

At the time of the inspection, the driver's restraint was extended from the retractor and laying on the seat, **Figure 8**. The retractor was locked by the fired pretensioner. The exposed webbing section measured 168 cm (66 in) from the outboard anchor to the spool of the locked retractor located in the upper B-pillar. The trim that guided and surrounded the belt path at the upper aspect of the left B-pillar separated and was laying on the seat. The trim separated due to the belt tensioning caused by the fired retractor pretensioner. Examination of the webbing revealed a 8 cm (3 in) section of stretched webbing located at the latch plate with the restraint in the buckled condition. Examination of the latch plate revealed evidence of historical use consistent with the age of the vehicle. All the evidence gathered during the inspection indicated the driver was restrained at the time of the crash.

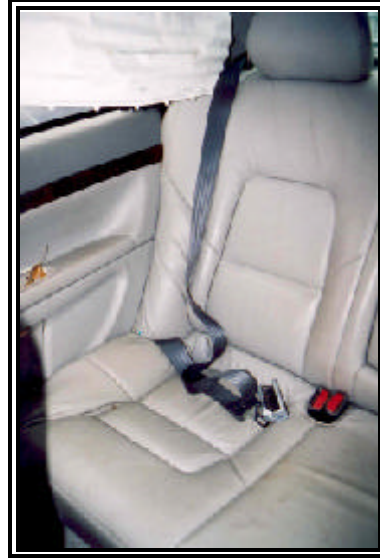
Figure 9: Rear right restraint.

The rear right restraint was extended from its retractor and laying on the rear bench seat, **Figure 9**. The retractor was locked by the fired pretensioner. The exposed webbing section measured 141.0 cm (55.5 in) measured from the seat bight to the upper belt guide. Examination of the webbing did not reveal any evidence of loading. However, given the relative mass of the occupant (as compared to the driver) and the principle direction of force in this crash loading evidence would not be expected. Latch plate examination revealed sign historical usage indicators. The evidence gathered during the inspection indicated the rear right occupant was restrained in this crash.

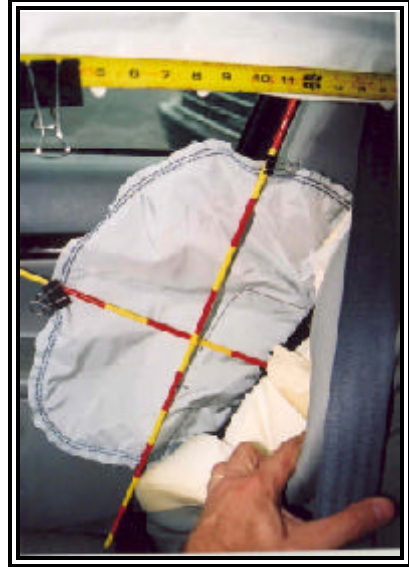
The right side impact air bag, **Figure 10**, was housed in a vertically oriented module housed in the outboard bolster of the right front seat back. The bolster seam stitching separated vertically allowing the forward expansion of the air bag. The side impact air bag was elliptical in shape and was designed to offer thorax protection. The air bag measured 39.4 cm x 25 cm (15.5 in x 10 in), vertically by longitudinally with respect to the vehicle. The air bag was not tethered and was vented by a single 2.5 cm (1.0 in) diameter port located on the upper aspect of the bag's outboard side. The air bag inflated to an estimated thickness of approximately 5 to 8 cm (2 to 3 in). There was no contact evidence noted on the air bag.

Figure 10: View of the deployed right side impact air bag.

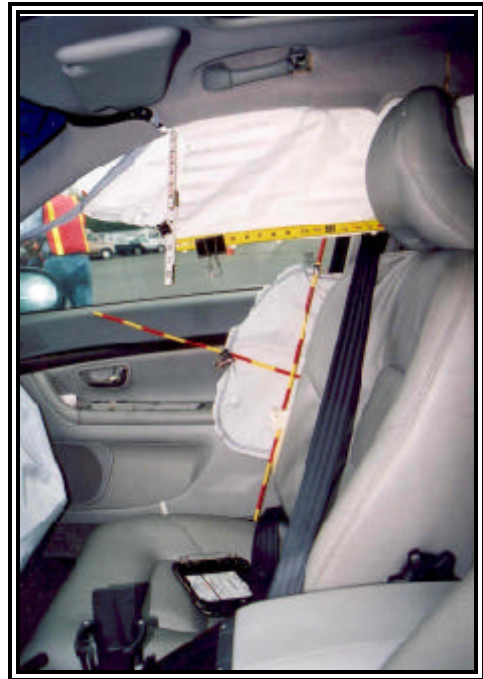
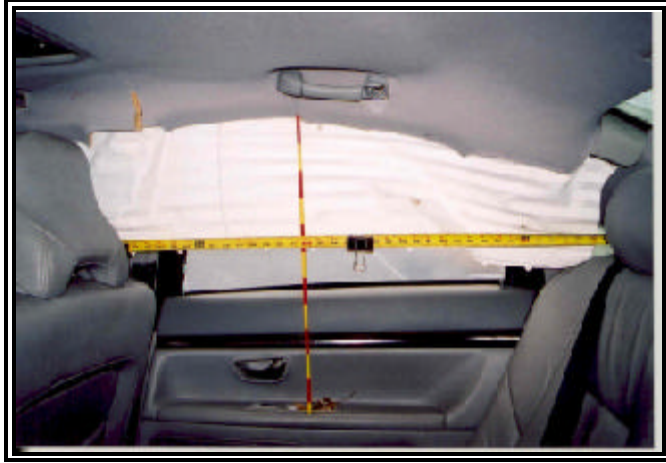
Figures 11 and 12 are left side views of the deployed right inflatable side curtain. The inflatable curtain deployed downward from the right roof rail. The curtain was rectangular in shape and measured 25 cm x 137 cm (10 in x 54 in) overall. The estimated thickness of the inflated curtain was approximately 5 cm (2 in). The headliner separated, along its length, from the upper interior trim allowing the curtain to deploy vertically down. The curtain provided approximately 137 cm (54 in) of coverage across the vehicle's right side glass. This coverage measured approximately 38 cm (15 in) forward of the B-pillar extending forward across approximately two thirds (2/3) of the right front glazing. The coverage extended approximately 86 cm (34 in) rearward of the B-pillar, across the left rear glazing and ending adjacent to the right rear seat back. The forward aspect of the curtain was fastened to the mid aspect of the A-pillar by a 47.0 cm (18.5 in) long tether strap. The strap was attached to the A-pillar 30 cm (12 in) above the instrument panel. The rear aspect of the curtain was fastened to the left roof rail at the C-pillar. The vertical dimension of the deflated curtain measured 25 cm (10 in). The curtain was designed with a distinct chambered pattern. There were 12 chambers with nominal dimensions that measured 8.9 cm x 21.6 cm (3.5 in x 8.5 in). This pattern provided the occupant protection when inflated, as well as providing some rigidity to the curtain and helped to maintain its shape. The curtain was not externally vented. A horizontally-mounted gas cylinder located in the upper aspect of the C-pillar provided the means for inflation.

Figure 11: Left interior view depicting the deployed right side impact protection.

Figure 12: Left interior view of the deployed inflatable curtain at the rear right position.

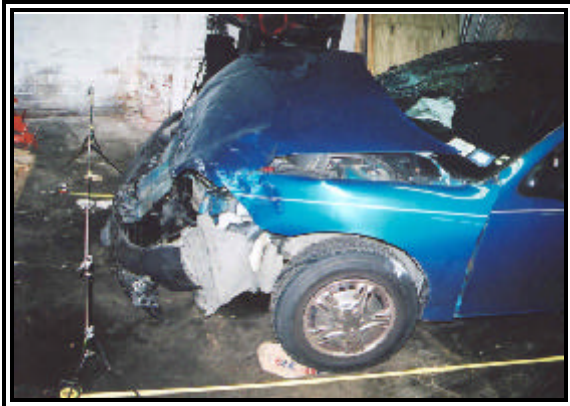
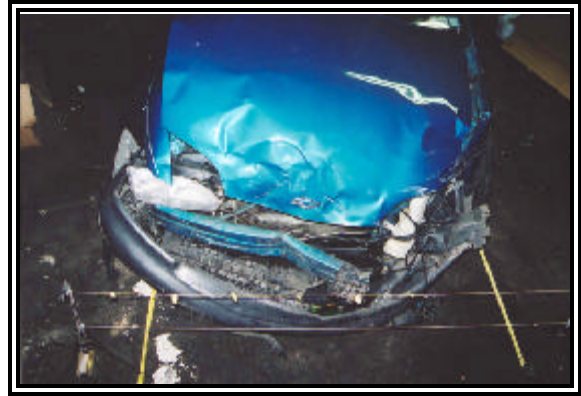
Figures 14 and 15 are a left lateral and an overhead frontal view of the vehicle's exterior damage. The frontal plane of the Chevrolet sustained moderate direct contact damage that extended across its entire 142 cm (56 in) end width. The lateral momentum of the Volvo during the impact phase caused a 30 cm (12 in) right lateral deformation of the Chevrolet's bumper structure. The crash damage extended longitudinally rearward to approximately the radiator support plane. The residual frontal crush profile along the bumper reinforcement bar was as follows: C1 = 14.1 cm (5.5 in), C2 = 31.4 cm (12.4 in), C3 = 35.3 cm (13.9 in), C4 = 34.9 cm (13.8 in), C5 = 29.5 cm (11.6 in), C6 = 29.3 cm (11.6 in). The right front fender shifted rearward and restricted the operation of the right door. The right wheelbase was reduced 6.5 cm

(2.6 in) and the right front tire was restricted. The left wheelbase dimension was unchanged. The total delta V calculated by the Damage algorithm of the WINSMASH model was 25.1 km/h (15.6 mph). The longitudinal and lateral components of the delta V were -19.3 km/h (-12.0 mph) and 16.2 km/h (10.1 mph), respectively. The impact's principle direction of force (PDOF) was in the vehicle's 11 o'clock sector estimated to be 320 degrees. The Collision Deformation Classification (CDC) was 11-FDEW-2.

Figure 14: Left lateral view.

Figure 15: View of the frontal damage.

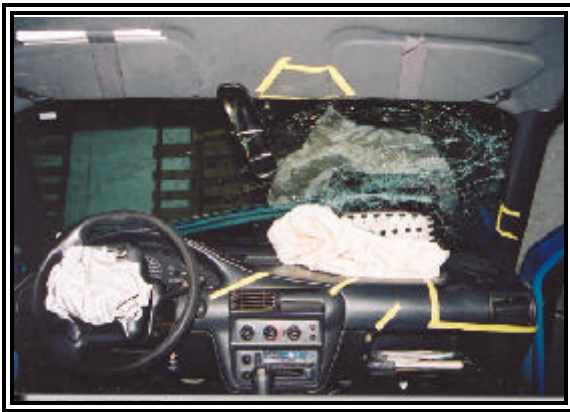
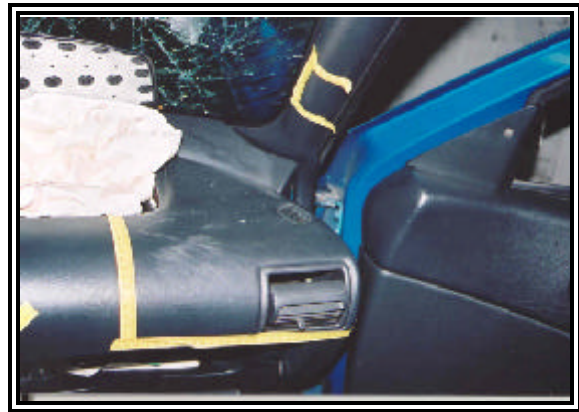
Figure 16 is an overall view of the Chevrolet's interior. Multiple areas of contact evidence were identified on the upper surface of the instrumental panel's right aspect. These contacts were attributed to contact from the impeded expansion of the front right passenger air bag due to the forward position of the lap seated child passenger. A 25 cm x 18 cm (10 in x 7 in), width by height, area of air bag scuffing was located on the right corner of the instrument panel, **Figure 17**. This contact pattern measured 13 cm (5 in) on the vertical face of the panel and wrapped 5 cm (2 in) onto its horizontal surface. The heating vent louvers were fractured by this contact. A 10 cm x 8 cm (4 in x 3 in) air bag scuff was identified on the vertical face of the instrument panel in its right center aspect. This scuff began 36.8 cm (14.5 in) left of the panels outboard edge. An 8.0 cm (3.0 in) air bag scuff was located on the trim panel covering the right A-pillar. This scuff began 15 cm (6 in) above the instrument panel. The right door interior trim panel exhibited a 14.0 cm (5.5 in) air bag scuff on its upper aspect at the intersection with the glazing. The pattern began 24.1 cm (9.5 in) rear of the forward edge of the glazing. The trim panel was fractured within this pattern from probable occupant contact.

Figure 16: Overall forward interior view.

Figure 17: Air bag transfer pattern to the right aspect of the IP.

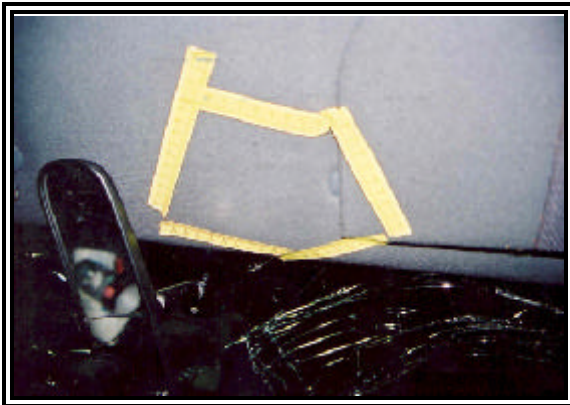
A head contact was identified on the center forward aspect of the headliner, **Figure 9**. The contact measured 15 cm x 10 cm (6 in x 4 in), width by length and was located 5 cm (2 in) right of the vehicle's centerline. The center mirror adjacent to this location rotated and fractured. A 13 cm x 13 cm (5 in x 5 in) body fluid spray was identified on the left aspect of the instrument panel brow located above the instrument cluster, **Figure 10**. The contact pattern began 72.4 cm (28.5 in) left of the instrument panel right outboard edge and extended left to approximately the steering column center line. Several strands of hair

Figure 18: Contact evidence to the headliner.

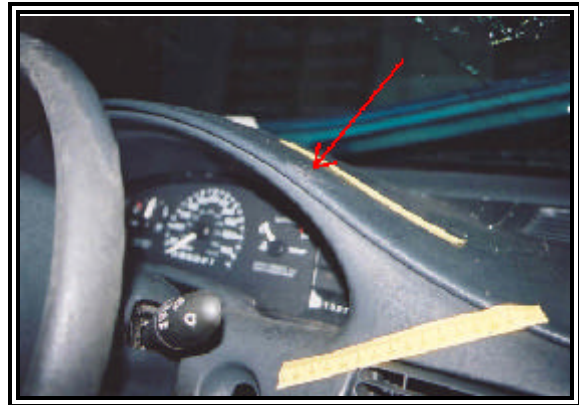
were located on the brow within a probable head contact in this contact pattern (identified by the arrow in Figure 10). These contacts were both associated to the child passenger due to their relative location and orientation.

Figure 19: Contact evidence to the IP brow.

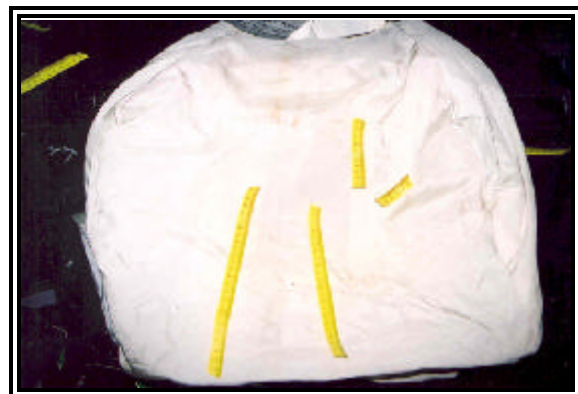
The top surface of the air bag, **Figure 20**, exhibited multiple patterns of contact evidence. A 25 cm x 15 cm (10 in x 6 in) region of vinyl transfers was located on the forward aspect of the top surface and began 15

Figure 20: Passenger air bag top surface.

cm (6 in) from the aft edge of the module. This pattern was attributed to contact with the cover flap during its impeded deployment. A 5 cm x 11.4 cm (2 in x 4.5 in) area of the air bag was yellowed from probable heating during the deployment. This pattern began 18 cm (7 in) from the module edge and was centered 18.5 cm (7.3 in) right of the inboard edge of the bag. A 14.0 cm (5.5 in) long by 3.8 cm (1.5 in) wide black vinyl transfer was located 14.0 cm (5.5 in) left of the right outboard edge of the bag. A secondary pattern linked to the former transfer measured 10 cm (4 in) long and was located on the outboard edge of the bag extending onto the outboard side panel. These transfers resulted from their contact with the right A-pillar trim. A 8 cm x 20 cm (3 in x 8 in), width by length, tissue transfer was located within the center aspect of the air bag's top surface, **Figure 21**. The transfer began 41 cm (16 in) from the module and extended rearward ending 61 cm (24 in) from the module. This transfer resulted from direct contact with the child occupant.

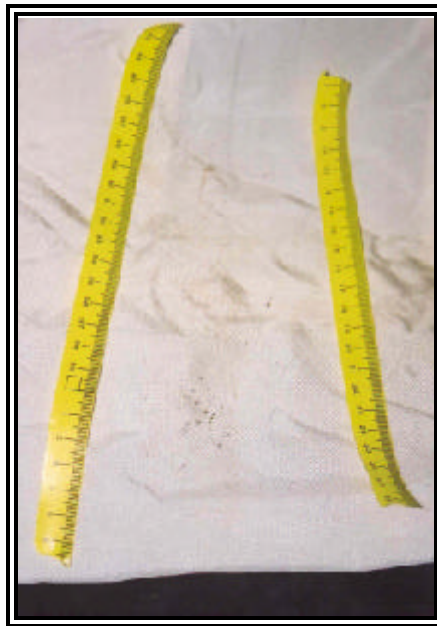
Figure 21: Close-up of the tissue transfer.

The 3 year child seated on the lap of the adult front right passenger sustained fatal cervical spinal cord and brain injuries as a result of direct contact with the expanding front right passenger air bag.
