ON-SITE ADVANCED OCCUPANT PROTECTION SYSTEM INVESTIGATION

VEHICLE: 2002 LEXUS ES300

GENERAL DYNAMICS CASE NO: CA02-047

CRASH DATE: OCTOBER 2002

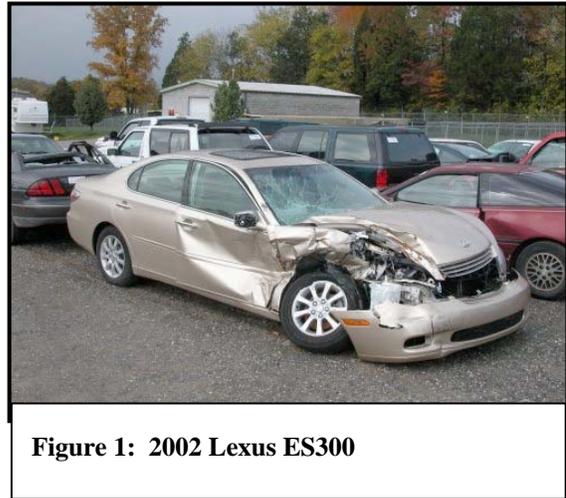
This on-site investigation focused on the performance of the Advanced Occupant Protection System (AOPS) in a 2002 Lexus ES300, **Figure 1**. The Lexus ES300 was equipped with front seat belt retractor pretensioners, dual-stage frontal air bags, side impact air bags, and inflatable head curtains. The vehicle was also equipped with an Event Data Recorder (EDR) that was capable of recording parameters associated to the crash. The Lexus was involved in an intersection crash with a 1999 Dodge Ram 1500 series pickup truck. The seat belt pretensioners and frontal air bags in the Lexus and the frontal air bags in the Dodge deployed as a result of the crash. The drivers of the respective vehicles sustained police reported minor injuries and refused treatment at the scene.

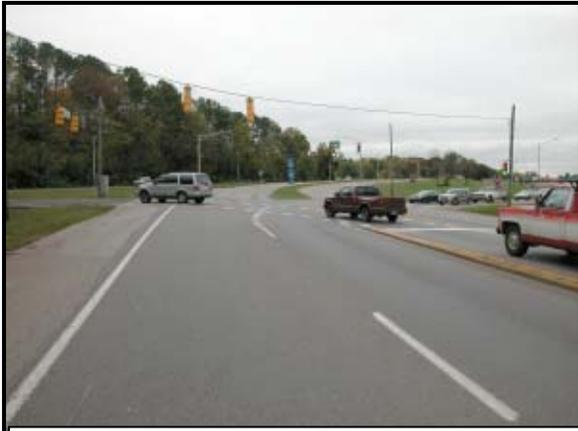
Figure 2: Northward view of the left turning traffic.

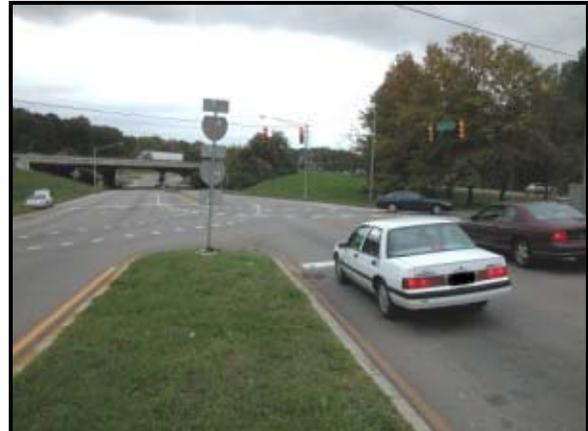
Figure 3: Southward look back view across the intersection.

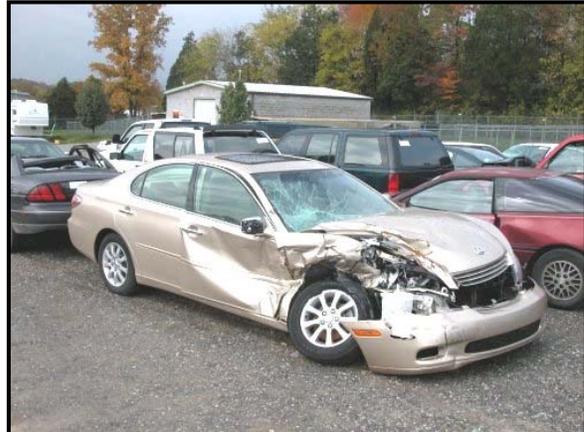
The 2002 Lexus ES 300, **Figure 4**, was identified by the Vehicle Identification Number (VIN): JTHBF30GX20 (production sequence deleted). The 4-door sedan was equipped with a 3.0 liter/V6 engine linked to a 5-speed automatic transmission. The service brakes were four-wheel disc with four sensor/four channel ABS. The manual restraint system consisted of 3-point lap and shoulder belts in the five seat positions. The front restraints were equipped with retractor pretensioners. The Advanced Occupant Protection System (AOPS) consisted of dual stage driver and front right passenger air bags. Additionally, the Lexus was equipped with front seat back mounted side impact air bags and inflatable side curtains. The electronic odometer could not be read at the time of the inspection. The vehicle's date of manufacture was November 2001. The subject vehicle was equipped with Toyo Proxes tires (size P215/60R16) on OEM alloy wheels. The manufacturer's recommended tire pressure was 200 kpa (29 psi). The specific measured tire data was as follows:

Figure 4: Left front view of the Lexus.

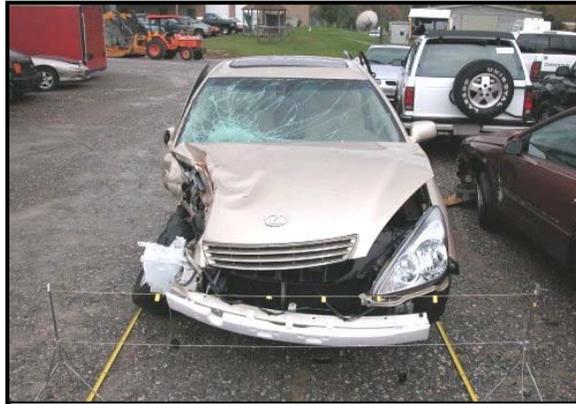
Figure 5 is a front view of the damaged Lexus. The front plane of the Lexus sustained 23.6 cm (9.3 in) of direct contact damage that began 49.0 cm (19.3 in) right of center and extended to the right corner. The combined width of the direct and induced damage extended across the vehicle's entire 145 cm (57 in) front end width. Additionally, the direct contact damage pattern extended rearward 199.6 cm (78.6 in) along the right side and ended on the forward aspect of the right front door. The nature of the impact damage was indicative of an angular corner impact with engagement of the Dodge onto the right side plane of the Lexus. The right front fender buckled and shifted rearward fracturing the right lower aspect of the windshield. The right front door compressed into the B-pillar and was jammed closed. The compression of the door caused the window frame to bow outward. The right front tire, wheel, and suspension were damaged. The right wheelbase was foreshortened 4.1 cm (1.6 in). The force of the impact caused localized buckling of the roof and right rear quarterpanel. The residual crush profile measured along the bumper reinforcement was as follows: C1 = 0, C2 = 1.0 cm (0.4 in), C3 = 5.0 cm (2.0 in), C4 = 11.0 cm (4.3 in), C5 = 14.0 cm (5.5 in), C6 = 25.0 cm (9.8 in). The Collision Deformation

Classification (CDC) was 01-FREE-6. The total delta V calculated by Damage algorithm of the WINSMASH model was 35.9 km/h (22.3 mph). The longitudinal and lateral delta V components were -31.1 km/h (-19.3 mph) and -18.0 km/h (-11.2 mph), respectively.

Figure 5: Front view of the Lexus.

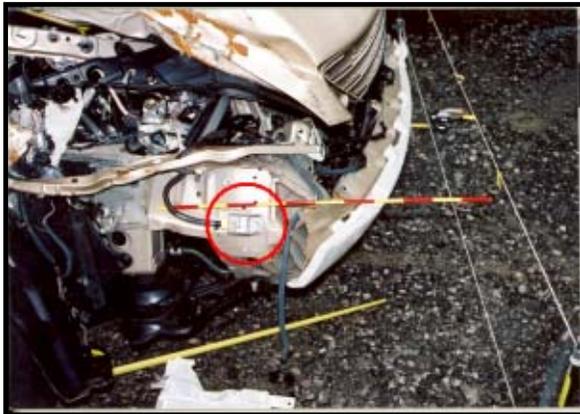
Figures 6 and 7 are close-up views of the damaged right forward frame member and the undamaged left forward frame member, respectively. The right side frame member's longitudinal crush measured 25.0 cm (9.8 in).

Figure 7: Lateral view of the crush at the right forward frame.

mounted under the forward aspect of the center console. The control module had Event Data Recording (EDR) capabilities. Two crash recognition sensors were located on the forward uni-body frame and are highlighted in **Figures 6 and 7** above.

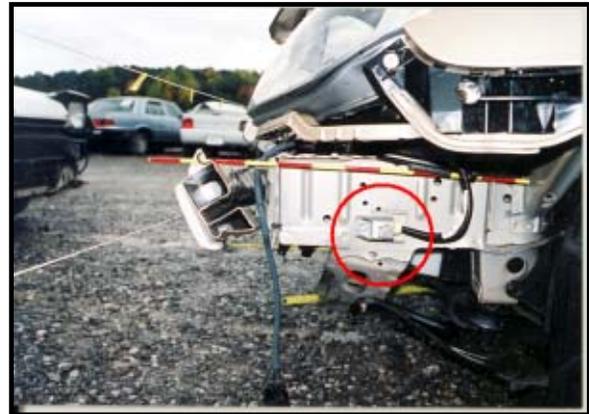
Figure 6: Lateral view of the undamaged left forward frame.

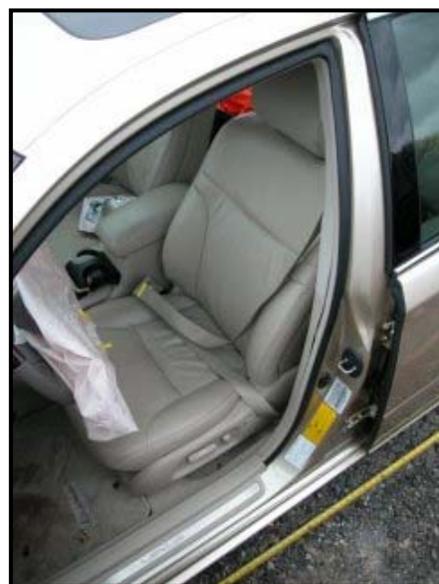
At the time of the inspection, the driver's restraint was extended from the retractor and laying on the seat, **Figure 8**. The retractor was locked. The D-ring was positioned 1.9 cm (0.75 in) above its lowest adjustment. The exposed webbing section measured 179.1 cm (70.5 in) from the outboard anchor to the adjustable D-ring. The exposed webbing in the lap portion of the belt measured 80.6 cm (31.75 in) and the exposed webbing in the torso section measured 98.4 cm (38.75 in). Examination of the webbing revealed a 4 cm (1.5 in) section of stretched webbing located at the latch plate with the restraint in the buckled condition. Examination of the latch plate revealed evidence of historical use consistent with the age of the vehicle. All the evidence gathered during the inspection indicated the driver was restrained at the time of the crash.

Figure 8: View of the driver's manual restraint.

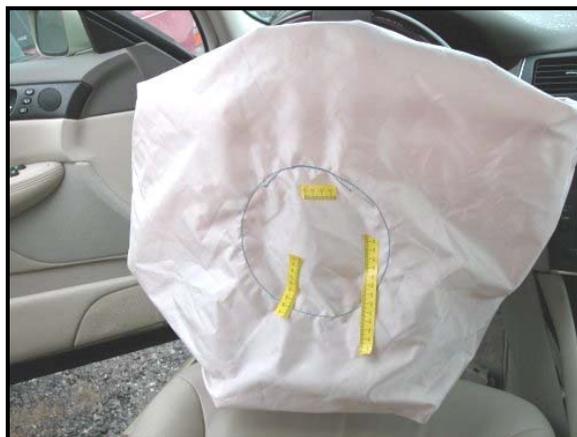
The driver air bag was housed in the typical manner in the center hub of the steering wheel. The H-configuration module cover flaps were asymmetrical. The upper flap measured 14.7 cm x 6.4 cm (5.8 in x 2.5 in); width by height, and the lower flap measured 14.7 cm x 10.1 cm (5.8 in x 4.0 in). The driver air bag measured 66 cm (26 in) in its deflated state. It was tethered by two 10 cm (4 in) wide straps sewn to the face of the bag. It was vented by two 3.3 cm (1.3 in) diameter ports in the 11/1 o'clock sectors on the back side of the bag. **Figure 9** is a view of the driver air bag. The contact evidence on the face of the driver air bag consisted of three areas of make-up transfer. The transfers measured 1.9 cm (0.75 in) in diameter, 2.5 cm x 8.9 cm (1.0 in x 3.5 in), width by height and 1.3 cm x 6.4 cm (0.5 in x 2.5 in), width by height. The transfers were located symmetrically along the vertical centerline of the air bag indicative of the driver being “in-position” at the time of the contact.

Figure 9: Driver air bag.

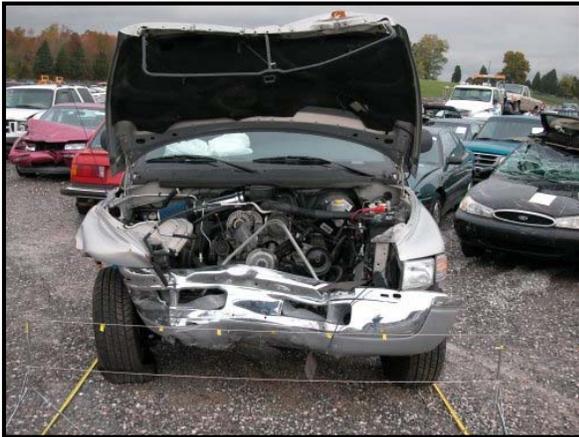
Figures 10 and 11 are the front and right lateral views of the damaged Dodge. The front plane of the Dodge sustained a 143.5 cm (56.5 in) of direct contact damage that began 57.1 cm (22.5 in) left of center and extended to the right corner of the front bumper. The combined width of the direct and induced damage extended across the entire 173 cm (68 in) frontal end width. The damaged components included the front bumper, center grille, hood, right headlamp assembly and right front fender. The damage extended rearward into the engine compartment to the radiator support plane. The residual location of the right corner of the bumper was inboard of the right front tire. The right front tire was deflated and the exterior surface of the rim was abraded. The right wheelbase was reduced 1.9 cm (0.75 in). The right front fender shifted rearward and restricted the operation of the right front door. There was no cab to bed contact. The residual crush profile measured at the bumper elevation was as follows: C1 = 0, C2 = 19 cm (7.3 in), C3 = 41 cm (16.0 in), C4 = 46 cm (18.3 in), C5 = 38 cm (15.3 in), C6 = 41 cm (16.0 in). The Collision Deformation Classification was 12-FDEW-2. The total delta V calculated by Damage algorithm of the WINSMASH model was 24.8 km/h (15.7 mph). The longitudinal and lateral delta V components were -24.8 km/h (-15.7 mph) and 0, respectively.

Figure 10: Front view of the Dodge.

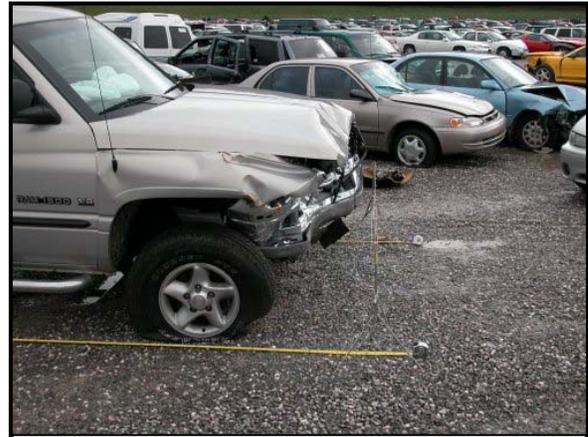
Figure 11: Right lateral view.
