AIR BAG RELATED EYE INJURY INVESTIGATION

VERIDIAN CASE NO: CA02-052

VEHICLE: 1994 NISSAN ALTIMA

LOCATION: WASHINGTON, DC

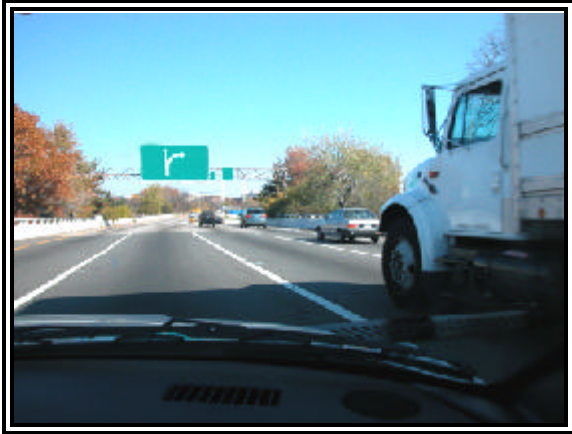
Figure 1: Eastbound trajectory view approximately 200 m (650 ft) west of the impact attenuator.

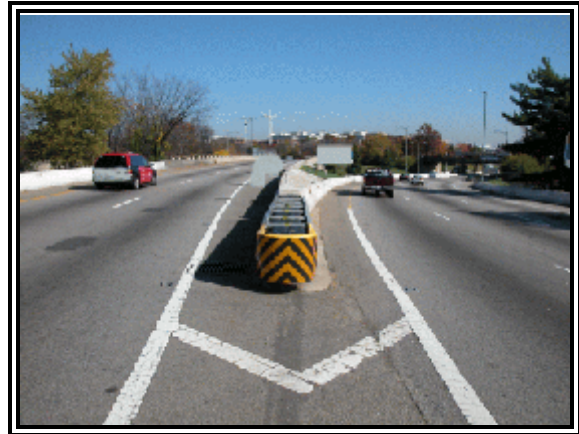
Figure 2: End-view of the impact attenuator.

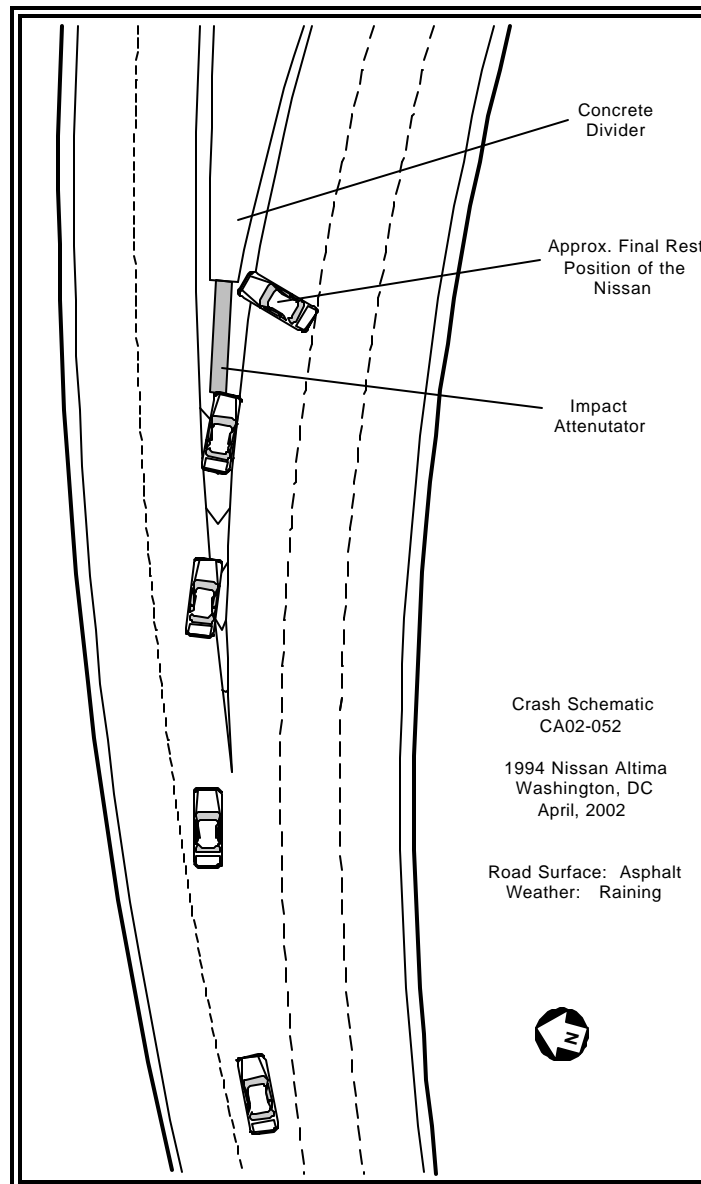
As the Nissan approached the change in the highway's configuration, the driver realized late in the pre-crash sequence that he needed to change lanes to the right due to his unfamiliarity with the highway. It was the driver's intention to travel on the right fork of the split. Reportedly, the driver slowed the vehicle and steered clockwise (right) through the gore area preceding the impact attenuator. The travel speed of the Nissan was not known. **Figure 3** is a schematic of the crash depicting the approximated crash sequence.

Figure 3: Crash Schematic.

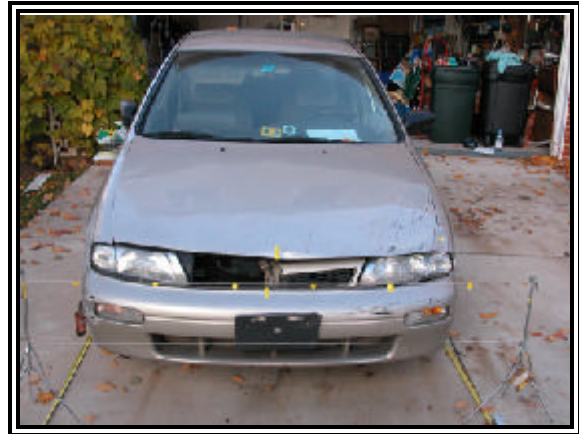
The 1994 Nissan Altima GXE, 4-door sedan, was identified by the Vehicle Identification Number (VIN): 1N4BU31D4RC (production sequence deleted) and is depicted in **Figure 4**. The Nissan was powered by a 2.4 liter, I4 engine linked to a 4-speed automatic transmission. The manual restraint system consisted of 3-point lap and shoulder belts in the four outboard positions. The center rear position was equipped with a lap belt. The Supplemental Restraint System (SRS) consisted of driver and front right passenger air bags that had deployed as a result of the crash. The odometer had registered 237,468 km (147,560 miles) at the time of the inspection. The vehicle had been pre-owned and was purchased by a family member on July 16, 2001. The mileage at the time of purchase was unknown. Reportedly, the vehicle had no prior crash history.

Figure 4: Front view of the Nissan.

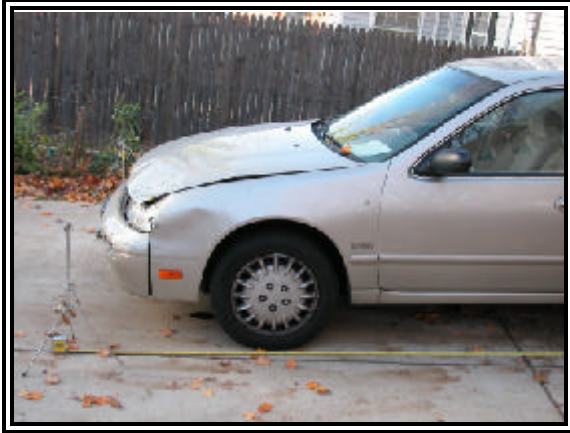
The Nissan sustained minor frontal damage during the crash that was managed primarily by the front bumper system. There was no residual crush at the bumper level. The direct contact damage on the fascia and hood face began 3.3 cm (1.3 in) right of the vehicle's center line and extended to the front left corner. The width of the direct contact measured 77.0 cm (30.3 in). The undeformed end width measured 147 cm (58 in). The frontal components damaged in the crash included the bumper fascia, the center grille, the left head lamp, and the left turn signal. The hood was buckled and there was minor deformation of the left front fender, **Figure 5**. The direct contact on the surface of the hood extended longitudinally rearward 48 cm (19 in). **Figure 6** is a view into the engine compartment depicting the residual damage along the upper radiator support. The residual crush profile measured along the support was as follows: C1 = 4.6 cm (1.8 in), C2 = 7.6 cm (3.0 in), C3 = 4.6 cm (1.8 in), C4 = 0.8 cm (0.3 in), C5 = 0, C6 = 0. There was no measurable change in the wheelbase dimensions. All the doors were operational and windshield and side windows remained intact. The Collision Deformation Classification was 12-FYEW-1. The delta V sustained by the Nissan was approximately 8 to 16 km/h (5 to 10 mph) based on SCI experience. An analysis using the Barrier Algorithm of the Winsmash model, for comparison purposes, determined the total delta V of the Nissan was approximately (10.9 km/h) 6.7 mph.

Figure 5: Left side view.

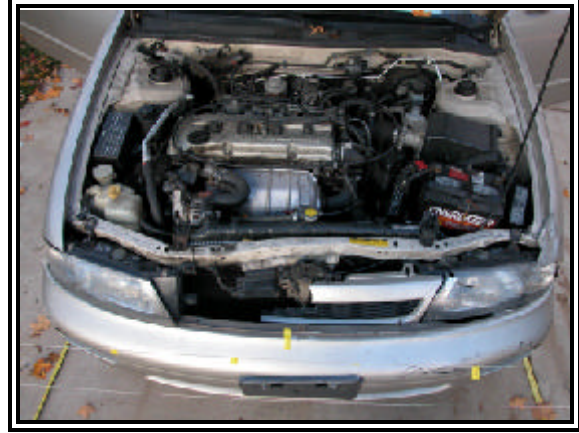
Figure 6: Engine compartment view.

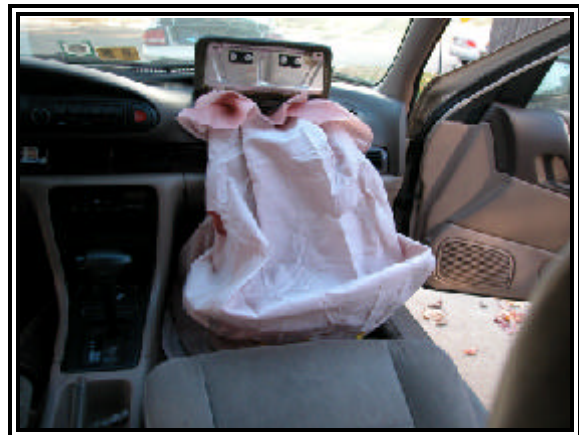
The front right passenger air bag was a top mount design located in the right aspect of the instrument panel, **Figure 7**. The air bag module cover flap was rectangular in shape and conformed to the contour of the instrument panel. The flap was comprised of vinyl with a sheet metal backer. The sheet metal deformed during the deployment and acted as a hinge during cover flap rotation. The flap measured 32.5 cm by 13.5 cm (12.8 in by 5.3 in), width by height. There was no contact evidence to the exterior surface of the cover flap.

Figure 7: View of the deployed front right passenger air bag.

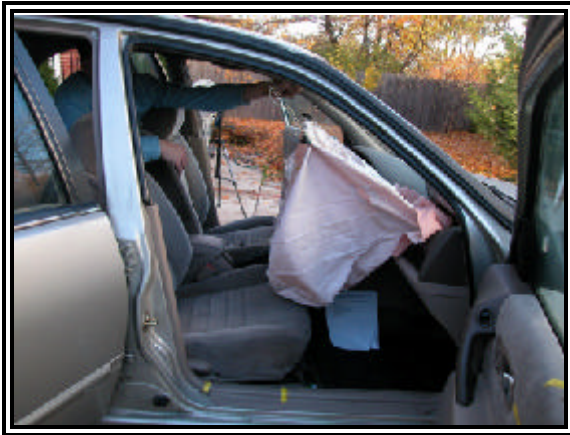
The rearward excursion of the bag measured 52.1 cm (20.5 in) from the aft edge of the module, **Figure 8**. The air bag module was located 5 cm (2 in) forward of the vertical face of the instrument panel, therefore the bag excursion measured 47.0 cm (18.5 in) from the vertical face of the instrument panel. The air bag was not tethered and was vented by two 5 cm (2 in) diameter ports located on the side panels of the bag.

Figure 8: Right lateral view depicting the excursion of the air bag.

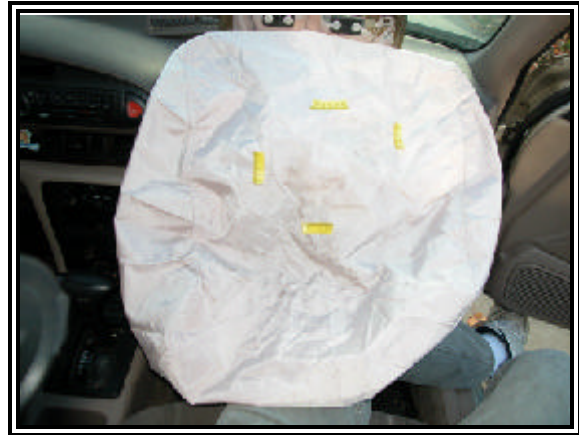
Figure 9 is view of the face of the passenger air bag and **Figure 10** is a dimensional schematic depicting the identified contact evidence. The bag's face exhibited evidence of direct occupant contact. The contact pattern appeared brown in color and was a probable pigment transfer from the face of the front right passenger. The contact area was approximately centered laterally on the face of the bag with gross overall dimensions that measured 19.1 cm by 19.1 cm (7.5 in by 7.5 in), width by height. The contact pattern began approximately 7.6 cm (3 in) above the construction seam.

Figure 9: View of the PAB face.

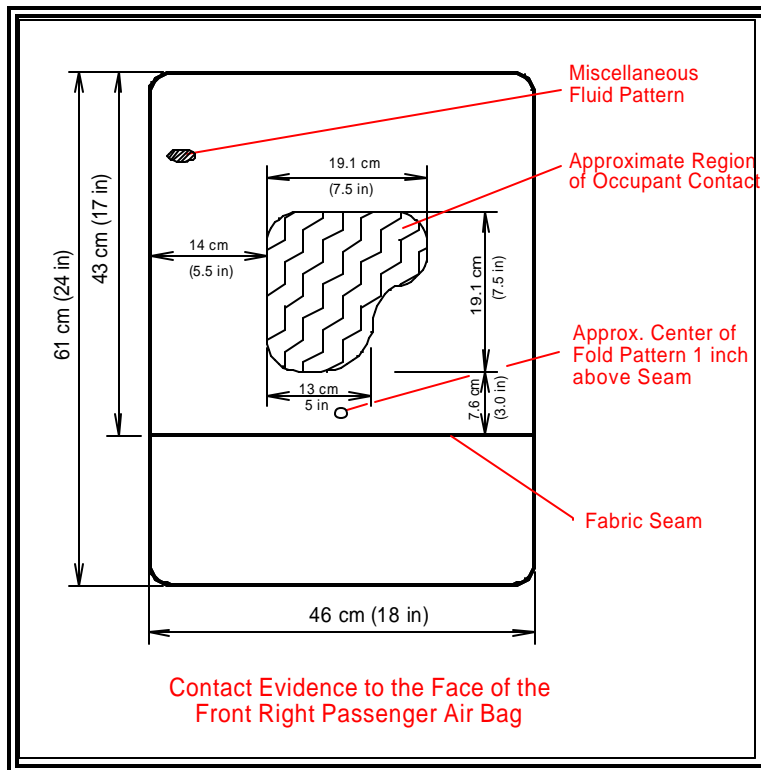
Figure 10: Schematic of the contact evidence to the face of the PAB.
