**SIDE IMPACT AIR BAG NON-DEPLOYMENT/DRIVER FATALITY INVESTIGATION**

**VERIDIAN CASE NO: CA02-054**

**VEHICLE: 2001 BUICK REGAL**

**CRASH DATE: OCTOBER, 2002**

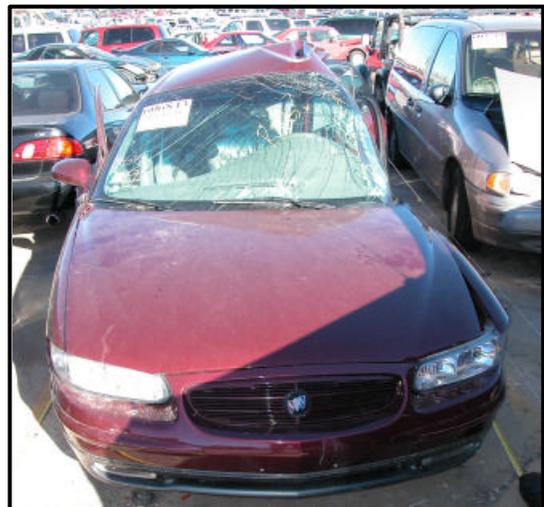
The 2001 Buick Regal GS, **Figure 3**, was identified by the Vehicle Identification Number (VIN): 2G4WF551211 (production sequence deleted). The vehicle was equipped with a 3.8 liter V6 supercharged engine linked to a 4-speed automatic transmission. The Buick was equipped with a four wheel anti-lock brake system (ABS). The manual restraint system consisted of 3-point lap and shoulder belts in the four outboard seat positions and a center rear lap belt. The Supplemental Restraint System (SRS) consisted of redesigned frontal air bags for the driver and front right passenger and a driver seat-mounted side impact air bag. None of the air bags deployed as a result of the crash. The vehicle was purchased new by the driver in October 2000. The vehicle's date of manufacture and odometer reading were unknown.

**Figure 3: Front view of the Buick Regal.**

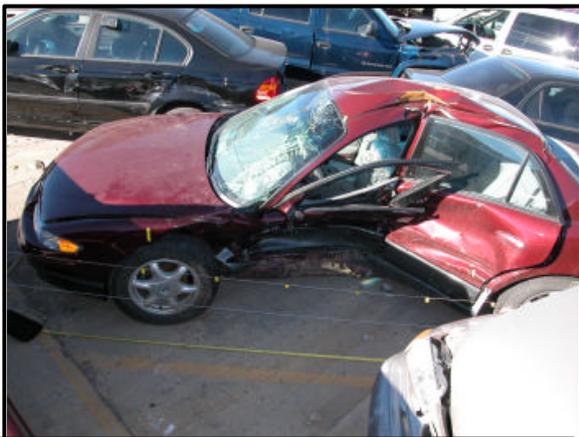
**Figures 4 and 5** are left side views of the Buick. The left side plane of the Regal sustained 214.0 cm (84.3 in) of direct contact damage as a result of the impact. The damage began 56.7 cm (22.3 in) forward of the left rear axle and extended forward onto the left front fender. The damage ended 6.4 cm (2.5 in) aft of the left front axle. The maximum crush was located at the mid-aspect

of the left front door and measured 78.0 cm (30.7 in). The residual crush profile at the mid-door elevation was as follows: C1 = 0, C2 = 26.0 cm (10.2 in), C3 = 65.0 cm (25.6 in), C4 = 78.0 cm (30.7 in), C5 = 62.0 cm (24.4 in), C6 = 18.0 cm (7.1 in). The lateral deformation of the left A-pillar fractured the windshield. The left front, right front and backlight glazing disintegrated upon impact. The left doors were jammed shut by the deformation. The right rear door was jammed due to body deformation. The right front door was opened by extrication. The force of the impact deformed the vehicle's unibody structure and caused it to bow. The bowing was reflected in the vehicle's wheelbase measurements. The wheelbase specification was 277.0 cm (109.1 in). The right wheelbase measured 282.0 cm (111.1 in). The left wheelbase measured 261.0 cm (102.8 in). The left front axle was displaced approximately 8 cm (3 in) forward during the impact. The total delta V calculated by the Damage Algorithm of the WINSMASH model was 45.0 km/h (27.9 mph). The longitudinal and lateral components were -7.8 km/h (-4.8 mph) and +44.3 km/h (+27.5 mph), respectively. The Principle Direction of Force (PDOF) was an estimated 280 degrees. The Collision Deformation Classification (CDC) was 09-LPAW-4.

Figure 4: Overall left side view.

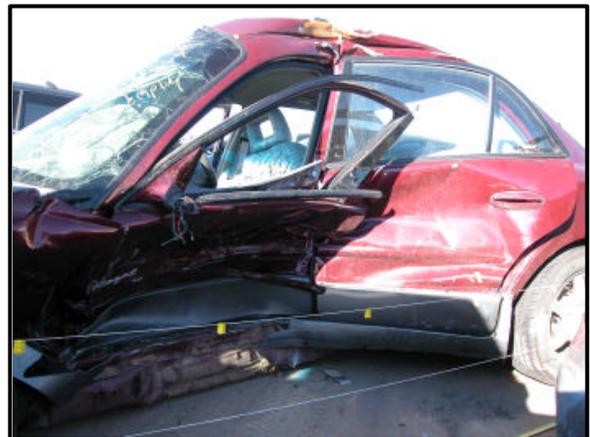
Figure 5: Close-up view of the left side damage.

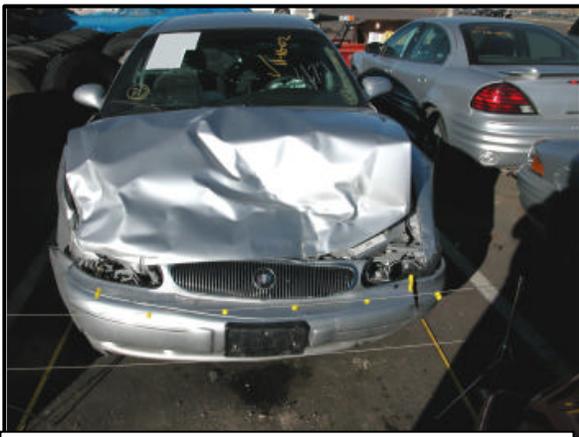
**Figures 6 and 7** are the front and right lateral views of the frontal damage. The front plane of the Buick Century sustained direct contact damage that extended across the vehicle's entire 147 cm (58 in) frontal end width. The direct contact damage on the hood along the vehicle's centerline extended rearward approximately 25 cm (10 in) from the hood's leading edge, [61.2 cm (24.1 in) from the original baseline]. The residual crush profile measured along the bumper reinforcement bar was as follows: C1 = 10.0 cm (3.9 in), C2 = 19.0 cm (7.5 in), C3 = 20.0 cm (7.9 in), C4 = 19.0 cm (7.5 in), C5 = 17.0 cm (6.7 in), C6 = 7.0 cm (2.8 in). The force of the crash caused both front fenders and the hood to buckle. All the doors remained operational. There was no change in the wheelbase dimensions. The energy of the crash was managed primarily by the vehicle's structures forward of the A-pillars. The Collision Deformation Classification (CDC) was 12-FDEW-1. The delta V calculated by the Damage Algorithm of the WINSMASH model was 42.0 km/h (26.1 mph). The longitudinal and lateral delta V components were -41.4 km/h (-25.7 mph) and -7.3 km/h (-4.5 mph), respectively.

**Figure 6: Front view of the Buick Century.**

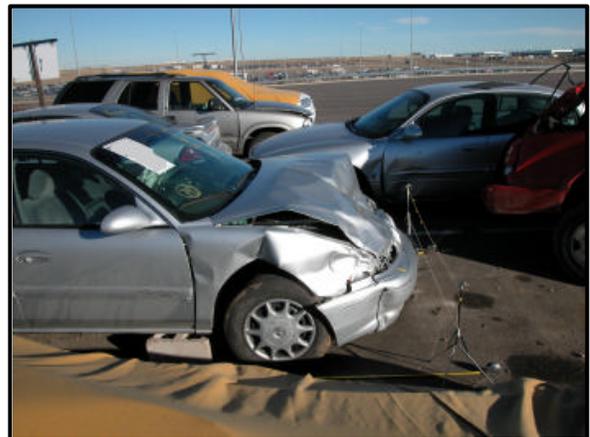
**Figure 7: Right lateral view of the damage.**

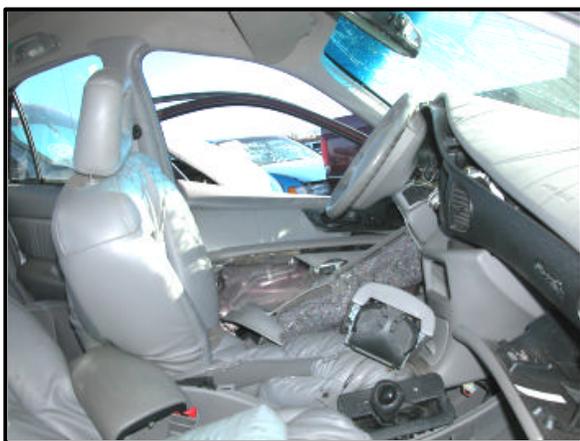
The Regal's front left and rear left occupant spaces sustained moderate intrusion as a result of the exterior crash forces. **Figure 8** is a view of the right lateral view of the driver's interior. **Figure 9** is a rear interior view through the backlight. The lateral intrusion into the driver's foot well measured 35.1 cm (13.8 in). The left corner of the instrument panel intruded laterally 12.7 cm (5.0 in). The lateral intrusion of the left front door measured at the center aspect of the arm rest was 25.9 cm (9.8 in). The lateral intrusion of the left rear door measured at its center aspect was 27.9 cm (11.0 in). The intrusion of the left B-pillar measured at the D-ring elevation and beltline was 38.4 cm (15.1 in) and 48.9 cm (19.3 in), respectively. The left B-pillar was in contact with the outboard aspect of the driver's seat back. The intruding left side had deformed the seat back laterally approximately 30 cm (12 in). The inboard aspect of the driver's seat contacted and fractured the center console.

**Figure 8: Right interior view.**

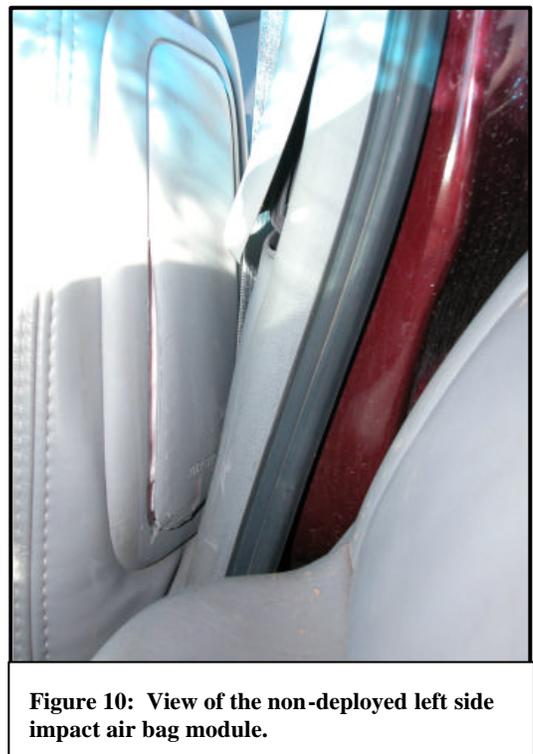
The left side impact air bag was housed in a module designed in the outboard aspect of the driver's seat back. **Figure 10** is a close-up view of the module looking rearward. (For orientation: the intruded B-pillar is depicted in the right side of the figure and the left door interior panel is in the lower right foreground. The outboard aspect of the seat and side impact module is in the left center of the figure.)

**Figure 10:** View of the non-deployed left side impact air bag module.

The side impact air bag (SAB) module was oriented vertically and measured 21.1 cm x 8.4 cm (8.3 in x 3.3 in), height by depth, respectively. Initial inspection revealed the lower forward aspect of the module cover flap had separated at the tear seam due to contact from the intruding B-pillar. The separation measured (4.5 in x 1.5 in), height by depth, along its perimeter.

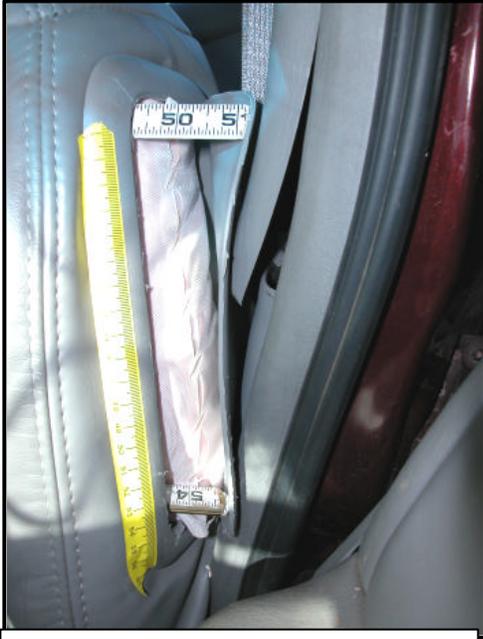
During the SCI vehicle inspection, the module was opened by the investigator to ascertain the condition of the side air bag. **Figures 11 through 14** are sequential views of the air bag examination. **Figure 11** is a view of the non-deployed side air bag packaged within the module. The non-deployed bag was folded and packaged within a sleeve designed to tear open along a weakened vertical seam. During the deployment sequence, this seam would separate and allow the egress of the expanding bag. **Figure 12** is a view of the folded air bag after separation of the tear seam.

**Figure 11: View of the packaged SAB under the cover flap.**

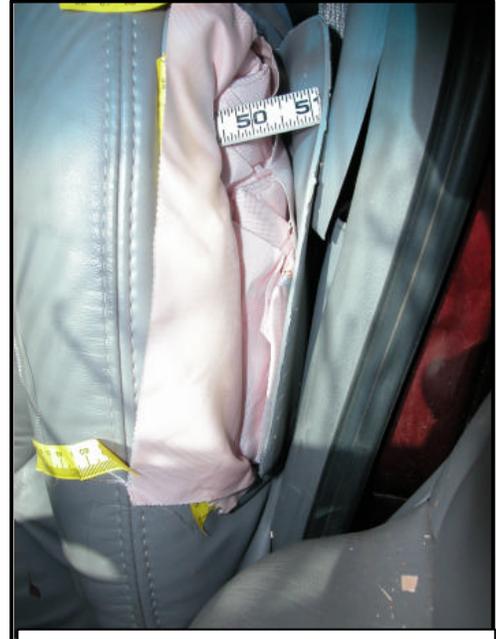
**Figure 12: View of the folded and undeployed SAB.**

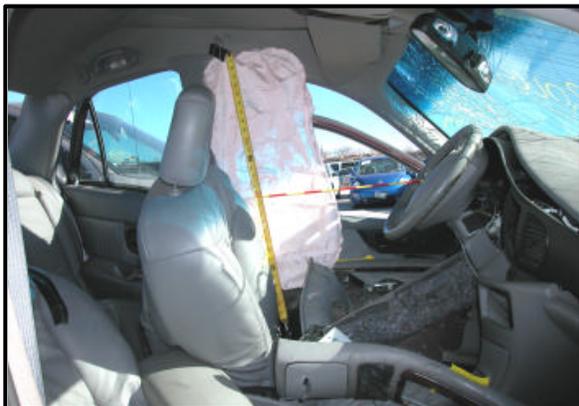
**Figures 13 and 14** are views of the side air bag after it was removed from the module and unfolded by the SCI investigator. The air bag was designed to offer head and thorax protection. It was approximately rectangular in shape and measured 66 cm x 30 cm (26 in x 12 in), height by width. The bag was tethered by two straps located in the upper aspect of the chamber. A 6.4 cm (2.5 in) wide strap was located 14.0 cm (5.5 in) below the top of the bag and a 10.2 cm (4.0) wide strap was located 33 cm (13 in) below the top reference. The air bag inflated to a lateral depth of approximately 8 cm (3 in). Inspection of the air bag surface was unremarkable. There were no

visible manufacturer's labels. The air bag was initially folded in an accordion pattern, unfolded without resistance and was not heat stressed. The physical condition of the side air bag indicated that it had not deployed. All the information gathered during the course of this investigation suggested that the side air bag module did not receive a deployment command during the crash sequence. The root cause of the non-deployment could not be determined.

**Figure 13: Right interior view of the SAB removed and unfolded from the module by the SCI investigator..**

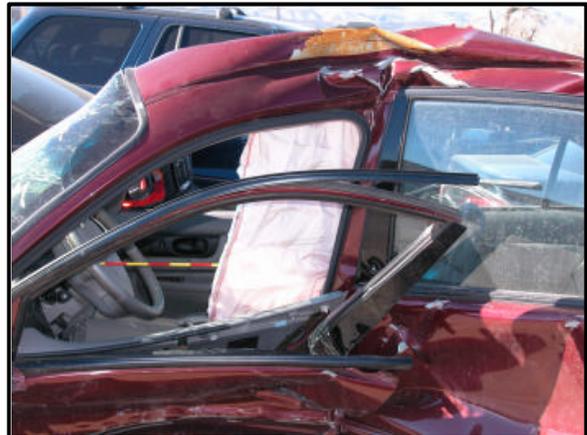
**Figure 14: Left view of the SAB removed and unfolded from the module by the SCI investigator.**
