**GENERAL DYNAMICS REMOTE SIDE IMPACT INFLATABLE OCCUPANT
PROTECTION INVESTIGATION
SCI TECHNICAL SUMMARY REPORT**

NASS/SCI COMBO CASE NO: 03-04-048E

VEHICLE: 2002 FORD EXPLORER

CRASH DATE: JULY 2003

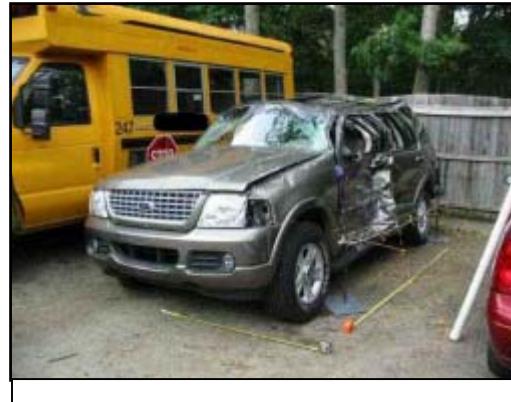
This remote investigation focused on the performance of the side impact inflatable occupant protection system that deployed in a 2002 Ford Explorer sport utility vehicle (**Figure 1**). The Explorer was also equipped with redesigned frontal air bags for the driver and front right passenger positions. The frontal air bags did not deploy in this crash. The Explorer was involved in an intersection crash with a 1991 Nissan Pathfinder. The Explorer was deflected laterally to its right in a counterclockwise (CCW) yaw, and rolled over, right side leading. The Explorer rolled four quarter-turns and impacted a concrete landscape wall around a roadside cemetery before coming to rest upright on top of the wall. As a result of the impacts, both side inflatable curtain (IC) air bags deployed. The Explorer was occupied by a 54-year-old male driver and a 49-year-old female front right passenger. The front right passenger's right arm was partially ejected through the right door window opening during the rollover event. She sustained deep complex lacerations and abrasions of the right forearm with glass and gravel debris embedded into the lesions. She also sustained a left hand abrasion and right arm contusion from interior vehicle contact during the rollover. The driver sustained a scalp abrasion and avulsion as a result of roof intrusion contact, bilateral arm and leg contusions, a left arm abrasion and a left knee abrasion as a result of interior contact during the rollover. Both the driver and the passenger of the Explorer were transported to a local hospital where they were treated and released.

Figure 1. Damaged 2002 Ford Explorer

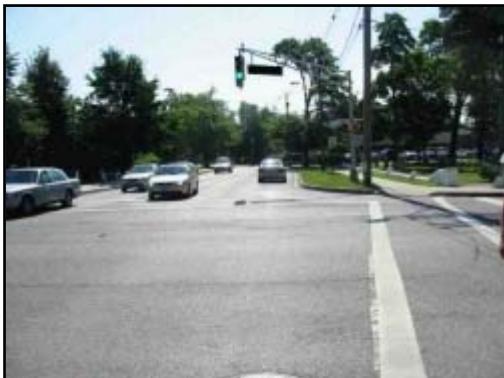
The 54-year-old male driver of the 2002 Ford Explorer was operating the vehicle in an eastbound direction on the two-lane roadway on approach to the four-leg intersection (**Figure 2**). The three-phase traffic signal was in the green phase for east/west traffic. The driver of the 1991 Nissan Pathfinder was operating the vehicle in a southbound direction on approach to the intersection (**Figure 3**). The three-phase traffic signal was in the red phase for north/south traffic. As the Explorer was passing through the intersection, the driver of the Pathfinder disregarded the red traffic signal and proceeded into the intersection.

Figure 2. Eastbound approach for the Ford Explorer

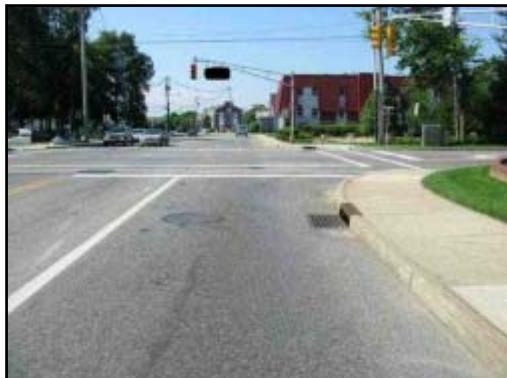
Figure 3. Southbound approach for the Nissan Pathfinder

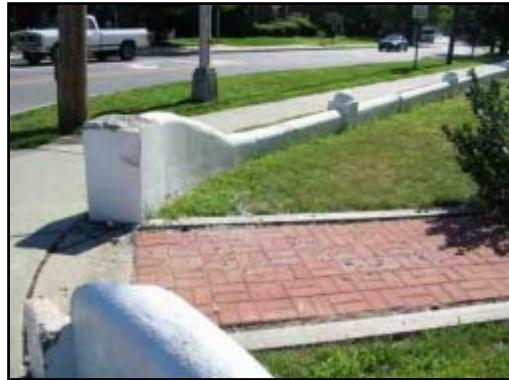
the Explorer struck the ground during the rollover event. During the rollover event, the front right passenger's right arm was partially ejected through the right front window. The Explorer rolled onto its roof and left side across the southwest corner of the intersection toward the cemetery walkway and concrete wall. The Explorer rolled onto the southwest corner with its left side and struck the south edge of the concrete wall (at the walkway) with the left rear side aspect, which fractured the struck portion of the wall. The Explorer rolled to an upright attitude and the undercarriage (gas tank and muffler, forward of the rear axle) struck the north edge of the wall (at the walkway). The Explorer came to rest straddling the brick walkway and opening in the wall (**Figure 4**). The Nissan Pathfinder rotated CCW and came to rest near the center aspect of the intersection.

Figure 4. View of struck wall

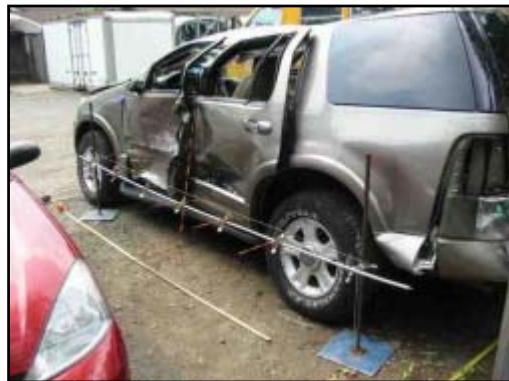
The 2002 Ford Explorer sustained moderate left side damage as a result of the initial impact with the 1991 Nissan Pathfinder (**Figure 5**). The direct contact damage began 110 cm (43") forward of the left rear axle and extended 115 cm (45") forward along the left side. The maximum crush measured 15 cm (6") and was located at C5; 194 cm (76") forward of the left rear axle. The left front door and left rear door sustained lateral crush, paint transfers and longitudinal abrasions. The direct contact damage was concentrated below the beltline and on the mid and lower aspects of the left doors. The cladding on the front left door was separated and the cladding on the left rear door was partially separated. Both left side doors were slightly displaced, although it appeared that rescue attempts with hydraulic tools might have contributed to the longitudinal deformation and displacement. The combined direct and induced damage began 60 cm (24") forward of the left rear axle and extended 240 cm (94") forward along the left side. Six crush measurements were

Figure 5. Left side damage to the Ford Explorer

documented by the NASS researcher and were as follows: C1 = 0 cm, C2 = 0 cm, C3 = 11 cm (4"), C4 = 12 cm (5"), C5 = 15 cm (6"), C6 = 6 cm (2"). The CDC was revised to reflect an 11 o'clock direction of force versus a 10 o'clock direction of force, based on crash dynamics and vehicle damage. The SCI-revised Collision Deformation Classification (CDC) for the initial impact with the Nissan Pathfinder was 11-LPEW-2.

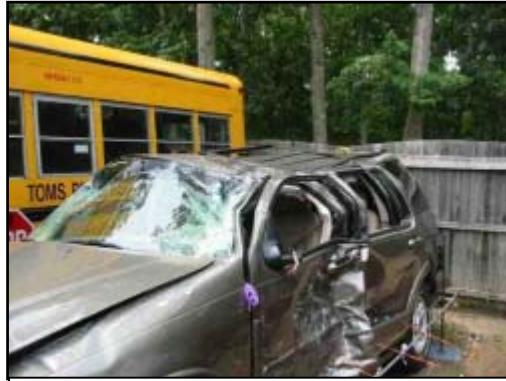
The Explorer sustained moderate damage as a result of the subsequent rollover. Both right side tires were debeaded and gouges were present on both alloy wheels from direct contact with the roadway surface. Angled abrasions were present on the entire length of the right side plane. Heavy lateral abrasions were present on the top aspect of the right A-pillar and right roof side rail. The roof sustained abrasions and the luggage rack was fractured and partially separated. The left aspect of the windshield header and the left roof side rail were crushed vertically from the rollover event (**Figure 6**). The windshield sustained fractures and was holed on the top right aspect as a result of the left A-pillar and windshield header deformation. The top aspects of the left front and left rear doors were deformed vertically as a result of the rollover. The CDC for the rollover event was 00-TDDO-3.

Figure 6. Rollover damage

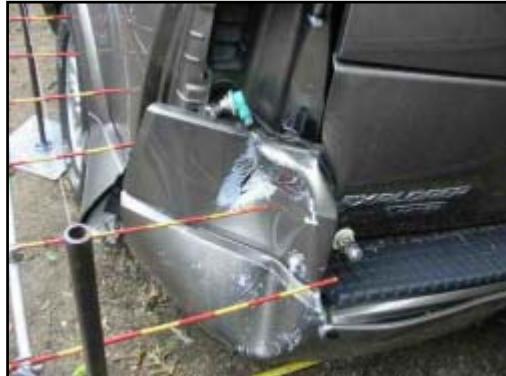
The left rear corner impact with the concrete wall resulted in minor damage to the left rear bumper corner and left rear quarter panel (**Figure 7**). The direct contact began at the left rear bumper corner and extended 30 cm (12") forward along the left side plane. The direction of force was non-horizontal and resulted in the lateral and upward displacement of the left rear bumper corner. There was no structural involvement. The combined direct and induced damage began at the left rear bumper corner and extended 93 cm (37") forward. The left rear tail light assembly was separated. The CDC for the left rear corner impact to the concrete wall was 00-LBEE-3.

Figure 7. Close-up of left rear damage from wall contact

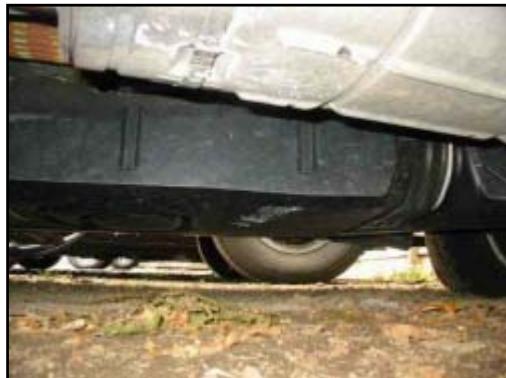
Figure 8. View from left side showing contact to fuel tank and muffler

Concrete transfers were present on the bottom aspect of the HDPE fuel tank (**Figure 8**) and on the bottom aspect of the muffler. There was no visible crush or deformation to the fuel tank or muffler in the NASS images. Although not included in the EDS file, a CDC for the undercarriage impact of 00-UPYW-1 was documented by the SCI reviewer.

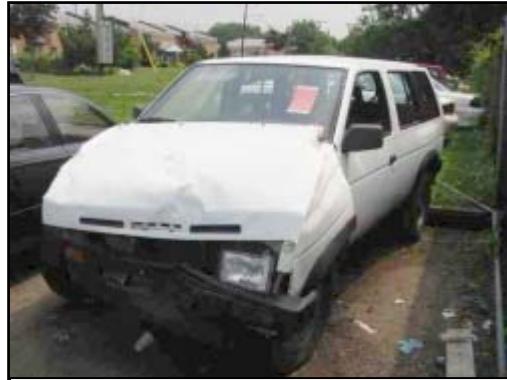
The 1991 Nissan Pathfinder sustained moderate frontal damage as a result of the impact with the Ford Explorer. The direct contact damage began on the front right bumper corner and extended laterally across the entire frontal plane. Although the NASS researcher was unable to document a frontal crush profile, the maximum bumper crush was estimated to be 38 cm (15"). The entire frontal structure was shifted to the left due to the forward momentum of the Ford Explorer. The hood also sustained longitudinal buckling as a result of the frontal impact. The CDC for the impact with the Ford Explorer was 01-FDEW-2. The CDC was incremented by 80

to account for the end shift to the left, and the revised CDC was 81-FDEW-2. Six crush measurements were estimated along the front bumper from NASS photographs as follows: C1 = 0 cm, C2 = 10 cm (4"), C3 = (8"), C4 = 25 cm (10"), C5 = 30 cm (12"), C6 = 38 cm (15").

Figure 9. Damaged 1991 Nissan Pathfinder

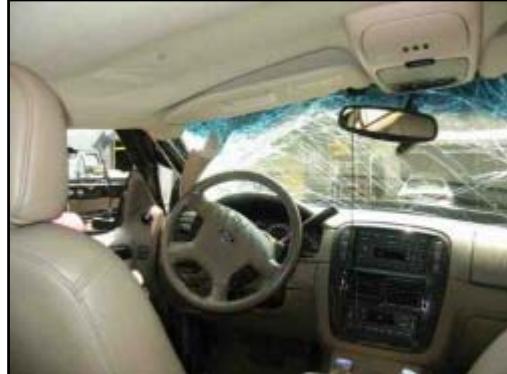
The 2002 Ford Explorer sustained moderate interior damage as a result of passenger compartment intrusion and occupant contact. Integrity loss occurred in the holed windshield and the front and rear side windows. The knee bolster was displaced and exhibited a scuff mark from contact with the driver's left knee. The intrusion of the roof on the left aspect (**Figure 10**) allowed the driver's head to contact the headliner, evidenced by a scuff mark above the driver's position. The left front interior door panel was displaced around the release handle, possibly a result of contact with the driver's left leg. The intruded roof contacted the top aspect of the driver's head restraint. Multiple passenger compartment intrusions were documented by the NASS researcher as follows:

Figure 10. View of driver's seating area and vertical intrusion

Position	Intruded Component	Magnitude of Intrusion	Direction
FL	Left A-pillar	9.0 cm (3.5")	Vertical
FL	Left B-pillar	20.0 cm (7.9")	Vertical
FL	Left roof side rail	20.0 cm (7.9")	Vertical
FR	Right A-pillar	7.0 cm (2.8")	Vertical
FR	Windshield header	5.0 cm (2.0")	Vertical
2 nd L	Left roof side rail	19.0 cm (7.5")	Vertical
2 nd L	Roof	23.0 cm (9.1")	Vertical
2 nd L	Left C-pillar	14.0 cm (5.5")	Vertical
2 nd C	Roof	15.0 cm (5.9")	Vertical
2 nd R	Roof	2.0 cm (1.6")	Vertical
3 rd L	Roof	12.0 cm (4.7")	Vertical

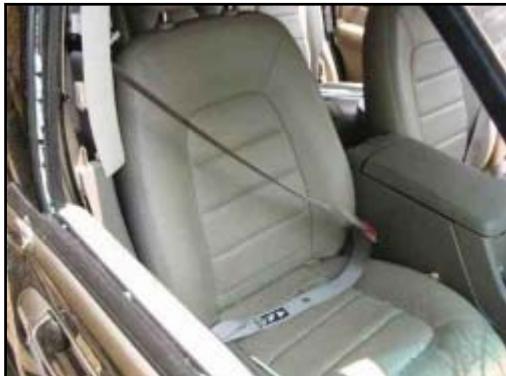
Figure 11. View of front right passenger's safety belt

NASS researcher documented a scuff mark on the driver's lap belt, and scuff marks on the front right passengers lap and shoulder belts. Minor deformation was noted to the driver's and front right passenger's shoulder belts from occupant loading in the NASS photographs.

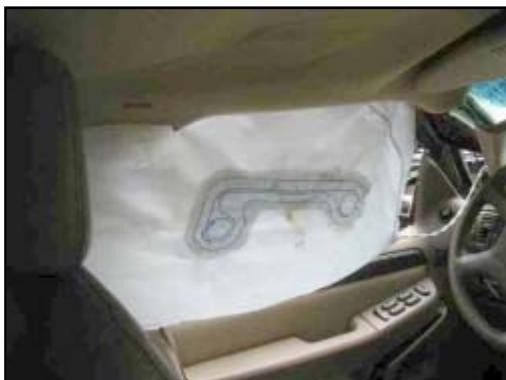
The 2002 Ford Explorer was equipped with side impact inflatable curtains (IC) that were designed to deploy in the event of a side impact. The left side IC deployed as a result of the initial side impact and the right IC deployed during the rollover event as the right side of the Explorer impacted the ground. The IC's (**Figures 12 and 13**) deployed downward from the left roof side rail through a separation in the outboard aspect of the headliner that measured 145 cm (57") in length between the left A- and C-pillars. Each IC was rectangular in shape and measured 150 cm (59") in length and 37 cm (15") in height. Each IC was tethered on the forward aspect by rope-type tethers. The right side IC tether had been cut by rescue personnel. There was no occupant contact evidence on either IC.

Figure 12. Left side IC (front aspect)

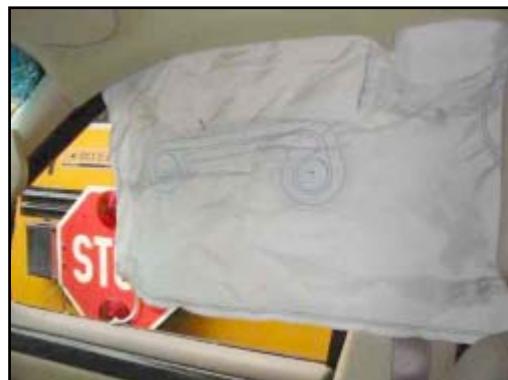
Figure 13. Right side IC (front aspect)
