**GENERAL DYNAMICS REMOTE CERTIFIED ADVANCED COMPLIANT
VEHICLE CRASH INVESTIGATION**

SCI TECHNICAL SUMMARY REPORT

NASS/SCI COMBO CASE NO. 03-08-109C

VEHICLE – 2003 GMC SIERRA

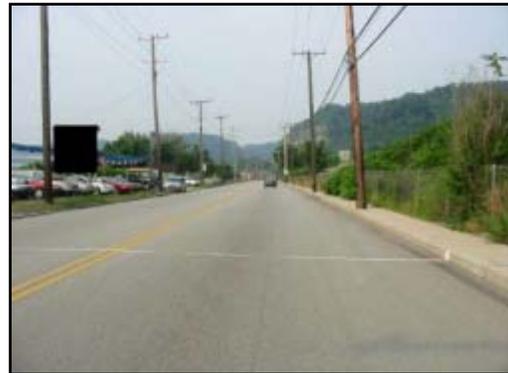
The hit and run vehicle crossed the centerline and impacted the left side of the GMC in a sideswipe impact configuration (**Figure 2**). The resultant direction of force was within the 12 o'clock sector for the GMC. The impact resulted in minor damage to the left side of the GMC. The WINSMASH program was not used to calculate a delta-V due to the minor sideswipe damage.

Figure 2. Area of impact between hit and run vehicle and GMC.

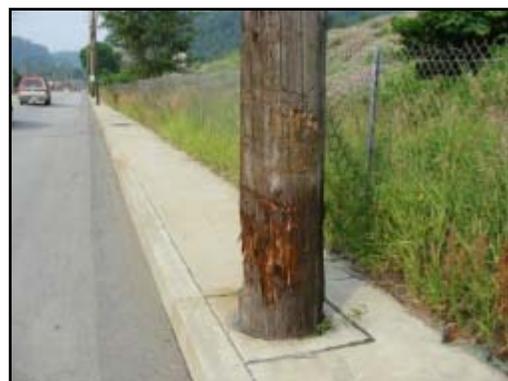
The driver stated to the NASS researcher that he possibly swerved right subsequent to the impact with the hit and run vehicle. The combination of the impact with the hit and run vehicle and steering input by the driver, redirected the GMC in a southwesterly direction. The GMC traveled approximately 29.0 meters (95.0 feet) forward and departed the west road edge at a shallow angle. The GMC traveled approximately 3.0 meters (10.0 feet) off-road and impacted a wooden utility pole (**Figure 3**) with its front right corner. The EDR data indicated that the driver did not apply the brakes during the five-second pre-crash recording. The resultant direction of force was within the 12 o'clock sector for GMC. A WINSMASH barrier equivalent speed algorithm was used to determine an approximate delta-V. The WINSMASH computed delta-V was 20.3 km/h (12.6 mph), which appears low due to the corner engagement that involved the frontal and right side planes. The damage from the pole did not engage the frame rail and

Figure 3. GMC's impact with utility pole.

extended down the right side of the vehicle, which is beyond the scope of the WINSMASH program. The EDR recorded a maximum delta V of -43.1 km/h (-26.8 mph), which is more representative of the damage.

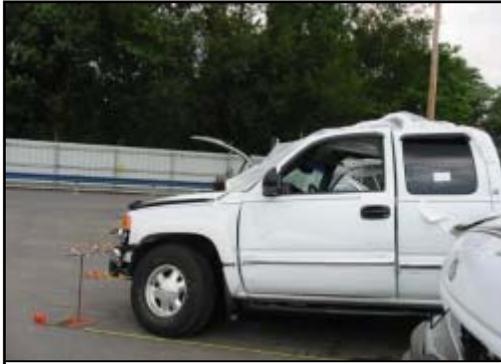
The 2003 GMC Sierra sustained minor severity damage as a result of the impact with the hit and run vehicle. The direct damage consisted of minor lateral deformation and a longitudinal scrape mark (**Figures 4 and 5**) that began approximately 13.0 cm (5.0”) forward of the left front door edge below the trim, and terminated approximately 10.0 cm (4.0”) rear of the left rear axle. No crush measurements were documented for this impact. The Collision Deformation Classification (CDC) for this impact was 12-LZLS-1.

Figure 4. Sideswipe damage to front left half from hit and run vehicle. Note damage is under door panel trim.

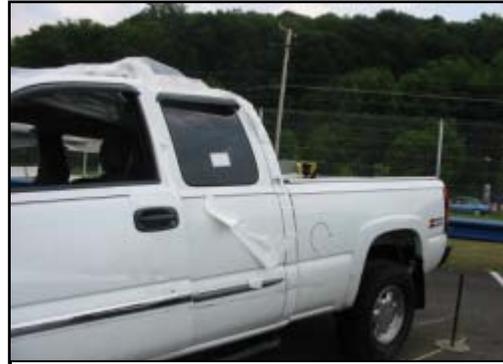
Figure 5. Sideswipe damage to rear left half from hit and run vehicle. Note damage is under door panel trim.

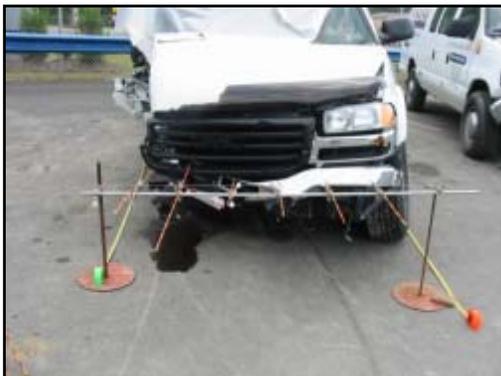
The 2003 GMC Sierra sustained severe severity damage as a result of the impact with the wooden utility pole (**Figures 6 and 7**). The direct contact damage began on the front right bumper corner and extended to the left 17.0 cm (6.7”). The direct contact damage also extended rearward 124.0 cm (48.8”) on the right side of the vehicle. Maximum crush was located at the front right bumper corner and measured 44.0 cm (17.3”). The damage from the pole impact involved the following a fractured right front axle and longitudinal deformation of the hood, right side of the upper and lower radiator support, right front fender and bumper. The induced damage consisted of longitudinal deformation of the right front and right rear doors. Six crush measurements were documented along the front bumper and were as follows: C1 = 0.0 cm, C2 = 0.0 cm, C3 = 0.0 cm, C4 = 10.0 cm (3.9”), C5 = 27.0 cm (10.6”), C6 = 44.0 cm (17.3”). The CDC for this impact was 12-FREE-5.

Figure 6. Frontal view of damage from pole impact.

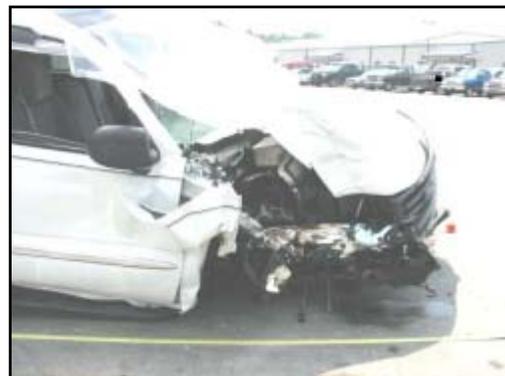
Figure 7. Damage to front right area from pole impact.

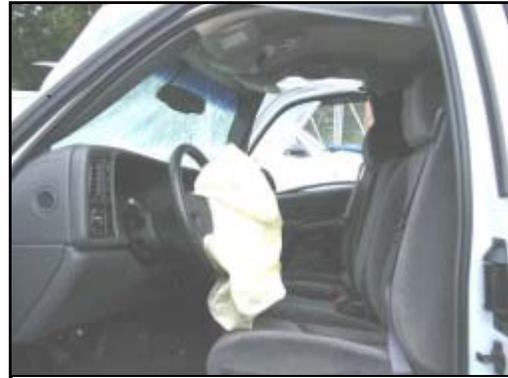
The 2003 GMC Sierra sustained moderate interior damage as a result of intrusion into the front right occupant (unoccupied) position. The NASS researcher noted no occupant contacts. **Figure 8** is lateral view of the first row. The interior intrusions are listed in the table below:

Figure 8. Lateral view of interior first row.

Intruded Component	Magnitude	Direction
Right instrument panel (estimated)	3.0-8.0 cm (1.0-3.0")	Longitudinal
Right toe pan (estimated)	3.0-8.0 cm (1.0-3.0")	Longitudinal
Right floor	3.0-8.0 cm (1.0-3.0")	Longitudinal

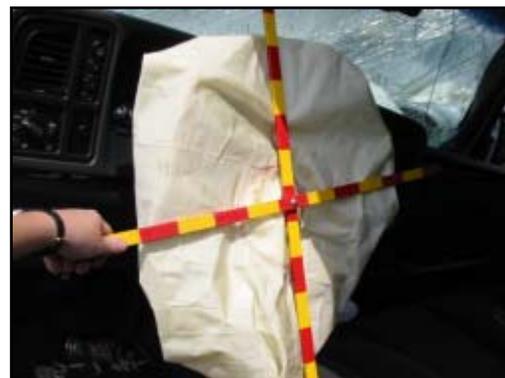
The front left air bag (**Figure 9**) was located in the center of the steering wheel hub. The air bag module consisted of two symmetrical I-configuration cover flaps that measured 12.0 cm (4.7") in height and 6.0 cm (2.4") in width. The air bag measured 55.0 cm (21.7") in diameter. The front left air bag contained two tethers and was vented by two vent ports on the rear aspect of the air bag at the 11 and 1 o'clock positions. There was no occupant contacts evidence or damage to the air bag membrane.

Figure 9. Deployed driver's frontal air bag.

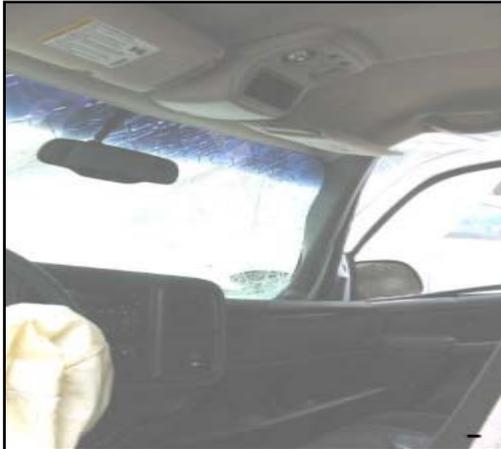
The front right seat was not occupied during the crash; therefore the system did not deploy the front right air bag (**Figure 10**). The front right air bag was equipped with a

Figure 10. Non-deployed front right air bag.

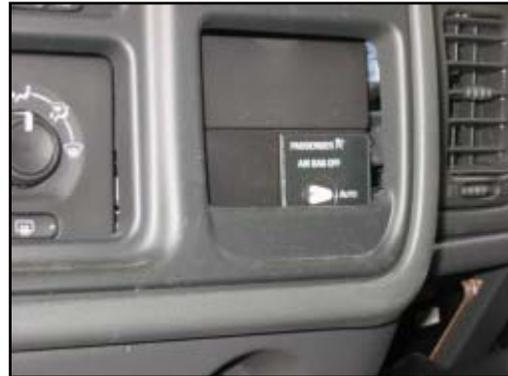
cut-off switch (**Figure 11**). At the time of the NASS inspection the switch was keyed to the “Auto On” position.

Figure 11. Front right air bag cut-off switch. Note the switch was keyed to the "Auto-On" position at the time of the NASS inspection.

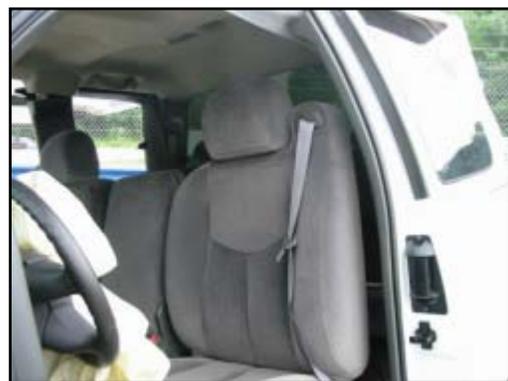
The 2003 GMC Sierra was equipped with integrated manual 3-point lap and shoulder belts for the front outboard positions (**Figure 12**) and a 2-point manual lap belt for the front center position. The rear seat was configured with manual 3-point lap and shoulder belts for the outboard positions and a manual 2-point lap belt for the center position. The driver’s safety belt was configured with a sliding latch plate and a belt-sensitive Emergency Locking Retractor (ELR). The driver utilized the integrated safety belt in this crash. No loading evidence was noted to the safety belt. According to the NASS researcher, evidence of historical use was present on the safety belt. The front center lap safety belt was configured with a locking latch plate and no retractor. The front right safety belt and the two rear outboard safety

Figure 12. Driver's integrated lap and shoulder belt.

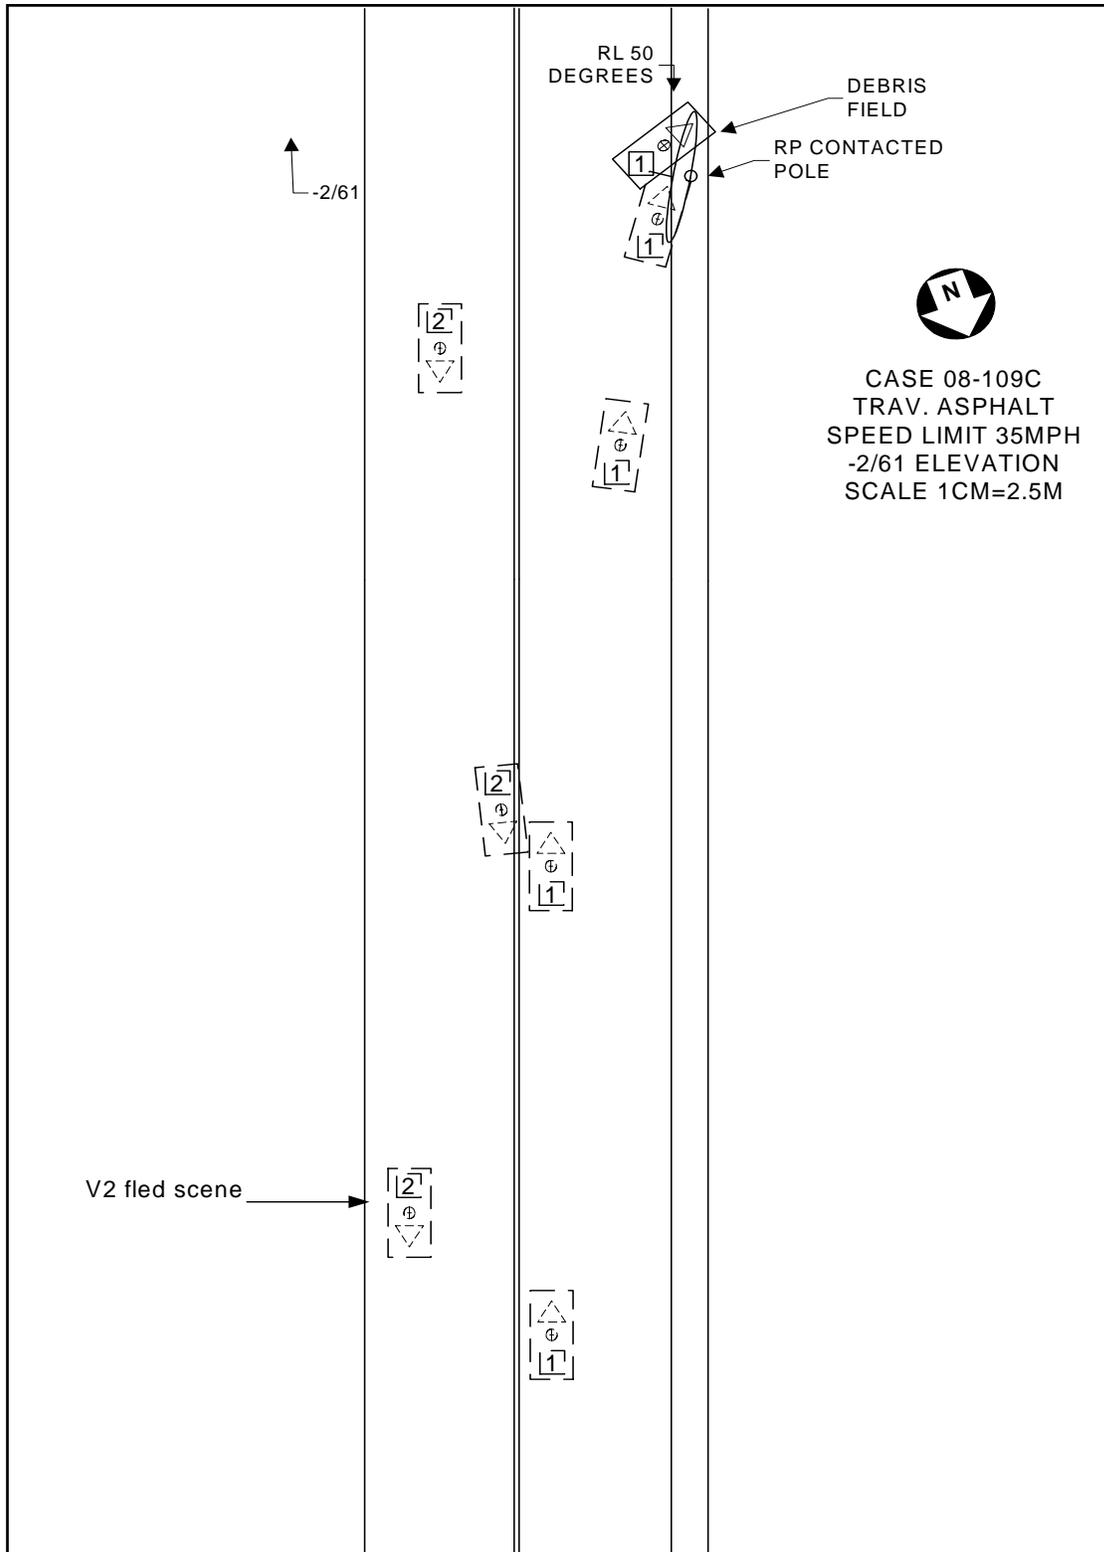
Figure 13: NASS scene schematic

The 2003 GMC Sierra was traveling southbound driven by a restrained 34-year-old male. An unknown type, hit and run vehicle was traveling northbound on the same roadway. The hit and run vehicle began to encroach into the southbound lane. Its unknown if the driver of the GMC attempted to avoid the oncoming vehicle. The driver stated to the NASS researcher that he did not recall the details of either impact. The EDR data indicated that the GMC was traveling at 61.2 km/h (38.0 mph) five seconds prior to crash and the vehicle speed increased to 62.8 km/h (39.0 mph) one second prior to the crash. The EDR also indicated that the brake switch circuit status was in the off-position from five seconds to one second prior to the crash. The recorded EDR data pertains to the pole impact, which resulted in the air bag deployment. The sideswipe impact was minor and not sufficient to wake-up the Sensing and Diagnostic control Module (SDM). The NASS scene schematic is included as **Figure 13** of this report.
