VEHICLE CRASH INVESTIGATION

SCI TECHNICAL SUMMARY REPORT

NASS/SCI COMBO CASE NO. 03-42-050E

VEHICLE – 2003 HONDA ODYSSEY

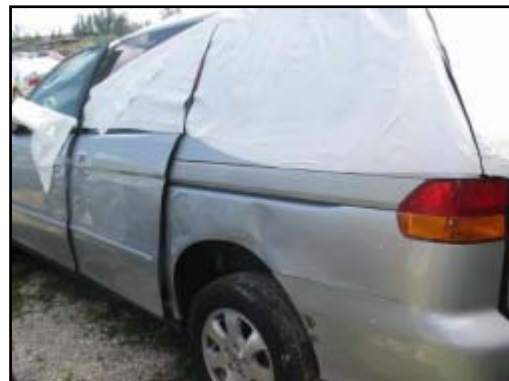
The 2003 Honda Odyssey sustained minor damage as result of the impact with the Ford (**Figure 6**). The direct damage width was 44.0 cm (17.3”) and began 50.0 cm (19.7”) rear of the left rear axle. The damage consisted of minor lateral deformation and scuffmarks on the left rear quarter panel. Six crush measurements were documented on the left rear quarter panel using a combined direct and induced damage width of 97.0 cm (38.2”) and were as follows: C1= 1.0 cm (0.4”), C2= 0.0 cm, C3= 3.0 cm

Figure 6. Sideswipe damage from impact with the Ford.

(1.2”), C4= 3.0 cm (1.2”), C5= 4.0 cm (1.6”), C6= 5.0 cm (2.0”). The CDC for this impact was 12-LBES-1.

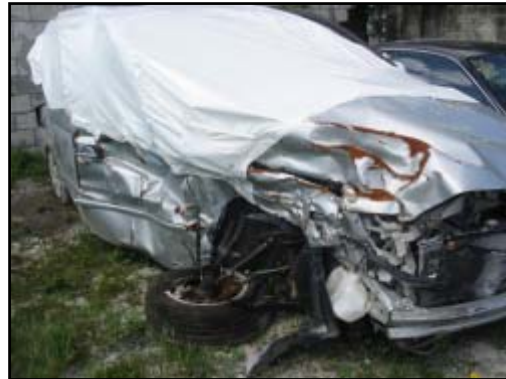
The 2003 Honda Odyssey sustained severe right side damage (**Figure 7**) as a result of the initial impact with the Jeep. The direct contact damage began at the front right bumper and extended rearward to the right front door handle. The damage consisted of a laterally deformed front right fender, hood, door, and front right suspension components. The front right axle and suspension components were also fractured and the front right wheel separated from the axle. The damage also consisted of a disintegrated front right glazing and a cracked and holed windshield. The windshield was holed at the front left A-pillar area from the deforming front end. Crush measurements were not obtained for this impact. The CDC for this impact was 02-RYEW-4.

Figure 7. View of damage from the initial impact with the Jeep.

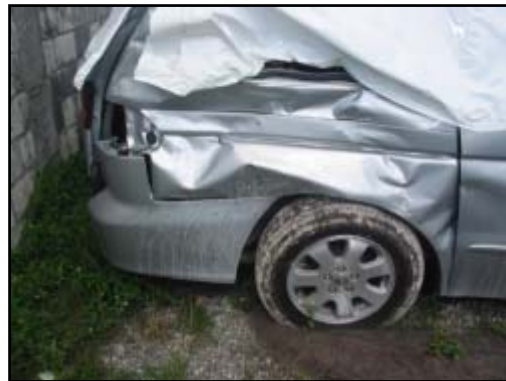
The Honda sustained minor right side damage from the secondary impact with the Jeep (**Figure 8**). The direct damage began at the right rear bumper corner and extended forward to the center of the right sliding door. The damage consisted of the right rear quarter panel and right sliding door being deformed lateral. The damage also consisted of the right rear, right rear quarter, and the backlight being disintegrated from impact forces. The remainder of the glazing was intact. The CDC for the impact was 03-RBEW-2.

Figure 8. View of damage from second impact with the Jeep.

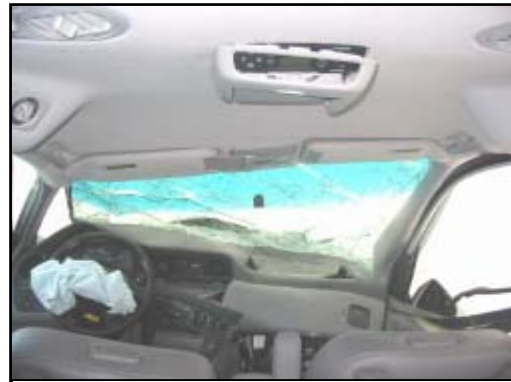
The 2003 Honda Odyssey sustained severe interior damage as a result of intrusions and occupant contacts (**Figure 9**). The intrusions are listed in table below:

The driver's contact points consisted of a deformed front left seat back from contact with driver's right hip and a scuffmark on the safety belt from the driver's chest. The driver's right hip contacted and deformed the seat back tray that folds between the front seats. Also body fluid was documented on the seatback from possible contact with the driver's right arm. The contacts for the 4-year-old male that was seated in the second row right seat in a forward facing child safety seat consisted of a possible contact to the rear of the front right seat back. This contact was evidenced by blood on the grab handle on the seat back. Also documented for this occupant was body fluid on the right side sliding door panel and possible body fluid on the child safety seat. The NASS researcher also documented body fluid on the third row left seat back from possible contact from the 9-year-old male.

Figure 9. View of interior first row.

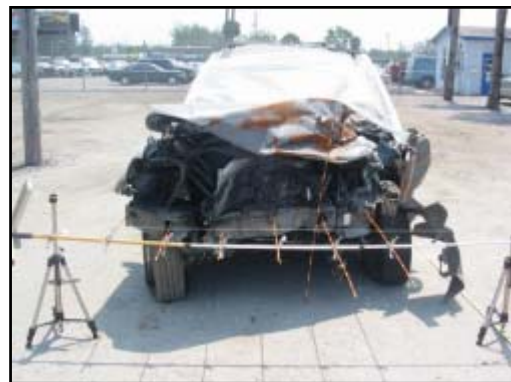
The 2000 Jeep Grand Cherokee sustained severe frontal damage as a result of the initial impact with the right side of the Honda (**Figure 10**). The direct damage began on the front left bumper and extended to front right bumper and measured 141.0 cm (55.5"). The damaged components consisted of the front bumper, hood, fenders, and the radiator being longitudinally deformed from contact damage. The majority of longitudinal deformation was to the front left aspect of the vehicle, which caused a reduction to the left side wheelbase of 12.0 cm (4.7"). The reduction of the left side wheelbase caused the right wheelbase to be elongated 19.0 cm (7.5"). Maximum crush was located at the front left bumper corner and measured 48.0 cm (18.9"). Six crush measurements were documented the bumper beam using a combined direct and induced damage with of 141.0 cm (55.5") and were as follows: C1= 48.0 cm (18.9"), C2= 43.0 cm (16.9"), C3= 44.0 cm (17.3"), C4= 42.0 cm (16.5"), C5=

Figure 10. View of frontal damage from initial impact with the Honda.

21.0 cm (8.3”), C6= 30.0 cm (11.8”). The CDC for the impact was 71-FDEW-2 with an 11 o’clock direction of force that was incremented 70 for lateral right shift.

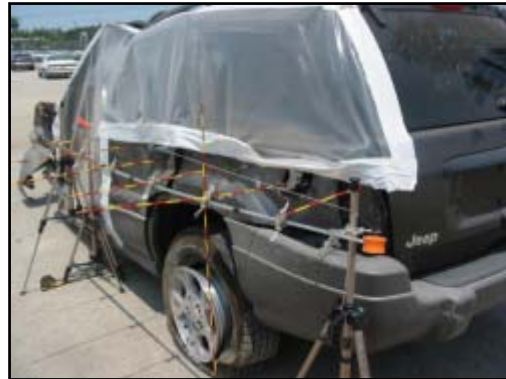
The second impact to the Jeep was the right side of the Honda impacting the left rear aspect of the Jeep. The direct contact damage began at the left rear bumper corner and extended forward 86.0 cm (33.9”). The damage consisted of a laterally deformed left rear quarter panel, door panel, and a disintegrated left rear glazing. Maximum crush was located at C1 and measured 19.0 cm (7.5”). Six crush measurements were documented along the mid-door level using a combined direct and induced damage width of 190.0 cm (74.8”) and were as follows: C1= 19.0 cm (7.5”), C2= 18.0 cm (7.1”), C3= 10.0 cm (3.9”), C4= 4.0 cm (1.6”), C5= 1.0 cm (0.4”), C6= 0.0 cm. The CDC for this impact was 09-LZEW-2.

Figure 11. View of damage from second impact with the Honda.

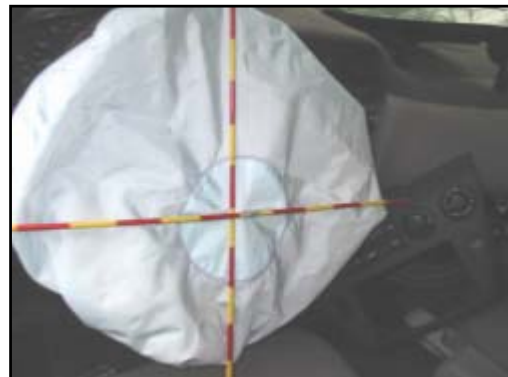
The front left air bag was located in the steering wheel hub (**Figure 12**). Two non-symmetrical cover flaps concealed the front left air bag. The top flap measured 8.0 cm (3.1”) height and 17.0 cm (6.7”) width at it widest point. The lower flap measured 5.0 cm (1.9”) in height and 13.0 cm (5.1”) in width at its widest point. The air bag was 61.0 cm (24.0”) in diameter. The air bag contained two tethers at the 12 and 6 o’clock positions on the face of the air bag and two vent ports at the 11 and 1 o’clock positions on the rear aspect. No contact evidenced was noted to the air bag.

Figure 12. Deployed driver's frontal air bag.

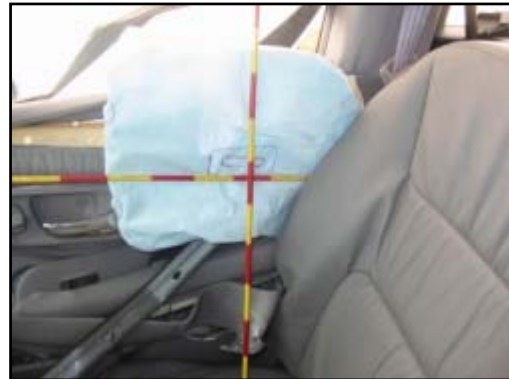
The front right side impact air bag deployed as a result of the initial crash with the Jeep (**Figure 13**). The air bag was located in the front right seat back and was concealed by a leather cover that measured 45.0 cm (17.8") in height and 15.0 cm (5.9") in width. The air bag measured 24.0 cm (9.5") in height and 30.0 cm (11.8") in width. The air bag was vented by two vent ports at the forward aspect and contained a single tether at the center aspect. There was no contact evidence or damage noted to this deployed air bag.

Figure 13. Deployed right side impact air bag.

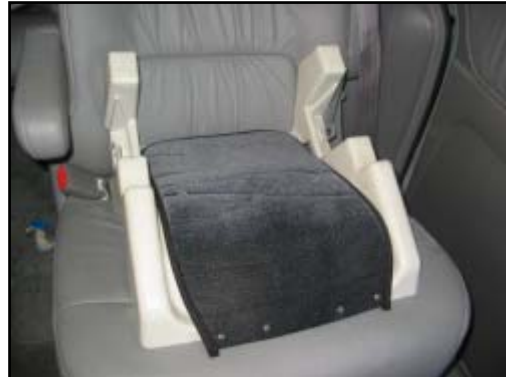
The 5-year-old male occupant of the Honda was seated in the second row left seat in a backless belt positioning booster seat (**Figure 14**). The manufacturer placard was not attached to the seat; therefore the date of manufacture was unknown. The seat was a Gerry Double Guard Model Number 072396C. The seat was constructed of a plastic shell and a cloth pad over the seating area. The seat also contained two metal latch plates on each side to be used with a shield. The child was restrained by the vehicles manual 3-point lap and shoulder safety belt.

Figure 14. Second row left backless belt positioning booster seat.

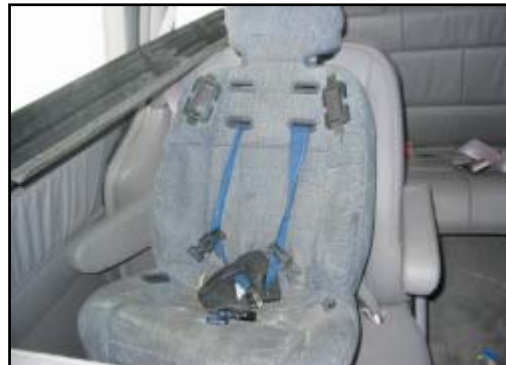
The 4-year-old male occupant of the Honda was seated in the second row right seat in a forward facing child safety seat (CSS) and was restrained by the integral 5-point harness system (**Figure 15**). The CSS was a Century Breverra, Model Number 4885CRT. The CSS was constructed of plastic and was equipped with an integrated head restraint and a 5-point harness system. Historical use was apparent on the harness system evidenced by creasing of the harness. The forward facing child safety seat (CSS) was restrained by the vehicles manual 3-point lap and shoulder belt system. The safety belt was routed through the rear belt paths. Also noted, was a locking clip that was on the vehicles seat cushion beside the CSS. It does not appear that the locking clip was used and no damage was noted to the CSS. The driver refused an interview with the NASS researcher; therefore the history of both child safety seats is unknown.

Figure 15. Second row right high back CSS.
