**GENERAL DYNAMICS REMOTE CERTIFIED ADVANCED COMPLIANT  
VEHICLE CRASH INVESTIGATION**

**SCI TECHNICAL SUMMARY REPORT**

**NASS/SCI COMBO CASE NO. 03-48-095C**

**VEHICLE – 2003 CHEVROLET AVALANCHE**

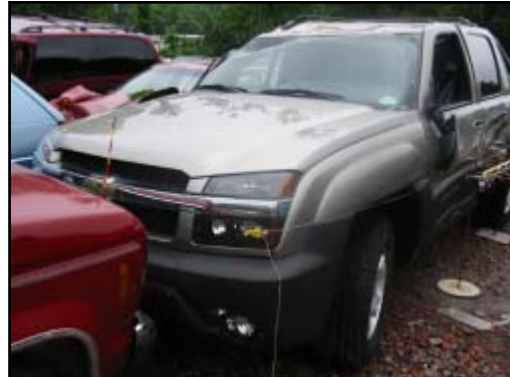
This remote investigation focused on the performance of the Certified Advanced Compliant safety system in the 2003 Chevrolet Avalanche (**Figure 1**). The manufacturer of this vehicle has certified that this 2003 Chevrolet Avalanche meets the advanced air bag requirements of the Federal Motor Vehicle Safety Standard (FMVSS) No. 208. The safety system included dual stage frontal air bags, seat track position sensors for the front left and front right seats and an occupant presence sensor for the front right seat. In addition, the Avalanche was equipped with an Event Data Recorder (EDR) that was downloaded (non-deployment) by the NASS researcher. However, the printout could not be located, therefore its not included in this report.

**Figure 1. Subject vehicle 2003 Chevrolet Avalanche.**

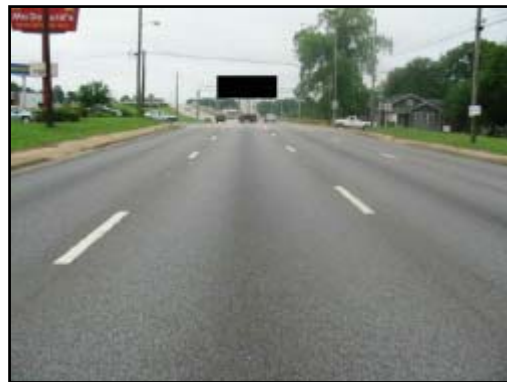
The unrestrained 52-year-old male driver of the Avalanche was operating the vehicle southbound in the second through lane (**Figure 2**) approaching an intersection where the driver was intending to turn left. An unrestrained 49-year-old female front right occupant also occupied the Avalanche. The driver of the Silverado was operating the vehicle southbound in the left lane adjacent to the Avalanche. The driver of the Avalanche failed to detect the Silverado and turned left across the path of the Silverado from the second lane at the intersection. There was no physical evidence documented at the crash site. The EDR data indicated that the Avalanche was traveling at 41.8 km/h (26.0 mph) five seconds prior to the crash and had slowed to 16.1 km/h (10.0 mph) one second prior to the crash. The EDR also indicated that the brake switch status was in the on-position from five to two seconds prior to the crash. The NASS scene schematic is included as **Figure 10** of this report.

**Figure 2. Southbound approach for the Chevrolet Avalanche.**

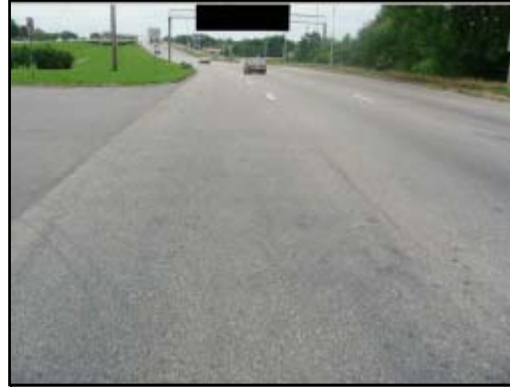
The front aspect of the Silverado impacted the left center aspect of the Avalanche (**Figure 3**) in the intersection. The impact resulted in minor severity damage to the left side of the Avalanche and unknown severity damage to the front aspect of the Silverado. The Silverado was under repair at the time of the NASS inspection therefore, the damage extent was unknown. This impact did not result in the deployment of the frontal air bag system in either vehicle. The resultant directions of force were within the 9 o'clock sector for the Avalanche and 1 o'clock sector for the Silverado. The WINSMASH program was not used by the NASS researcher to calculate a delta-V for this impact due to the Silverado being under repair and the Avalanche being out of the scope of the WINSMASH program. The Avalanche was configured with steel tubular step rails that were engaged during the impact. The step rails altered the stiffness of the side plane of the Avalanche therefore; this vehicle is out of the scope of the WINSMASH program for NASS. SCI used the results of the WINSMASH missing vehicle algorithm as a baseline velocity change for this impact. The total calculated delta-V by the WINSHASH program for the Avalanche was 5.0 km/h (3.1 mph). The longitudinal and lateral components were 0 km/h and 5.0 km/h (3.1 mph), respectively. The total calculated delta V for the Silverado was 6.0 km/h (3.7 mph). The longitudinal and lateral components were -5.6 km/h (-3.5 mph) and -2.1 km/h (-1.3 mph), respectively. The Avalanche's EDR recorded a maximum longitudinal velocity change of -0.5 km/h (-0.3 mph).

**Figure 3. Area of impact between the Avalanche and the Silverado.**

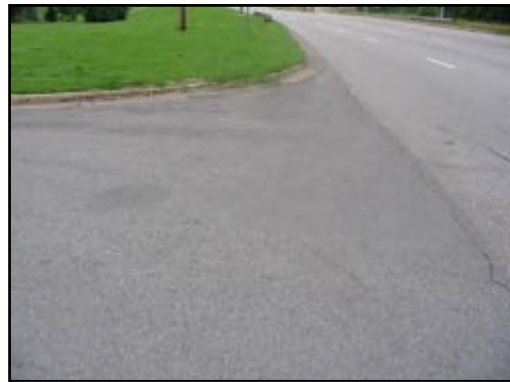
As a result of the front of the Silverado impacting the left the side of the Avalanche, the Avalanche subsequently initiated a lateral rollover with its right side leading. The rollover was initiated in the intersection (**Figure 4**) as a result of the vehicle engagement. The Avalanche rolled two quarter turns coming to rest on its roof. At rest, the vehicle was position south of the intersection facing a westerly direction partly on the sidewalk and in the left travel lane.

**Figure 4. Avalanche's trajectory to rollover and final rest.**

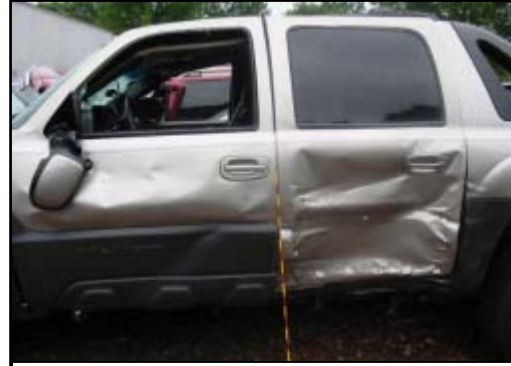
The 2003 Chevrolet Avalanche sustained minor severity left side damage as a result of the collision with the Silverado (**Figure 5**). The NASS researcher documented the direct damage width as 133.0 cm (52.4”), which began rear of the left rear door and extended forward to the leading edge of the left rear door. The damage consisted of a laterally deformed door panel, sill, and tubular step rail. The Collision Deformation Classification (CDC) for this impact was 09-LZEW-3.

**Figure 5. Area of damage from impact with the Silverado. Note: the damage to the upper left door and side view mirror is from vehicle being rolled back onto its wheels.**

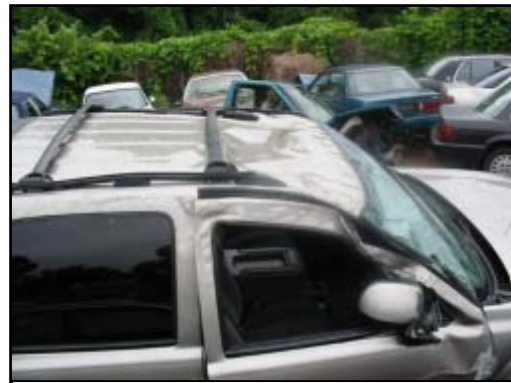
The Avalanche sustained moderate severity damage to its right side and roof as a result of the rollover (**Figure 6**). The direct damage extended the full length of the vehicle on the right side and across the entire width of the roof at the windshield header and forward aspect of the roof. The damage on the right side consisted of abrasions and lateral deformation of the body panels. The roof and windshield header damage consisted of vertical deformation. As a result of the windshield header deformation, the windshield was fractured and vertically deformed. The left front window frame, A-pillar, and side view mirror also appeared to have sustained rollover damage. However, based on the final rest position of the vehicle, the tow removal was probably executed by rolling the vehicle over onto its left side, then onto its wheels in southerly direction away from the intersection in order to upright the vehicle. The left front and right doors remained closed and operational post-crash. The left rear door was jammed closed as result of the initial impact. The left front and right front glazing were disintegrated as result of the rollover. The remainder of the glazing was not damaged.

**Figure 6. Roof and right side damage from rollover.**

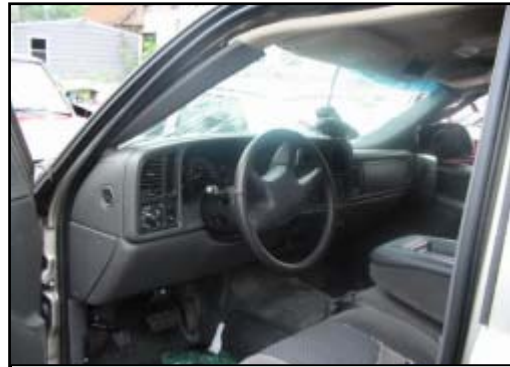
The 2003 Chevrolet Avalanche sustained moderate interior damage (**Figure 7**) as a result of interior intrusions and occupant contacts. The occupant contacts consisted of the driver’s head contacting and deforming the front left area of the roof. The front right passenger’s contacts consisted of the passenger’s head contacting and deforming the front right area of the roof. The interior intrusions are listed in the table below:

**Figure 7. Interior of 2003 Chevrolet Avalanche.**

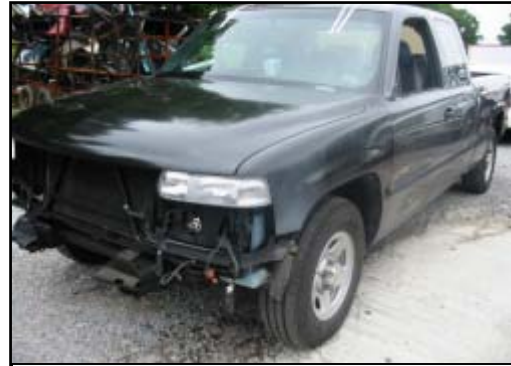
The 2001 Chevrolet Silverado sustained unknown severity frontal damage (**Figure 8**). The specific damage could not be identified due to the frontal components being replaced prior to the NASS inspection. The CDC for this impact was coded in the NASS EDS as 99-9999-9. Based on the crash configuration and impact location on the Silverado the CDC used for this SCI remote investigation was 01-F999-9.

**Figure 8. 2001 Chevrolet Silverado.**  
**Note: vehicle was under repair.**

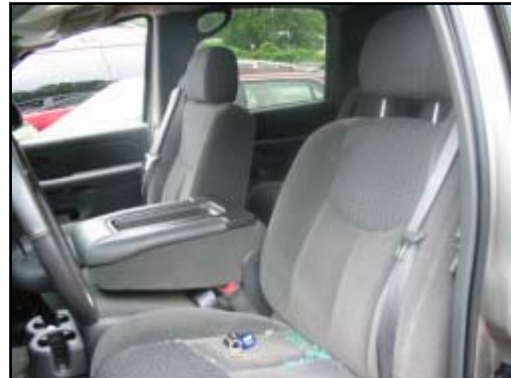
The 2003 Chevrolet Avalanche was equipped with integrated manual 3-point lap and shoulder safety belts for the front outboard seating positions (**Figure 9**). The front center and rear center seating positions were configured with manual 2-point lap belts. The rear outboard seating positions were configured with manual 3-point lap and shoulder safety belts. The driver's safety belt was configured with a sliding latch plate and a belt-sensitive Emergency Locking Retractor (ELR). Although the NASS researcher documented belt usage for the driver and front right passenger there were no witness marks to support belt usage at the time of the crash. The EDR data indicated that the driver's belt system was unbuckled at the time of the crash. Therefore, the SCI revised the belt status for the driver and front right passenger to unrestrained. The front right and rear safety belts were configured with sliding latch plates and switchable ELR/Automatic Locking Retractor's (ALR). The front center safety belt was configured with a locking latch plate and no retractor. The NASS EDS was coded with six seating positions, however the front center safety belt was not coded in the NASS file. Additionally, the NASS EDS coding of the safety belt retractors of ELR only for the front right and rear safety belts was incorrect.

**Figure 9. Integrated restraints in the Avalanche.**
