## SCI/NASS COMBINATION CASE REPORT

CASE NUMBER - NASS-2003-49-115B

VEHICLE - 1999 CHEVROLET SILVERADO 1500 PICKUP TRUCK

CRASH DATE - May 2003

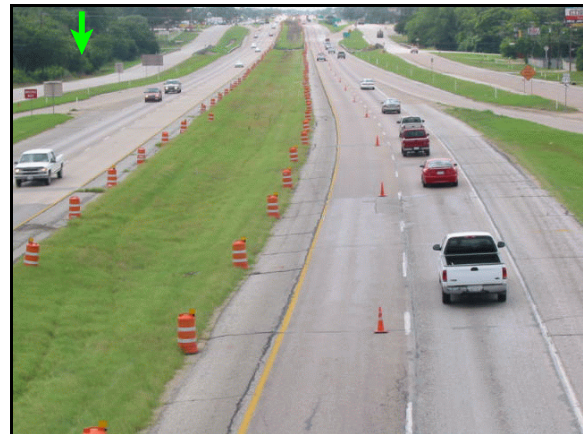
The case vehicle was traveling east in the outside eastbound lane of a two-lane roadway that was part of a divided trafficway (i.e., two lanes in each direction separated by grass median), apparently intending to continue straight ahead (**Figure 1**). It was dark but lighted and it was raining, with the concrete road surface wet but otherwise free of defects. The speed limit was 97 km.p.h. [60 m.p.h.]. For some unknown reason, the case vehicle traveled off the left (north) side of the roadway and entered the median. The crash events began within an interchange area, but there is no evidence that the driver's actions were related to negotiating the exit/entrance area. The case vehicle crossed the median, the westbound travel lanes, a gore area and a westbound exit lane, and departed the north side of the trafficway heading approximately north (**Figure 2**). It continued north on the roadside beyond the exit lane, crossed an east-west frontage road, vaulted a ditch (**Figure 3**), passed through a barbed wire fence and struck a large tree head-on, causing the case vehicle's driver air bag to deploy (**Figure 4**). The case vehicle came to rest against the tree, heading north.

**Figure 1:** Looking east along the case vehicle's eastbound approach; final rest was beyond the frontage road, in the trees at the upper left corner of this view (arrow)

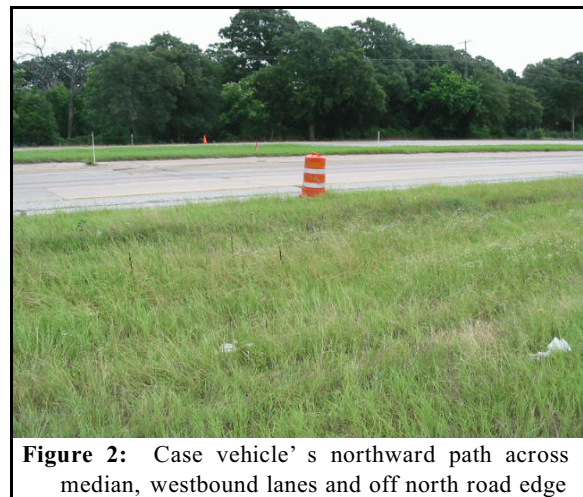
**Figure 2:** Case vehicle's northward path across median, westbound lanes and off north road edge

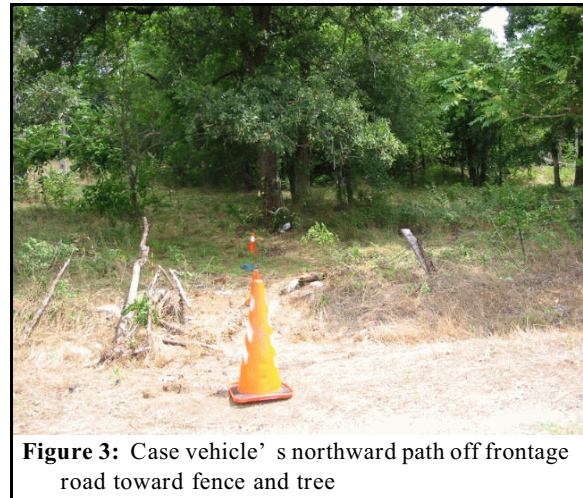
**Figure 3:** Case vehicle's northward path off frontage road toward fence and tree

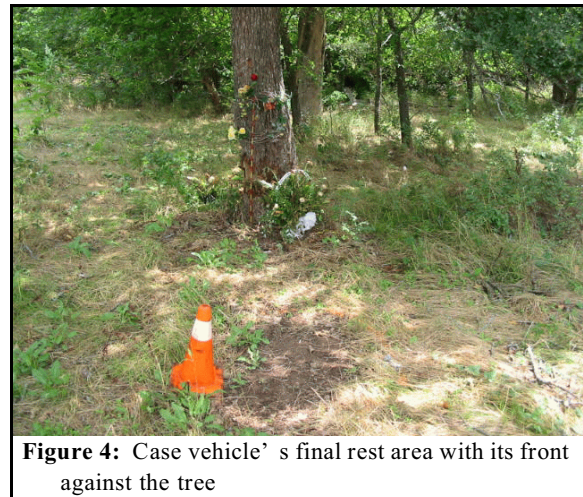
**Figure 4:** Case vehicle's final rest area with its front against the tree

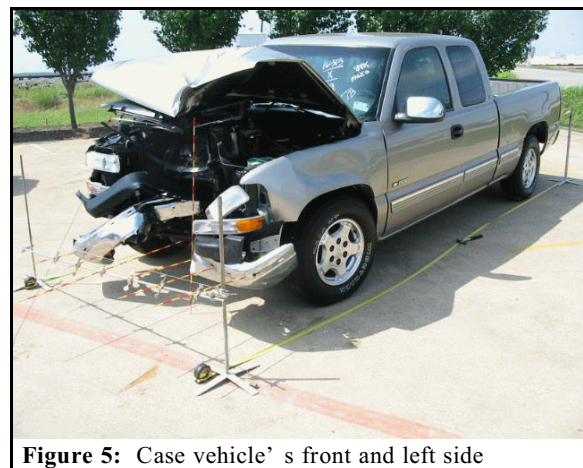
The case vehicle impacted the tree head-on, slightly left of center, causing a deep narrow impact with maximum crush measured as 57 centimeters [22.4 inches] (**Figure 5**). The plastic bumper cover was displaced upward and the steel bumper was fractured near the center and displaced downward, with the broken ends crushed rearward (**Figure 6**). The radiator and its upper support brackets were crushed rearward. The leading edge of the engine hood was folded downward. There was minor induced damage on the fenders. The windshield was cracked and there was no other glazing damage. The wheelbase was shortened 10 centimeters [3.9 inches] on the left and 3 centimeters [1.2 inches] on the right. None of the tires were deflated and the front left tire was restricted. The CDC for the tree impact was determined to be **12-FYEW-3 (0)**. The WinSMASH reconstruction program, barrier algorithm, was used on the case vehicle's most severe impact (event #2). The total, longitudinal and lateral delta Vs are, respectively: 37 km.p.h. [23.0 m.p.h.], -37 km.p.h. [-23.0 m.p.h.] and 0 km.p.h. [0 m.p.h.].

**Figure 5:** Case vehicle's front and left side

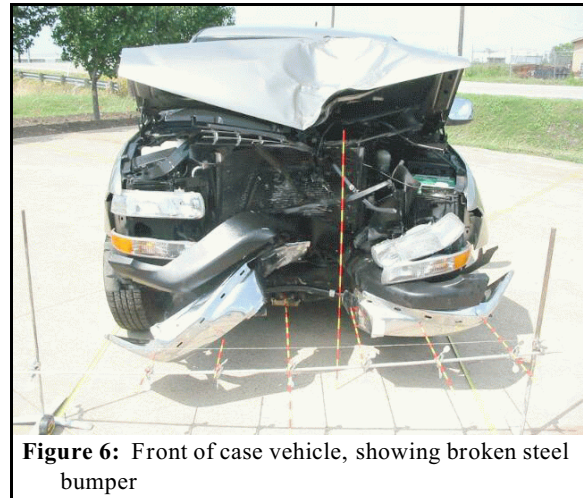
**Figure 6:** Front of case vehicle, showing broken steel bumper

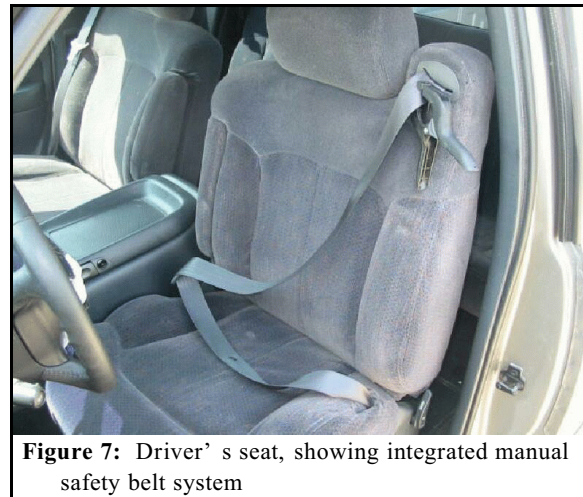
The case vehicle was fitted with two bucket seats in the front row and a bench seat in the back row. The two front seats had integrated safety belts (**Figure 7**). The interior had been thoroughly cleaned by the salvage operator prior to the NASS inspection and there was little evidence remaining. The inspection of the case vehicle's interior did reveal 5 centimeters [2 inches] of longitudinal intrusion by the center portion of the instrument panel, and no other intrusions. There was evidence of occupant contact on the front of the driver's air bag, on the safety belt webbing and on the knee bolster. In addition, the right side of the steering wheel rim was cracked (but not measurably bent) and the column-mounted automatic transmission selector lever was bent, probably due to occupant contact.

**Figure 7:** Driver's seat, showing integrated manual safety belt system

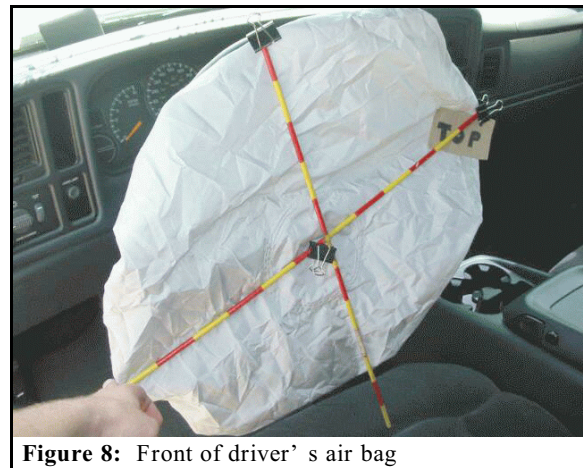
The driver's air bag was installed in the steering wheel hub with the module cover flaps in the I-configuration. The flaps opened at the tear points and there was no evidence of damage to the flaps or the adjacent structures. Each flap measured 11 centimeters [4.3 inches] vertically and 8 centimeters [3.1 inches] horizontally. The deployed air bag was round with a diameter of 60 centimeters [23.6 inches], and with two vent ports on the back at the 11 and 1 o'clock positions. There was no evidence of damage to the air bag (**Figure 8**). The NASS investigator indicated that there was contact evidence on the front of the air bag, but this is not visible in the photographs.

**Figure 8:** Front of driver's air bag

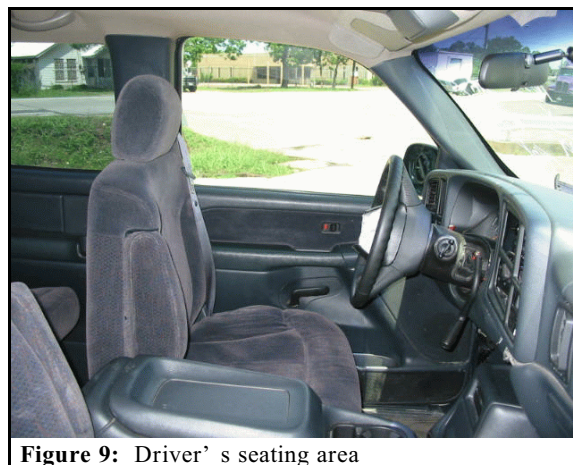
seat track and seat back incline adjustments are not known. The tilt steering wheel was found in the full down position (**Figure 9**). The autopsy report indicates that her blood alcohol concentration was 0.09 milligrams per decaliter.

**Figure 9:** Driver' s seating area

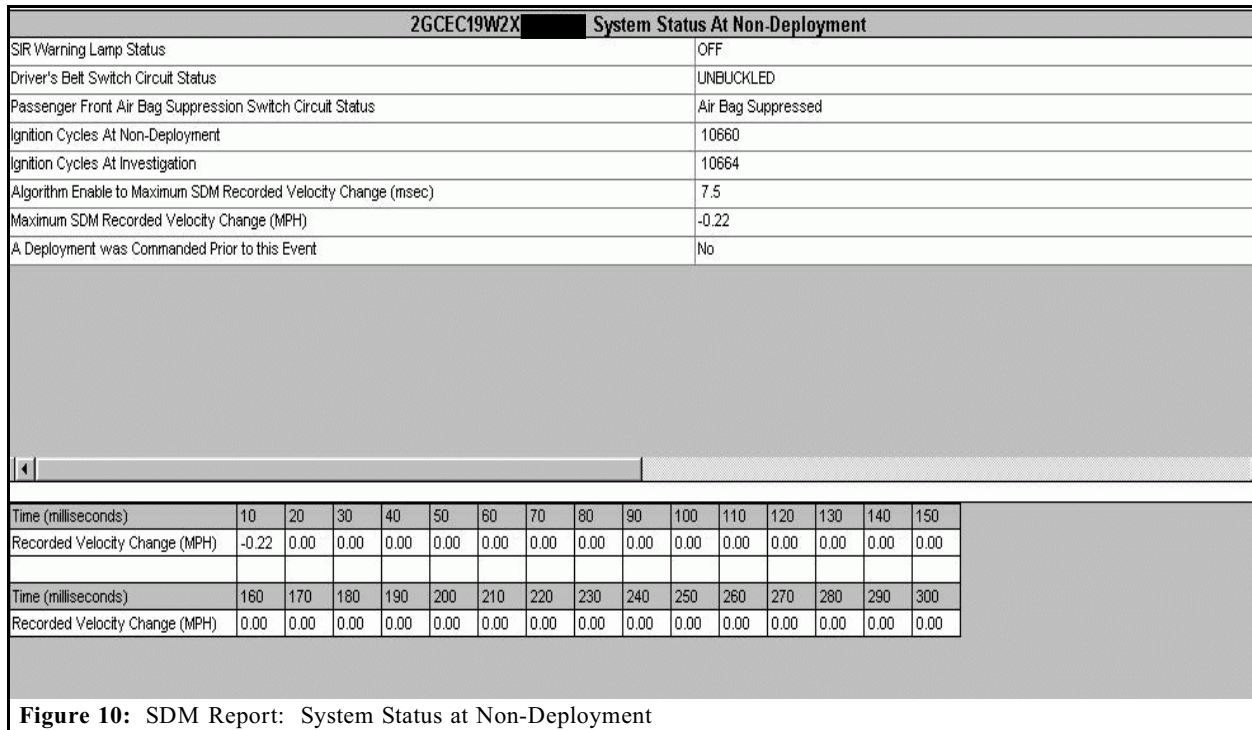
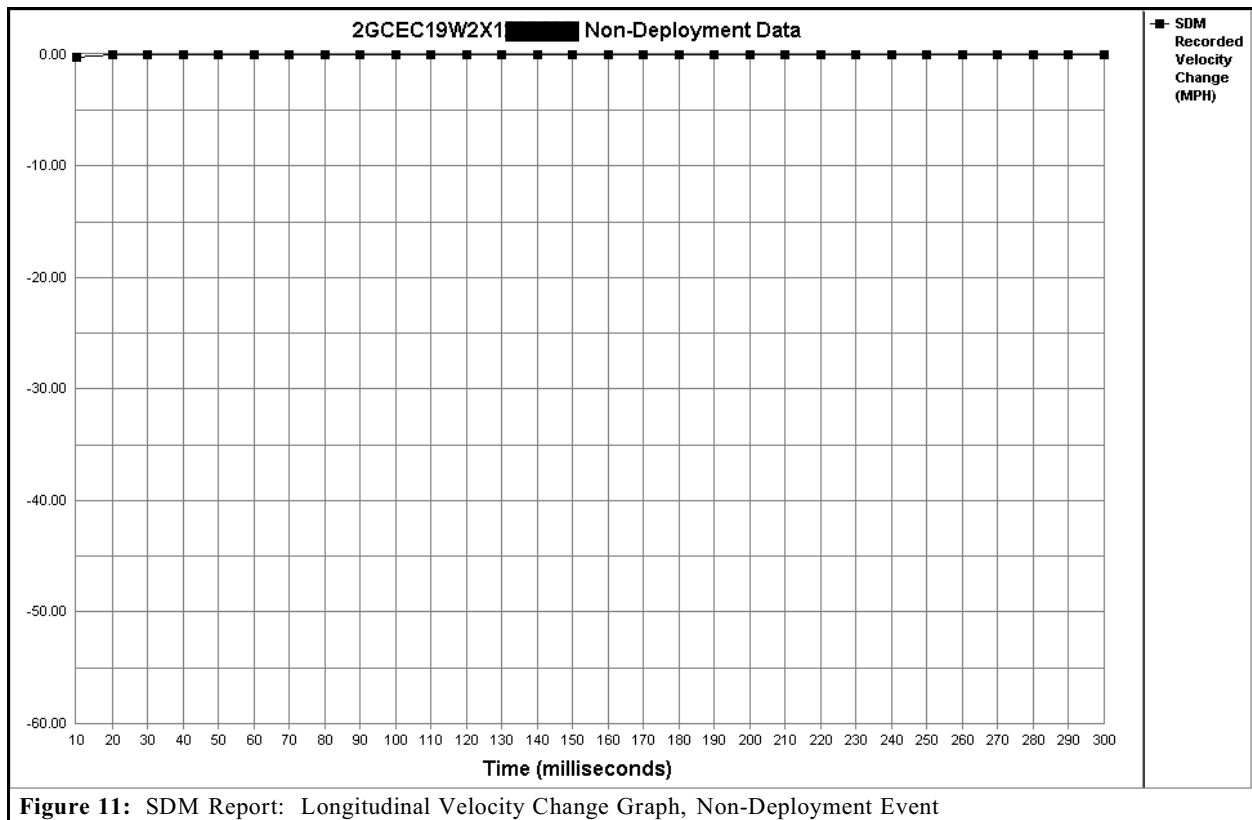
Figure 12: SDM Report: System Status at Deployment

The SDM System Status at Non-Deployment report (**Figure 10**) and the System Status at Deployment report (**Figure 12**) both indicate that the SIR Warning Lamp showed no faults in the air bag circuits, the events occurred during ignition cycle 10,660 and the EDR download was obtained during ignition cycle 10,664. Both reports indicate that the driver's safety belt was unbuckled, but this is believed to be false reporting due to disruption of the EDR electrical circuit. Both reports also indicate that the passenger's air bag was suppressed, and the manually operated suppression switch was found in the "OFF" position.

The Deployment report indicates that the maximum recorded longitudinal velocity change for the deployment event was -50.5 km.p.h. [-31.37 m.p.h.] and this maximum was reached at 140 milliseconds [0.140 seconds] after algorithm enable (**Figures 12 and 13**). The Deployment report also indicates that the command to deploy was issued 6.25 milliseconds [0.00625 seconds] after algorithm enable. The deployment event is associated with the tree impact (NASS event #2). The Deployment report indicates that algorithm enable for the deployment event was 0.14 seconds after algorithm enable for the non-deployment event, which is reasonable for the physical configuration at the scene. The deployment velocity change graph (**Figure 13**) shows a steep pulse for the first 100 milliseconds, followed by a plateau that persists, with slight modulation, for the 300 millisecond interval recorded for this impact.

2GCEC19W2X1 System Status At Deployment	
SIR Warning Lamp Status	OFF
Driver's Belt Switch Circuit Status	UNBUCKLED
Passenger Front Air Bag Suppression Switch Circuit Status	Air Bag Suppressed
Ignition Cycles At Deployment	10660
Ignition Cycles At Investigation	10664
Time From Algorithm Enable To Deployment Command (msec)	6.25
Time Between Non-Deployment And Deployment Events (sec)	.14

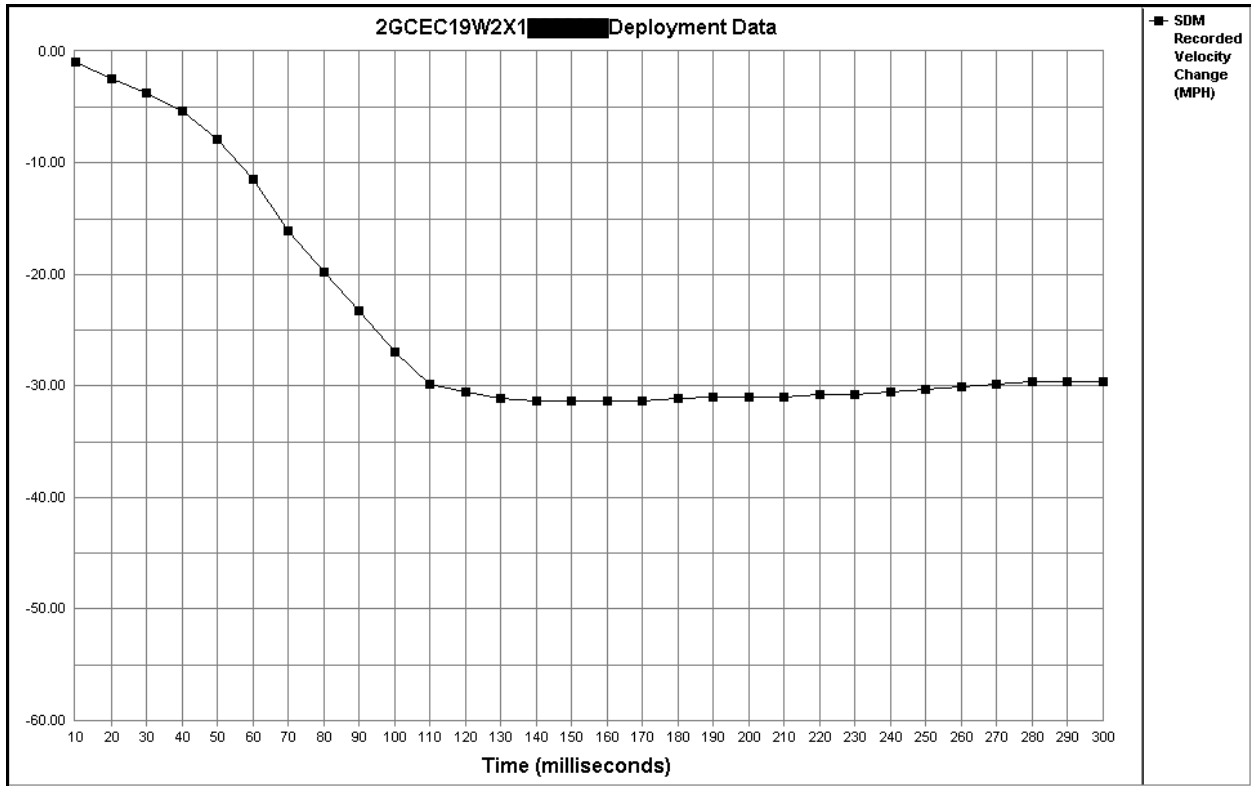
Figure 13: SDM Report: Longitudinal Velocity Change Graph, Deployment Event

Time (milliseconds)	10	20	30	40	50	60	70	80	90	100	110	120	130	140	150
Recorded Velocity Change (MPH)	-0.88	-2.41	-3.73	-5.27	-7.90	-11.41	-16.02	-19.75	-23.26	-26.99	-29.84	-30.50	-31.15	-31.37	-31.37
Time (milliseconds)	160	170	180	190	200	210	220	230	240	250	260	270	280	290	300
Recorded Velocity Change (MPH)	-31.37	-31.37	-31.15	-30.94	-30.94	-30.94	-30.72	-30.72	-30.50	-30.28	-30.06	-29.84	-29.62	-29.62	-29.62
