TRANSPORTATION RESEARCH CENTER

SCI/NASS COMBINATION CERTIFIED ADVANCED 208-COMPLIANT VEHICLE INVESTIGATION

CASE NUMBER - NASS-2003-49-135C
LOCATION - Texas
VEHICLE - 2003 CHEVROLET TAHOE
CRASH DATE - June 2003

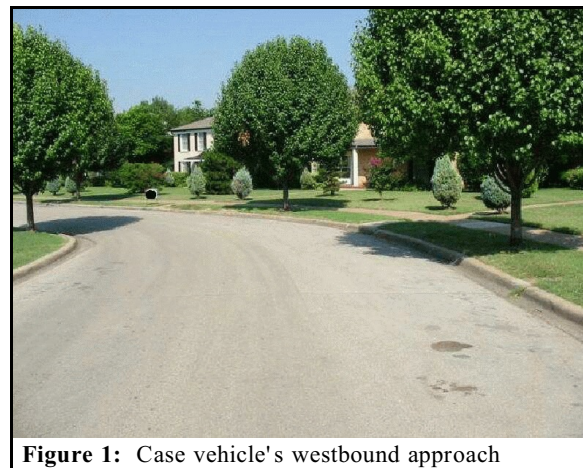
Figure 1: Case vehicle's westbound approach

The case vehicle was traveling west at high speed in the westbound travel lane of a two-lane residential city street, and was entering a curve to the left (**Figure 1**). The Freightliner and the Suburban were both legally parked and unoccupied, heading west in the westbound parking lane of the same street. The weather was clear, the asphalt road surface was dry and free of defects, it was dark but lighted and the posted speed limit was 48 km.p.h. [30 m.p.h.]. The case vehicle driver failed to negotiate the curve and drifted to the right from the travel lane into the parking lane. The crash occurred in the parking lane along the north edge of the street.

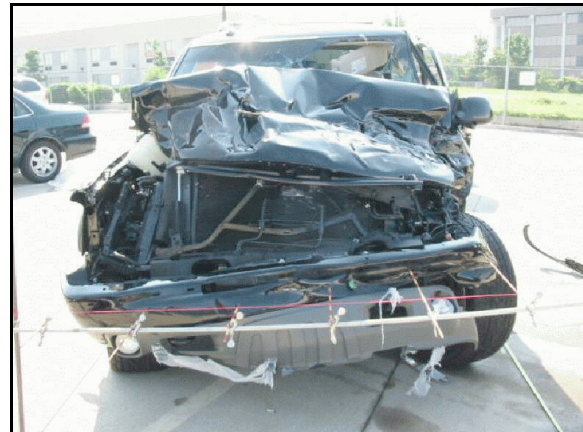
The case vehicle sustained heavy direct damage across the entire front (**Figure 2**). The damage exhibits the classic heavy truck rear underride pattern, with maximum bumper-level crush 46 centimeters [18.1 inches] at the front left corner where the case vehicle's bumper impacted the Freightliner's left rear wheel/tire assembly. The engine was hood heavily scraped and crushed rearward from sliding under the Freightliner's cargo deck (**Figures 3 and 4**), but maximum crash for the above-bumper damage was not measured. The rear edge of the hood was pushed into the windshield, causing extensive cracking across the entire width of the windshield glazing, the left front (driver's) door window glazing disintegrated due to the impact, and there was no other glazing damage. The left front wheel was pushed rearward and the left wheel base was shortened by 14 centimeters [5.5 inches] while the right wheelbase was lengthened by 2 centimeters [0.8 inches]. The right front wheel was deformed and the right rear wheel had minor damage due to striking the curb, and both right tires were deflated (**Figure 4**).

The case vehicle's most severe impact was event #1. This contractor estimates that the CDC is **12-FDEW-4 (0 degrees)**. (The coded NASS case data contain a different extent zone for this CDC. SCI changed the extent zone because the bumper-level only crush profile does not fully represent the underride configuration of this impact.) This impact is out of scope for the WinSMASH reconstruction program (heavy truck impact with underride). The crash severity for the

Figure 2: Case vehicle's front damage; note, overhanging structure engagement on hood

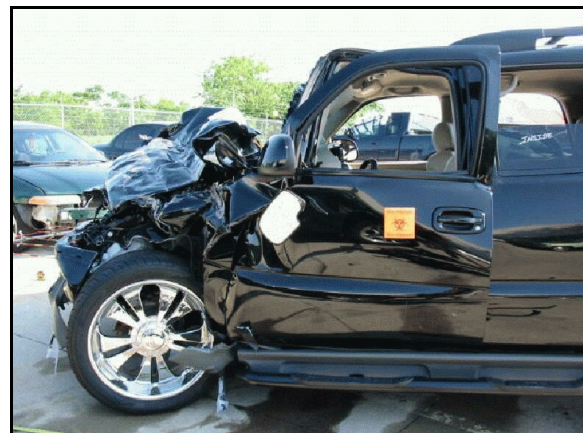
Figure 3: Case vehicle's front damage viewed from left; note, overhanging structure engagement on hood and front left wheel displaced rearward

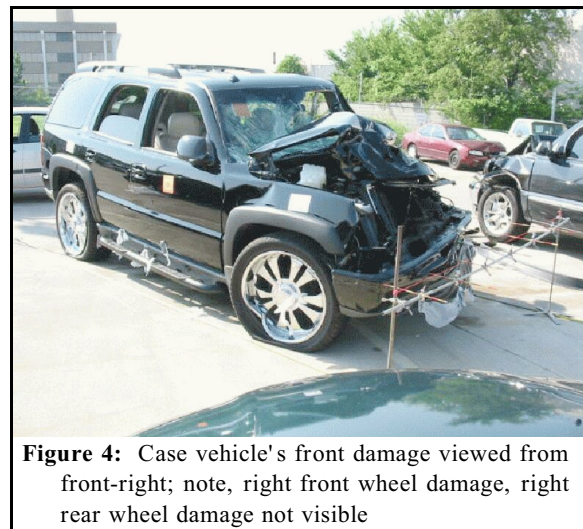
Figure 4: Case vehicle's front damage viewed from front-right; note, right front wheel damage, right rear wheel damage not visible

case vehicle's most severe impact was moderate (25-40 km.p.h. [15-25 m.p.h.]). The CDCs for the right front (event #2) and right rear (event #3) wheel impacts are **12-FRWN-3 (0)** and **12-FRWN-9 (0)**, respectively. These impacts are out of scope for the WinSMASH reconstruction program. The crash severity for both wheel impacts was minor (1-13 km.p.h. [1-8 m.p.h.]).

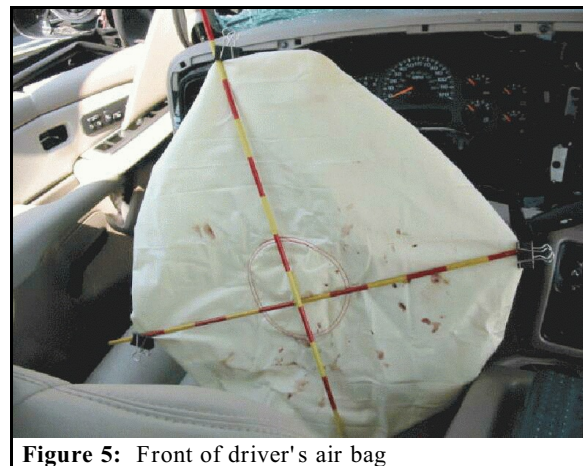
Figure 5: Front of driver's air bag

The driver's air bag was mounted in the steering wheel hub, with the module cover flaps in the I-configuration. Each cover flap measured 7 centimeters [2.8 inches] horizontally and 11 centimeters [4.3 inches] vertically. There was no evidence of damage to the cover flaps or the adjacent structures. The deployed driver's air bag was round, with a diameter of 60 centimeters [23.6 inches]. There were two vent ports of unknown diameter, located on the back of the air bag at the 9:30 and 2:30 o'clock positions. The front of the air bag showed scattered drops and smears of blood (**Figure 5**). There was no evidence of contact on the back of the air bag, and there was no evidence that the air bag was damaged.

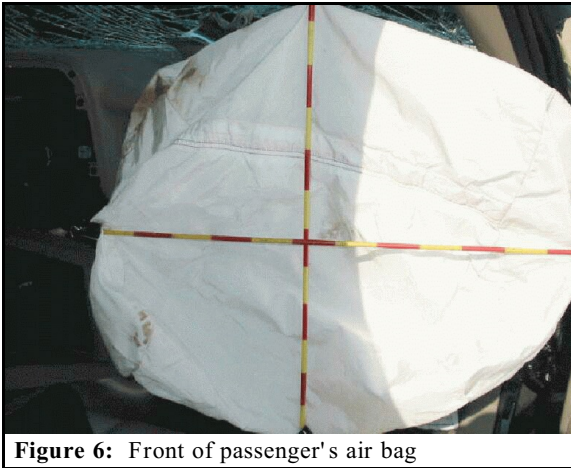
Figure 6: Front of passenger's air bag

The front right passenger's air bag was mounted in the mid-instrument panel location, with a single cover flap hinged on the top edge. The cover flap measured 39 centimeters [15.4 inches] horizontally and 14 centimeters [5.5 inches] vertically. There was no evidence of damage to the cover flap or the adjacent structures. The deployed front right passenger's air bag was rectangular, measuring 61 centimeters [24 inches] horizontally and 58 centimeters [22.8 inches] vertically (**Figure 6**). There were two vent ports of unknown diameter located on the left and

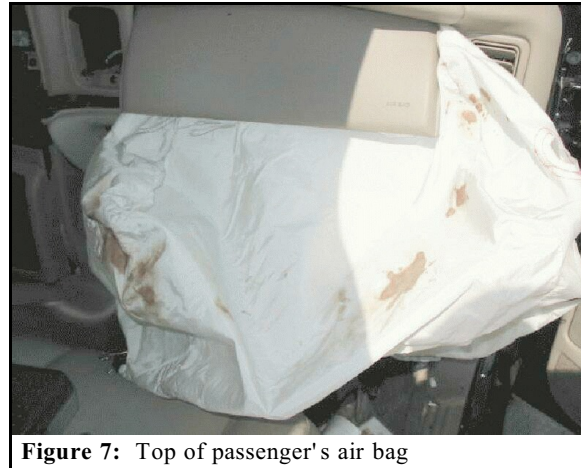
Figure 7: Top of passenger's air bag

right side panels, respectively, of the air bag fabric. There was a small amount of blood on the left edge of the front of the air bag fabric extending onto the left side, and extensive blood stains on the top panel of the air bag's fabric (**Figure 7**).

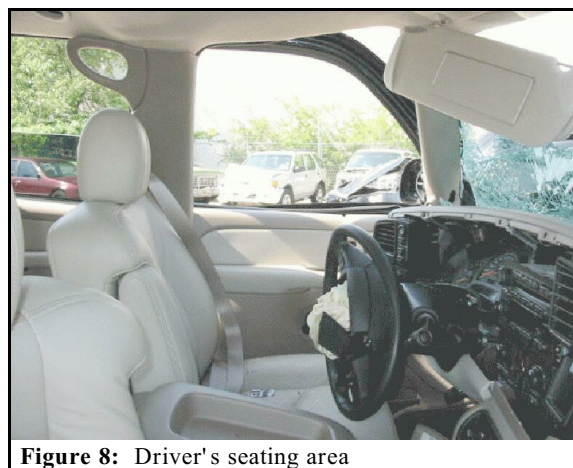
Figure 8: Driver's seating area

The case vehicle's driver (21-year-old male, white, non-Hispanic, 185 centimeters, 88 kilograms [73 inches, 194 pounds]) was not restrained by the available, integrated, manual, three-point, lap-and-shoulder safety belt system. He was in a normal, upright driving posture, with his back against the seat back, his left foot on the floor, his right foot operating the foot controls and both hands on the steering wheel. His seat track was adjusted between the middle and rearmost positions, his seat back was slightly reclined and the tilt steering wheel was adjusted at an unknown position (**Figure 8**).

driver deflated the air bag and his head impacted the windshield header, resulting in a short episode of unconsciousness. His right arm impacted the center of the instrument panel, causing an abrasion on his right elbow. His left knee impacted the knee bolster, causing a contusion on his knee, and his left thigh impacted the steering wheel rim, causing a contusion on his left thigh. His left ankle was forced against the floor/toe pan, causing a contusion. He was removed from the vehicle while he was unconscious and his position at final rest is not known.

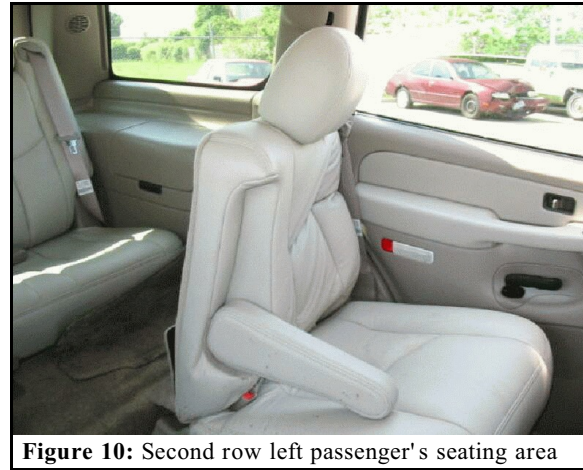
Figure 10: Second row left passenger's seating area

The case vehicle driver braked in an unsuccessful attempt to avoid the collision. The second row left passenger moved forward in response to the braking deceleration. The front of the case vehicle impacted the back of the Freightliner, causing the second row left passenger to move further forward and slightly upward, toward the 12 o'clock direction of force. He may have lifted his arms in an attempt to brace/protect himself. He impacted the back of the driver's seat, causing a fracture of his left forearm. Simultaneously, the third row left passenger pitched forward and impacted the back of the second row seat, causing it to bend forward with residual deformation of 14 centimeters [5.5 inches]. His position at final rest is not known.

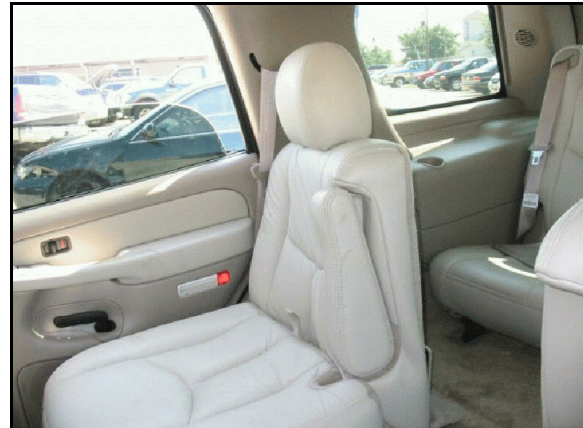
Figure 11: Second row right passenger's seating area

He impacted the back of the front right passenger's seat, causing a laceration on his forehead. Simultaneously, the third row right passenger pitched forward and impacted the back of the second row seat, causing it to bend forward with residual deformation of 10 centimeters [3.9 inches]. His position at final rest is not known.

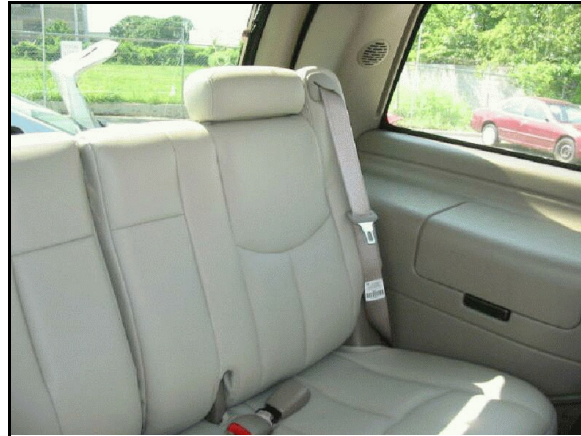
Figure 12: Third row left passenger's seating area

The case vehicle driver braked in an unsuccessful attempt to avoid the collision. The third row left passenger moved forward in response to the braking deceleration. The front of the case vehicle impacted the back of the Freightliner, causing the third row left passenger to move further forward and slightly upward, toward the 12 o'clock direction of force. He impacted the back of the second row left seat, resulting in a herniation of an intervertebral disc in his lumbar spine. His position at final rest is not known.

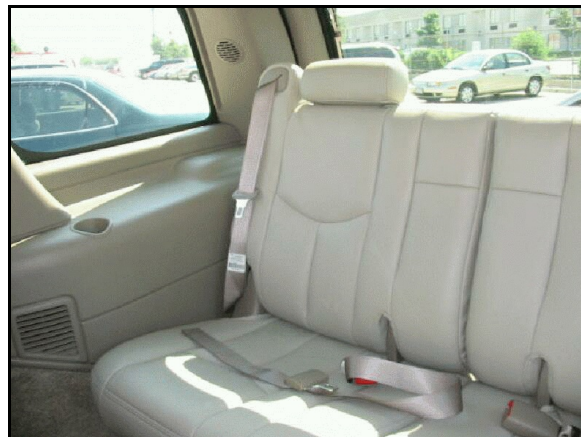
Figure 13: Third row right passenger's seating area

toward the 12 o'clock direction of force. His right knee impacted the back of the second row right seat, causing a dislocation of his right hip. His position at final rest is not known.

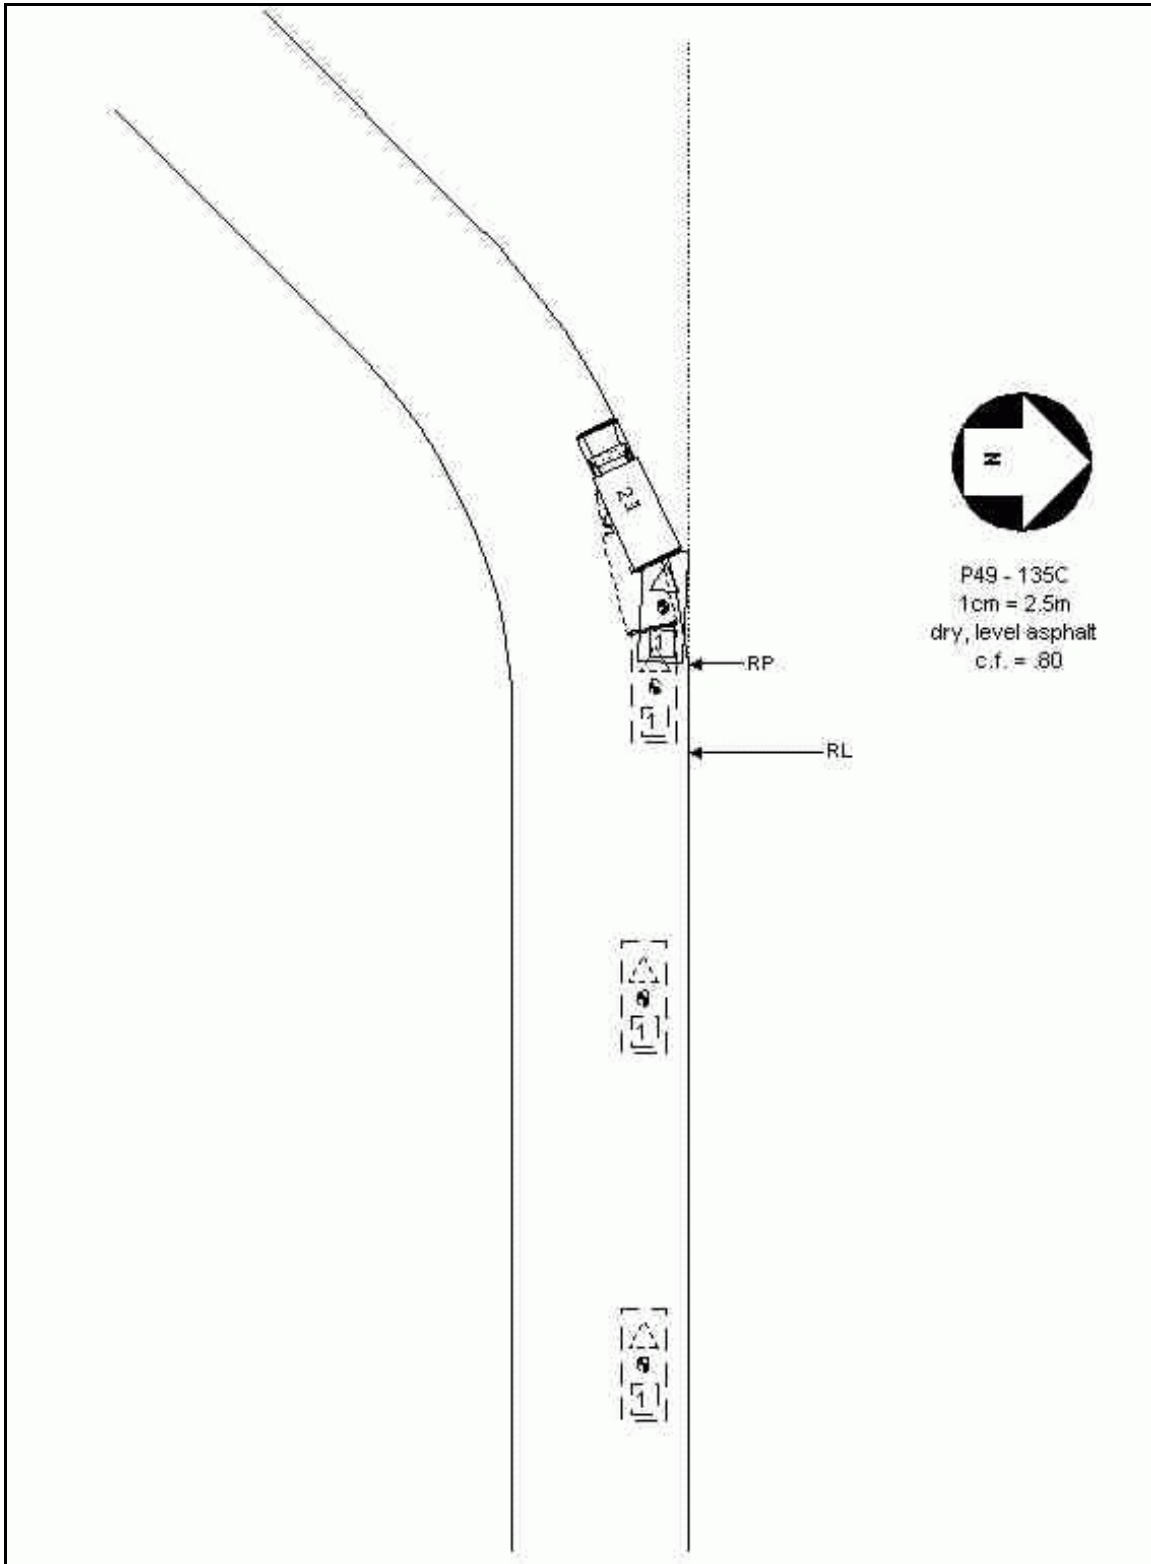
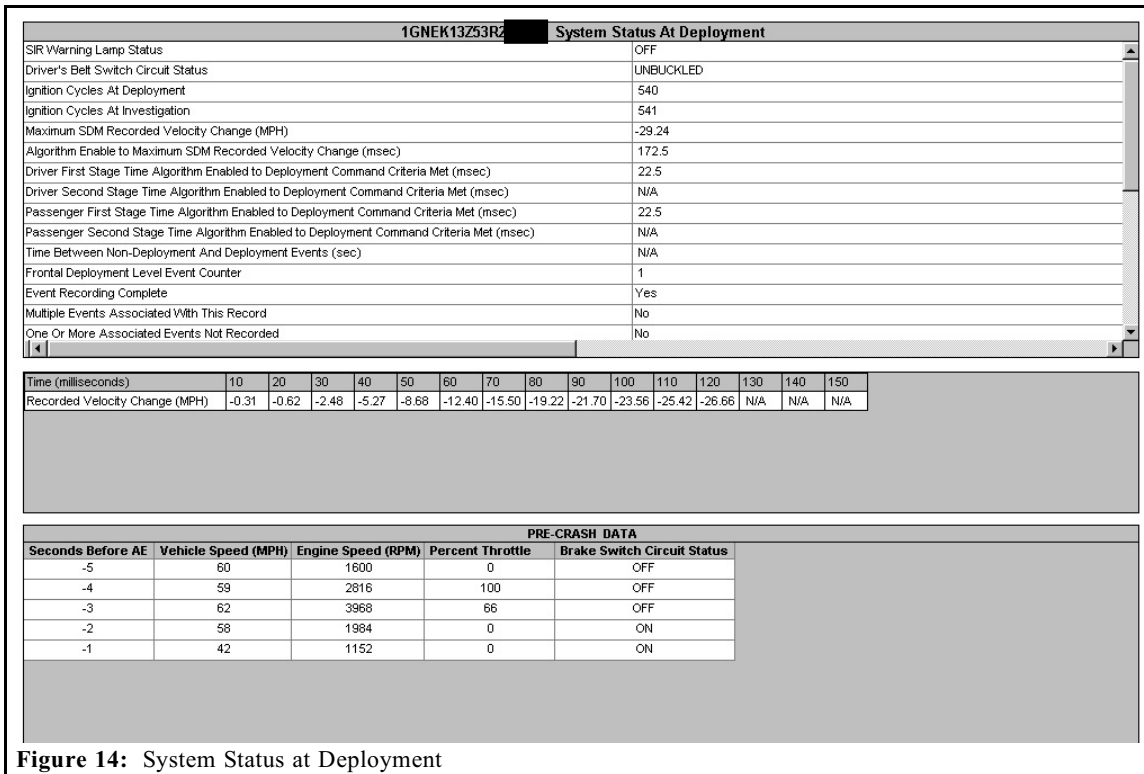
Figure 14: System Status at Deployment

The System Status Report at Deployment report (**Figure 14**) indicates that the SIR Warning Lamp was off. The deployment event occurred during ignition cycle 540 and the EDR was downloaded on cycle 541. The Pre-Crash data (**Figures 14** and **15**) indicate that the case vehicle was traveling 97 km.p.h. [60 m.p.h.] five seconds prior to algorithm enable (AE). The driver applied 100 percent throttle input at four seconds prior and accelerated to 100 km.p.h. [62 m.p.h.] at three seconds prior. The driver braked at two seconds prior and the case vehicle slowed to 66 km.p.h. [42 m.p.h.] at one second prior to AE. The driver's seat belt is reported as unbuckled. The command for first stage deployment of the driver's and front right passenger's air bags was issued 22.5 milliseconds after AE, and second stage deployment was not commanded. The SDM recorded a maximum longitudinal velocity change of -47.1 km.p.h. [-29.24 m.p.h.] at 172.5 milliseconds after algorithm enable (**Figure 14**). The Deployment Velocity Change graph (**Figure 16**) shows a gradual (i.e., not steep) slope to -42.9 km.p.h. [-26.66 m.p.h.] at 120 milliseconds, after which the SDM stopped recording.

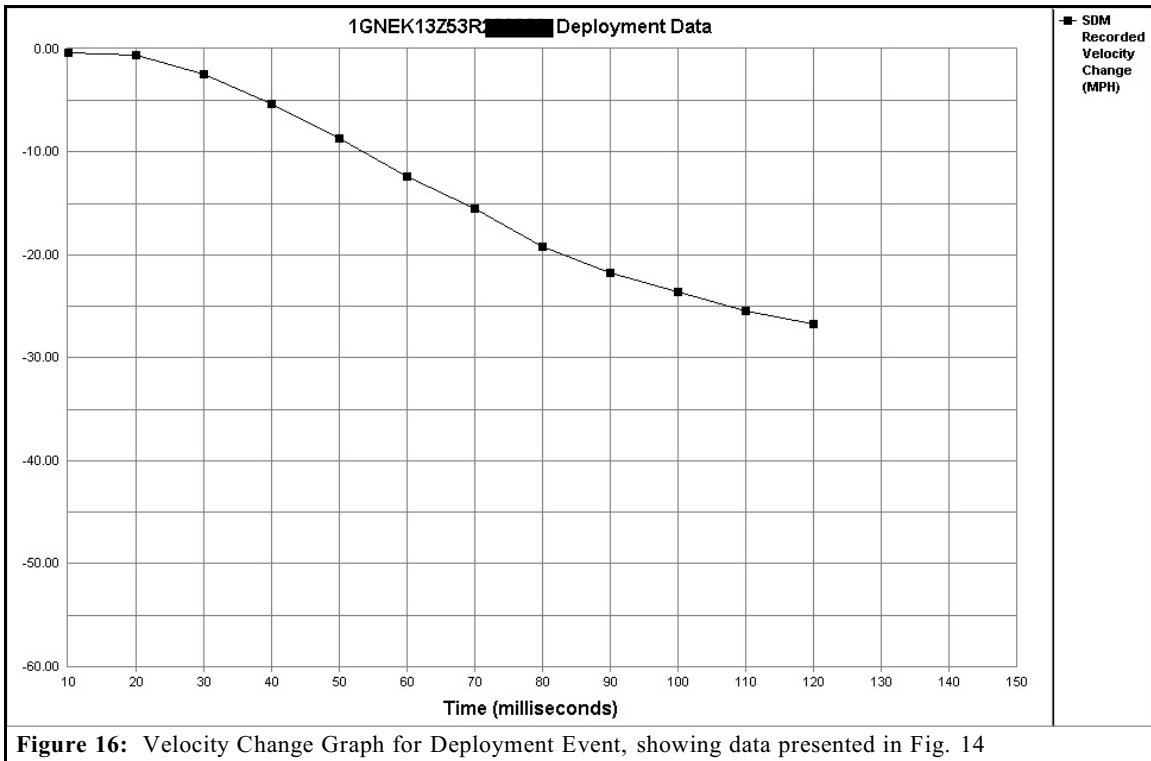
Figure 16: Velocity Change Graph for Deployment Event, showing data presented in Fig. 14

The case vehicle sustained a major impact with the back of a Freightliner straight truck and the case vehicle exhibited a classic heavy truck rear underride damage profile. This collision event involved a sustained impact pulse as the front of the case vehicle engaged the rearmost structures on the back of the Freightliner, penetrated under the rear overhang while the engine hood snagged against the cargo deck, and then encountered the left rear wheel/tire assembly. The Systems Status Report at Deployment (**Figure 14**) indicates that there was not a non-deployment event prior to the deployment (Time Between Non-Deployment and Deployment Events = N/A). In addition, the Pre-Crash Data for the Deployment and the Non-Deployment events (**Figures 14 and 17**) coincide exactly. Accordingly, this contractor concludes that the SDM's recording of the non-deployment event is an artifact of the prolonged impact pulse associated with the underride dynamics of this single event, although it could also be associated with one of the wheel impacts. The non-deployment event (**Figures 17 - 19**) is not discussed further.
