TRANSPORTATION RESEARCH CENTER

SCI/NASS COMBINATION SIDE IMPACT INFLATABLE OCCUPANT PROTECTION REPORT

CASE NUMBER - NASS-2003-49-205A
LOCATION - Texas
VEHICLE - 2001 OLDSMOBILE AURORA
CRASH DATE - September 2003

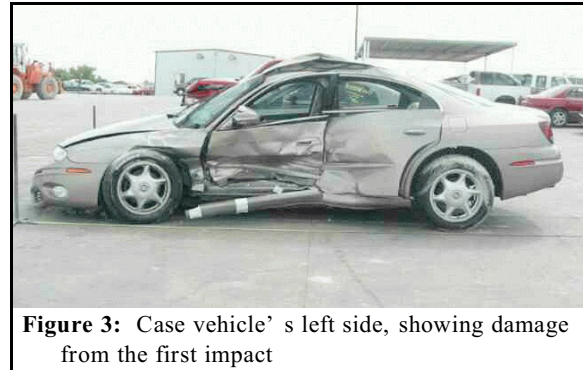
The first impact resulted in direct contact damage along the left A-pillar, driver's door, B-pillar and back door, above the sill, with substantial deformation into the passenger compartment and induced buckling of the left roof rail and roof (**Figures 3 and 5**). The crush profile was measured as 260 centimeters [102.4 inches] long, with maximum crush 65 centimeters [25.6 inches] at the center of the driver's door. The windshield was cracked, the two left side windows disintegrated and there was no other glazing damage. The left front wheel/tire was restricted, the right front tire was deflated and there was no other damage to the wheels or tires.

Figure 3: Case vehicle's left side, showing damage from the first impact

The CDC for the first impact was determined to be **10-LYAW-4 (290)**. The WinSMASH reconstruction program, damage algorithm based on the measured crush profile of both vehicles, was used. The total, longitudinal and lateral delta-Vs are, respectively: 33 km.p.h. [20.5 m.p.h.], -11 km.p.h. [-6.8 m.p.h.] and + 31 km.p.h. [+ 19.3 m.p.h.]. These results appear reasonable. This was an impact of moderate severity (24-40 km.p.h. [15-25 m.p.h.]) for the case vehicle.

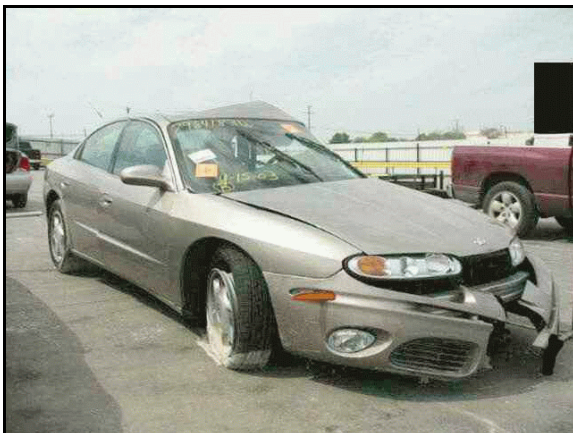
Figure 4: Case vehicle's front and right side

The case vehicle's front impact with the guardrail caused relatively modest damage on the front (**Figures 4 and 5**). The bumper cover was torn and the steel bumper was crushed slightly rearward. Maximum crush was measured as 11 centimeters [4.3 inches] at the left front corner, but this probably reflects some distortion from the left side impact. The CDC for the second event was determined to be the **12-FZEW-1 (0)**. This impact is out of scope for the WinSMASH reconstruction program because the guardrail yielded, but the barrier equivalent speed was calculated as 12 km.p.h. [7.5 m.p.h.]. This second impact was of minor severity (1-13 km.p.h. [1-8 m.p.h.]) for the case vehicle.

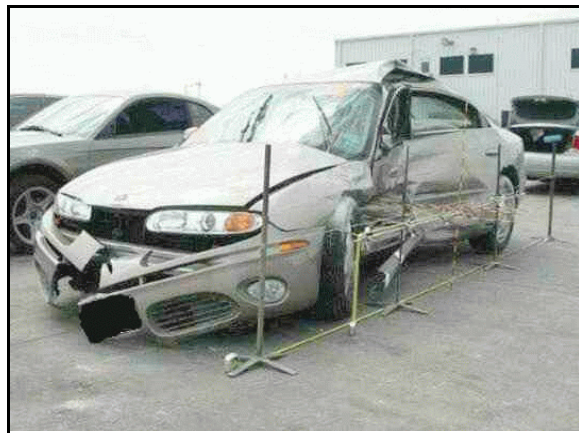
Figure 5: Case vehicle's front and left side

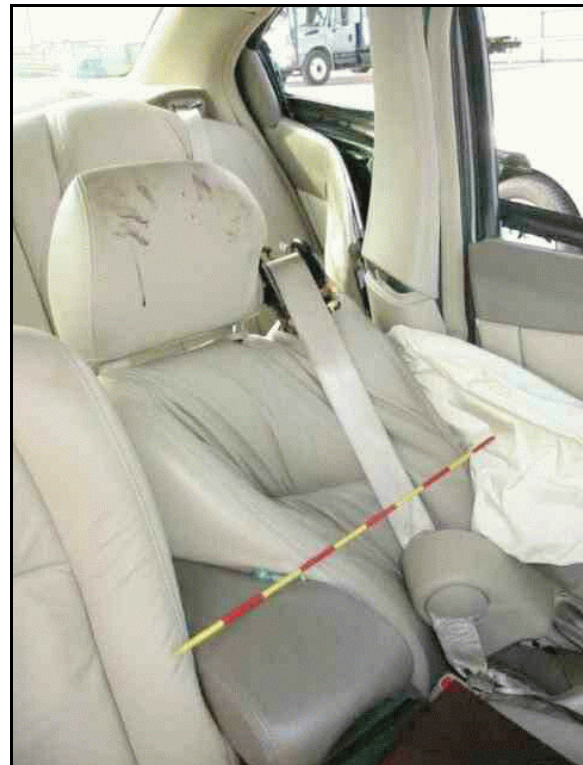
Inspection of the case vehicle's interior revealed substantial intrusion by numerous components (**Figure 6**). The interior surface of the driver's door intruded laterally approximately 40 centimeters [15.7 inches] and the left B-pillar 20 centimeters [7.9 inches], with other left side intrusions in the front and back seat areas. The driver's seat cushion and seat back were displaced laterally and deformed by the intruding components, and the center console intruded into the front right seat position. There were blood smears on the upholstery on the driver's seat. The left side of the center console showed evidence that the driver had loaded against it.

Figure 6: Case vehicle driver's seat area, showing substantial lateral intrusion and deformation of driver's seat; note, integrated safety belt system retractor housing displaced

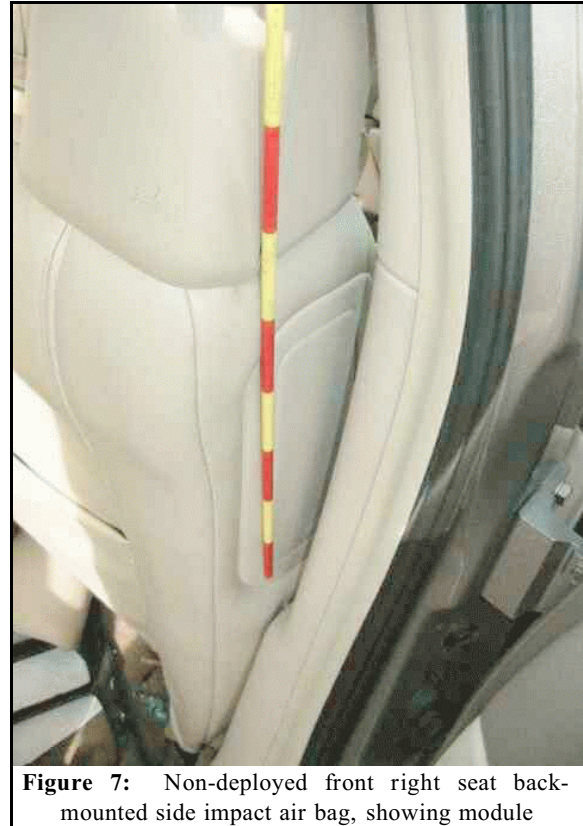
The driver' s side impact air bag module was located in the outboard edge of the driver' s seat back. The module measured approximately 9 centimeters [3.5 inches] wide and 22 centimeters [8.7 inches] long (**Figure 7**). The deployed air bag was approximately pear-shaped, measuring 36 centimeters [14.2 inches] horizontally and 30 centimeters [11.8 inches] vertically (**Figure 8**). There was no evidence of damage to any of the side air bag system components.

Figure 7: Non-deployed front right seat back-mounted side impact air bag, showing module

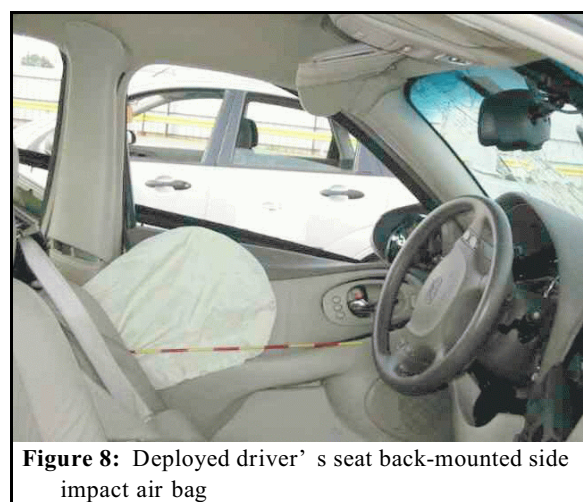
Figure 8: Deployed driver' s seat back-mounted side impact air bag

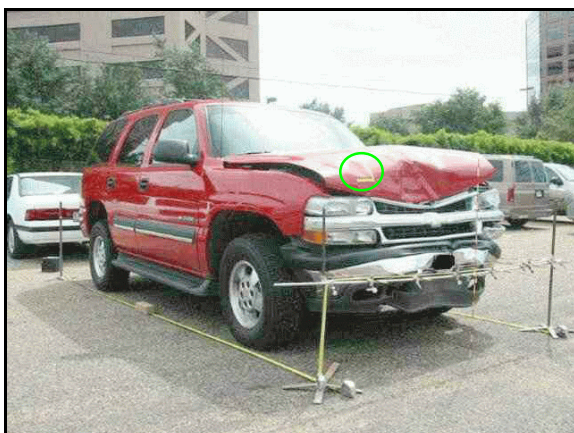
The Tahoe sustained direct contact damage across the entire front (**Figures 9 and 10**). The bumper was crushed rearward, the grille was displaced and the leading edge of the hood was folded downward and crushed rearward. The left headlamp and turn signal assemblies were displaced or shattered and the left fender showed induced buckling, but the front right components were relatively undamaged except the bumper was crushed rearward. Maximum crush was measured as 20 centimeters [7.9 inches], near the middle of the front bumper. The left wheelbase was shortened by 8 centimeters [3.1 inches] and the right wheelbase was unchanged. Both front tires were restricted due to the bumper being crushed against them, and there was no other wheel/tire damage. There was no glazing damage.

Figure 9: Other vehicle' s front and right side; highlighting shows where the case vehicle driver' s head left an imprint

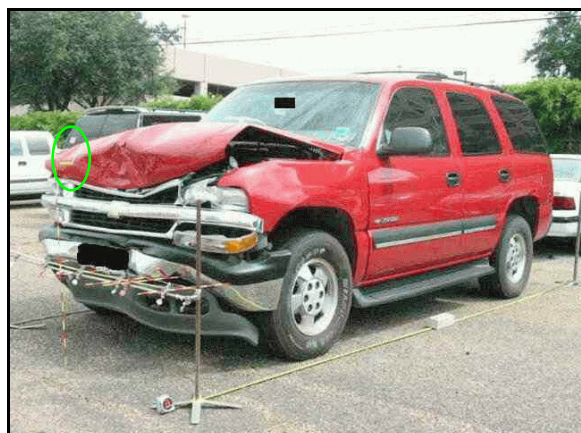
Figure 10: Other vehicle' s front and left side; highlighting shows where the case vehicle driver' s head left an imprint

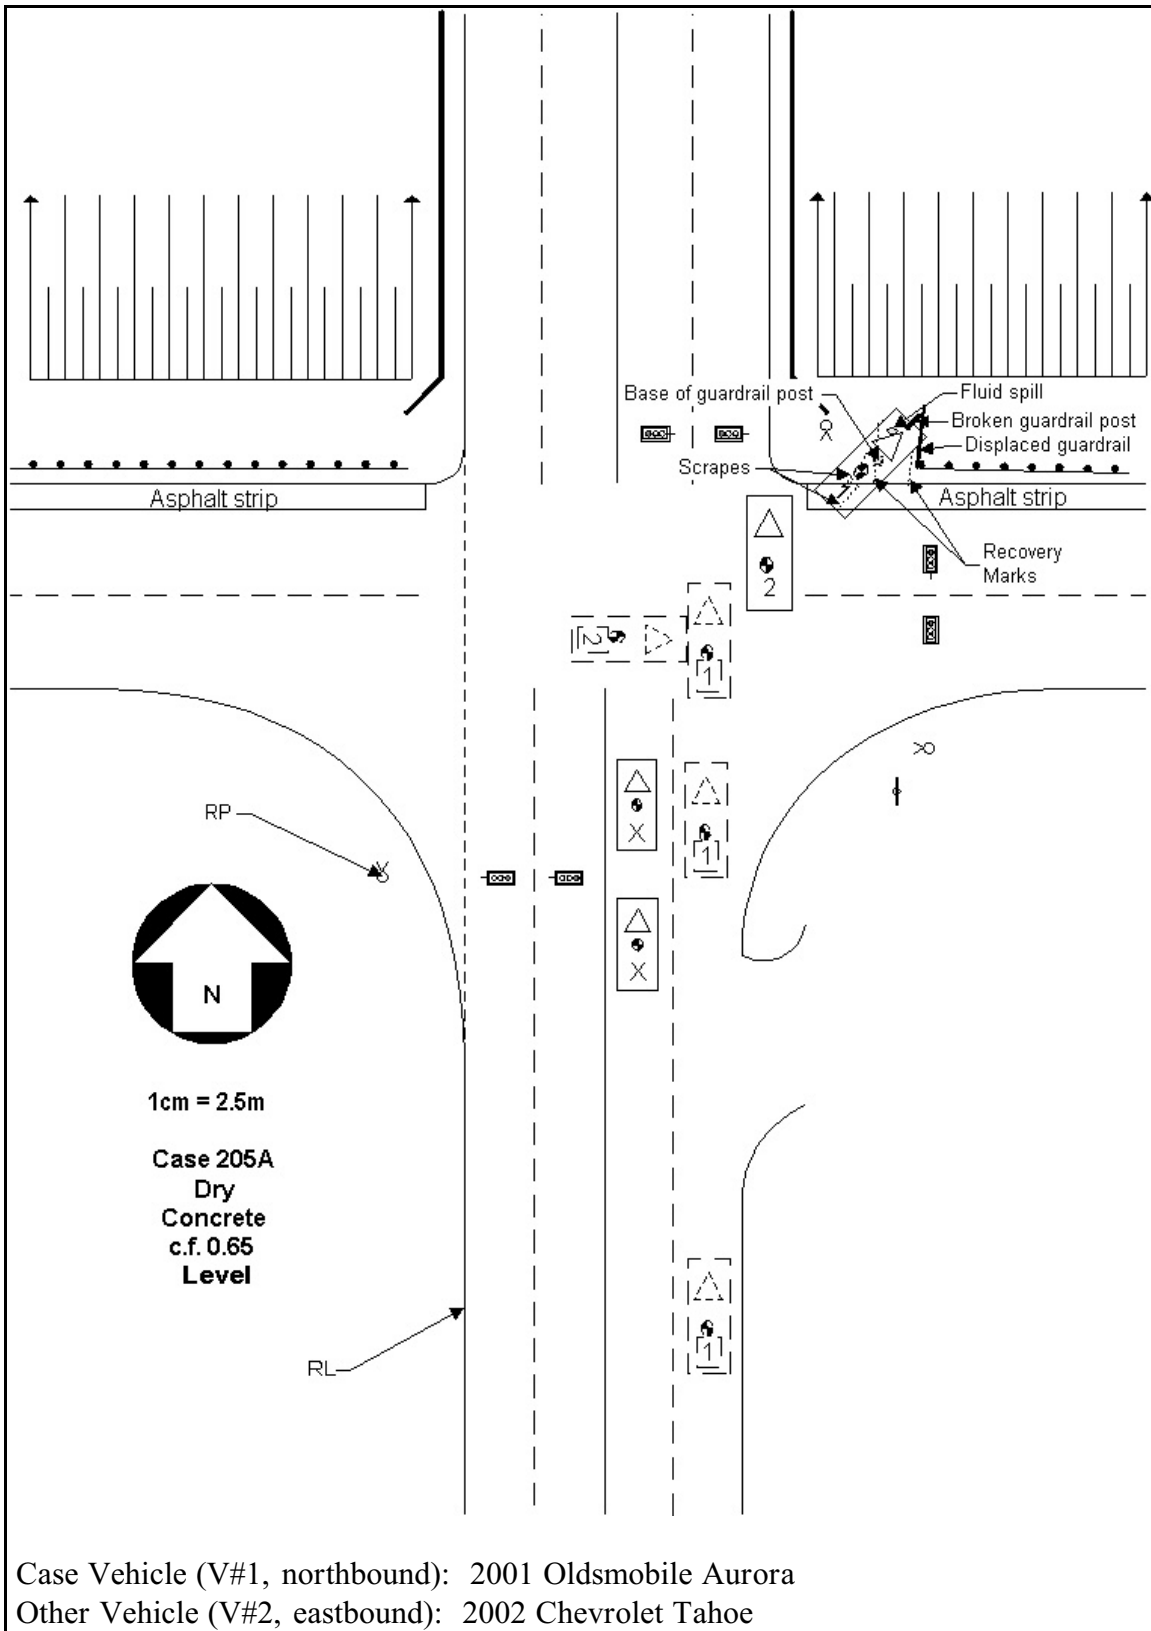
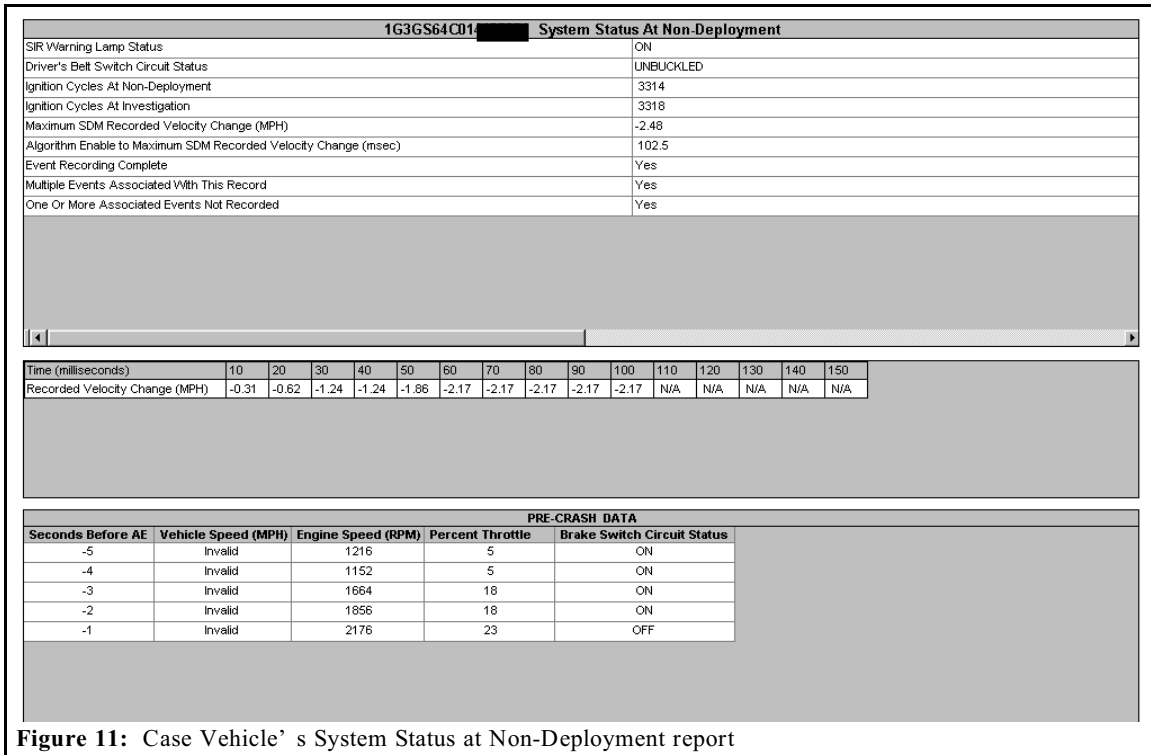
Figure 11: Case Vehicle's System Status at Non-Deployment report

The SDM System Status at Non-Deployment report (**Figure 11**) indicates that the event was recorded on ignition cycle 3,314 and the download was accomplished on 3,318. The driver's safety belt is reported as not buckled. The report indicates that the data recording for this one event is complete and that there were multiple events detected with additional data not recorded.

The SDM Pre-Crash Data (**Figure 11**) and the Pre-Crash Graph (**Figure 12**) show that the case vehicle driver was braking with the five percent throttle at five seconds prior to algorithm enable. The case vehicle's pre-crash travel speed was not recorded. The driver accelerated slightly over the next four seconds, with throttle input increasing to 23 percent, engine rpm

The SDM Non-Deployment Velocity Change Data (**Figure 11**) and Velocity Change Graph (**Figure 13**) show a gradual decline to -3.5 km.p.h. [-2.17 m.p.h.] at 90 milliseconds [0.09 seconds], after which the SDM stopped recording. The maximum recorded longitudinal velocity change is reported as -4.0 km.p.h. [-2.48 m.p.h.], at 102.5 milliseconds [0.1025 seconds] after algorithm enable.
