Combination Child Safety Seat Investigation / Vehicle to Vehicle
Dynamic Science, Inc. / Case Number: 2003-74-110B
1994 Chevrolet Camaro
Nebraska
May, 2003

| 4. Title and Subtitle Combination Child Safety Seat Investigation | | 5. Report Date December 16, 2003 | |
| 16. Abstract This child seat involved crash occurred in Nebraska within the confines of a four-leg intersection in May, 2003 at 1750 hours. The speed limit is 89 km/h (55 mph) for travel north and south. The case vehicle was a 1994 Chevrolet Camaro Z28 convertible driven by an unrestrained 20-year-old male. The convertible top of the vehicle was down at the time of the crash. A 17-month-old male occupied the right rear seat position. The child was seated in a Cosco Alpha Omega convertible child safety seat. The other vehicle was a 2003 Honda CR-V EX four-door sport utility vehicle being driven by a 44-year-old female. This vehicle was equipped with advanced dual stage frontal air bags. The case vehicle was traveling north, approaching the intersection, and began a left hand turn to go west. The other vehicle was traveling southbound. As the Chevrolet Camaro turned it was struck in the right side by the front of the Hon

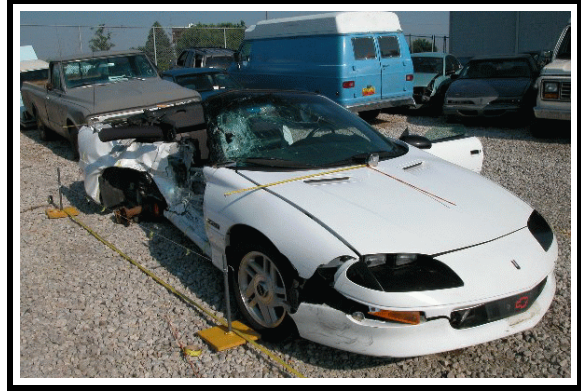
The 1994 Chevrolet Camaro sustained major side damage as a result of the impact with the Honda. The direct damage began 60.0 cm (23.6 in) rear of the front axle and extended 226.0 cm (88.9 in) down the side. The right rear tire was broken away from the axle. The field L began 70.0 cm (27.5 in) aft of the front axle and extended 245.0 cm (96.4 in) down the side. The Honda overrode the sill of the Camaro. The crush profile was taken at the mid door plane. The crush profile is as follows: C1=4.0 cm (1.6 in), C2=37.0 cm (14.5 in), C3=51.0 cm (20.0 in), C4=52.0 cm (20.4 in), C5=42.0 cm (16.5 in), C6=20.0 cm (7.9 in).

Figure 4. Front right, case vehicle

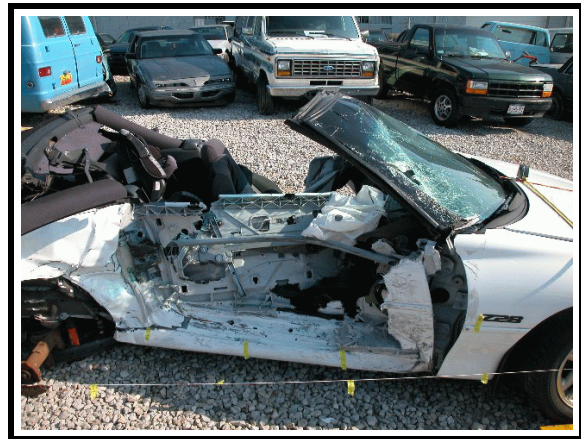
Damage Description: Major side damage. Right front door jammed shut.
 Right sill overridden.

Figure 5. Right side, case vehicle

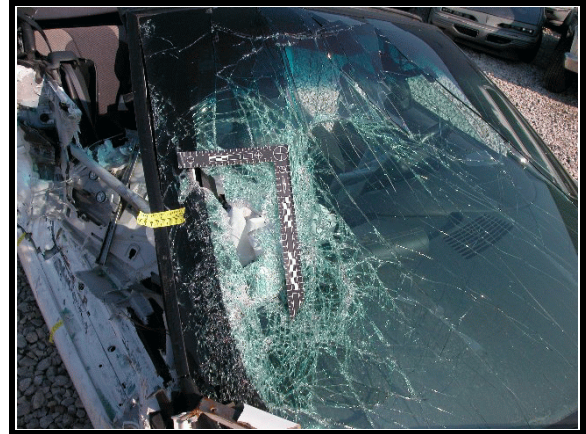
Interior damage to the 1994 Chevrolet Camaro was extensive and attributed to occupant contact and passenger compartment intrusion. The right side of the windshield was fractured and holed from impact forces. The right door was jammed shut. There was extensive intrusion to the right side. The maximum intrusion to the right front door was 27.0 cm (10.6 in). The right front seat was pushed into the left seating area. The maximum intrusion to the right rear seating area was 30.0 cm (11.8 in).

Figure 6. Right side windshield damage

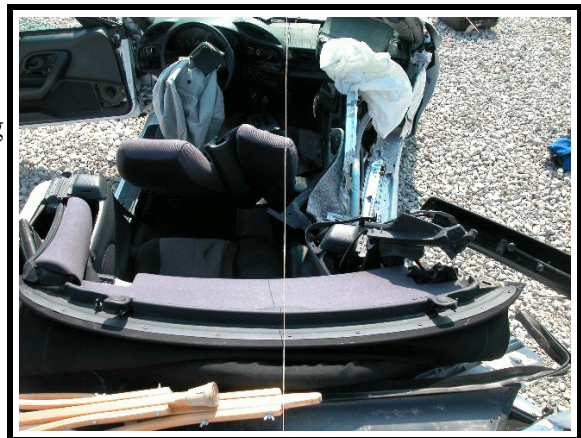
Figure 7. Overview of vehicle interior showing right side intrusion

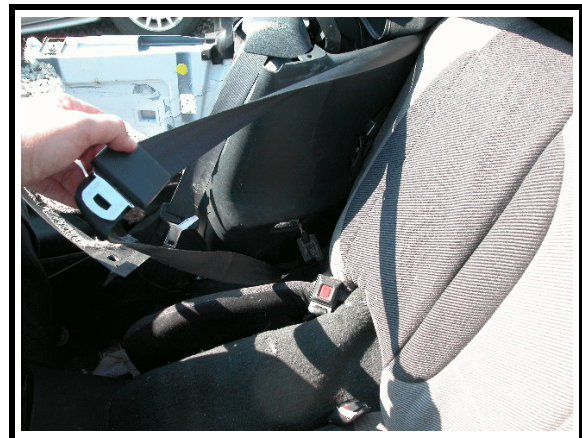
The 1994 Chevrolet Camaro was configured with 3-point lap and shoulder belts with sliding latch plates for all four seating positions. The driver's seat belt was configured with an emergency locking retractor. The retractor type for the front right seat position is not known. Both rear seat belts were configured with switchable retractors. The driver's seat belt was not in use at the time of the crash. The rear right seat belt was being used in conjunction with a child safety seat at the time of the crash.

Figure 8. Right rear seat belt

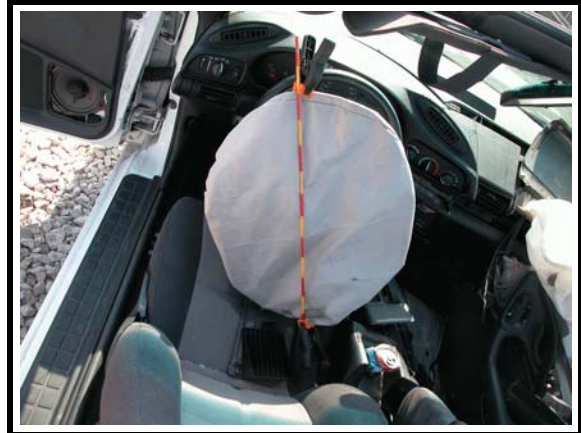
The case vehicle was equipped with a driver's air bag and a front right passenger's air bag. The driver's air bag was mounted in the steering column. It measured 50.0 cm (19.6 in) in diameter in its deflated state. It was equipped with two vent ports and did not have any tethers. There were nine horizontal folds on the air bag face. The module cover was an "I" design. The left and right flaps each measured 10.0 cm (3.9 in) wide by 12.0 cm (4.7 in) high. There were no indications of contact or damage to the module cover. There was a small cut found on the bottom right quadrant of the air bag. The front passenger's air bag was mounted in the top of the instrument panel. It measured 50.0 cm (19.6 in) wide by 60.0 cm (23.6 in) high. It was equipped with two vent ports (at the 9 and 3 o'clock positions) and two tethers. There was a single rectangular module cover that was 35.0 cm (13.7 in) wide by 24.0 cm (9.4 in) high. The cover was secured by a single 15.0 cm (5.9 in) long tether. There were no indications of contact or damage to the module cover. There were cuts found on the top left quadrant of the air bag. This had been caused by the bag's interaction with the windshield.

Figure 9. Driver's air bag

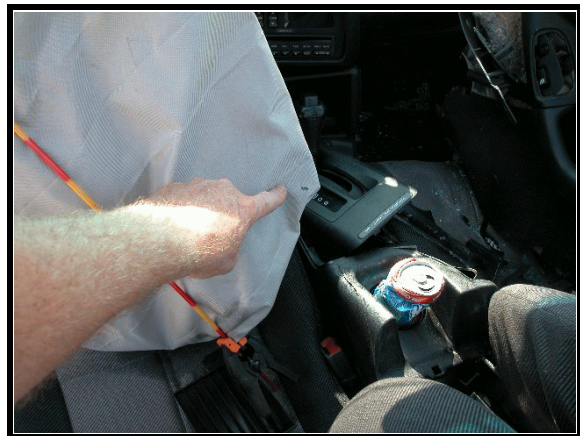
Figure 10. Small hole, driver's air bag

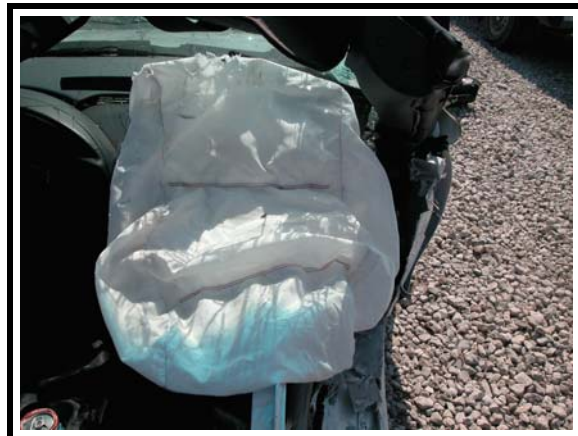
Figure 11. Front right passenger's air bag

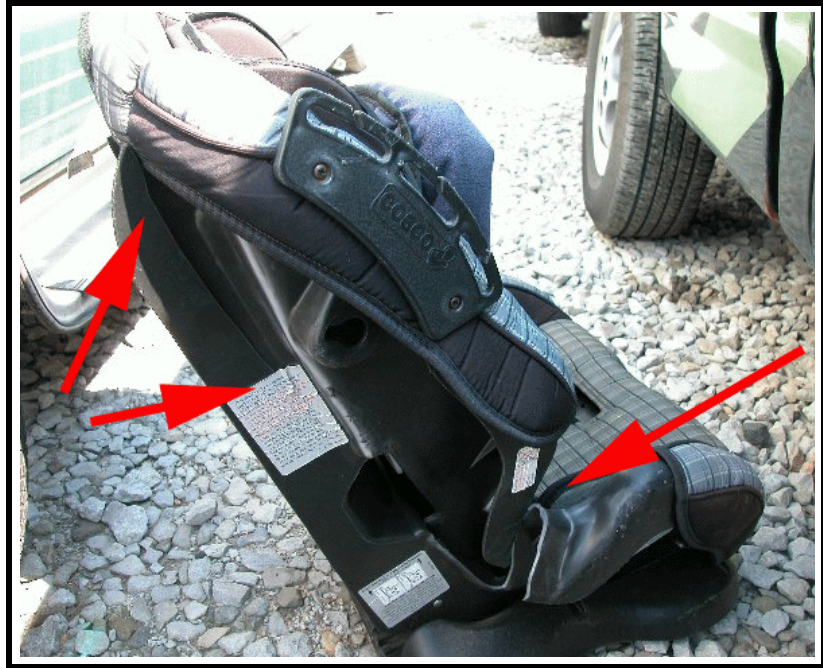
The impact and subsequent intrusion fractured and displaced the right side of the shell. The fracture ran vertically down the right side of the shell and compressed the bottom of the base.

Figure 14. Shell fractures to seat back and side panel

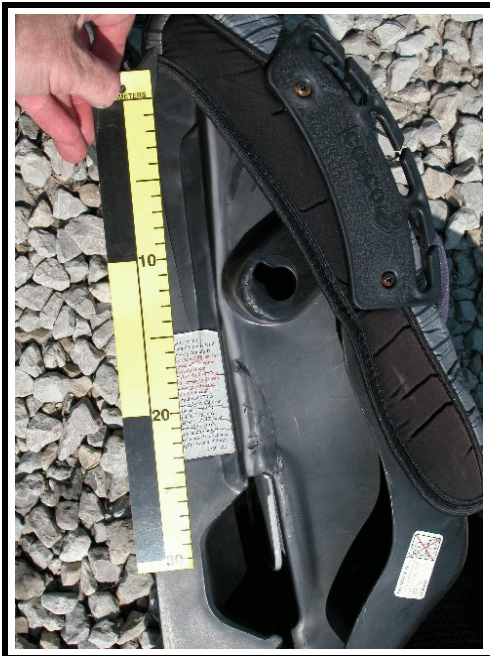
Figure 15. Side view of CSS showing seat back fracture

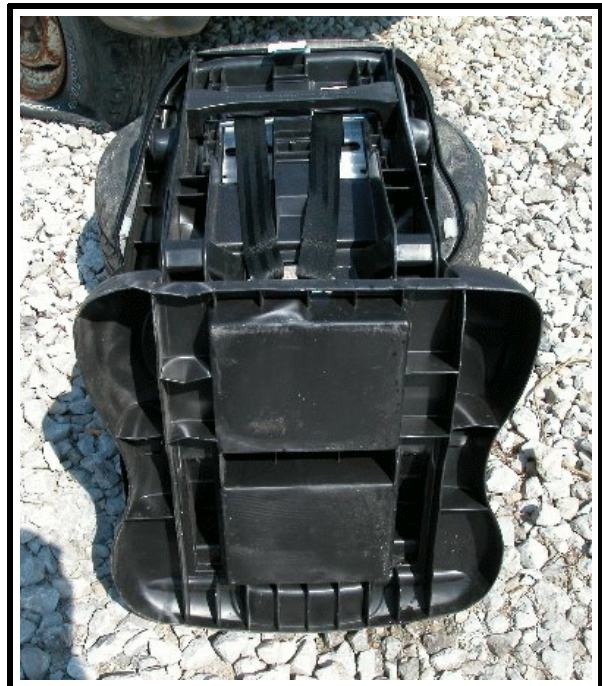
Figure 16. Bottom of child seat—shows compression to left side of base.

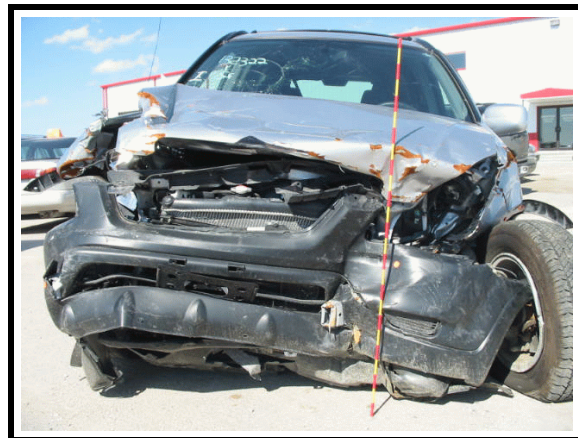
| Damage Description: | Moderate frontal crush. Damage to bumper, grille, hood. | |

Figure 17. Front, other vehicle

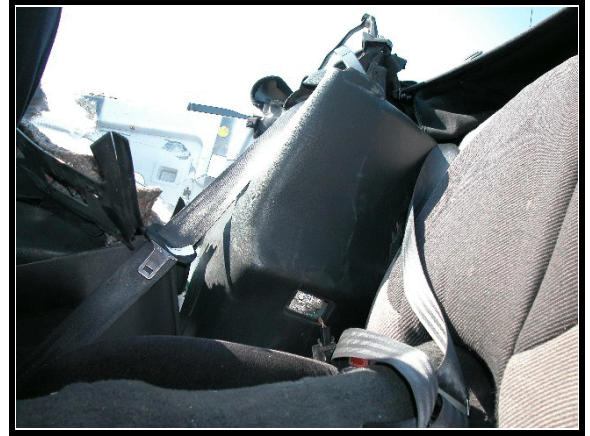
| | <u>INJURY</u> | <u>OIC CODE</u> | <u>SOURCE</u> |
|---|---|---|---|
| Right rear occupant: | Traumatic brain injury | 115299.7,0 | Right side panel, reinforced by right side of child restraint |

Figure 18. Right rear intruding surface

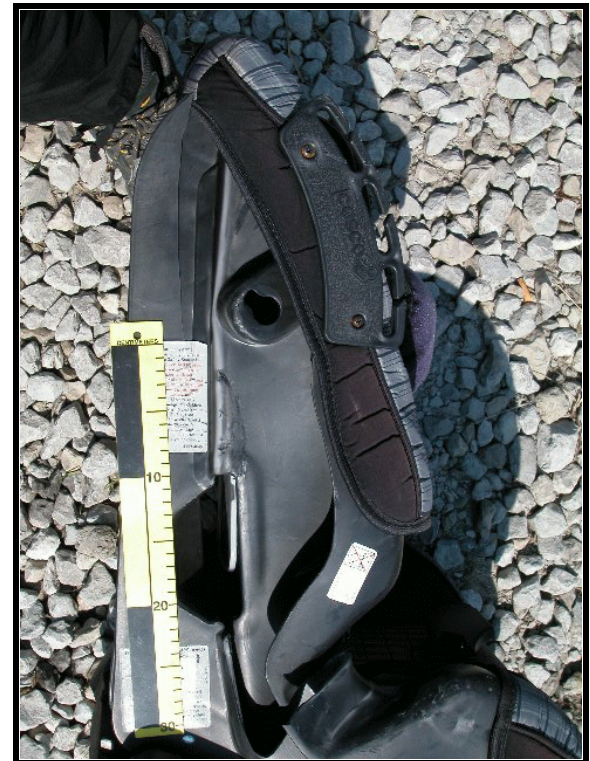
Figure 19. Right side of child safety seat (exterior)

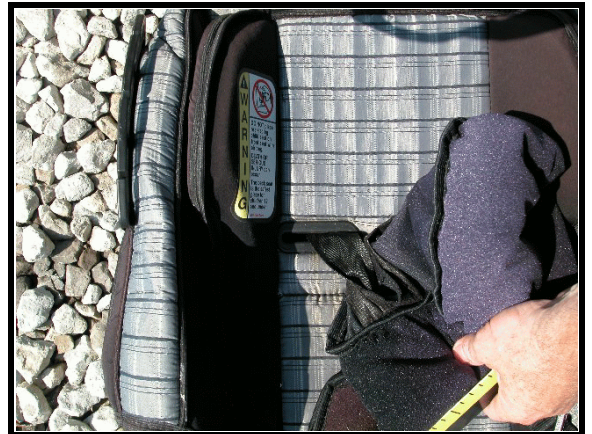
Figure 20. Right side of child seat (interior)
