Certified Advanced 208 Compliant Investigation / Single vehicle crash  
Dynamic Science, Inc. / Case Number: 2003-74-186G  
2003 Honda Odyssey  
Nebraska  
October, 2003

1. Report No. 2003-74-186G		2. Government Accession No.		3. Recipient Catalog No.	
4. Title and Subtitle Certified Advanced 208 Compliant Investigation				5. Report Date April 14, 2004

**Dynamic Science, Inc.**  
**Crash Investigation**  
**Case Number: 2003-74-186G**

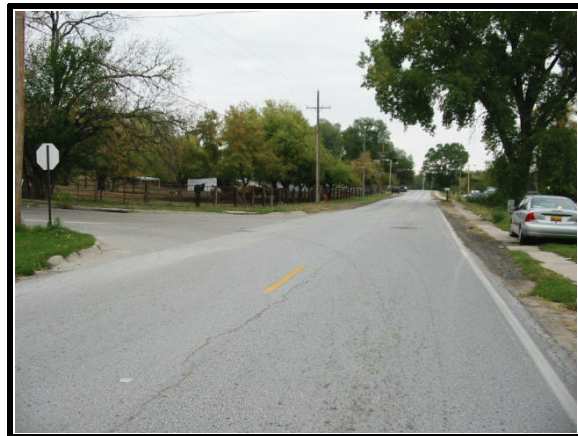
**Figure 1.** Approach to area of impact (east)

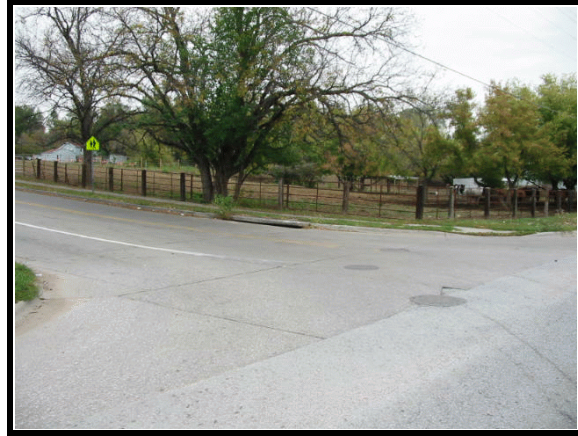
The Odyssey was originally traveling east. As the Odyssey approached the intersection, the driver began a left hand turn. The driver took the turn too wide (Fig. 2) and the right front of this vehicle struck the storm drain (Fig. 3) with the right front (12FRLE4). The frontal air bags deployed at this point. The pretensioners did not actuate and the side air bags did not deploy. The right rear wheel of the vehicle then also contacted the curb (12RBWN1).

**Figure 2.** Left hand turn, approach to area of impact (east to north)

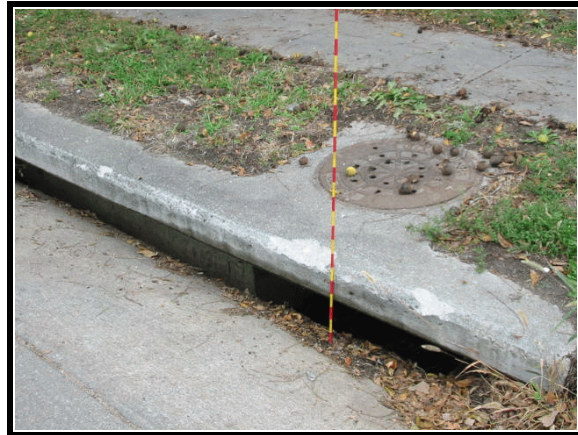
**Figure 3.** Area of curb impact

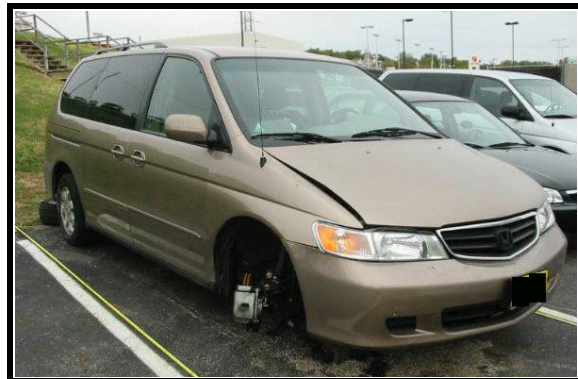
**Figure 4.** Front right, case vehicle

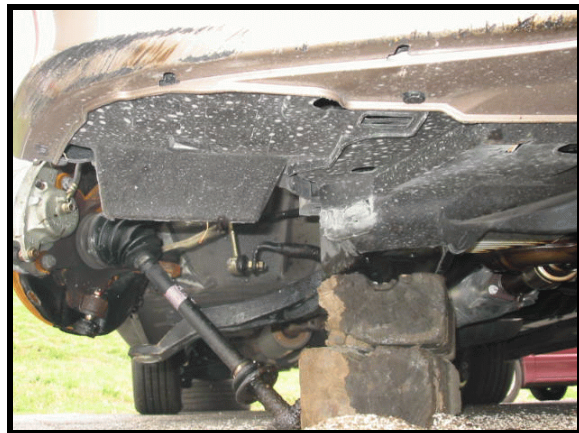
Damage Description: The right front wheel and suspension were damaged. The right drive shaft was loose. The wheel had been removed prior to the vehicle inspection. There was direct contact damage to the right front bumper fascia (Figs. 5 & 6). There was abrasion contact damage to the right rear wheel (Fig. 7).

**Figure 5.** Front right bumper corner, fascia damage

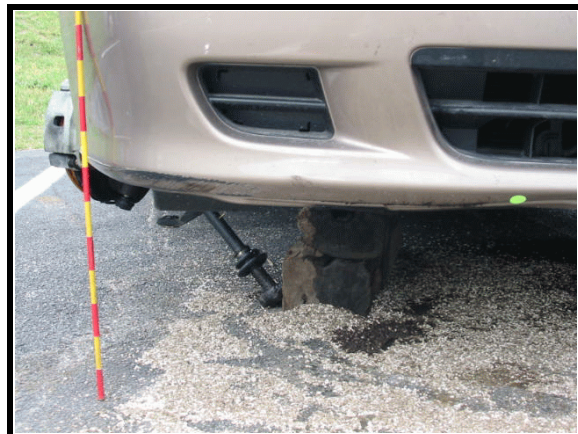
**Figure 6.** Close up of damage to front right bumper fascia

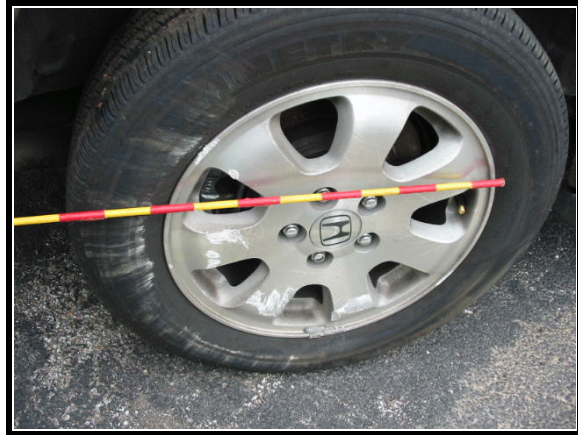
**Figure 7.** Damage to right rear wheel

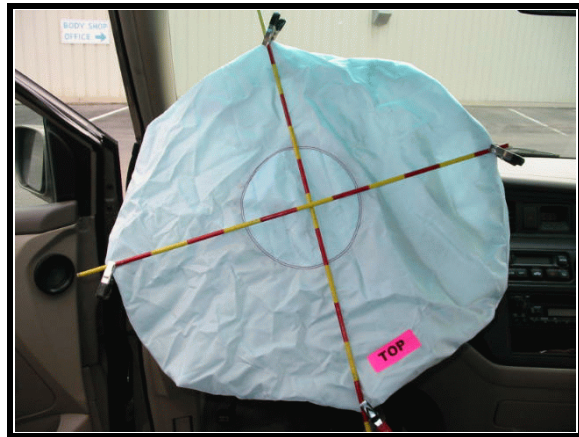
The driver and front right passenger air bags deployed during the curb impact. The driver's air bag module was an "H" design and located in the center hub of the steering wheel rim. The top flap measured 16.0 cm (6.3 in) x 12.0 cm (4.7 in) high. The bottom flap measured 16.0 cm (6.3 in) wide x 9.0 cm (3.5 in) high. There was no contact evidence on the cover flaps. The diameter of the air bag measured 50.0 cm (19.6 in) in its deflated state (Fig. 8). There were circular vent ports located at the 10 and 2 o'clock positions on the back of the air bag, and two internal tethers. There were color transfers to the bottom left of the air bag face.

**Figure 8.** Driver's air bag

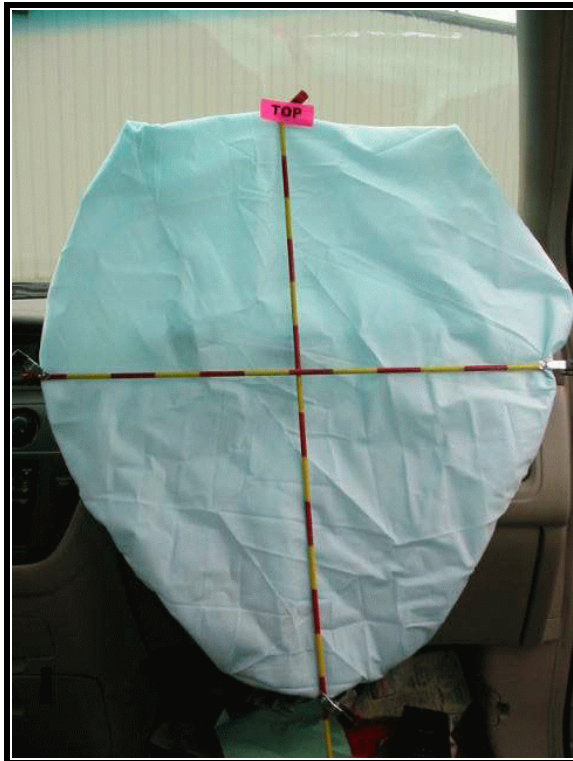
**Figure 9.** Front right passenger's air bag

The front right passenger air bag was a top mount design located in the right aspect of the instrument panel. There was a single module cover that was vaguely rectangular in shape. It measured 23.0 cm (9.1 in) wide x 9.0 cm (3.5 in) high (Fig. 9). The deflated air bag measured 60.0 cm (23.6 in) wide x 70.0 cm (27.5 in) high. The air bag was not equipped with vent ports. There was no damage or contacts to either the air bag module cover or the air bag itself.

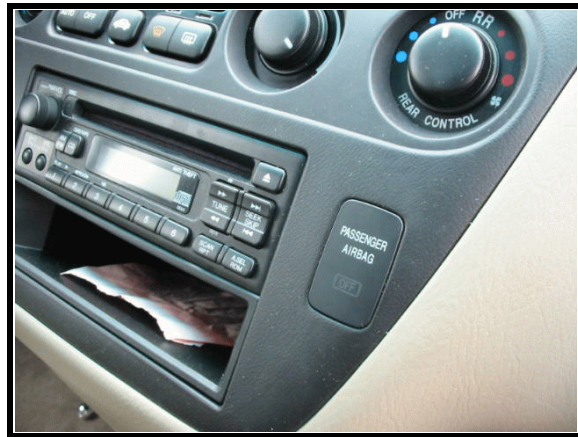
**Figure 10.** Front right passenger's air bag cut off indicator

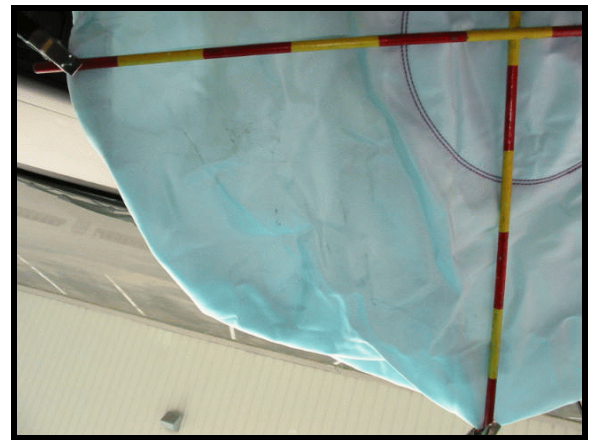
The unrestrained 16-year-old male driver was sitting upright in the fabric covered bucket seat. Both hands were on the steering wheel at the 10 and 2 o'clock positions. The seat had been adjusted to between the forward most and middle seat track positions. The seat back was essentially upright. As the case vehicle approached the intersection the driver began a sharp left hand turn. According to the driver, the vehicle was traveling at 56 km/h (35 mph). The left hand turn pitched this occupant to right somewhat. At impact with the curb the driver's air bag deployed. The driver engaged the deployed air bag. There was a color transfer contact to bottom left of the air bag face (Fig. 12) but there were no resulting injuries.

**Figure 12.** Bottom left of face of driver's air bag (image rotated)

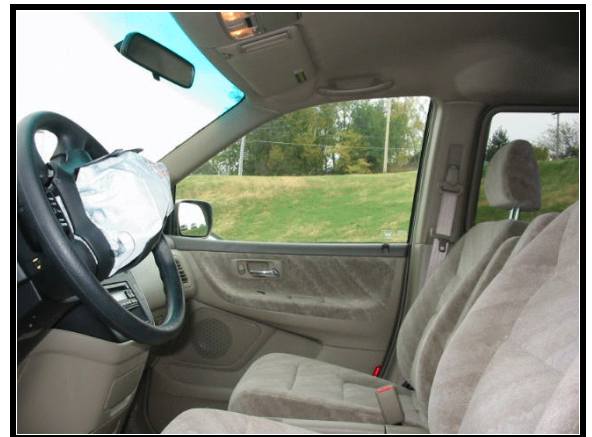
The unrestrained 15-year-old male front right passenger was seated, forward facing, in the fabric covered bucket seat. The seat had been adjusted to the middle seat track position. The seat back was essentially upright. As the case vehicle approached the intersection the driver began a sharp left hand turn. The left hand turn pitched this occupant to right somewhat—causing him to possibly load the right side door. At impact with the curb the front right passenger's air bag deployed. This occupant likely engaged the deployed air bag but there were no resulting contacts or injuries.

**Figure 13.** Side view showing front right seat occupant position

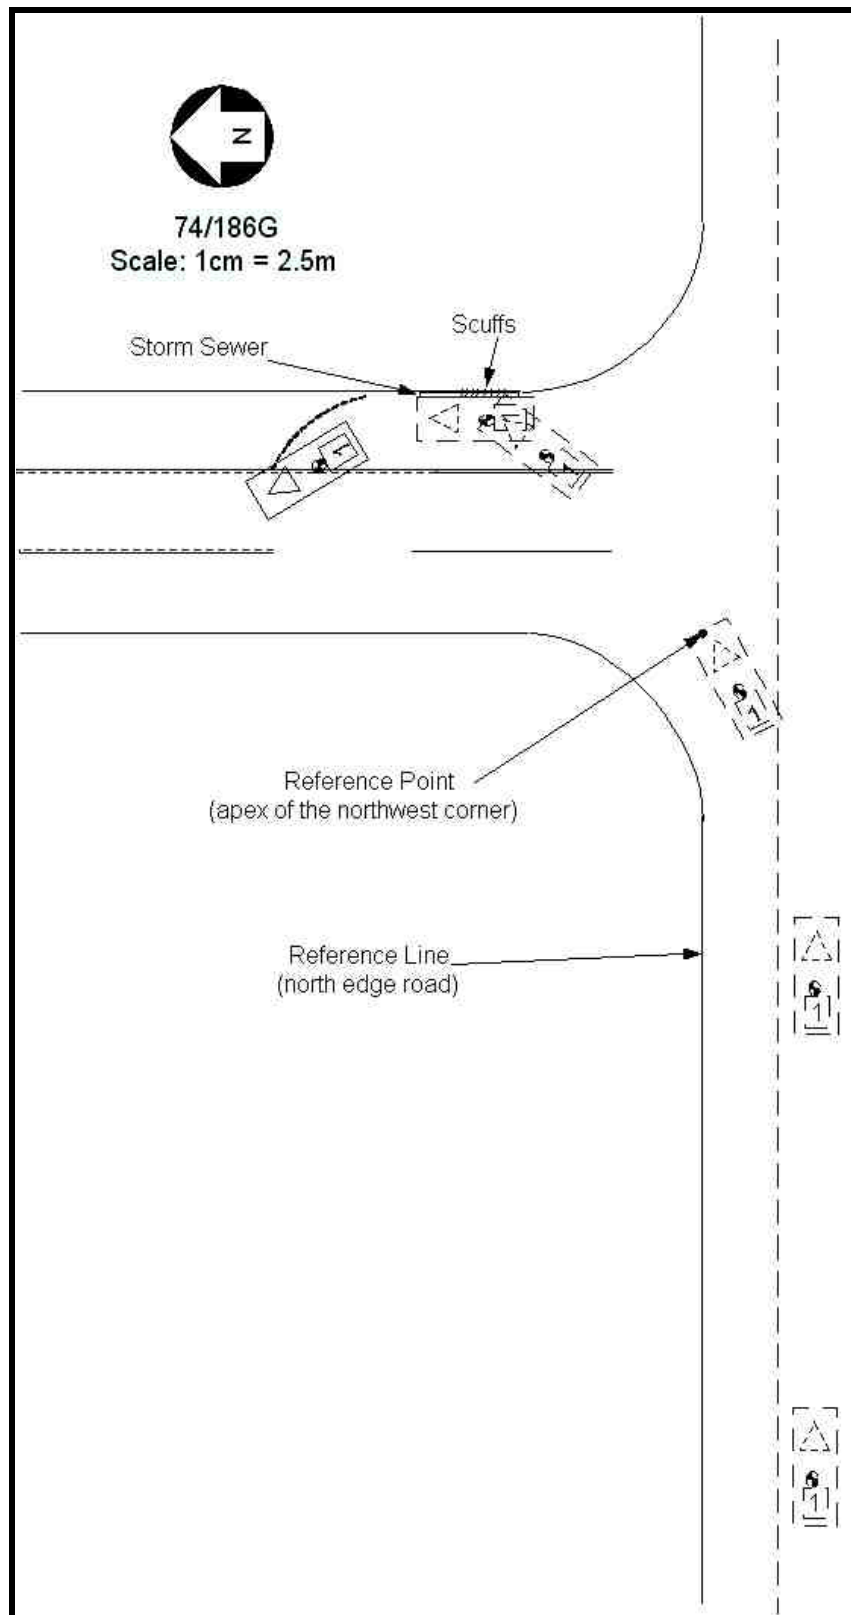
Attachment 1. Scene Diagram

Figure 14. Scene diagram
