Side Air Curtain Investigation / Vehicle to Vehicle
Dynamic Science, Inc. / Case Number: 2003-79-057E
2003 Volvo XC90 sport utility vehicle
California
March, 2003

1. Report No. 2003-79-057E		2. Government Accession No.		3. Recipient Catalog No.	
4. Title and Subtitle Side Air Curtain Investigation				5. Report Date

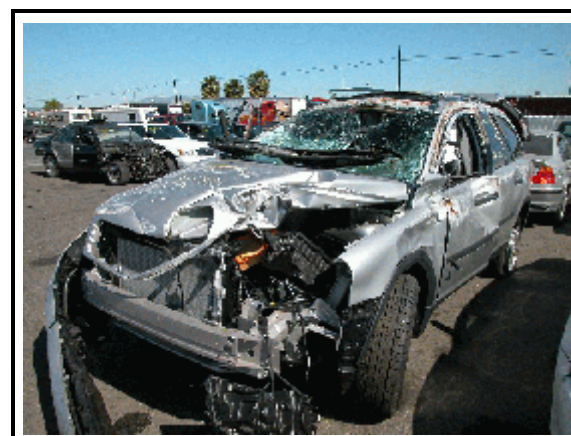
Figure 2. Front right, case vehicle

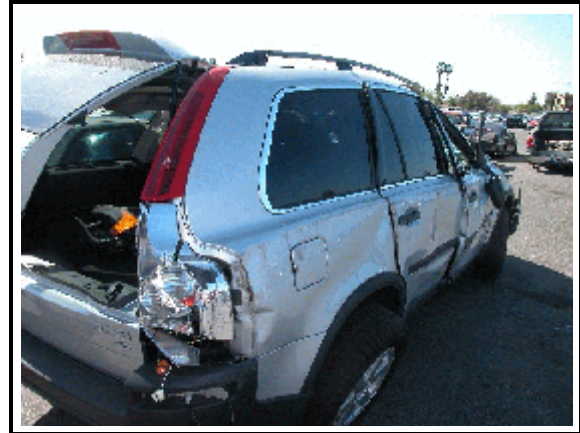
Figure 3. Right rear, case vehicle

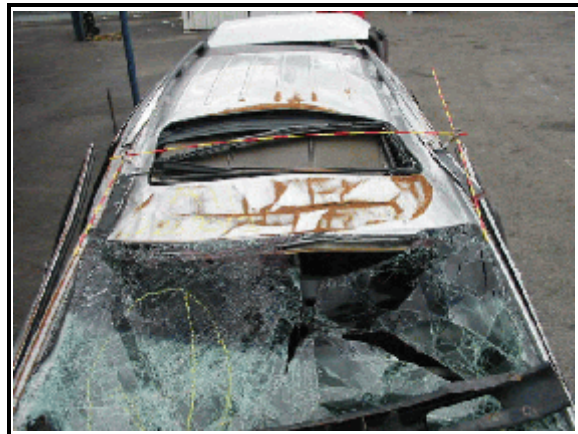
An external examination of the Volvo XC90 revealed a 5-door sport utility vehicle with moderate damage to the top and side planes from rolling over (Event 3), and minor damage to the rear plane from being initially struck by the Ford Mustang (Event 1). None of the wheels were visibly restricted, but the right rear axle was bent and canted underneath the Volvo at a noticeable angle. The left rear tire was flat. The top plane sustained the maximum crush, which was measured at 15.0 cm (5.9 in). This resulted in a CDC of 00TDDO3. The rear impact, Event 1, resulted in a CDC of 05BCMNI and was very minor. The rollover impact resulted in integrity loss due to the fracturing and consequent disintegration of both the left and right side window glazing. The roof glazing also disintegrated, and the windshield sustained a hole that was large enough to allow a human head to exit the vehicle. The sunroof glazing had also disintegrated as the vehicle rolled over. None of the side doors opened, nor were they jammed shut. The rear hatch did come open; a failure of the door support structure was noted during the inspection.

Figure 5. Top damage to Volvo XC90

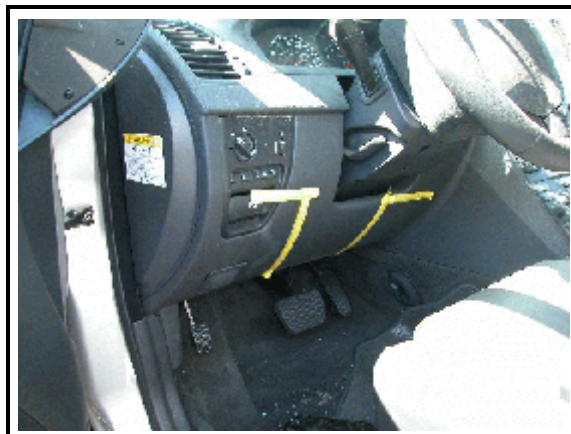
Interior damage to the Volvo XC90 was moderate and attributed to occupant contact and passenger compartment intrusion. The entire windshield was fractured from impact forces. The side glass for the front right and front left doors disintegrated. The rear hatch came open. A number of interior components intruded as a result of the rollover². The greatest intrusion, 9.0 cm (3.5 in), occurred as the right roof rail was displaced vertically inward. The right A pillar moved vertically a distance of 7.0 cm (2.8 in). The right front windshield header moved vertically 1.0 cm (0.4 in). The left front A pillar, the left front roof rail and the left front roof area were visibly observed to have intruded vertically a small amount-somewhere in the 3.0-8.0 cm (1.1-3.1 in) range. There were bilateral knee contacts to the left lower knee bolster. There was scuffing to the left interior door and the glove compartment door. The upper half of the steering wheel rim was bent approximately 3.0 cm (1.1 in).

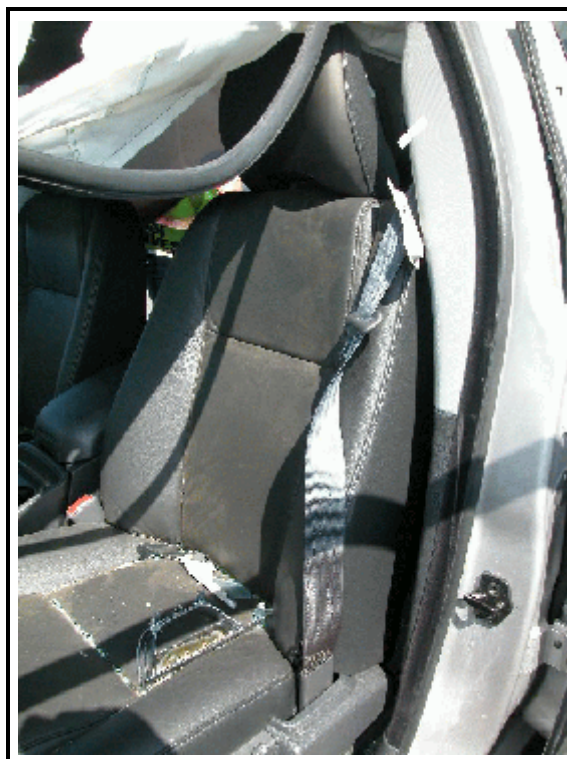
The Volvo XC90 was configured with manual 3-point lap and shoulder belts with sliding latch plates for both front positions and the rear outboard positions. The middle rear seat was configured with an integral lap and shoulder belt with a sliding latch plate and a belt positioning device. The driver's seat belt had an emergency locking retractor while all the other seat belts were equipped with switchable retractors. All the seat belts were also equipped with pretensioners and force limiters. The pretensioners at all seat positions actuated during the rollover. The driver's seat belt caused the cover of the automatic adjustable shoulder belt positioner to be dislodged. The cover of the shoulder belt positioner on the passenger side remained in place. The belt positioning guide for the rear middle seat was broken due to pretensioner movement. The rear left seat belt anchorage was not attached to the anchorage point at the time of the inspection. The reasons for this are unclear. There were no indications that the two components were forced apart.

Figure 7. Driver's seat belt

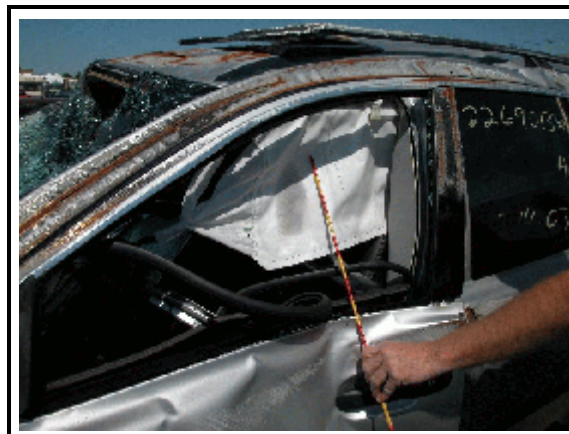
During the rollover sequence, both side curtains did deploy. The deployed left side curtain air bag was measured and found to be 150 cm (59.0 in) in length, and approximately 37.0 cm (14.6 in) in width. It had two tethers. The tether which was attached to the A pillar was found to be approximately 34.0 cm (13.4 in) in total length. The other tether, which was affixed to the area near the C pillar, was found to be approximately 33.0 cm (12.9 in) in length. Both the left and right side curtain air bags were identical. The curtain air bags descend vertically almost to the base of the side windows and extend longitudinally to provided coverage for both front and rear seat occupants.

The left side curtain came into contact with the roadway/ground after the side glass shattered. There was no damage noted to the air bag fabric from this ground contact.

Figure 11. Exterior view, left side air curtain

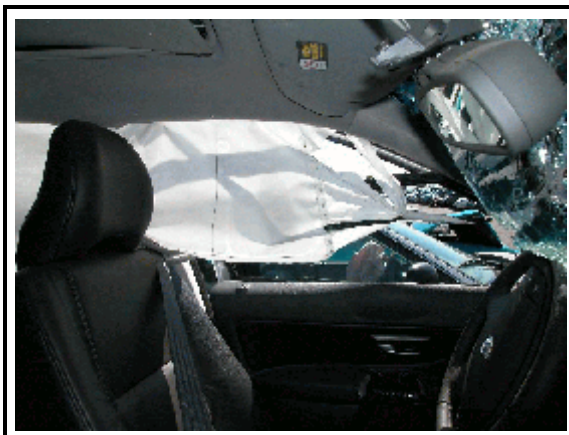
Figure 12. Interior view, left side curtain

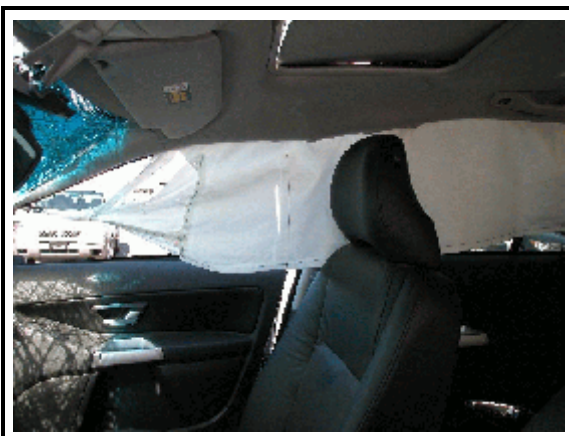
Figure 13. Interior view, right side air curtain

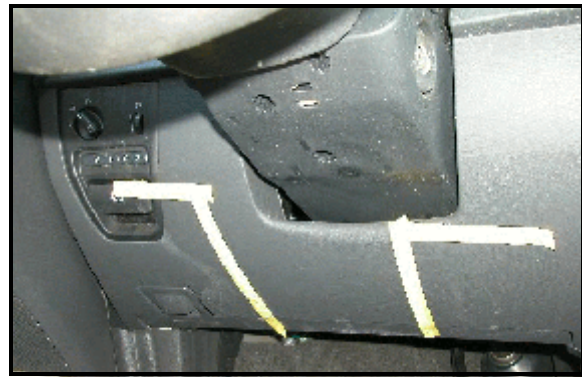
As a result of the initial impact, the case vehicle made a rapid clockwise rotation. Upon so doing, the vehicle began a lateral movement which resulted in the vehicle rolling to the left. Although the manual 3-point lap and shoulder belt safety systems prevented the driver from leaving her seating position, occupant contacts visible within the vehicle illustrate that she did strike the rigid knee bolsters with her lower extremities. She may have also struck her left shoulder on the door area, as there was an area of deformation noted in that region. The driver complained of hand lacerations, as well as neck and upper back pain. The hand lacerations were most likely due to coming into contact with flying glass as the side window and roof glazing disintegrated during the rollover.

Figure 15. Driver knee contacts
