ON-SITE CHILD SAFETY SEAT INVESTIGATION

CASE NUMBER - IN-03-001

VEHICLE - 1994 ACURA INTEGRA LS

CRASH DATE - November 2002

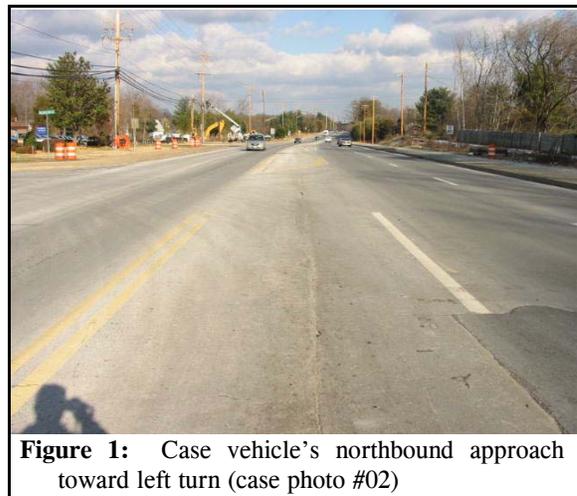
The case vehicle had been traveling north in the northbound left turn lane of a five-lane undivided state roadway, approaching an uncontrolled three-leg intersection, and was starting to make a left turn to travel west. The Chevrolet was traveling south in the outside southbound lane of the same roadway and intended to continue straight ahead. It was daylight with fog, there were no viewing obstructions and the asphalt road surface was worn but dry and free of defects. The speed limit was 56 km.p.h. [35 m.p.h.]. There were two northbound and two southbound through lanes, with a left turn lane for northbound traffic on the south leg of the intersection (**Figure 1**). The case vehicle driver did not attempt any avoidance maneuvers. The crash occurred within the intersection.

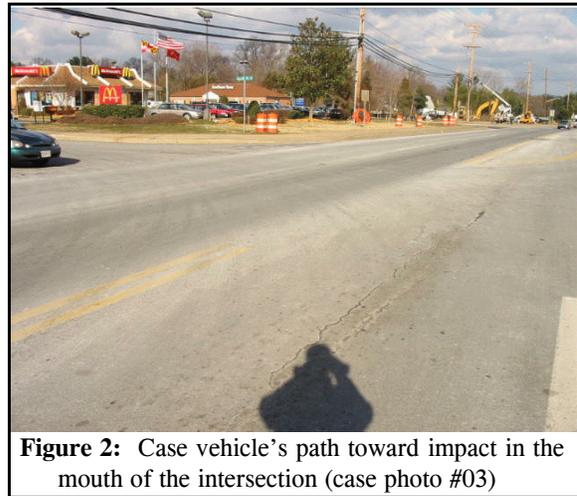
The front of the other vehicle impacted the right side of the case vehicle. The case vehicle was redirected toward the southwest, rotated a few degrees clockwise and come to rest a short distance southwest of the point of impact, heading a few degrees west of due north. The other vehicle rotated a few degrees clockwise and came to rest a short distance westward of the point of impact, heading a few degrees west of due south (Figure 2).

Figure 2: Case vehicle's path toward impact in the mouth of the intersection (case photo #03)

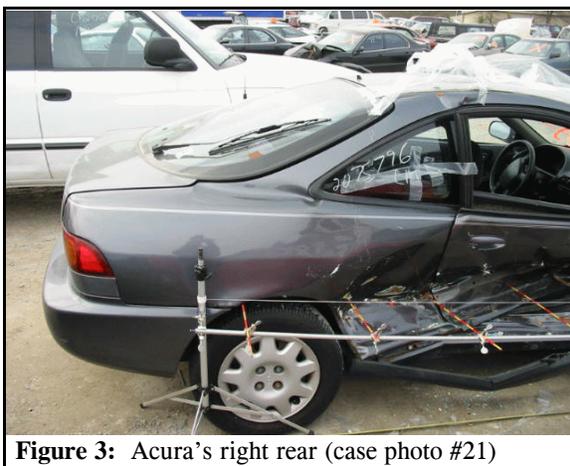
The Chevrolet contacted the case vehicle's right door, sill, and the side panel rearward of the front door (Figures 3 and 4). The right front door window glazing was shattered, the right side of the windshield was cracked and there was no other glazing damage. Direct damage began 31 centimeters [12.2 inches] forward of the right rear axle and extended 167 centimeters [65.7 inches] along the right side of the vehicle. Maximum crush was measured as 44 centimeters [17.3 inches] slightly forward of the center of the right door. The wheelbase on the case vehicle's left side was lengthened 2 centimeters [0.8 inches] while the right side was shortened 1 centimeter [0.4 inch]. The case vehicle's right door, sill, B-pillar and the side panel rearward of the door were

Figure 3: Acura's right rear (case photo #21)

crushed inward. There was slight buckling on the right side of the roof. None of the wheels or tires were damaged in the crash.

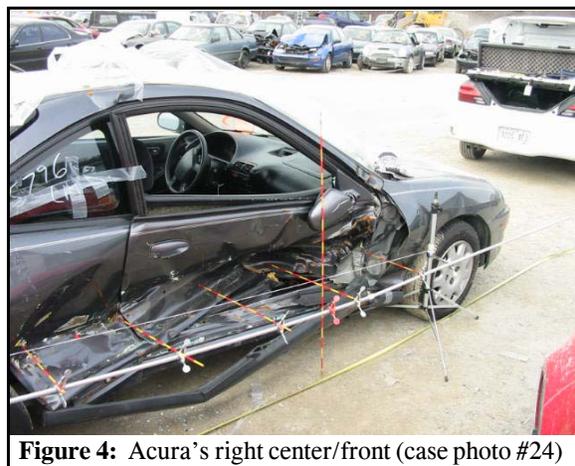
Figure 4: Acura's right center/front (case photo #24)

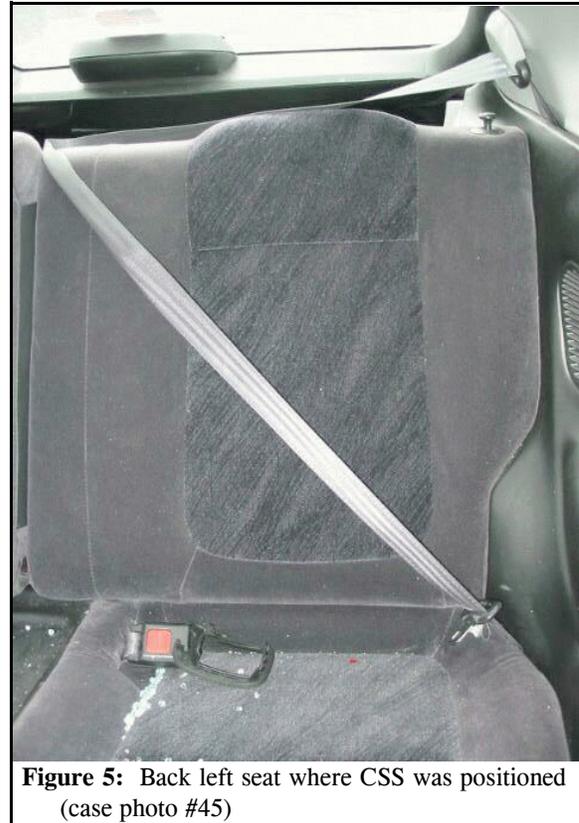
Figure 5: Back left seat where CSS was positioned (case photo #45)

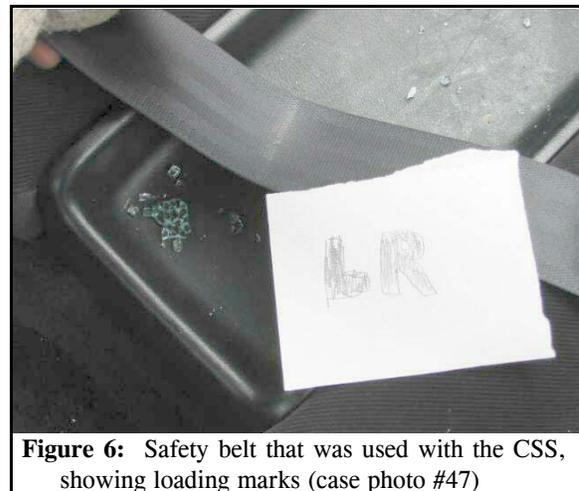
Inspection of the case vehicle's interior revealed lateral intrusion of the right door panel (37 centimeters [14.6 inches]), the right B-pillar (13 centimeters [5.1 inches]), and the side panel rearward of the B-pillar, which measured 20 centimeters [7.9 inches] immediately rearward of the B-pillar and tapered off to 0 at the C-pillar. There was a possible occupant contact to the right side panel, rearward of the B-pillar. The safety belt webbing at the driver's and back right seat positions showed evidence of use, but no evidence of loading from this side impact. The safety belt system at the back left position (**Figure 5**) showed loading marks (stretching/indentations) consistent with its having been used to secure the child safety seat (**Figure 6**).

Figure 6: Safety belt that was used with the CSS, showing loading marks (case photo #47)

shoulder straps and a harness retainer clip. The shoulder harnesses were threaded into the lower slots. The CSS was secured by the vehicle's three-point continuous loop safety belt, which had a sliding latch plate and an emergency locking retractor. There was evidence of loading on the safety belt, consisting of depressions in the webbing where the belt engaged the CSS frame (**Figure 6**). There were no loading marks on the CSS. The CSS did not have an integral tether and no aftermarket tether was added. The CSS had been removed from the case vehicle at the time of inspection, but, based on the interview with the driver and the available evidence, it appears that the child seat was installed and secured with the vehicle's safety belt routed through the CSS frame.

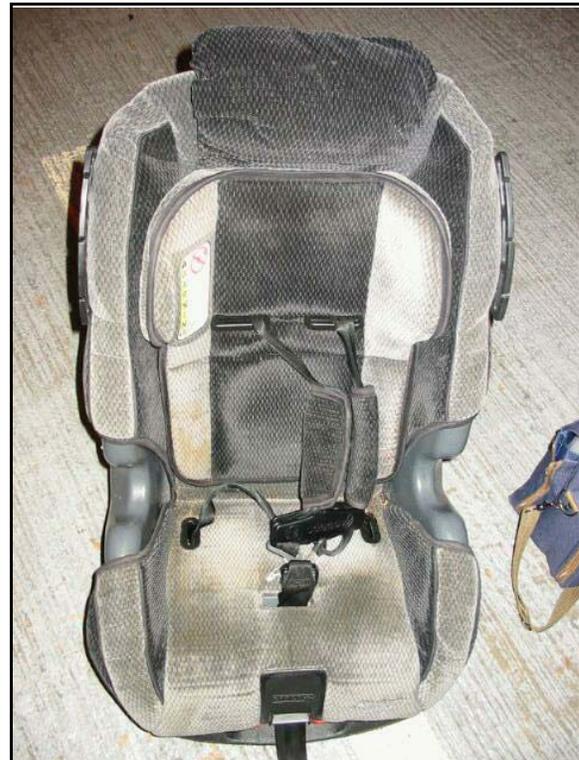
The case vehicle's back left passenger was seated in a forward facing convertible child safety seat (CSS). The CSS was identified as a Cosco "Alpha Omega" model #02 531 BNG, dated 12-08-00 (**Figures 7, 8 and 9**). The CSS label indicated that the seat was appropriate for children between 13.6 - 36.3 kilograms [30 - 80 pounds] in the forward-facing configuration. The seat was equipped with a five-point harness, with padded

Figure 7: CSS that was in the case vehicle's back left seat area (case photo #53)

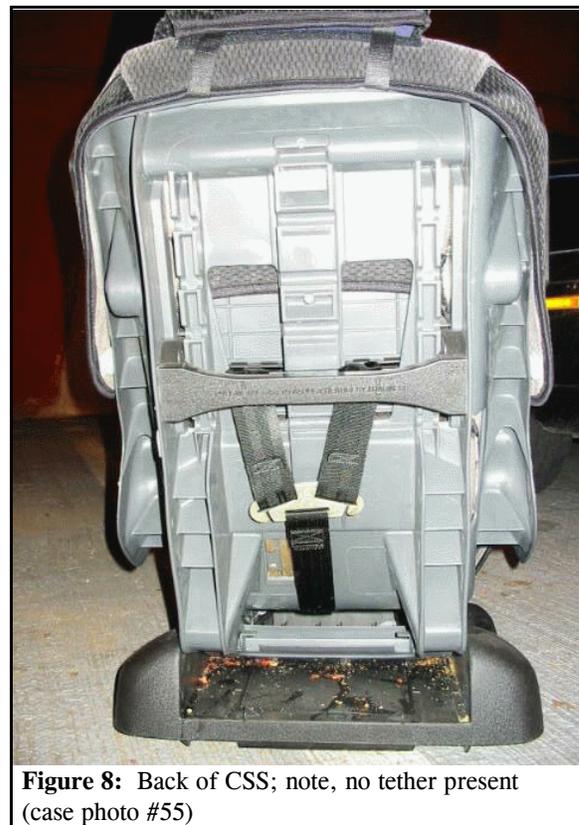
Figure 8: Back of CSS; note, no tether present (case photo #55)

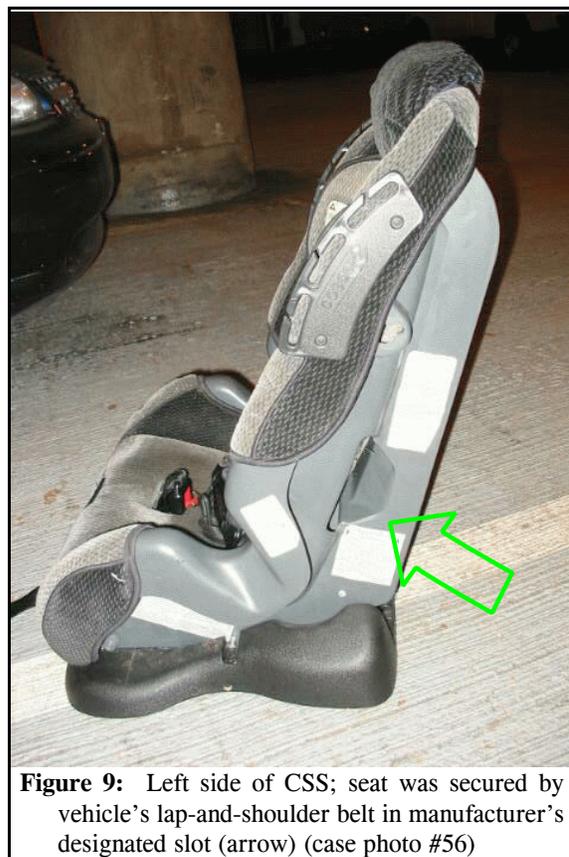
Figure 9: Left side of CSS; seat was secured by vehicle's lap-and-shoulder belt in manufacturer's designated slot (arrow) (case photo #56)
