**VERIDIAN ON-SITE AIR BAG RELATED CHILD FATALITY INVESTIGATION**

**VERIDIAN CASE NO. CA03-001**

**SUBJECT VEHICLE – 1996 DODGE GRAND CARAVAN**

**CRASH DATE – NOVEMBER 2002**

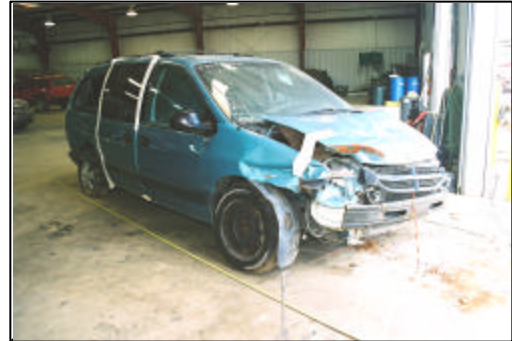
**Figure 1. Damaged 1996 Dodge Caravan**

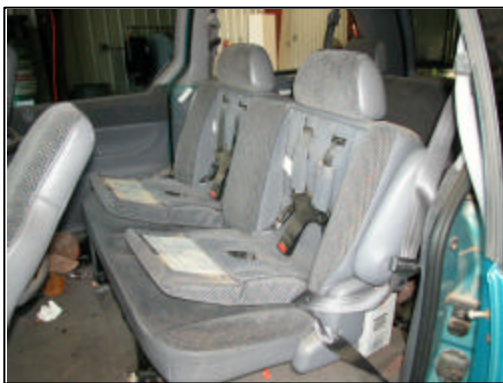
The second row was configured with a two-person bench seat with integrated CSS's and adjustable head restraints, which were in the full-down position. Inspection of the integrated CSS's (**Figures 5 and 6**) revealed little or no historical use, as significant dust/dirt buildup was present on the exposed aspects of the harness system and non-exposed webbing looked new in appearance. Neither of the CSS latch plates showed any abrasions suggestive of frequent use. The third row was configured with a three-person bench seat with adjustable head restraints for the outboard positions. A spare wheel/tire and a full-size wheel/tire were located in the cargo area. They were not secured at the time of the vehicle inspection.

Figure 5. Inegrated CSS's

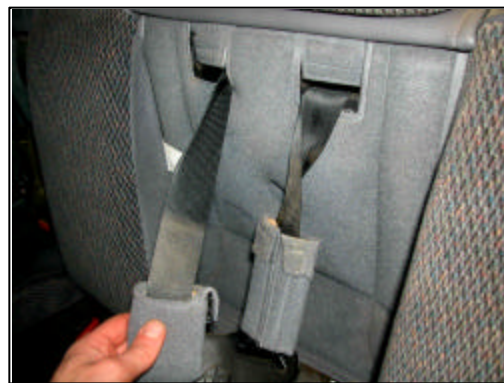
Figure 6. Close-up of straps showing color contrast/non-use

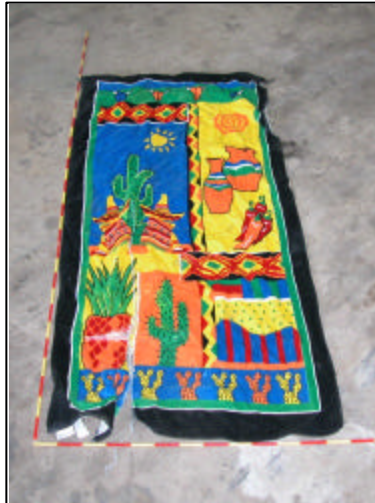
A brightly colored beach towel (**Figure 7**) was found in the vehicle during the inspection. The towel exhibited a large longitudinal tear and minor abrasions. Based on fabric transfers within the vehicle, it appears the towel was used in some capacity with the CSS in the front right position of the vehicle. The canopy for the CSS (**Figure 8**) was also found in the vehicle, separated from the CSS. The canopy did not exhibit damage.

**Figure 7. View of colored beach towel**

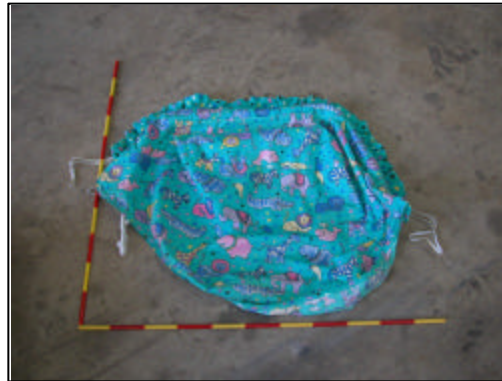
**Figure 8. CSS canopy**

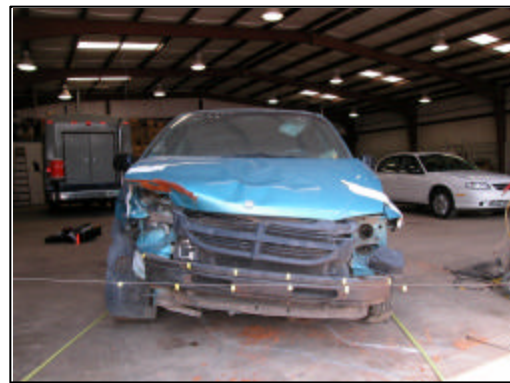
The 1996 Dodge Grand Caravan sustained moderate frontal damage as a result of the impact with the Pontiac Grand Am (**Figure 9**). The direct contact damage on the hood began 26.7 cm (10.5”) to the right of the centerline and extended 50.2 cm (19.8”) along the leading edge of the hood to the front right corner. The front right aspect of the hood was crushed rearward and abraded. The leading edge of the hood and leading aspect of the right front fender exhibited grey paint transfers from contact with the Grand Am. The right headlamp was fractured and the right aspect of the radiator was crushed rearward. The front bumper fascia was separated from the vehicle and was not available for inspection. The grille was displaced and the left headlamp was separated. The bumper beam was crushed rearward on the right side, which caused the displacement of the entire bumper beam. The left front fender was displaced rearward and outward at the forward aspect. The right front fender was crushed rearward and inward at the forward aspect. The frontal crush resulted in the reduction of the right wheelbase by 9.0 cm (3.5”). The hood was displaced slightly to the left. The combined direct and induced damage involved the entire frontal width of the Grand Caravan and measured 134.0 cm (52.8”) across the bumper beam. Six crush measurements were documented along the front bumper beam and were as follows: C1 = 4.4 cm (1.8”), C2 = 2.2 cm (0.9”), C3 = 3.2 cm (1.3”), C4 = 6.4 cm (2.5”), C5 = 11.7 cm (4.6”), C6 =

**Figure 9. Frontal damage to the 1996 Dodge Grand Caravan**

15.9 cm (6.3"). The Collision Deformation Classification (CDC) for the frontal impact with the Grand Am was 01-FREW-1.

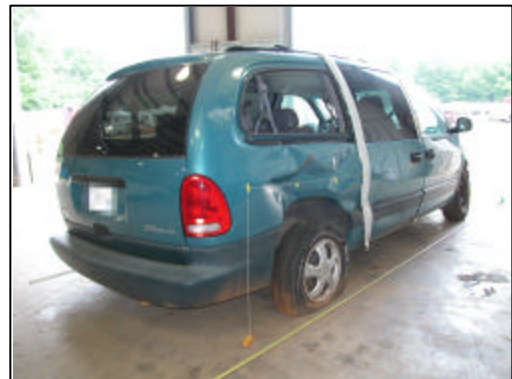
The Dodge Grand Caravan sustained moderate right rear side damage (**Figure 10**) as a result of the secondary sideslap impact with the Grand Am. The direct contact damage began 48.9 cm (19.3") rear of the right rear axle and measured 110.5 cm (43.5") forward along the right side plane of the vehicle. The maximum lateral crush measured 11.4 cm (2.5") and was located 27.5 cm (10.8") rear of the right rear axle. Direct contact abrasions were present on the right rear quarter panel and grey paint transfers were present on the right D-pillar, located 14.0 cm (5.5") above the beltline. The right rear wheel cover was abraded and the right rear tire exhibited a sidewall tear. Six crush measurements were documented along the right side plane and were as follows: C1 = 0.0 cm, C2 = 1.0 cm (0.4"), C3 = 2.9 cm (1.1"), C4 = 4.8 cm (1.9"), C5 = 8.3 cm (3.3"), C6 = 0.0 cm. The CDC for the sideslap impact was 03-RZEW-2.

**Figure 10. View of right rear side damage from the sideslap**

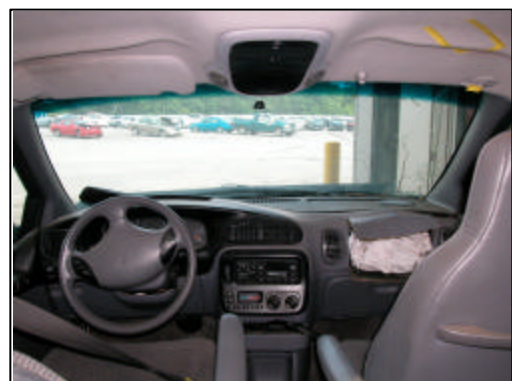
The 1996 Dodge Grand Caravan sustained minor interior damage as a result of the frontal impact (**Figure 11**). All of the doors on the vehicle were operational. The windshield sustained fractures on the right aspect from impact forces. The right rear glazing disintegrated from impact forces associated with the sideslap event. The steering column-mounted transmission selector arm was fractured from the column. It was not known if it was the result of occupant contact, although the steering column was not compressed. The right tow pan intruded longitudinally 4.4 cm (1.8"). The right rear side panel adjacent to the third bench seat intruded 3.2 cm (1.3") laterally. The plastic clip for the inboard aspect of the driver's sun visor was fractured. The rear-view mirror was separated. The plastic arm for the front right sun visor was fractured 6.0 cm

**Figure 11. View of front seating positions and contacts**

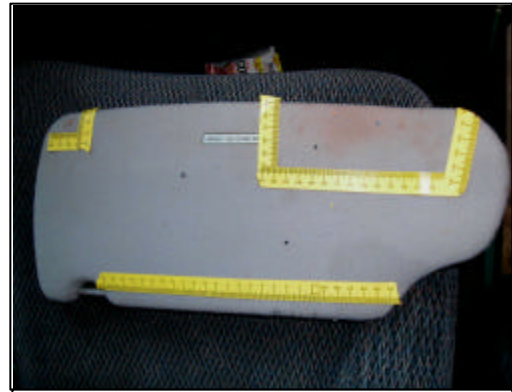
(2.3") inboard of the elbow. The sun visor was found on the front right floor during the vehicle inspection. The front right sun visor exhibited colored fabric transfers and fibers (**Figure 12**), consistent with the colored fabric of the beach towel that was present in the vehicle. The leading edge of the sun visor was also abraded from contact with the expanding front right passenger's air bag. A small amount of fluid spatter was noted on the headliner aft of the sun visor. The pattern of the spatter measured 6.4 cm (2.5") in width and 16.5 cm (6.5") in length. The source of the spatter was unknown, as the child passenger did not sustain any open soft-tissue injuries. Two dark linear scuffs were present on the headliner adjacent to the right B-pillar trim that measured 11.0 cm (4.3") in length and were spaced 7.0 cm (2.8") apart. The third seat back exhibited marks from the tires located in the cargo area, which struck the seat back during the frontal impact.

**Figure 12. View of damaged front right sun visor, fabric transfers, and fibers**

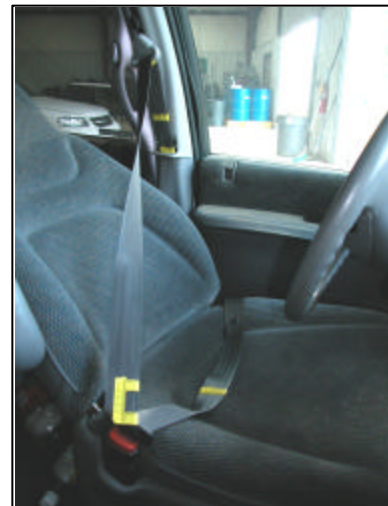
The 1996 Dodge Caravan was equipped with manual 3-point lap and shoulder belts for all outboard seating positions. Both front safety belts were designed with Emergency Locking Retractors (ELR's) and adjustable D-rings that were positioned in the full-down positions. The driver's restraint was configured with a sliding latch plate and front right restraint was configured with a cinching latch plate. The driver's safety belt webbing (**Figure 13**) exhibited minor stretching that began 78.1 cm (30.5") above the lower anchor and extended 27.9 cm (11.0"). A section of the inboard aspect of the webbing that measured 2.5 x 1.6 cm (1.0 x 0.6") was gathered in the latch plate at the top end of the stretched area. A plastic transfer was present on the inboard face of the webbing on the left B-pillar from engagement against the D-ring as the webbing was loaded by the driver. The driver's D-ring was moderately abraded from the loading of the webbing. The transfer measured 5.1 cm (2.0") in height and extended across the full-width of the webbing. The front right safety belt webbing exhibited minor stretching which began 81.3 cm (32.0") above the lower anchor and extended 38.1 cm (15.0"). There were no plastic transfers or abrasions on the webbing from the CSS.

**Figure 13. View of driver's safety belt**

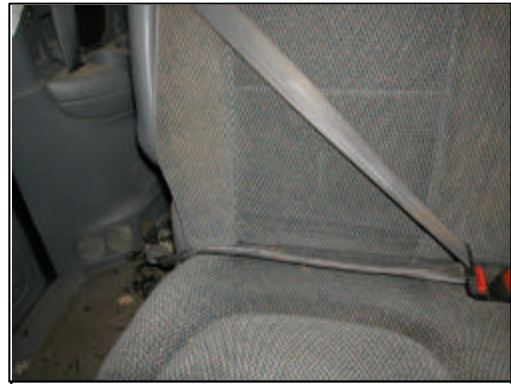
The second row bench seat was configured with manual 3-point lap and shoulder belts for both seating positions. Both safety belts were configured ELR's, cinching latch plates, and adjustable D-rings that were located in the full-down positions. The left safety belt showed latch plate abrasions consistent with historical use. The right safety belt was roped along the entire lap belt section (**Figure 14**). A total of eight complete twists were present in the webbing between the latch plate and the lower anchor. One half-twist was present between the latch plate and the D-ring, and one additional twist was present between the D-ring and the retractor. There was no loading evidence on the safety belt webbing, and the latch plate showed abrasions consistent with historical use.

**Figure 14. Close-up of roped lap belt**

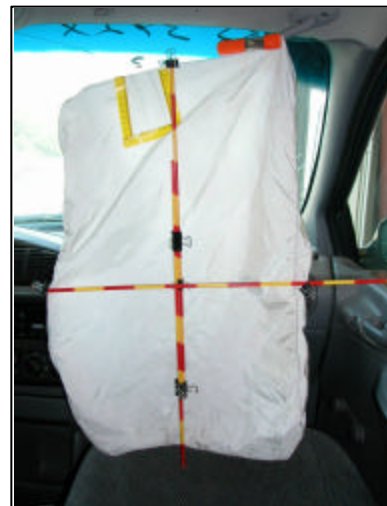
**Figure 15. Front right passenger's air bag**

The front right passenger's air bag (**Figure 15**) deployed as a result of the frontal impact with the 1990 Grand Am. The air bag deployed from a mid-mount module configured with vinyl cover flaps. The top flap measured 12.1 cm (4.8") in height and the bottom flap measured 6.4 cm (2.5") in height. The lateral tear seam measured 27.9 cm (11.0") in width. The air bag measured 66.0 cm (26.0") in height and 40.6 cm (16.0") in width in its deflated state. The horizontal distance from the face of the air bag

module cover flaps (instrument panel face) to the mid-point of the front right seat back measured 68.6 cm (27.0”).

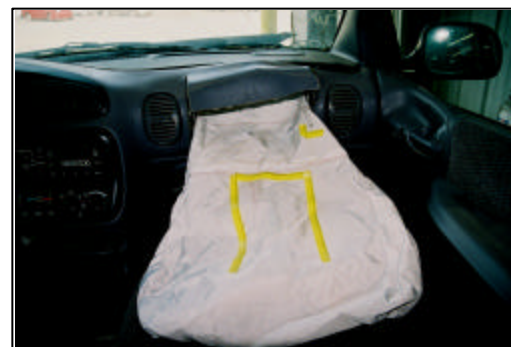
Multiple transfers were present on the air bag from interaction with the colored beach towel. An area of faint green/red fabric transfer (**Figure 19**) was present on the top aspect of the air bag. The transfer began at the forward seam on the top aspect of the air bag and was centered between the side aspects. The transfer area measured 24.1 cm (9.5”) in length and 10.2 cm (4.0”) in width. Faint diagonal abrasions were present on the outboard aspect of the transfer that may have resulted from interaction with the plastic shell of the CSS. The abrasions measured 11.0 cm (4.3”) in length and were located 16.5 cm (6.5”) inboard of the right side aspect of the air bag. A small tear in the air bag membrane was located 3.8 cm (1.5”) from the right side aspect and 10.2 cm (4.0”) from the air bag module. The tear measured 1.3 cm (0.5”) in length and resulted from snagging the bottom right corner of the top cover flap as the air bag deployed against the CSS.

**Figure 19.** View of top of front right passenger air bag showing area of transfers and membrane tear

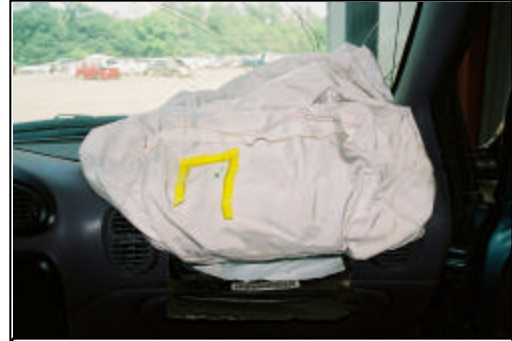
Green fabric fibers from the beach towel were present on the rear bottom left corner of the air bag (**Figure 20**). They were located 7.0 cm (2.8”) forward of the bottom seam and 11.4 cm (4.5”) inboard of the left side aspect.

**Figure 20. View of green fabric fibers on bottom aspect of the air bag**
