INDIANA UNIVERSITY

TRANSPORTATION RESEARCH CENTER

ON-SITE ADVANCED OCCUPANT PROTECTION SYSTEM INVESTIGATION

CASE NUMBER - IN-03-003
LOCATION - Texas
VEHICLE - 2002 FORD WINDSTAR
CRASH DATE - November 2002

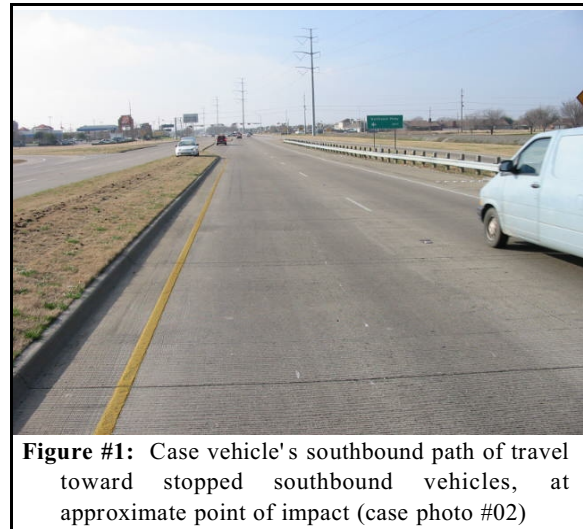
The case vehicle was traveling south in the inside southbound lane of a two-lane, one-way roadway that was part of a divided trafficway and intended to continue straight ahead (i.e., both the north and southbound roadways had two through lanes, separated by a curbed, grass median). The Chevrolet Avalanche, the Dodge and the Chevrolet Blazer were all stopped due to congested traffic, heading south in the same lane of the same roadway. There were no adverse weather conditions and it was dark and not lighted. The speed limit was 80 km.p.h. [50 m.p.h.], the concrete road surface was straight, level, dry and there were no roadway defects. The case vehicle's driver made no avoidance maneuvers prior to the crash. The crash occurred in the inside southbound through lane of the roadway (**Figure 1**).

Figure #1: Case vehicle's southbound path of travel toward stopped southbound vehicles, at approximate point of impact (case photo #02)

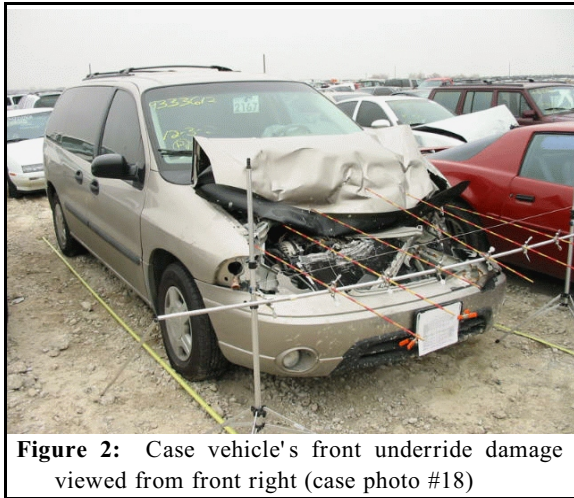
The case vehicle's contact with the Avalanche involved the front plane, mostly above the front bumper, resulting in a classic front underride damage configuration (**Figures 2 and 3**). Direct damage extended across the entire front plane except the rightmost portion of the right fender, above the bumper, a measured distance of 153 centimeters [60.2 inches]. Crush measurements were taken on the front bumper and on the upper radiator support. Maximum crush was measured as 49 centimeters [19.3 inches] at C4, near the center on the leading edge of the hood. The wheelbase on the case vehicle's left side was shortened 2 centimeters [0.8 inches] while the right side was lengthened 1 centimeter [0.4 inches]. The case vehicle's front bumper and

bumper fascia were only slightly contacted but the grille, hood, radiator, and other engine components were directly damaged and crushed rearward. None of the case vehicle's tires were physically restricted or deflated. There was minor cracking along the base of the windshield and no other glazing damage. Both the right and left headlight and turn signal assemblies were shattered and crushed rearward. The leading edge of the left fender was crushed rearward, but the right fender had only very minor deformation.

Figure 2: Case vehicle's front underride damage viewed from front right (case photo #18)

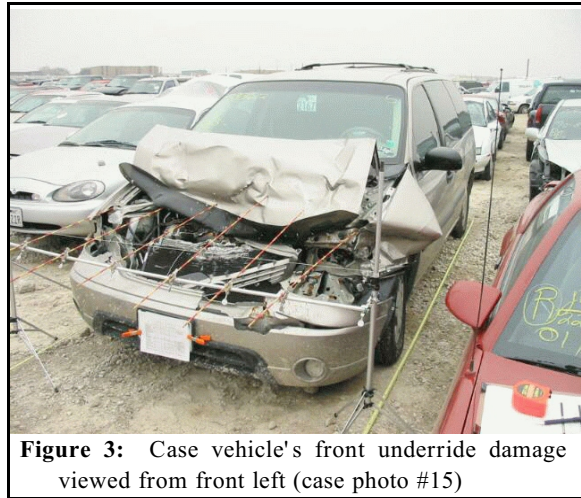
Figure 3: Case vehicle's front underride damage viewed from front left (case photo #15)

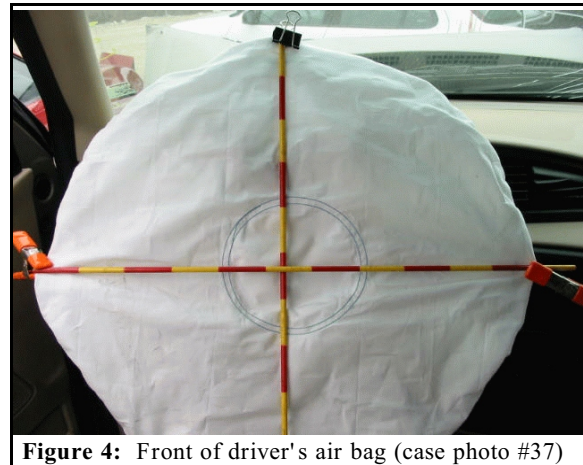
The case vehicle's driver air bag was located in the steering wheel hub. An inspection of the air bag module's cover flaps and air bag revealed that the cover flaps opened at the designated tear points, and there was no evidence of damage during the deployment to the air bag or the cover flaps. The deployed driver's air bag was round with a diameter of 57 centimeters [22.4 inches] (**Figure 4**). The driver's air bag was designed with two tethers, each 12 centimeters [4.7 inches] wide, and had two vent ports, approximately 3.5 centimeters [1.4 inches] in diameter, located at the 11 and 1 o'clock positions. There were routine deployment scuffs but no contact evidence.

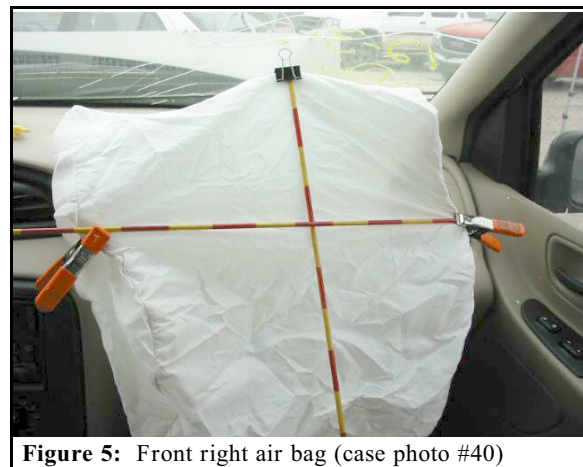
The front right passenger's air bag was located in the top of the instrument panel. An inspection of the module's cover flap and air bag revealed that the cover flap opened at the designated tear points, and there was no evidence of damage during the deployment to the air bag or the cover flap. The deployed front right air bag was rectangular with a height of approximately 58 centimeters [22.8 inches] and a width of approximately 48 centimeters [18.9 inches] (**Figure 5**). The front right passenger's air bag was

designed without any tethers and had one vent port, approximately 3 centimeters [1.2 inches] in diameter, located at the 9:30 o'clock position. There was no contact evidence on the air bag.

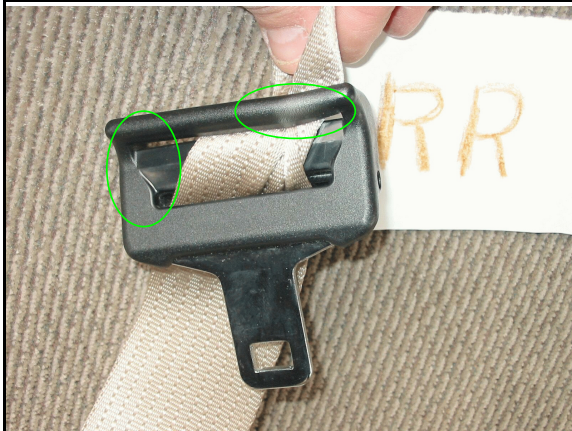
The second row right safety belt latch plate showed evidence of damage beyond basic loading stress. The safety belt system was fitted with a light weight locking/cinching latch plate. The guide bar was visibly deformed and the plastic casing was stressed. The cinch bar was manufactured with a convex profile, but one end of the cinch bar was partially torn from its

housing and had been deformed into a concave profile. At the time of the inspection, the belt webbing was found folded and creased where it passed through the latch plate (**Figures 6 and 7**).

Figure 6: Top of second row right safety belt latch plate; note, guide bar deformed (right) and cinch bar torn and deformed (left) (case photo #44)

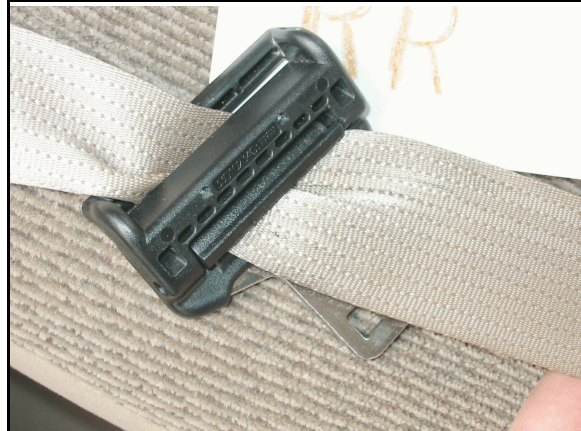
Figure 7: Bottom of second row right safety belt latch plate (case photo #45)

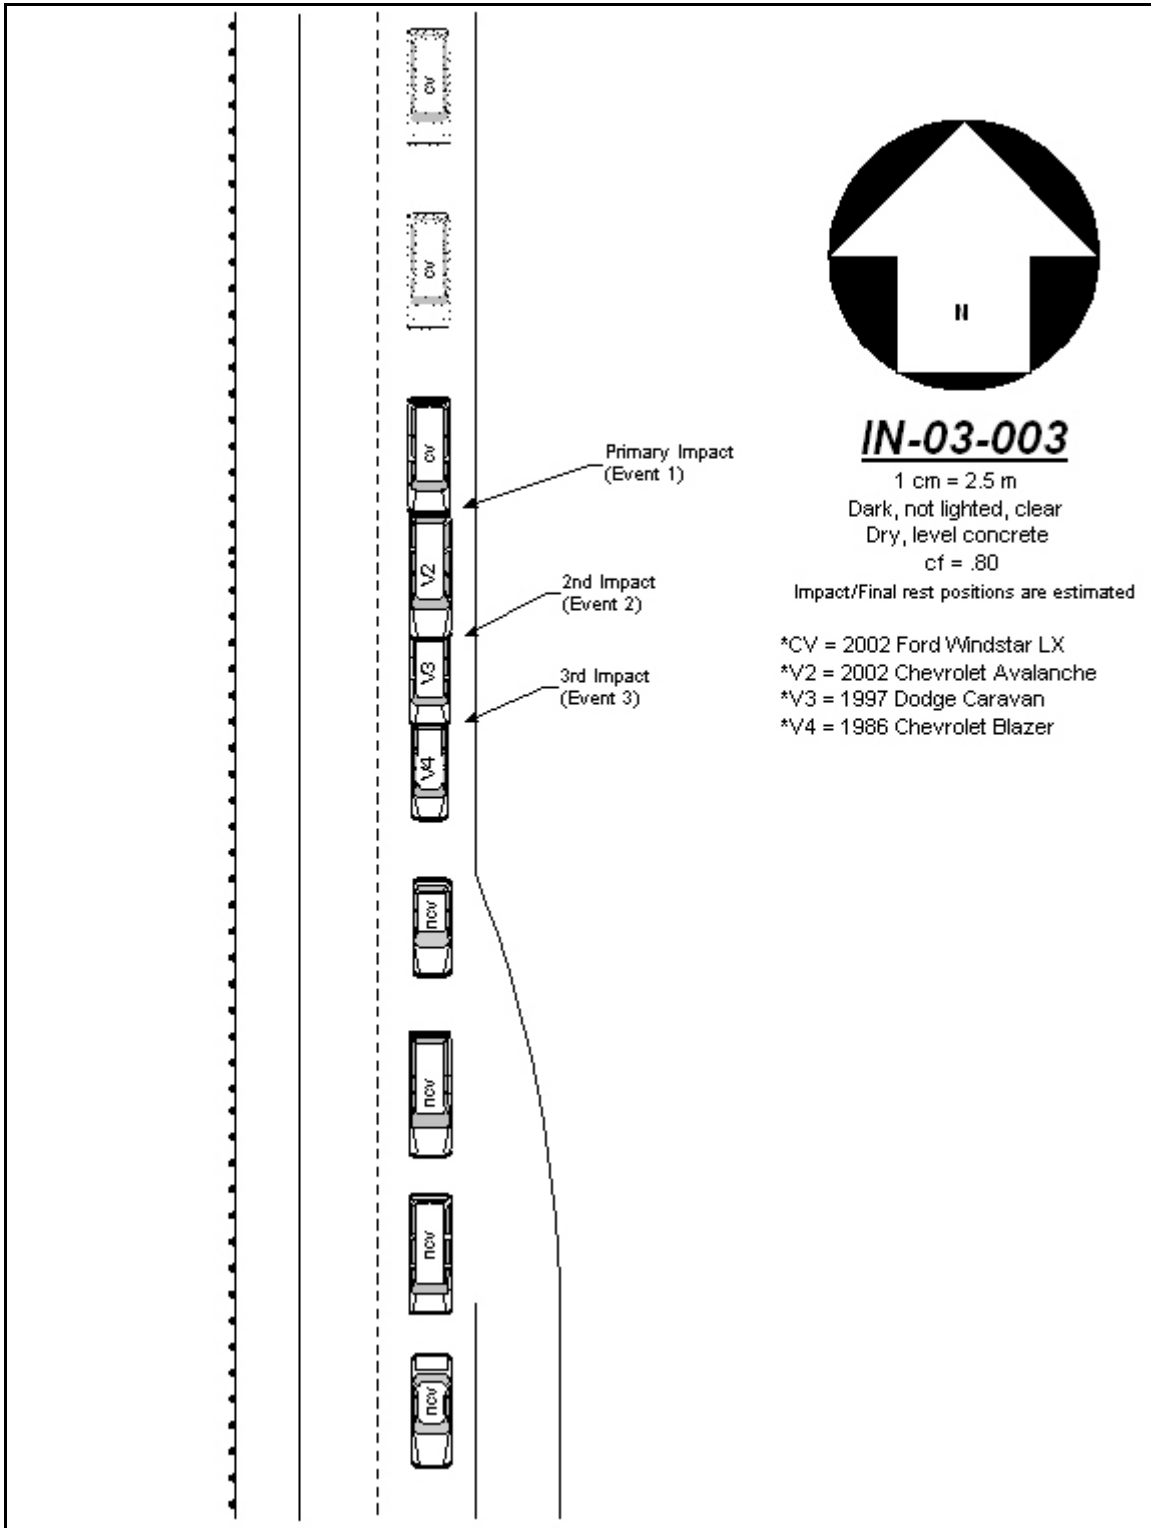
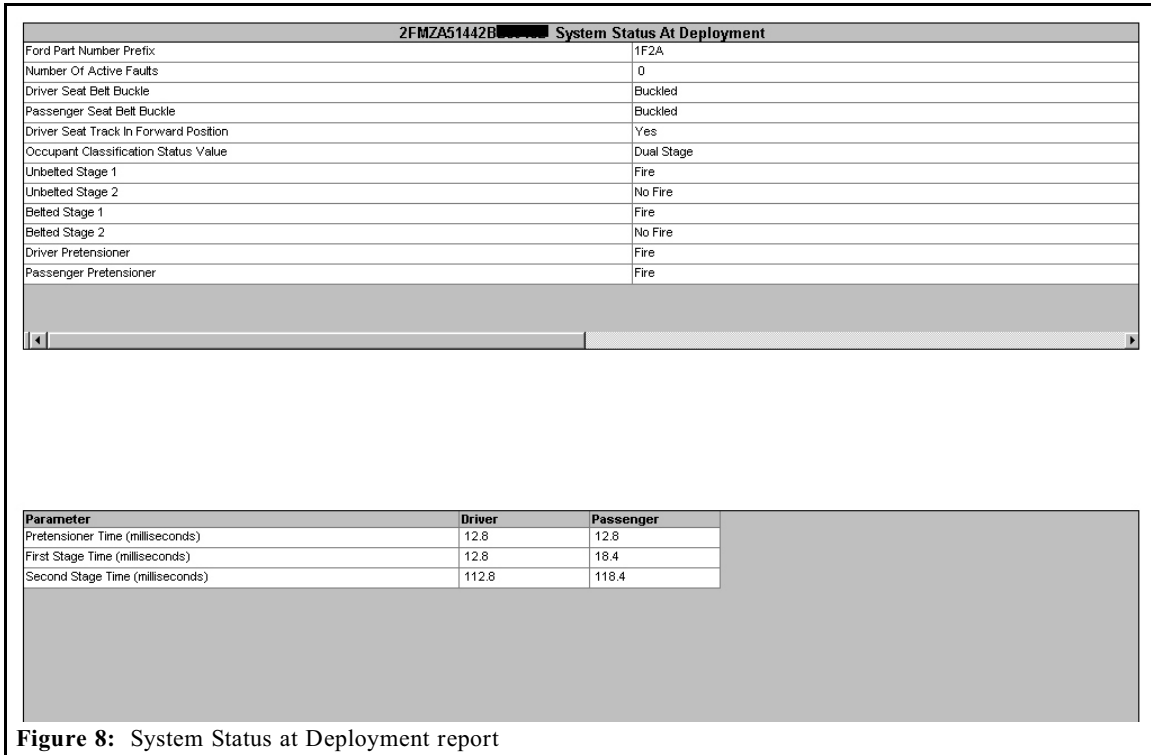
Figure 8: System Status at Deployment report

The case vehicle's EDR was harvested and forwarded to the NHTSA to be downloaded. The Restraints Control Module (RCM) reports are included as **Figures 8** and **9**. The System Status at Deployment report (**Figure 8**) indicates that there were no faults in the automatic restraint circuitry and the air bags were a dual stage system. The driver and front right passenger seat belts are reported as buckled, with the driver's seat reported in the forward position. The driver and front right passenger pretensioners were commanded to actuate at 12.8 milliseconds [0.0128 seconds] after algorithm enable. First stage deployment of the driver's air bag was commanded at 12.8 milliseconds [0.0128 seconds] and first stage deployment of the passenger's air bag was commanded at 18.4 milliseconds [0.0184 seconds]. The second stage deployment was not commanded for either air bag and the second stage charges were disposed at 112.8 milliseconds [0.1128 seconds] (driver) and 118.4 milliseconds [0.1184 seconds] (passenger).

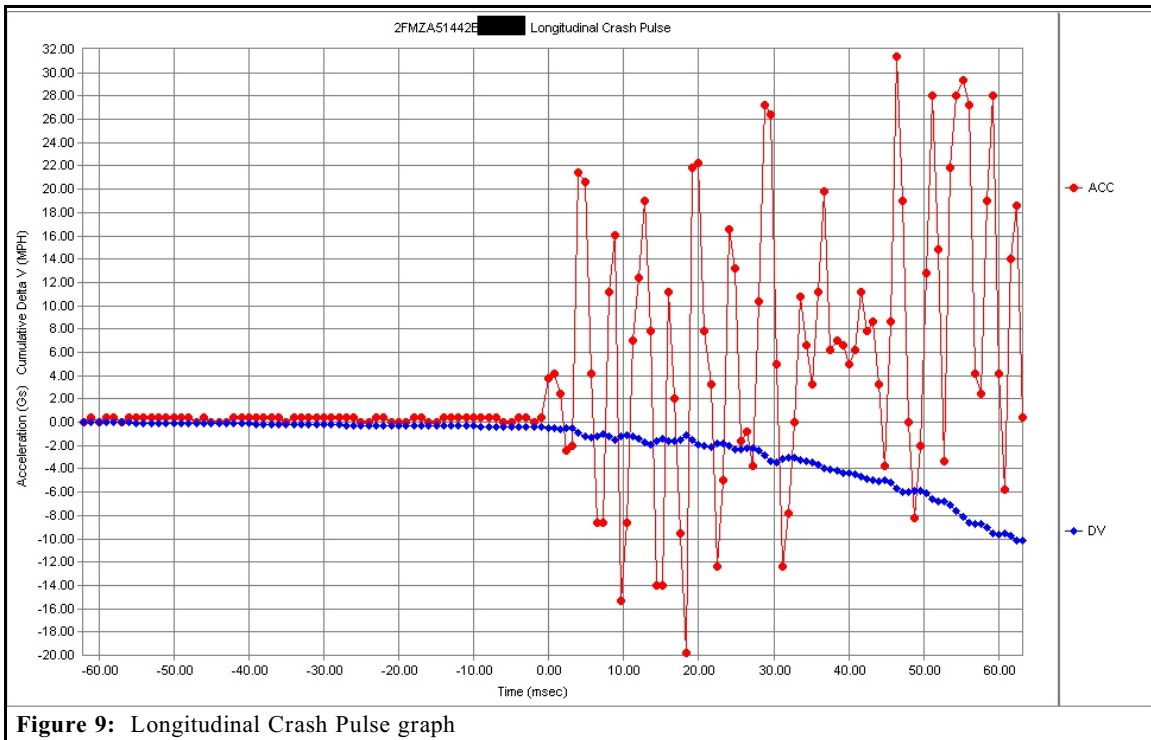
Figure 9: Longitudinal Crash Pulse graph

The Longitudinal Crash Pulse Graph (**Figure 9**) shows longitudinal delta V as a gradual slope (rather than a spike), with the maximum recorded value -16.3 km.p.h. [-10.12 m.p.h.] at 63.2 milliseconds after algorithm enable. The recording stopped at this data point, but this probably reflects a power interruption and the crash pulse recording is probably incomplete.
