TRANSPORTATION RESEARCH CENTER

ON-SITE ADVANCED OCCUPANT PROTECTION SYSTEM INVESTIGATION

CASE NUMBER - IN-03-004
LOCATION - TEXAS
VEHICLE - 2003 NISSAN ALTIMA S
CRASH DATE - December 2002

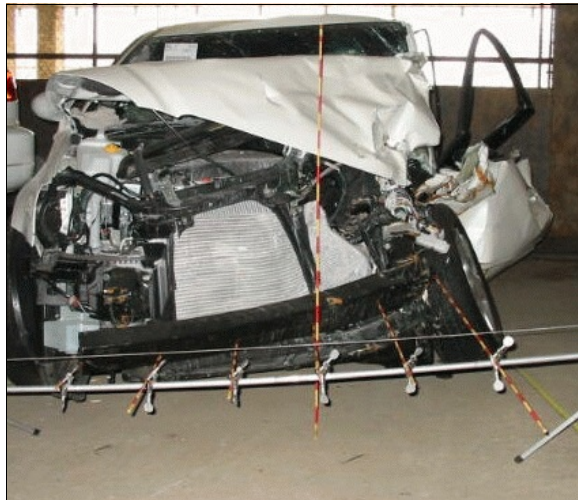
Figure 5: Case vehicle's frontal damage from impacts with GMC pickup and Ford SUV; Note: contour gauge positioned along bumper reinforcement bar (case photo #15)

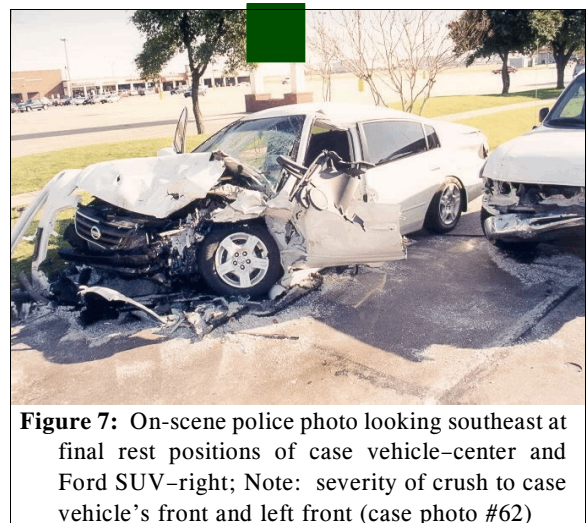
Figure 7: On-scene police photo looking southeast at final rest positions of case vehicle—center and Ford SUV—right; Note: severity of crush to case vehicle's front and left front (case photo #62)

lane (Figure 9). It is this contractor's opinion that the front (Figure 10) of the GMC pickup (2nd event) impacted the case vehicle's front and left sides (Figure 7 above) and that the GMC was in sustained contact with and being pushed south-southeasterly by the Ford. It is unclear whether the Ford and GMC had exactly the same heading angle or whether the GMC's heading angle was slightly clockwise relative to the Ford's. In this contractor's opinion, the GMC was redirected along the case vehicle's left fender, eventually separating from the case vehicle as it continued southward. Next, the front left of the case vehicle was impacted (3rd event) by the front of the Ford (Figure 11). The case vehicle's driver and front right supplemental restraints (air bags) deployed, most likely as a result of the impact with the GMC.

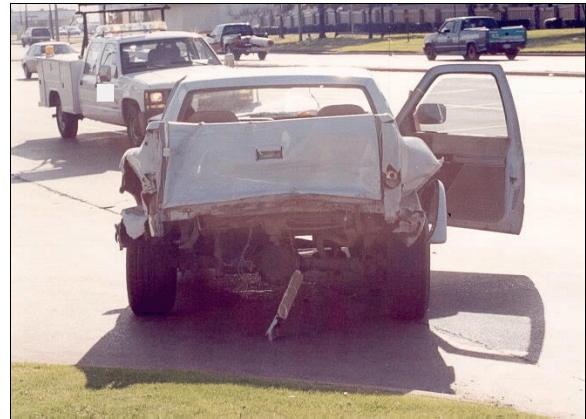
Figure 8: On-scene police photo looking southwest at GMC pickup's back damage from sustained contact impact by Ford SUV; Note: crease line across tailgate of pickup corresponds with Ford's hood deformation (case photo #70)

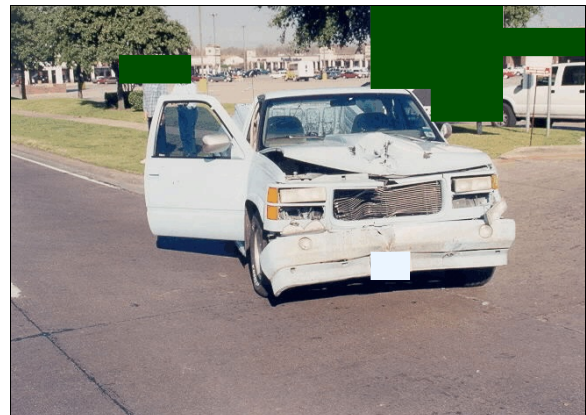
Figure 10: On-scene police photo looking northeast at GMC pickup's final rest position in junction of driveway and outside through lane of northbound roadway; Note: pickup's frontal damage from impact with case vehicle (case photo #69)

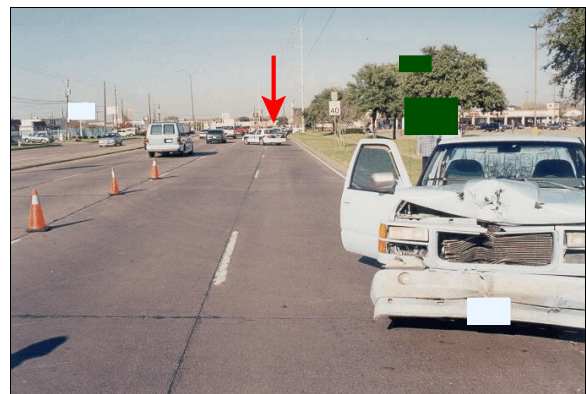
Figure 15: On-scene police photo looking north in the outside through lane of the northbound roadway showing final rest position of GMC pickup, frontal damage, and rest positions (arrow in background) of case vehicle and Ford (case photo #68)

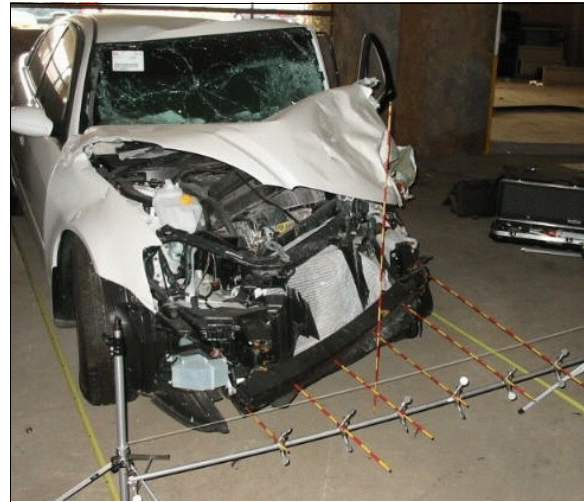
Figure 16: Elevated view of case vehicle's frontal damage viewed from right of front with contour gauge positioned along bumper reinforcement bar (case photo #14)

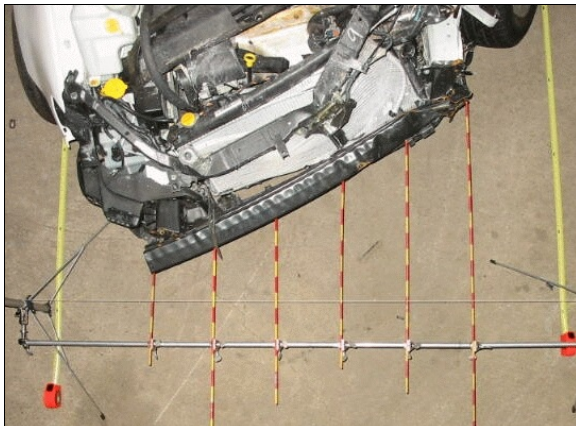
Figure 17: Overhead view of case vehicle's frontal damage with contour gauge position along bumper reinforcement bar; Note: greatest crush at front left bumper corner (case photo #16)

Exterior Damage: The case vehicle's initial contact with the GMC and the Ford involved primarily the front left half. The exact location of the direct damage cannot be determined because the case vehicle's bumper fascia was not present at the time of our inspection (**Figure 16**). Direct and induced damage occurred to the entire front bumper which measured 103 centimeters (40.6 inches) in length. Maximum crush was measured as 64 centimeters (25.2 inches) at C_1 (**Figure 17**). The case vehicle's side slap contact—most likely with the Ford, involved primarily the left quarter panel (**Figure 18**). Direct damage began 32 centimeters (12.6 inches) forward of the left rear axle and extended, a measured distance of 119 centimeters (46.9 inches), along the left quarter panel toward the left rear bumper corner. Residual maximum crush was measured as 14 centimeters (5.5 inches) at C_2 (**Figure 19** below). The table below shows the case vehicle's crush profile.

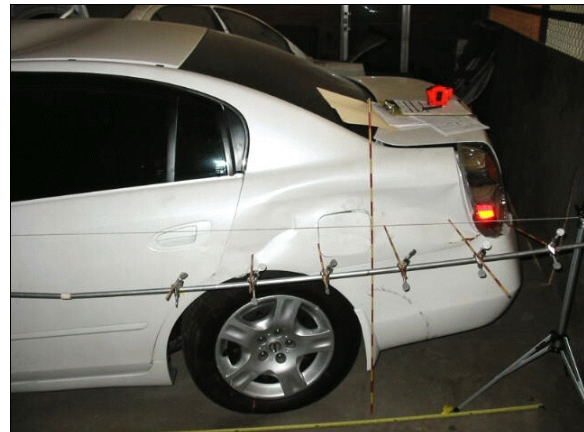
Figure 18: Elevated view of damage to case vehicle's left quarter panel with contour gauge positioned above mid-door level (case photo #22)

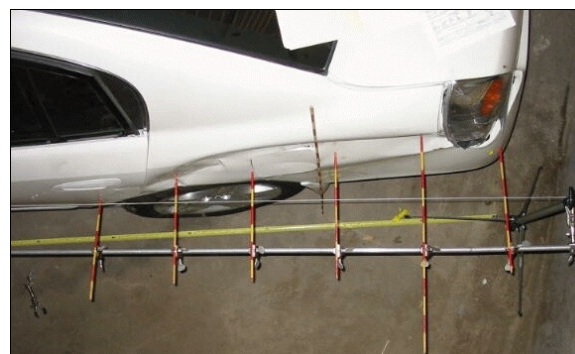
The wheelbase on the case vehicle’s left side was shortened 27 centimeters (10.6 inches) while the right side was extended 6 centimeters (2.4 inches). The case vehicle’s front bumper fascia, bumper, grille, hood, radiator, right and left headlight and turn signal assemblies, left fender, left front wheel assembly, and left “A”-pillar were directly damaged and crushed rearward (Figures 5, 7, 11, and 16 above). The left fender and left front door were directly damaged and crushed inward (Figure 18 above and Figure 19). Both the right and left fenders sustained induced damage as well as the case vehicle’s windshield and left “A”-pillar. No obvious induced damage or remote buckling was noted to the remainder of the case vehicle’s exterior.

Figure 19: Overhead view of damage to case vehicle’s left quarter panel; Note: maximum crush at C₂ (case photo #24)

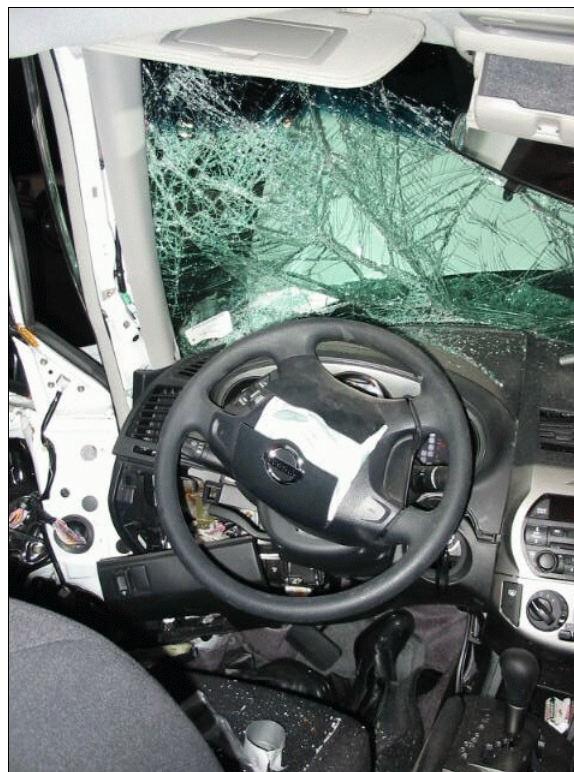
Vehicle Interior: Inspection of the case vehicle’s interior revealed significant intrusion into the driver’s seating area (**Figures 20** and **21** below). Specifically, the left “A”-pillar was intruded approximately 30 centimeters (11.8 inches) rearward while the left and center instrument panels were intruded both rearward (longitudinally) and rightward (laterally) from the collisions with the GMC and Ford. The left instrument panel moved approximately 6 centimeters (2.4 inches) laterally and the center instrument panel moved approximately 3 centimeters (1.2 inches) laterally (**Figure 22** below). In addition, the left side panel, forward of the left “A”-pillar, was pushed inward (i.e., laterally) approximately 12 centimeters (4.7 inches). There was obvious contact evidence to the left side of the driver’s knee bolster, most likely from the driver’s left knee area (**Figure 23** below). On the other hand, there was no evidence of occupant contact to the front right passenger area. In addition, the steering wheel was jammed forward against the intruding left instrument panel. Finally, the steering column compression could not be determined because of the severity of longitudinal and lateral intrusions.

Figure 20: Vertical view of case vehicle’s driver seating area showing deployed driver air bag, deformation to left instrument panel area, and occupant contact evidence to left side of driver’s knee bolster (case photo #33)

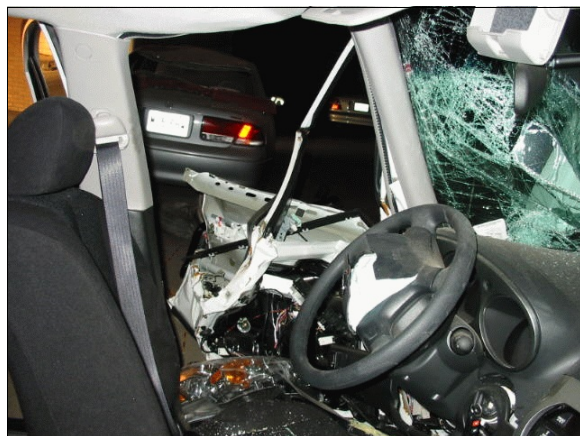
Figure 21: Case vehicle’s driver seating area showing intrusion to occupant space from left “A”-pillar and left and middle instrument panels (case photo #32)

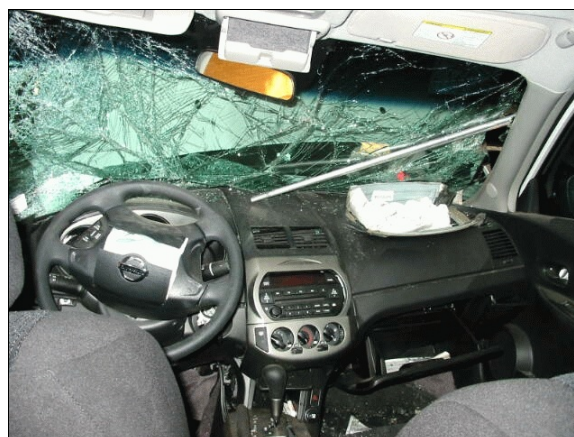
Figure 22: Case vehicle’s front right passenger seating area showing deployed front right air bag, lateral (toward the right) movement of center instrument panel, and no apparent evidence of occupant contact (case photo #37)

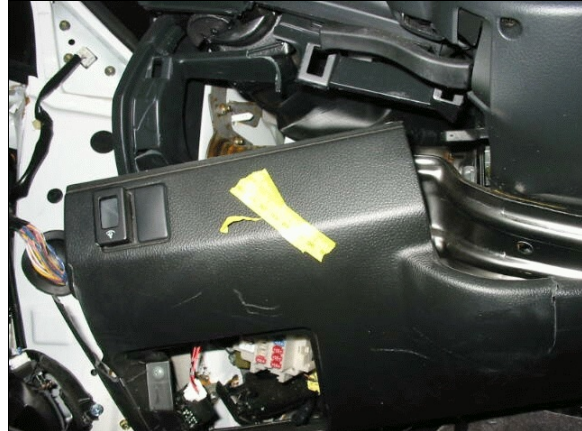
Figure 23: Close-up of occupant contact evidence on left side of case vehicle's driver knee bolster (case photo #34)

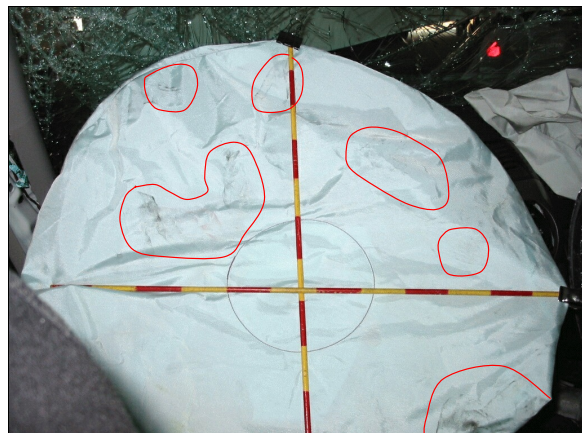
Figure 24: Case vehicle's deployed driver air bag showing scuff evidence (arrows) on air bag's fabric most likely from interaction with case vehicle's driver; Note: air bag rotated approximately 180 degrees—12 o'clock position is at bottom of photo (case photo #47)

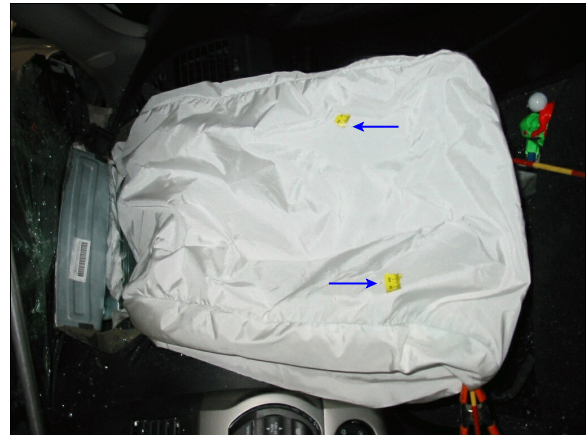
Figure 25: Top surface of case vehicle's deployed front right air bag showing small holes in air bag's fabric, possibly from contact with cracked right windshield's glazing (case photo #51)

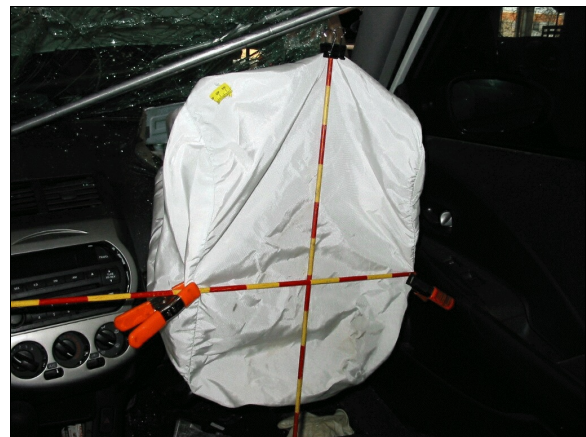
The front right passenger's air bag was located in the top of the instrument panel. There were two asymmetrical, "H"-configuration, modular cover flaps made of a thick vinyl over a sheet metal frame/liner which acted as the hinge point for the deploying flaps. The flap's dimensions were: 30 centimeters (11.8 inches) at the top horizontal seam, 33 centimeters (13.0 inches) at the bottom horizontal seam, 9 centimeters (3.5 inches) vertically for the upper flap, and 8 centimeters (3.1 inches) vertically for the lower flap. The distance between the mid-center of the front right seat back, as positioned at the time of the vehicle inspection, and the front surface of the air bag's fabric at full excursion was 36 centimeters (14.2 inches). An inspection of the front right air bag module's cover flap and the air bag's fabric revealed that the cover flap opened at the designated tear points, and there was no evidence of damage during the deployment to the air bag or the cover flap. The front right passenger's air bag was designed without any tethers. The front right air bag had two vent ports, approximately 3 centimeters (1.2 inches) in diameter, located at the 9 and 3 o'clock positions. The deployed front right air bag was rectangular with a height of approximately 51 centimeters (20.1 inches) and a width of approximately 38 centimeters (15.0 inches). An inspection of the front right passenger's air bag fabric revealed two small holes on the top surface of the air bag near the beginning of the front surface (**Figure 25**). Specifically, there was a small hole located 5 centimeters (2.0 inches) from the left surface and 0.8 centimeters (0.3 inches) from the front surface. A second small hole was located 8 centimeters (3.1 inches) from the right surface and 10 centimeters (3.9 inches) from the front surface. It is believed that these holes resulted from contact by shards of flying glass. The air bag's front surface showed no obvious contact evidence on the front right air bag's fabric (**Figure 26**).

Figure 26: Front surface of case vehicle's deployed front right air bag showing no apparent evidence of occupant contact (case photo #55)

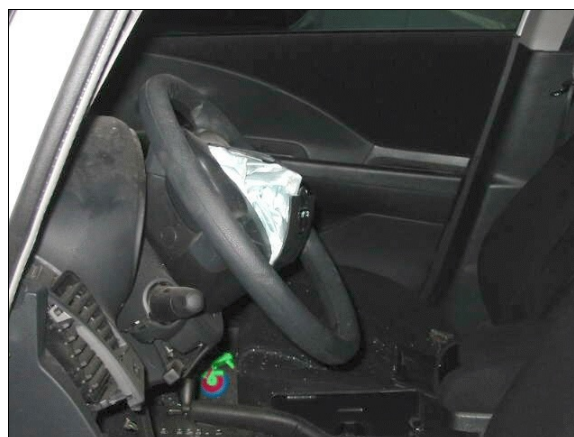
to the crash is unknown. The driver was most likely was seated in a reclined posture with her back against the seat back, her left foot on the floor, her right foot on the accelerator, and at least one hand on the steering wheel. Based on the vehicle inspection, her seat track was located in its rearmost position and the seat back was slightly reclined. Based on the driver's stature, it unlikely that she was sitting in the rearmost position at the time of the crash. Based on this contractor's experience, the driver's seat was most likely positioned near its middle seat track position and was moved post-crash for extrication purposes. The case vehicle was equipped with both a tilt and a telescoping steering column, but their pre-crash positions could not be determined because the steering wheel was jammed against the left instrument panel (**Figure 27**).

Figure 27: Case vehicle's tilt and telescoping column jammed against instrument panel; Note: no steering wheel rim deformation (case photo #28)

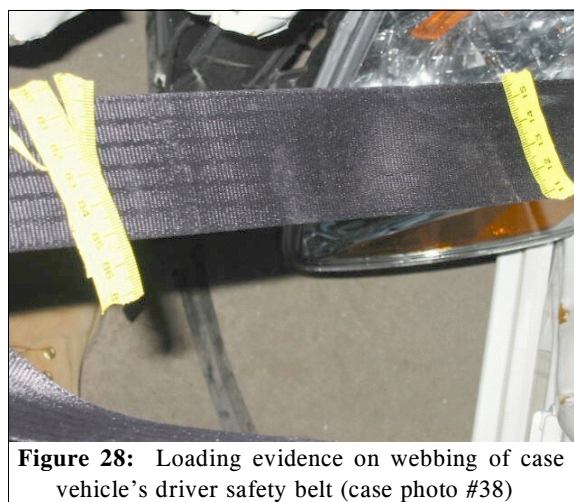
Based on this contractor's vehicle inspection and supported by her medical records, the case vehicle's driver was restrained by her available, active, three-point, lap-and-shoulder, safety belt system; the belt system was equipped with a retractor-mounted pretensioner with force limiters, housed within the "B"-pillar. Furthermore, there was medical evidence of belt pattern bruising and/or abrasions to the driver's torso, and the inspection of the driver's seat belt webbing, "D"-ring, and latch plate revealed that the pretensioner had actuated. In addition, there was evidence of loading on the belt's webbing (**Figure 28**).

Figure 28: Loading evidence on webbing of case vehicle's driver safety belt (case photo #38)

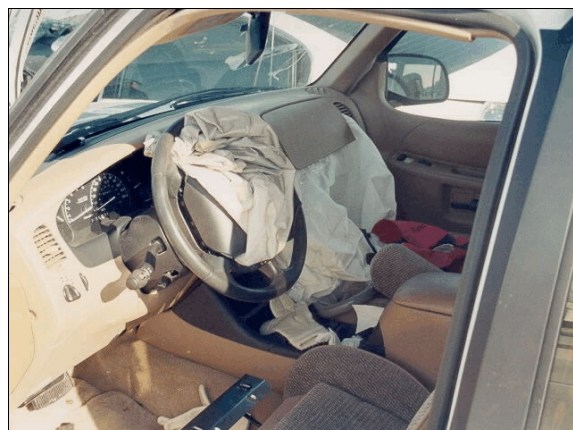
Figure 29: On-scene police photo showing Ford SUV's front seating area and deployed driver and front right passenger air bags (case photo #64)

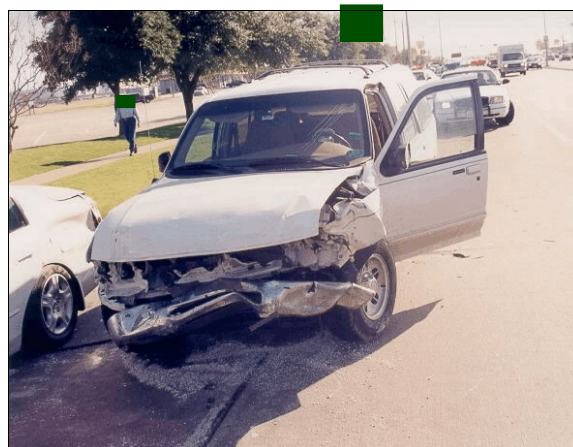
Exterior Damage: Based on the available police photographs, one CDC for the three events that the Ford was most likely involved in is estimated as: **12-FDEW-2 (0 degrees)** for the impacts with the back of the GMC and the front of the case vehicle (**Figure 30**). Damage to the Ford's front is a result of two overlapping impacts. With no clear vehicle photographs of the Ford's right side slap damage, the CDC for this impact (4th event) is most likely estimable as: **03-R{B,Y}{M,E}W-1 (90 degrees)**. However, the WinSMASH reconstruction program, missing vehicle algorithm, was used on the Ford's right side slap impact. The Total, Longitudinal, and Lateral Delta Vs are, respectively: 6.0 km.p.h. (3.7 m.p.h.), 0.0 km.p.h. (0.0 m.p.h.), and -6.0 km.p.h. (-3.7 m.p.h.). According to the Police Crash Report, the Ford was towed due to damage.

Figure 30: On-scene police photo looking south-southeast at Ford's final rest position showing SUV's frontal damage; Note: Ford's front first impacted GMC pickup's back and second case vehicle; compare severity of Ford's frontal damage with damage to case vehicle (case photo #63)

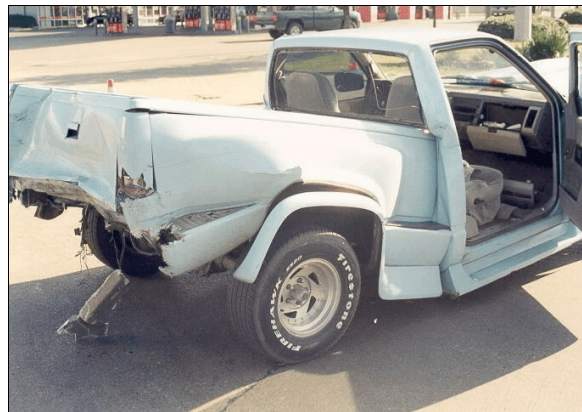
Exterior Damage: Based on the available police photographs, the CDCs for the two events (1st and 2nd) that the GMC was most likely involved in are estimable as: **26-BDEW-2 (180 degrees)** for its back (1st event–**Figure 32**) impact and **12-FDEW-1 (0 degrees)** for its frontal impact (2nd event–**Figure 10** above) with the case vehicle. According to the Police Crash Report, the GMC was towed due to damage.

Figure 32: On-scene police photo looking southeast at sustained contact damage to GMC pickup's truck bed from impact by Ford SUV; Note: upward rotation of truck bed was exacerbated during GMC's impact with case vehicle (case photo #71)
