Advanced Air Bag Investigation / Vehicle to Vehicle
Dynamic Science, Inc. / Case Number: DS03004
2003 Chevrolet Venture LS Minivan
California
November, 2002

1. Report No. DS03004	2. Government Accession No.	3. Recipient Catalog No.	
4. Title and Subtitle Advanced Air Bag Investigation		5. Report Date August 25, 2005

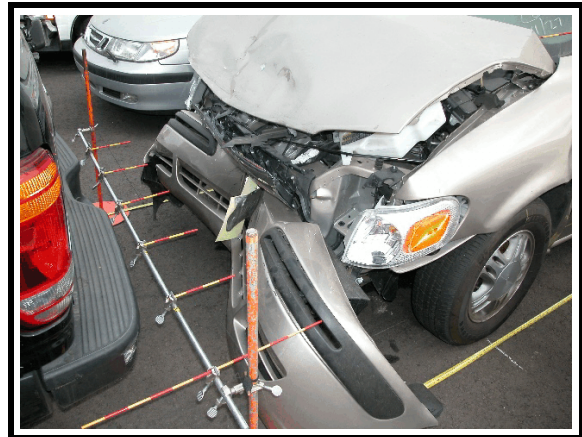
Direct contact damage involved the entire frontal plane of the case vehicle and was 149.0 cm (67.0 in.) in length. Damaged components involved the front bumper fascia and bumper bar, upper and lower radiator supports, grille, hood, both fenders and the laminated windshield was cracked due contact by the passenger air bag module door. Maximum crush was 25.0 cm (10.0 in) and was located at the vehicle centerline. The improved principal direction of force was estimated at 20 degrees (12 o'clock side of the 1 o'clock sector). The right side wheelbase was reduced by 4.0 cm (2.0 in) while the left side wheelbase was elongated by 4.0 cm (2.0 in).

Figure 4. Frontal damage, Chevrolet Venture

Damage Description: Moderate/ Primary Frontal Impact (Highest Delta V):
 Longitudinal displacement to the front bumper and fascia cover, hood, grille, upper / lower radiator supports, both fenders and the windshield was cracked due to contact from the module cover door of the deployed front, right passenger air bag unit. Maximum crush was 26.0 cm (10.2 in) located at the vehicle centerline. The right side wheelbase was reduced by 4.0 cm (2.0 in) while the left side wheelbase was elongated by 4 cm (2.0 in).

C measurements: Six equidistant crush measurements were documented at the bumper level and the crush profile is as follows; C₁=0 cm, C₂= 4.0 cm (1.6 in), C₃= 16.0 cm (6.3 in.), C₄= 26.0 cm (10.2 in.), C₅= 11.0 cm (4.3 in.), C₆ = 0 cm. Maximum crush was documented at C₄ or at the vehicle centerline

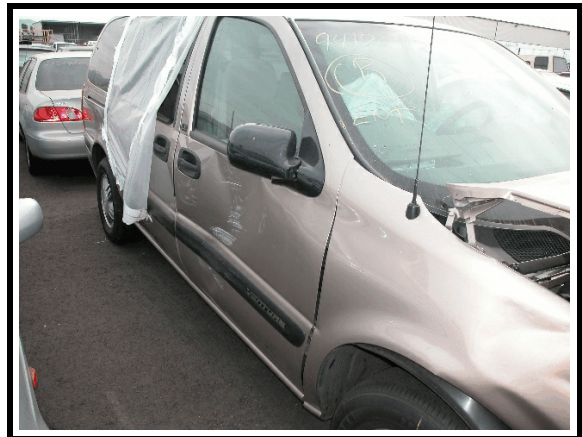
The other vehicle 2000 Toyota Echo initiated a rapid clockwise rotation due to the initial left front tire/wheel impact. The left quarter panel/bumper corner of the other vehicle impacted the front, right door panel of the case vehicle in a secondary sideslap type impact. Direct contact from the sideslap impact initiated 179.5 cm (70.7 in.) forward of the rear axle and extended forward 60.5 cm (23.8 in). The combined direct and induced damage length was 113.0 cm (44.5 in) in length and initiated 153.0 cm (60.2 in) forward of the rear axle. In addition, the right rear tempered side glazing disintegrated due to the secondary impact forces. A Collision Deformation Classification (CDC) of 03RPEW2 was assigned to the case vehicle for the secondary impact damage.

Figure 5. Sideslap damage, Chevrolet Venture

Minor/ Secondary Right Side Sideslap Impact : Lateral deformation noted to the front, right door panel along with surface scratches and abrasions. The right rear tempered side glazing disintegrated due to the secondary impact forces.

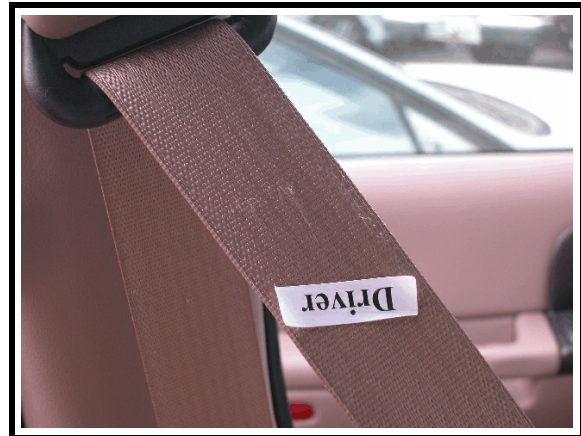
The driver's restraint exhibited evidence of historical use in the form of scratching to the latch plate. There was also evidence of loading in the form of frictional streaking/scoring diagonally across the seat belt webbing. The Deployment Event recorded by SDM reports that the driver's belt switch circuit status was "BUCKLED". The third row right restraint exhibited evidence of historical use in the form of scratching to the latch plate and faint frictional abrasions to the D-ring. The restraints in all the other seating position also exhibited evidence of historical use in the form of scratching striations to the latch plates.

Figure 6. Loading evidence to driver's seat belt

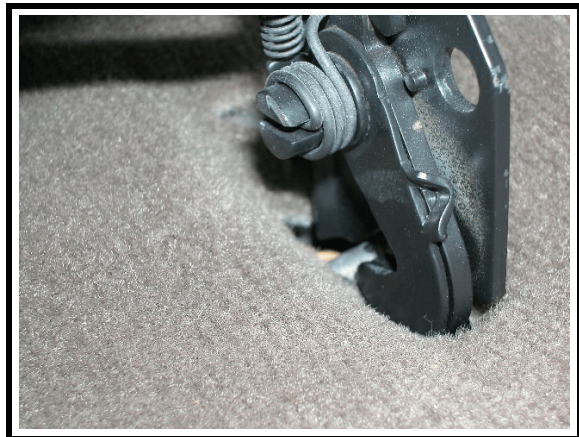
The police report indicates that the third row, right side seat that the 9-year-old female occupant occupied had come forward off the floor and that she flew forward to the right slipping out of the safety seat belt. The insurance adjuster indicated that a General Motors representative in the presence of the driver had inspected the third row split bench seat latching mechanism and had conclude that it was operating properly. Inspection of the third row split bench seat by the SCI investigator found that the latching mechanism of the left half of the split bench operated

Figure 7. Latch mechanism misalignment

properly. The right half, however, did not properly line up with the striker post. The latch would contact the post and not allow the latch to lock. The latching mechanism had to be manually pushed forward away from the striker post and then it would align properly and lock around the striker post. The second and third row split bench seats are designed to be removed to load vehicle with cargo. The third row split bench seat can also be folded forward and stowed for cargo loading.

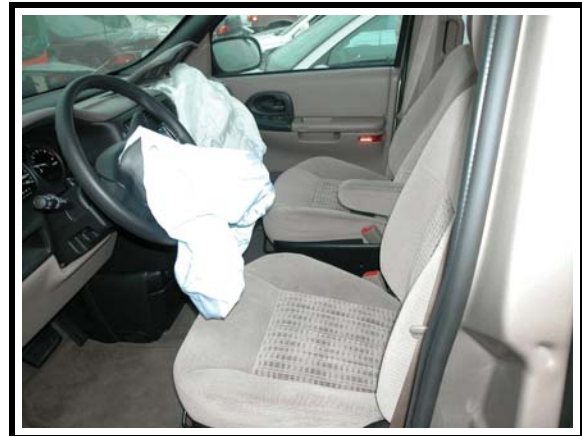
The Chevrolet Venture was equipped with redesigned (reduced force) driver and front right passenger front air bags and front seat mounted side air bags. The driver's air bag was mounted in the steering wheel hub. The driver air bag module was located in the center hub of the steering wheel rim with a vertically oriented flap tear seam (I-configuration). The diameter of the deflated circular air bag was 65 cm (26 in). It was equipped with two internal tether straps and had two vent ports (11 and 01 o'clock positions). The maximum deflated air bag excursion measured approximately 20 cm (8 in). There were no indications of any damage to driver's air bag or the module cover flaps. On the face of the lower right quadrant of the air bag, there were vinyl transfers to the membrane from expansion within the module. There was no occupant contact evidence on the air bag.

Figure 8. Driver's air bag

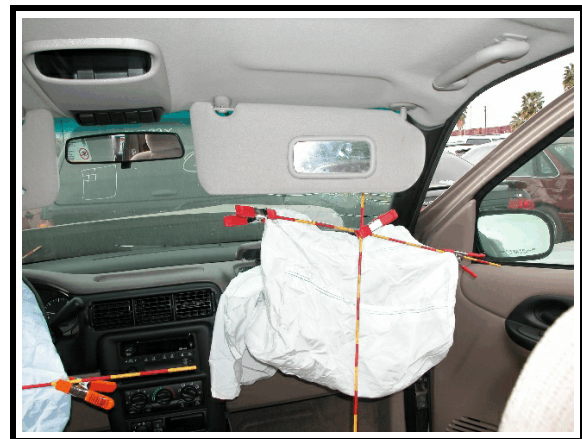
Figure 9. Front right passenger air bag

The front right passenger air bag was a mid instrument panel mount with dual symmetrical module cover flaps. The deflated air bag was rectangular in shape with a height of approximately 50 cm (20 in) and a width of approximately 54 cm (21 in). The maximum deflated air bag excursion measured approximately 58 cm (23 in). The air bag had a single tethered sewn across the entire face of the air bag and had two vent ports (02 and 10 o'clock positions). There were no indications of any damage to front right passenger air bag. There was faint evidence of vinyl transfer to the membrane from expansion within the module to the upper middle face of the air bag. The single hinged module cover flap was rectangular in shape and measured 40 cm (16 in) wide by 30 cm (12 in) high. The right corner of the module cover flap was scuffed and bent from contact with the windshield. The windshield glazing was cracked and had vinyl transfer from the front right module cover flap.
