Advanced Occupant Protection System Investigation / Vehicle to Vehicle
Dynamic Science, Inc. / Case Number: DS03007
2003 Toyota Matrix XR sport utility
Texas
January, 2003

Dynamic Science, Inc.
Accident Investigation
Case Number: DS03007

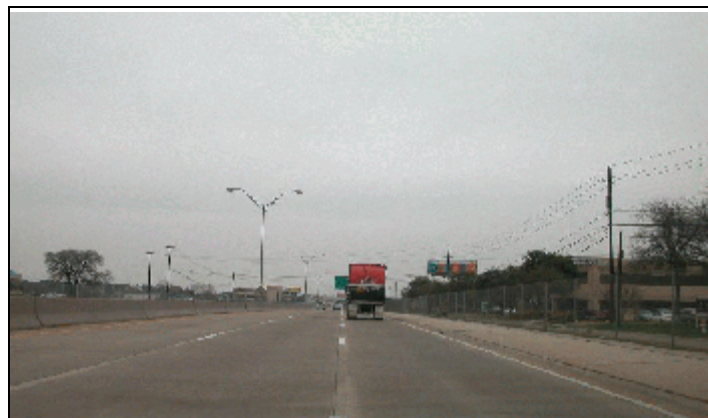
Figure 1. Overview of crash scene (north). Struck wall is on the left.

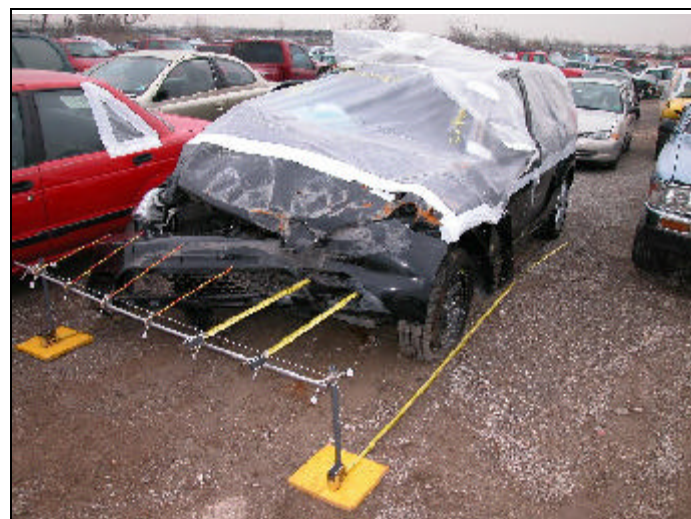
Figure 2. Front left, initial impact with wall

The case vehicle was traveling northbound in the far right lane of the toll road. The police report indicates that the driver reached down to pick up some coins. The vehicle apparently drifted to the right at this point. The driver over-corrected to the left and lost control of the vehicle. The vehicle traveled across the adjacent lanes and struck a concrete wall (12FDEW2). The total velocity change calculated by the Barrier algorithm of the WinSmash collision model was 25.0 km/h (15.5 mph). The longitudinal and lateral components were -24.6 km/h (-15.3 mph) and -4.3 km/h (-2.7 mph), respectively.

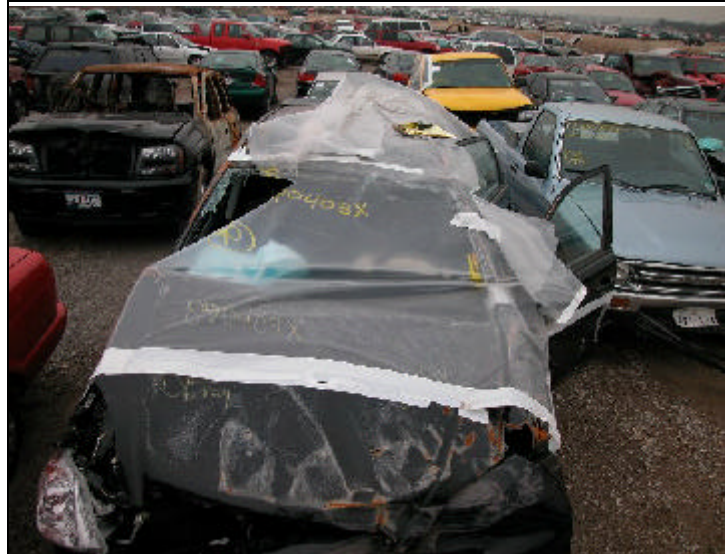
Figure 3. Top of hood, roof, rollover damage

As the vehicle engaged the wall, it went into a counterclockwise rotation. The vehicle tripped and began to overturn—first onto its right side then onto its roof (00TDDO2). While on its roof, the vehicle continued to rotate until striking the concrete wall with the rear of the vehicle (00BZHW2).

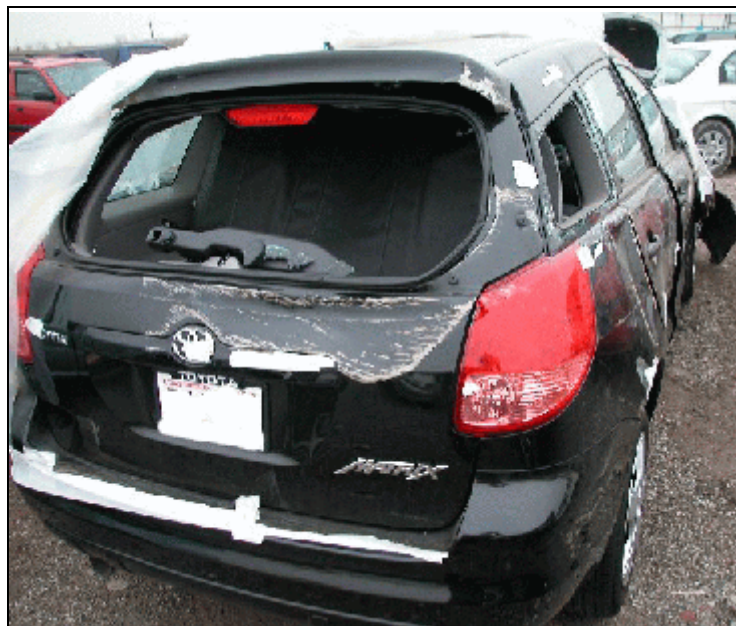
Figure 4. Rear of vehicle—impact with wall

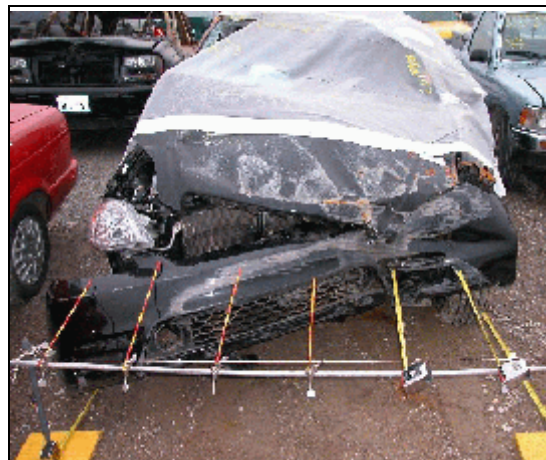
The case vehicle sustained 154 cm (61 in) of direct contact across the entire front end. The residual crush as measured along the bumper and backing bar was as follows: C1=13 cm (5 in), C2=26 cm (10 in), C3=24 cm (9 in), C4=17 cm (7 in), C5=14 cm (6 in), and C6=0 cm (0 in). The maximum crush was at C2. The principle direction of force was within the 12 o'clock sector and was an estimated 10 degrees.

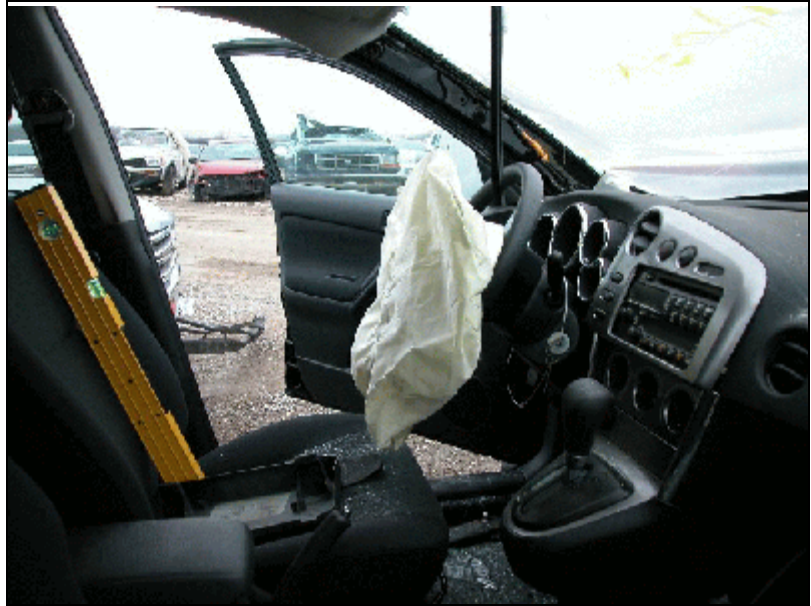
Figure 7. Driver's seated position

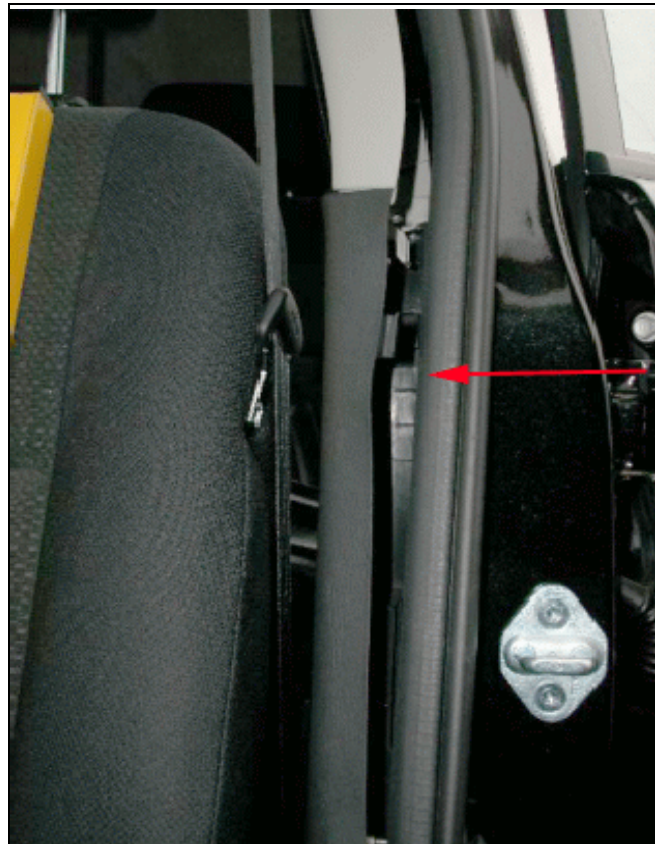
The driver and front right passenger air bags deployed as a result the wall impact; both front seat belt pretensioners fired and locked the seat belts in their stowed positions.

Figure 8. Driver's seat belt-locked in stowed position

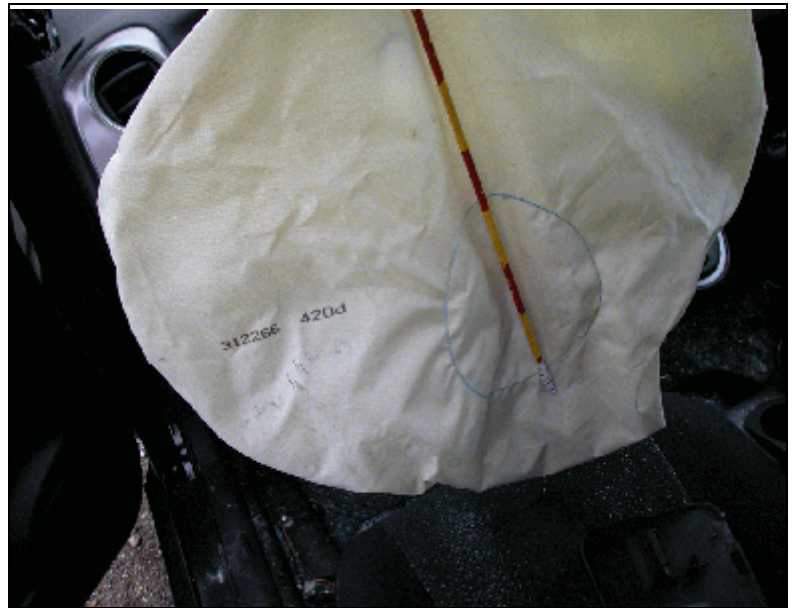
The driver's air bag module was a three part design and located in the center hub of the steering wheel rim. The single top flap measured 15 cm (6 in) wide and 6 cm (2 in) high. Each of the bottom two flaps measured 8 cm (3 in) wide and 6 cm (2 in) high. There was no contact evidence on the cover flaps. The diameter of the air bag measured 70 cm (28 in) in its deflated state. There was a single tether and two vent ports. The ports were at the 11 and 1 o'clock positions.

Figure 9. Driver's air bag

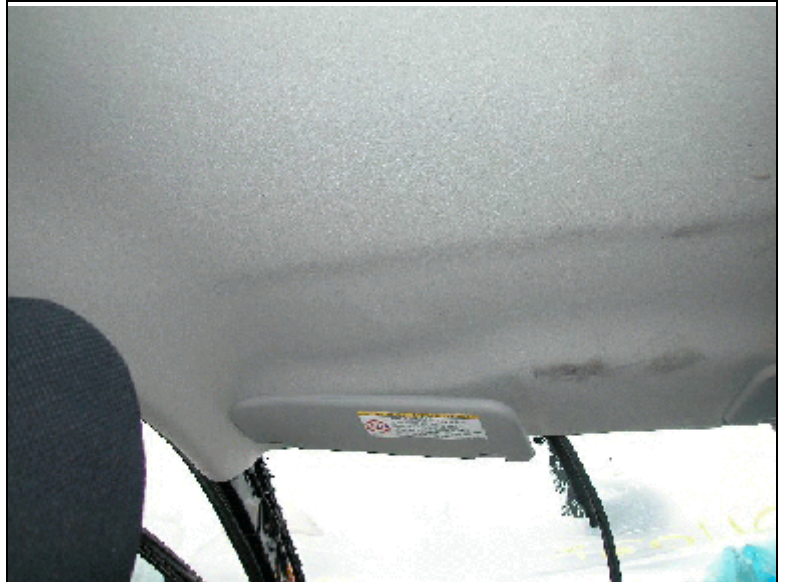
The 38-year-old male driver was seated in a normal, upright fashion. The fabric covered bucket seat was adjusted to between the middle and rear most track position. The seat back was at a 67 degree angle from the horizontal. The driver was not wearing the available lap and shoulder belt. He was wearing a short sleeve shirt and was not wearing glasses of any kind. Just prior to the crash, the driver leaned to the right and looked down trying to find coins for an upcoming toll plaza. He was reaching into the center console with his right hand. His left hand remained on the steering wheel. The vehicle veered to the right. The driver steered sharply to the left and lost control of the vehicle. At impact, both frontal air bags deployed and both pretensioners fired. The seat belts were locked in their stowed positions. The driver responded to the 12 o'clock direction of force by moving forward. His face engaged the front of the deployed driver's air bag—causing the nasal fracture. Both inner forearms contacted the deploying air bag—causing bilateral abrasions. As the vehicle began its counterclockwise rotation, the driver shifted to the left and engaged the door panel. As the vehicle tripped onto its right side and then onto its roof, the driver came out of his seat and eventually came to rest on the roof near the windshield header (see scuffs in Figure 10). There were blood drops found on the roof but these were likely related to the earlier nasal fracture. There were no indications of any steering wheel damage or steering column movement.

Figure 10. Roof/windshield header (scuffs)

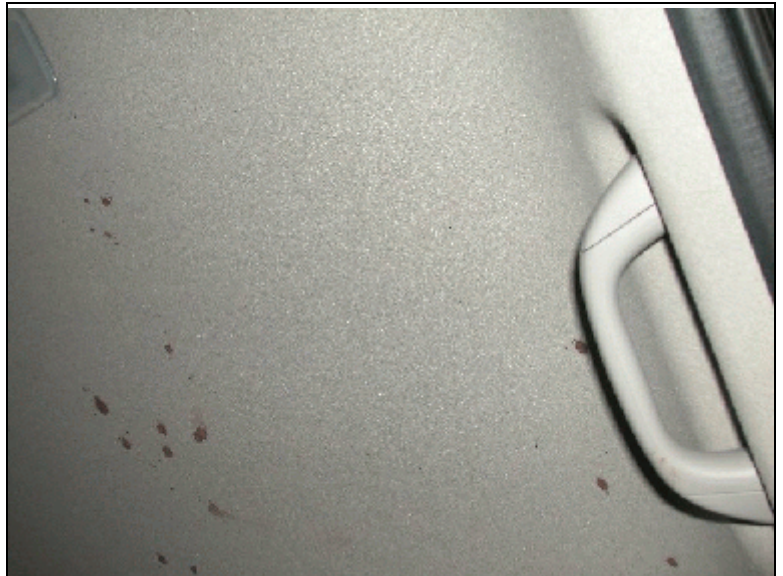
Figure 11. Roof (blood drops)
