Advanced Air Bag Investigation / Vehicle to Vehicle
Dynamic Science, Inc. / Case Number: DS03008
2003 Chevrolet Avalanche
Texas
February, 2003

1. Report No. DS03008		2. Government Accession No.		3. Recipient Catalog No.	
4. Title and Subtitle Advanced Air Bag Investigation				5. Report Date November 3, 2003

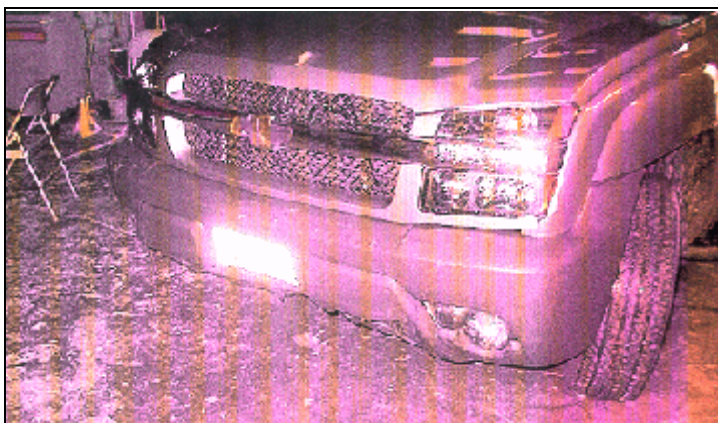
Figure 2. Front left, case vehicle (insurance photo)

Damage Description: Minor front and rear end damage. PAR vehicle damage rating=BD2, FD2. Vehicle towed from the scene

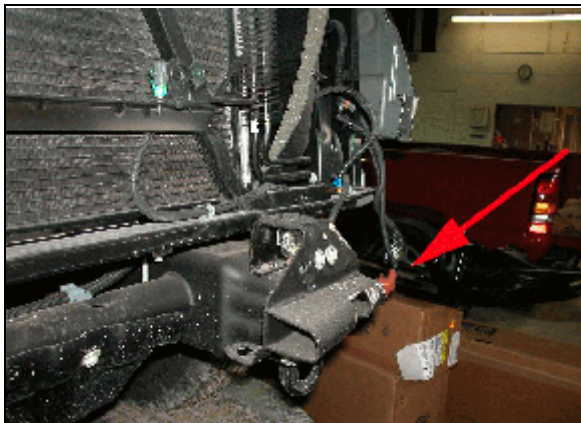
Figure 6. Left bumper mounting bracket—minor scuffing/scratches

The downloaded data indicated that the case vehicle had a maximum recorded velocity change of -6.4 km/h (-4.04 mph) at the 100 ms mark as a result of the forward impact. The result appears slightly low given that there was residual damage to the bumper mounting bracket.

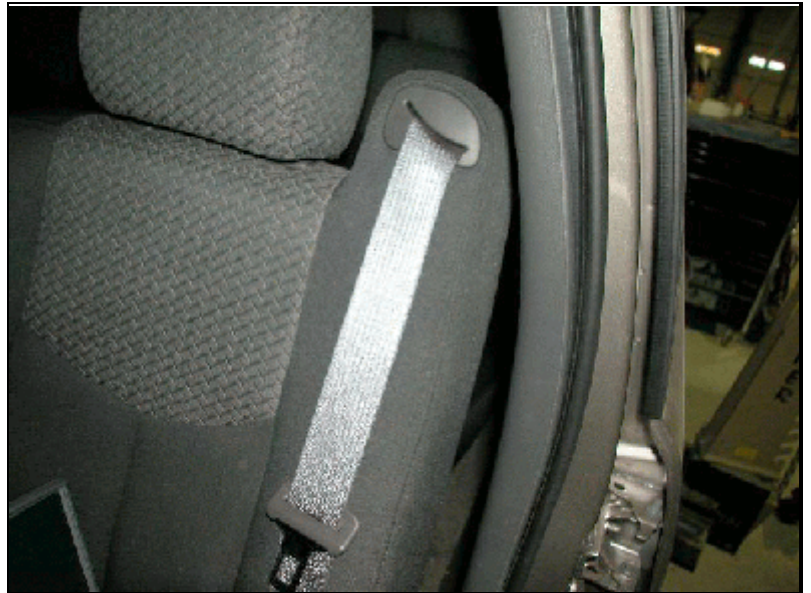
There is an indicator on the center rear-view mirror that alerts vehicle occupants to the status of the system at all times. If the light reads "Passenger Air Bag ON," the air bag is programmed to deploy in a frontal crash of sufficient severity. If it reads "Passenger Air Bag OFF," the system has turned off the air bag because it determined either that there is no occupant on the front passenger seat, or that a rear-facing infant seat, a forward-facing child restraint, a booster seat or a smaller person, such as a child who has outgrown child restraints, is present. The sensing system is standard on most 2003 full-size pickups and sport-utility vehicles. There were no air bag deployments. The vehicle was equipped with seat integrated seat belts. There were no indications of seat belt loading.

Figure 9. Driver's integral seat belt

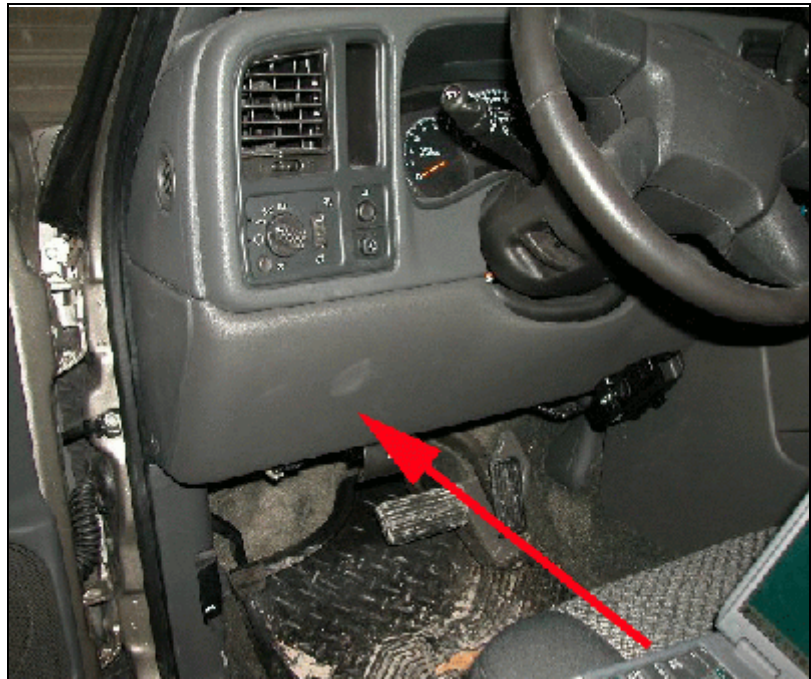
The 44-year-old male driver of the case vehicle was seated in a normal, upright fashion in the cloth covered split bench seat. The seat was adjusted to the rear most track position. The seat back was slightly reclined. The adjustable head rest was in the full down position. The driver was wearing the integral lap and shoulder belt. Prior to impact, the case vehicle was slowing and the driver had his foot on the brake. The case vehicle was then struck in the rear by the Chevrolet 2500 series pickup. The driver moved rearward in response to the 6 o'clock direction of force. The vehicle was pushed forward. The driver reacted to this motion by braking once again. The vehicle then decelerated to 10 km/h (6 mph) before striking the rear of the Toyota Camry. He moved slightly forward in response to the 12 o'clock direction of force. His left knee contacted the left lower instrument panel. There was no injury related to this contact.

Figure 8. Left knee contact
