### ON-SITE CHILD SAFETY SEAT INVESTIGATION

CASE NUMBER - IN-03-008  
LOCATION - ILLINOIS  
VEHICLE - 2003 CHEVROLET K1500 TAHOE  
CRASH DATE - January 2003

August 10, 2007

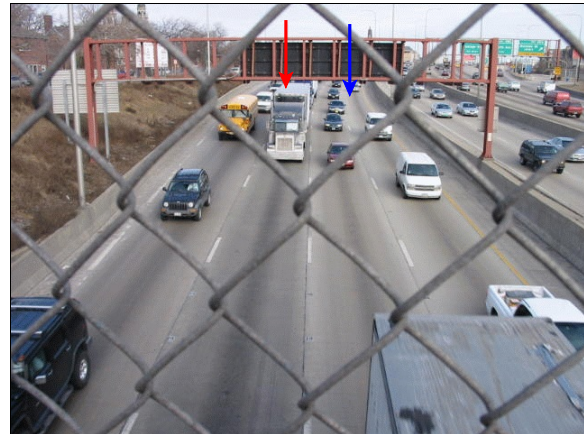
**Figure 1:** Northward view from perpendicular overpass of interstate trafficway's southbound local roadway; Note: arrows indicate pre-crash travel lanes for case vehicle—blue and Volvo—red (case photo #12)

**Pre-Crash:** The case vehicle was traveling south in the inside through lane of the four-lane southern roadway and intended to proceed straight ahead (**Figure 1** above). The Volvo was also traveling southward, but it was traveling in the right center through lane and intended to proceed straight ahead (**Figure 2** above). According to the case vehicle's front right passenger, a noncontact vehicle traveling just ahead of the case vehicle in the left center lane swerved from right to left into the same lane as the case vehicle. At this point, in an attempt to avoid any contact, the case vehicle's driver veered to the left and back to the right an undetermined number of times before losing control of the vehicle. According to the Police Crash Report and the occupant's interview, the case vehicle rotated approximately 60-75 degrees clockwise and crossed the left center lane prior to entering the right center lane. The crash took place on the interstate trafficway in the right center lane of the local southern roadway.

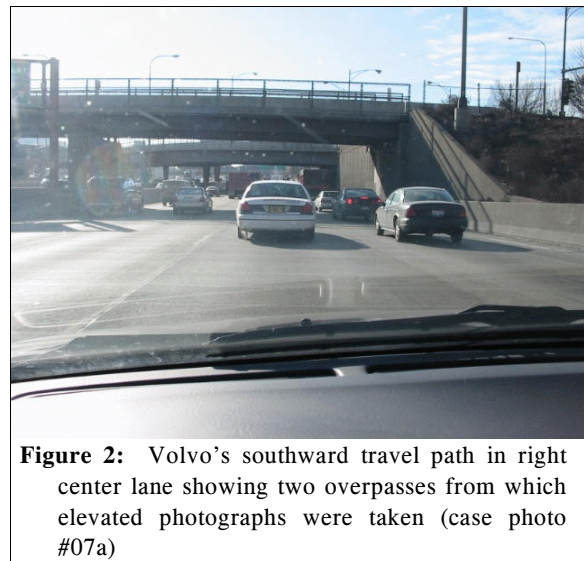
**Figure 2:** Volvo's southward travel path in right center lane showing two overpasses from which elevated photographs were taken (case photo #07a)

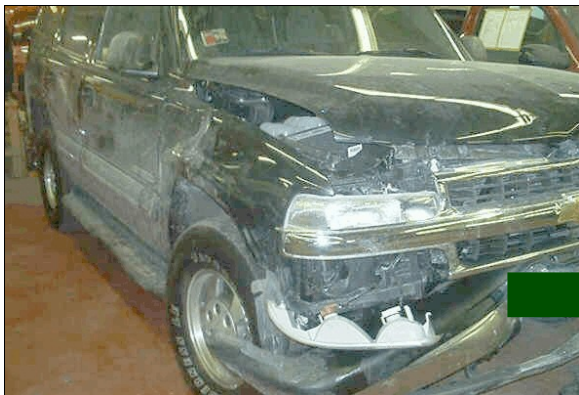
**Figure 3:** Body shop photo showing case vehicle's front right direct damage and induced damage to right fender and right front door (case photo #109)

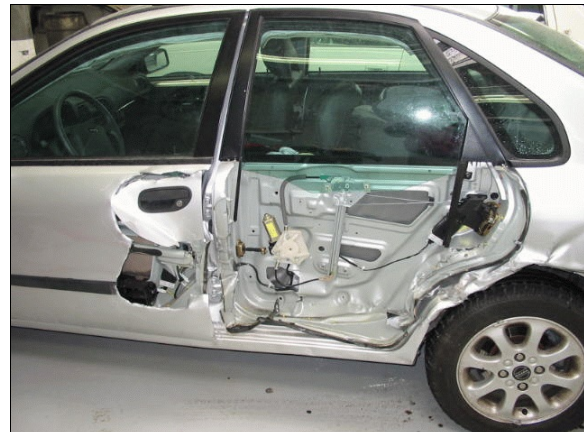
**Figure 4:** Impact on Volvo's left passenger area caused by front of case vehicle; Note: impact deployed Volvo's driver seat back-mounted side air bag and left side curtain air bag (case photo #63)

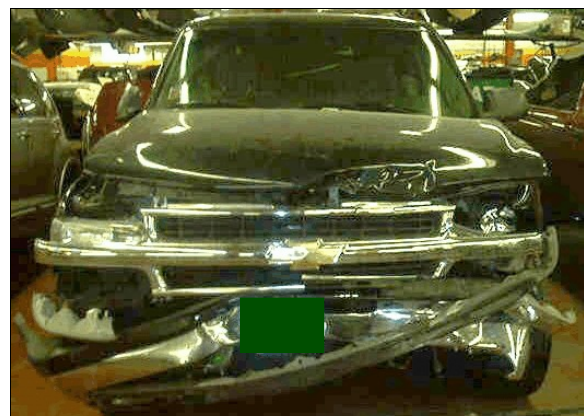
**Post-Crash:** As a result of the initial impact, the case vehicle continued in its southwesterly direction, and the front (**Figure 5** and **Figure 6** below) of the case vehicle impacted the concrete

**Figure 5:** Body shop photo of case vehicle's frontal damage showing damage across entire front (case photo #108)

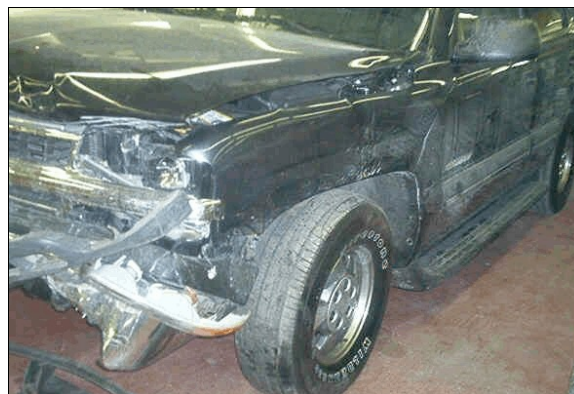
**Figure 6:** Body shop photo showing case vehicle's front left direct damage and induced damage to left fender and left front door (case photo #111)

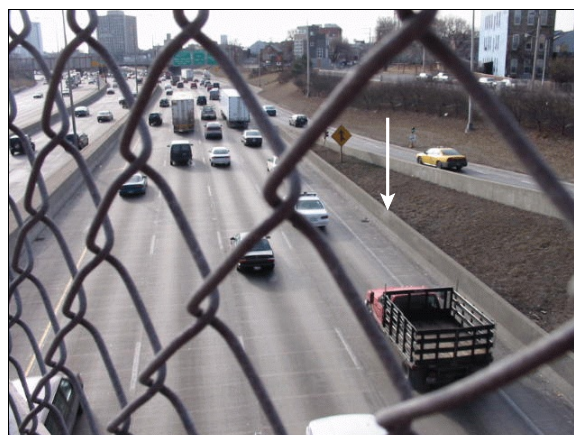
**Figure 7:** Southward view from oblique overpass showing approximate area of impacts and final rest for both vehicles; Note: arrow indicates suspected impact location between one of the vehicles and longitudinal barrier (case photo #11a)

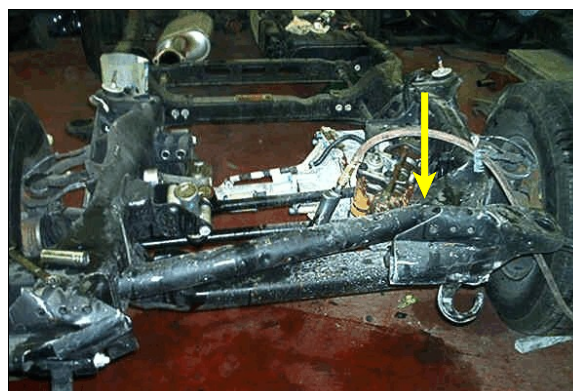
**Figure 8:** Body shop photo of case vehicle’s frame showing damage to frame’s front cross-member (case photo #113)

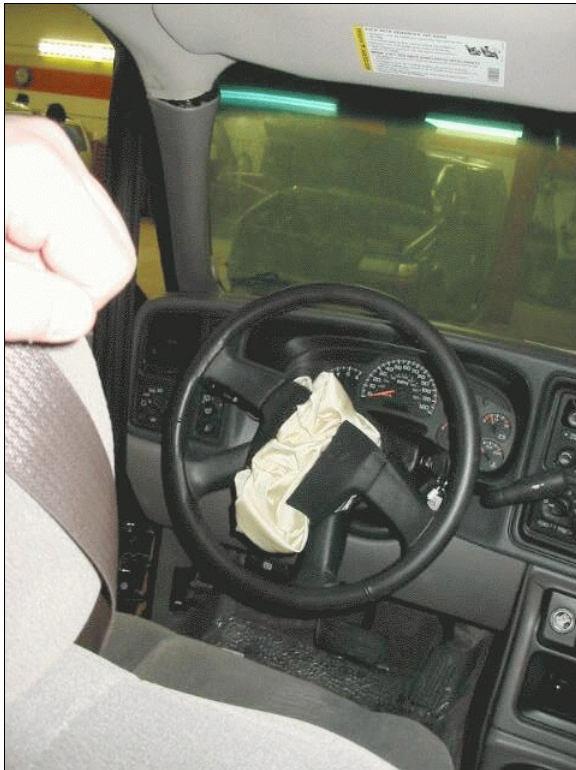
**Figure 9:** Case vehicle's driver seating area showing no apparent evidence of occupant contact to the steering wheel, instrument panel, or greenhouse components (case photo #23)

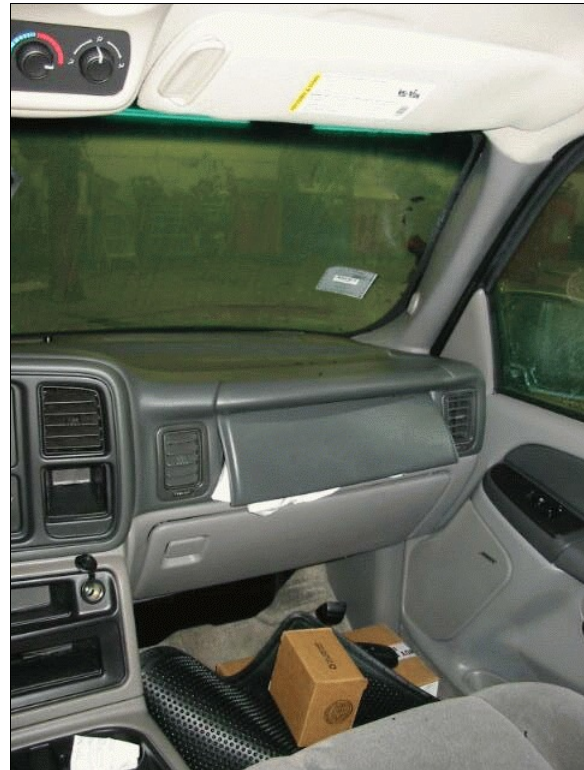
**Figure 10:** Case vehicle's front right passenger seating area showing no apparent occupant contact evidence to the instrument panel or greenhouse components (case photo #25)

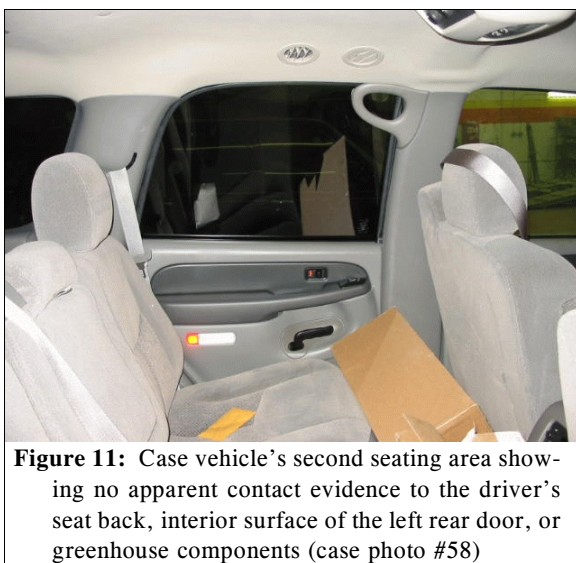
**Figure 11:** Case vehicle's second seating area showing no apparent contact evidence to the driver's seat back, interior surface of the left rear door, or greenhouse components (case photo #58)

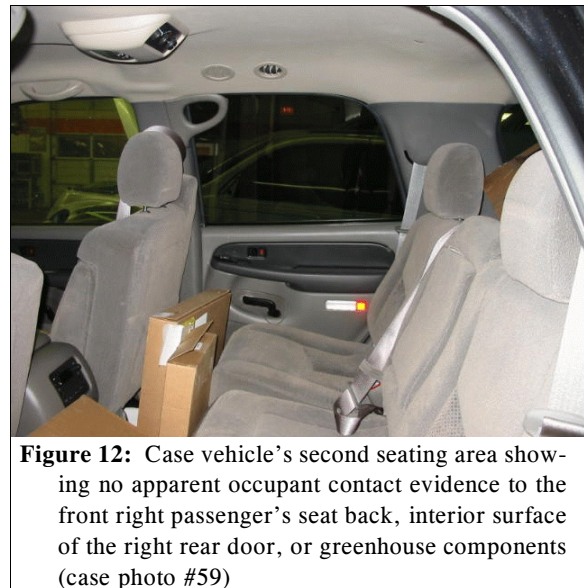
**Figure 12:** Case vehicle's second seating area showing no apparent occupant contact evidence to the front right passenger's seat back, interior surface of the right rear door, or greenhouse components (case photo #59)

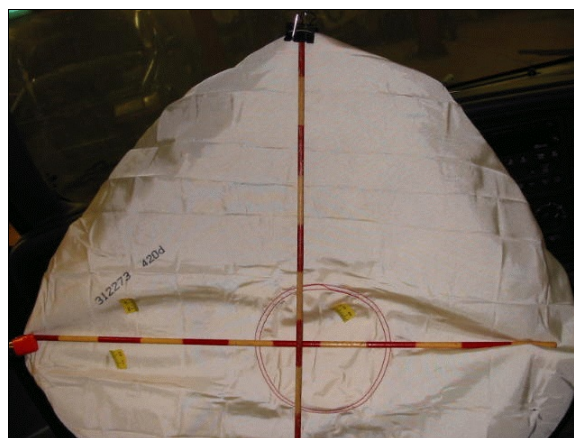
The case vehicle was equipped with a Supplemental Restraint System (SRS) that contained dual stage frontal air bags at the driver and front right passenger positions. Both frontal air bags deployed as a result of the frontal impact with the longitudinal barrier along the east side of the trafficway. Only one stage of the dual-stage air bags was activated. The case vehicle's driver air bag was located in the steering wheel hub. The module cover consisted of asymmetrical, essentially, "I"-configuration cover flaps made of thick vinyl. Both the left and right flaps were trapezoidal in shape with overall dimensions of 7 centimeters (2.8 inches) at the top horizontal seam, 5 centimeters (2.0 inches) at the bottom horizontal seam, and 12 centimeters (4.7 inches) vertically along the seam that separated the two flaps. An inspection of the air bag module's cover flaps and the air bag's fabric revealed that the cover flaps opened at the designated tear points, and there was no evidence of damage during the deployment to the air bag or the cover flaps. The driver's air bag was designed with two tethers, with each strap approximately 15 centimeters (5.9 inches) in width. The driver's air bag had two vent ports, approximately 3 centimeters (1.2 inches) in diameter, located at the 11 and 1 o'clock positions. The deployed driver's air bag was round with a diameter of 65 centimeters (25.6 inches). An inspection of the driver's air bag fabric revealed a makeup smear within the 15 centimeter (5.9 inch) center circular stitching and other possible contacts located toward the left side of the air bag's fabric [i.e., 15 centimeters (5.9 inches) inboard and 5 centimeters (2.0 inches) above the lateral centerline of the air bag **and** 11 centimeters (4.3 inches) inboard and 2 centimeters (0.8 inches) below the lateral centerline—**Figure 13**].

**Figure 13:** Case vehicle's deployed driver air bag showing makeup smear within center circular stitching and possible contacts toward 9 o'clock position (case photo #29)

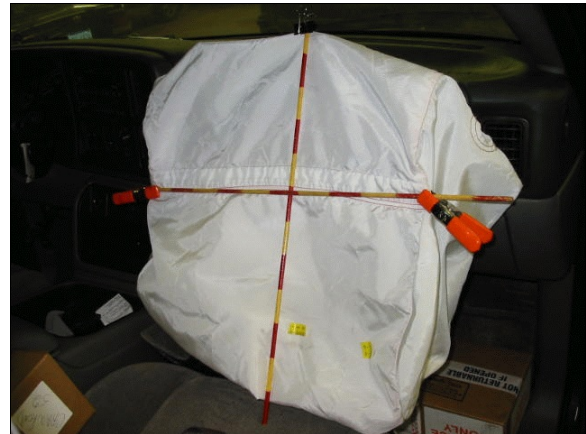
The front right passenger's air bag was located in the middle of the instrument panel. There was a single, essentially rectangular, modular cover flap. The cover flap was made of a semi-pliable vinyl. The flap's dimensions were 39 centimeters (15.4 inches) at the lower horizontal seam and 13.5 centimeters (5.3 inches) along both vertical seams. The profile of the case vehicle's instrument panel was flush with the leading edge of the cover flap. The distance between the mid-center of the front right seat back, as positioned at the time of the vehicle inspection, and the front surface of the air bag's fabric at full excursion was 25 centimeters (9.8 inches). An inspection of the front right air bag module's cover flap and the air bag's fabric revealed that the cover flap opened at the designated tear points, and there was no evidence of damage during the deployment to the air bag or the cover flap. The front right passenger's air bag was designed with one wide tether that measured approximately 39 centimeters (15.4 inches) in width. The front right air bag had two vent ports, approximately 3 centimeters (1.2 inches) in diameter, located at the 9:30 and 2:30 clock positions. The deployed front right air bag was rectangular with a height of approximately 60 centimeters (23.6 inches) and a width of approximately 50 centimeters (19.7 inches). An inspection of the front right passenger's air bag fabric revealed that there was some kind of fluid stain evidence apparent on the front surface of the air bag's fabric near the center of the lower right quadrant [i.e., 10 centimeters (3.9 inches) from the bottom and 6 centimeters (2.4 inches) inboard from the right edge]. In addition, there was some irregular scuffing at the lower center of the bag [i.e., 8 centimeters (3.1 inches) from the bottom and 18 centimeters (7.1 inches) inboard from the right edge—**Figure 14**].

**Figure 14:** Front surface of case vehicle's deployed front right passenger air bag showing a stain and a scuff in the middle of the lower right quadrant and toward the 6 o'clock position, respectively (case photo #39)

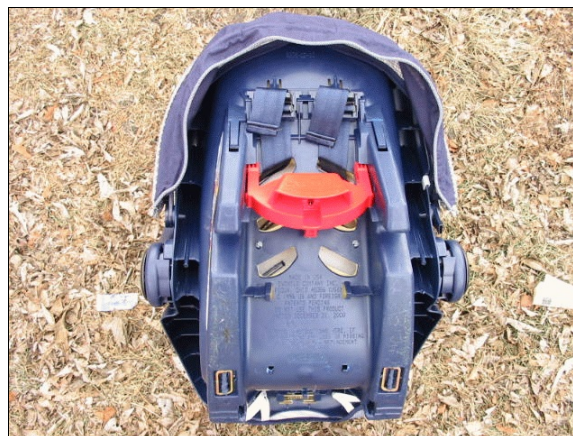
**Figure 19:** Overhead view of underneath side of shell of infant child safety seat used by case vehicle's back center passenger; Note: no apparent damage (case photo #105)

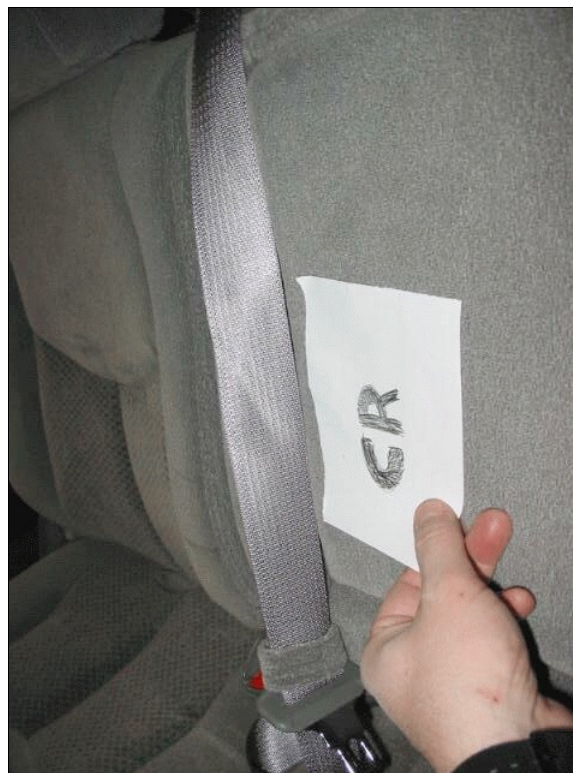
**Figure 20:** Seat belt webbing for case vehicle's back center passenger showing stress marks indicative of restraint usage (case photo #54)

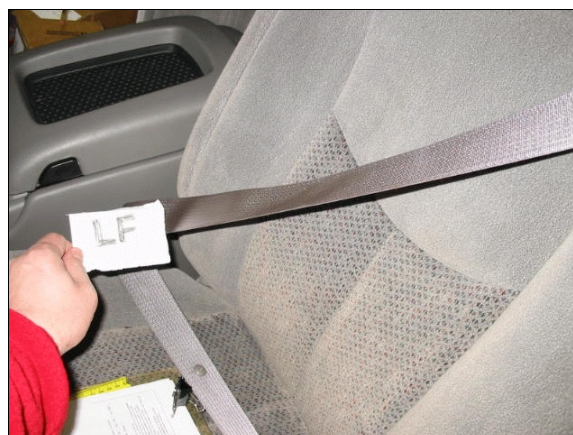
Based on this contractor's vehicle inspection and supported by the interview with the case vehicle's front right passenger and the **EDR** data, the driver was restrained by her available, active, three-point, integral lap-and-shoulder, safety belt system; the belt system was not equipped with a pretensioner. There was no mention by the front right passenger of belt pattern bruising and/or abrasions to the driver's torso, and while the inspection of the driver's seat belt webbing, shoulder belt guide, and latch plate found no obvious loading evidence on the integrated safety belt's webbing or latch plate, the webbing was slightly rippled indicating trace loading (**Figure 21**).

**Figure 21:** Safety belt webbing for case vehicle's driver showing trace evidence (i.e., slight rippling) of loading (case photo #13)

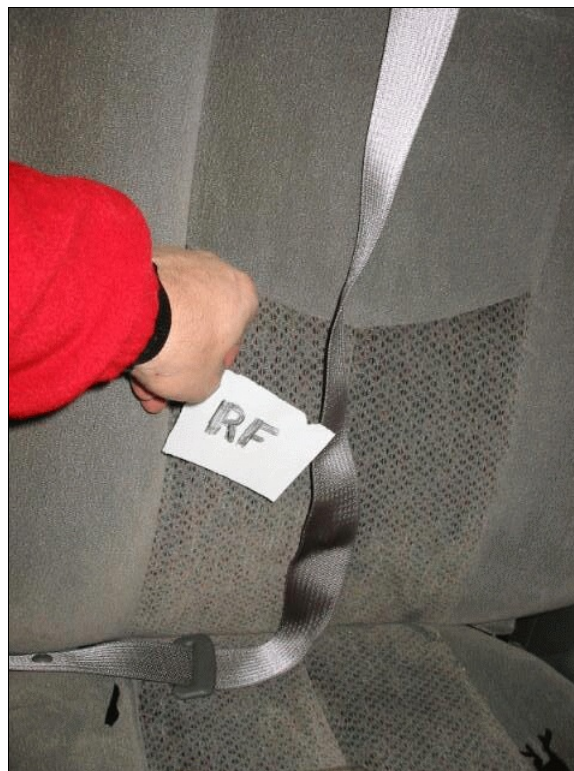
**Figure 22:** Safety belt webbing for case vehicle's front right passenger showing a wavy pattern indicative of occupant loading (case photo #17)

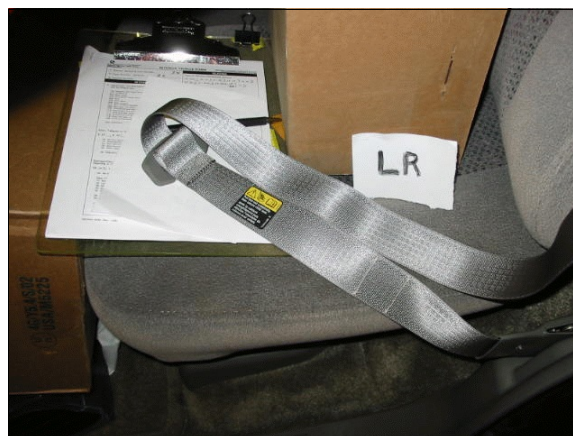
This passenger was restrained by her available, active, three-point, lap-and-shoulder, safety belt system. There was no mention by the front right passenger of belt pattern bruising and/or abrasions to the second seat left passenger's torso, but the inspection of the second seat left passenger's seat belt webbing and latch plate showed evidence of usage (i.e., rippling) during this crash (**Figure 23**).

**Figure 23:** Seat belt webbing for case vehicle's back left passenger showing a wavy pattern indicative of occupant loading (case photo #51)

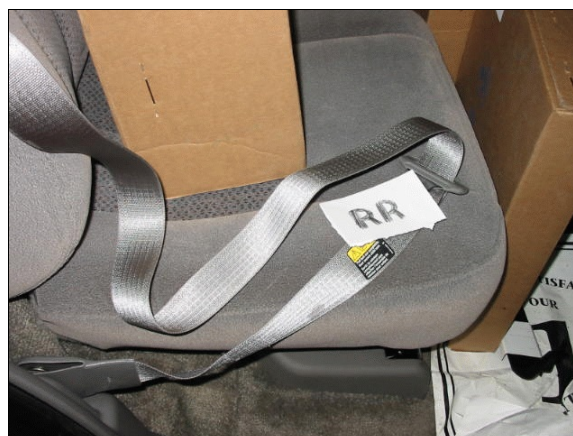
The second seat right passenger was restrained by her available, active, three-point, lap-and-shoulder, safety belt system; however, given this child's stature, it is unknown if but unlikely that the torso portion of the safety belt engaged this child's shoulder as designed. There was no mention by the front right passenger of belt pattern bruising and/or abrasions to the second seat right passenger's torso, but the inspection of the second seat right passenger's seat belt webbing and latch plate showed only trace evidence of usage during this crash (**Figure 24**).

**Figure 24:** Seat belt webbing for case vehicle's back right passenger showing stress marks indicative of occupant loading (case photo #48)

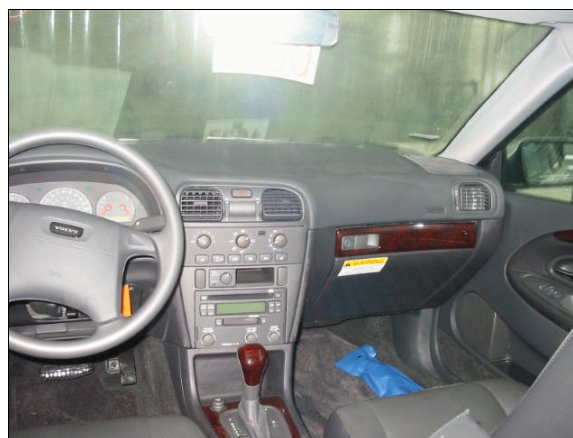
**Figure 25:** Volvo's front seating area showing non-deployed driver and front right passenger air bags; Note: steering wheel, instrument panel, and greenhouse area show no apparent evidence of occupant contact (case photo #70a)

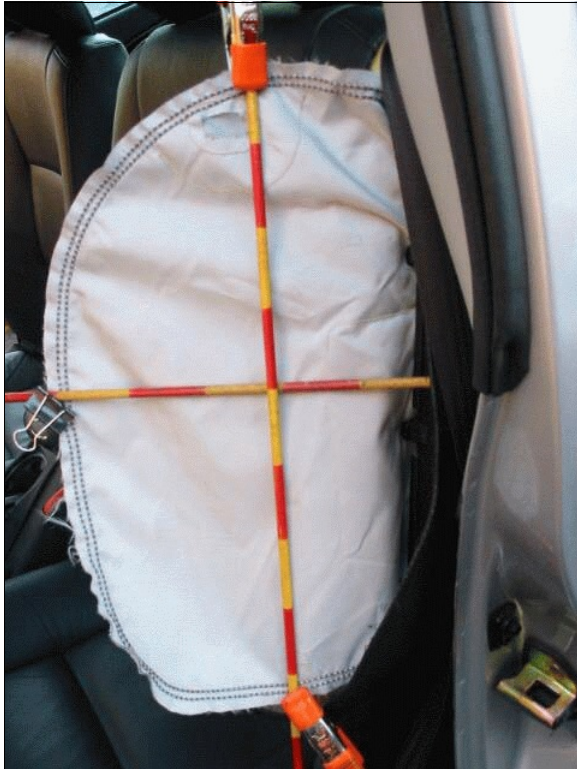
**Figure 26:** Outboard surface of Volvo's driver seat back-mounted side impact air bag showing no evidence of intrusion or contact (case photo #82)

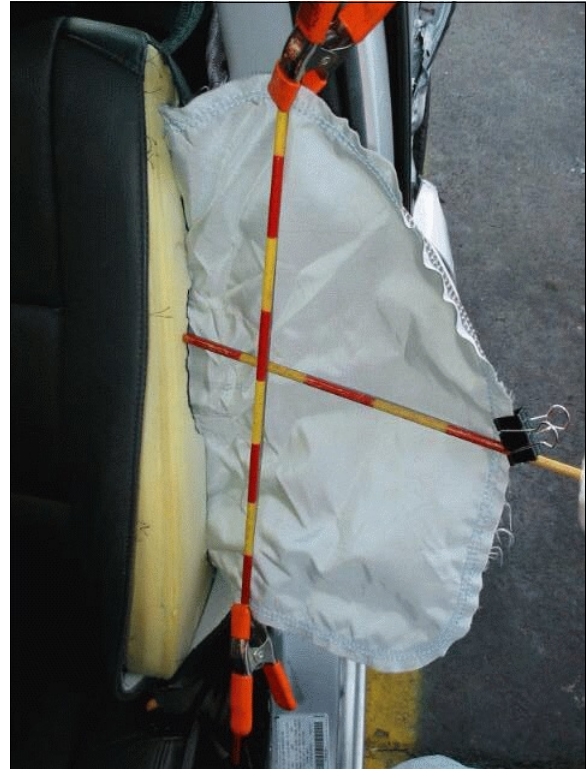
**Figure 27:** Inboard surface of Volvo's driver seat back-mounted side impact air bag showing no apparent occupant contact evidence (case photo #77)

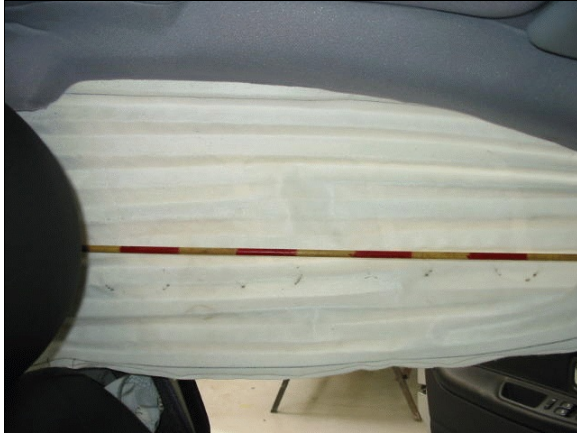
**Figure 30:** Inboard surface of Volvo's left side inflatable curtain protecting driver's seating area; Note: a hair and a possible lip print were found on the curtain's fabric (case photo #84)

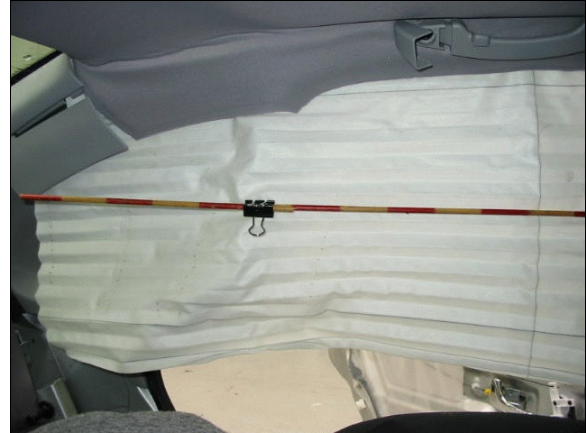
**Figure 31:** Inboard surface of Volvo's left side inflatable curtain protecting back left seating area; Note: no apparent evidence of occupant contact (case photo #89)

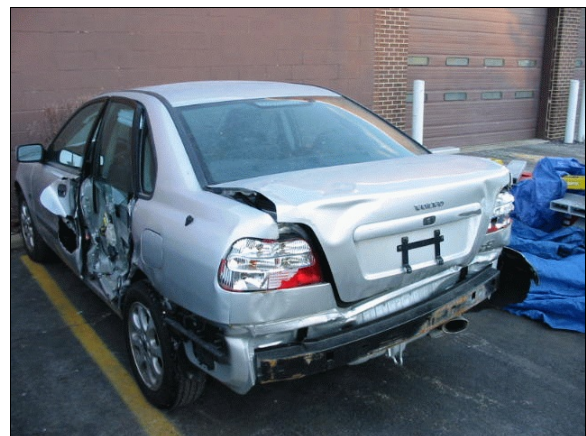
pneumatic shears. No crush profile was taken on the impact to the Volvo's back (Figure 32 below) because this impact occurred with a longitudinal barrier and the case vehicle was not involved. The Volvo manufacturer's recommended tire size was: P195/60R15, and the Volvo's tires were the recommended size. The Volvo's tire data are shown in the table below. At the time of inspection, none of the Volvo's tires were damaged, deflated, or physically restricted. The Volvo was towed due to damage.

**Figure 32:** Damage to Volvo's left and back surfaces viewed from left of back; Note: greatest damage to Volvo's back occurred to back right bumper (case photo #64)

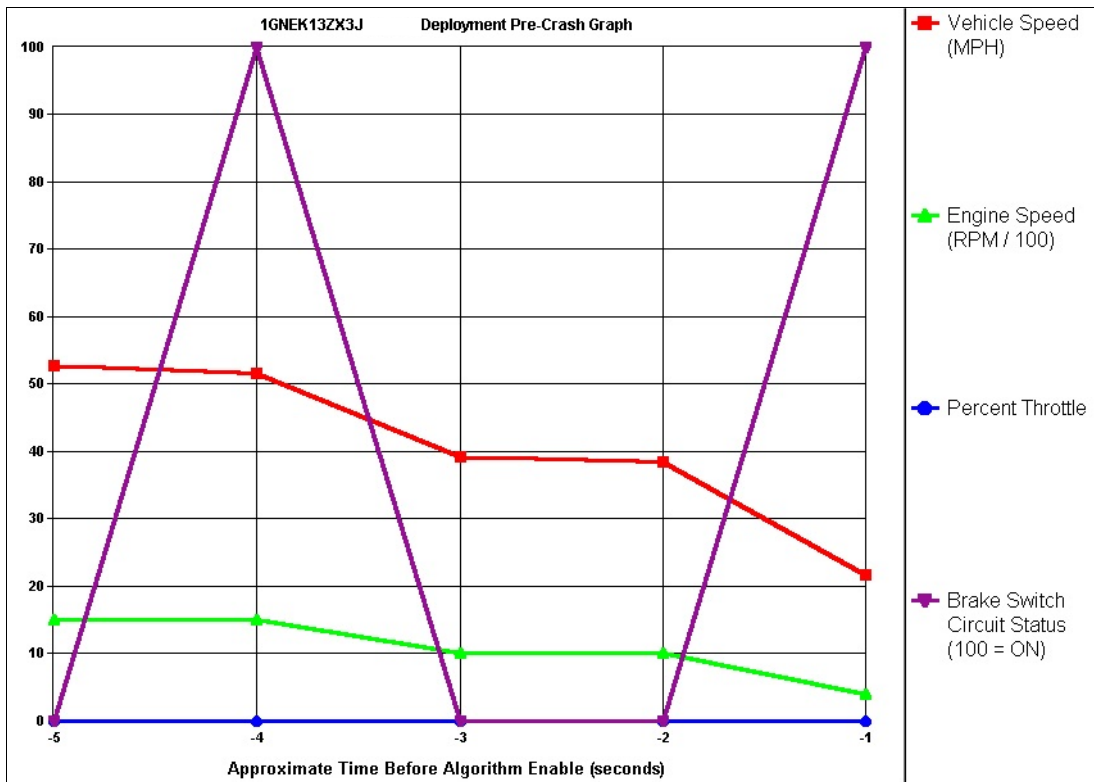
**Figure 34:** Case vehicle's pre-crash speed and brake switch circuit status showing that the vehicle's speed was recorded at 85 km.p.h. (53 m.p.h.), with the brake not activated, at approximately 5 seconds prior to algorithm enable and that the brake switch had been activated twice, once during the 4<sup>th</sup> and again during the 1<sup>st</sup> recorded sample periods prior to algorithm enable.

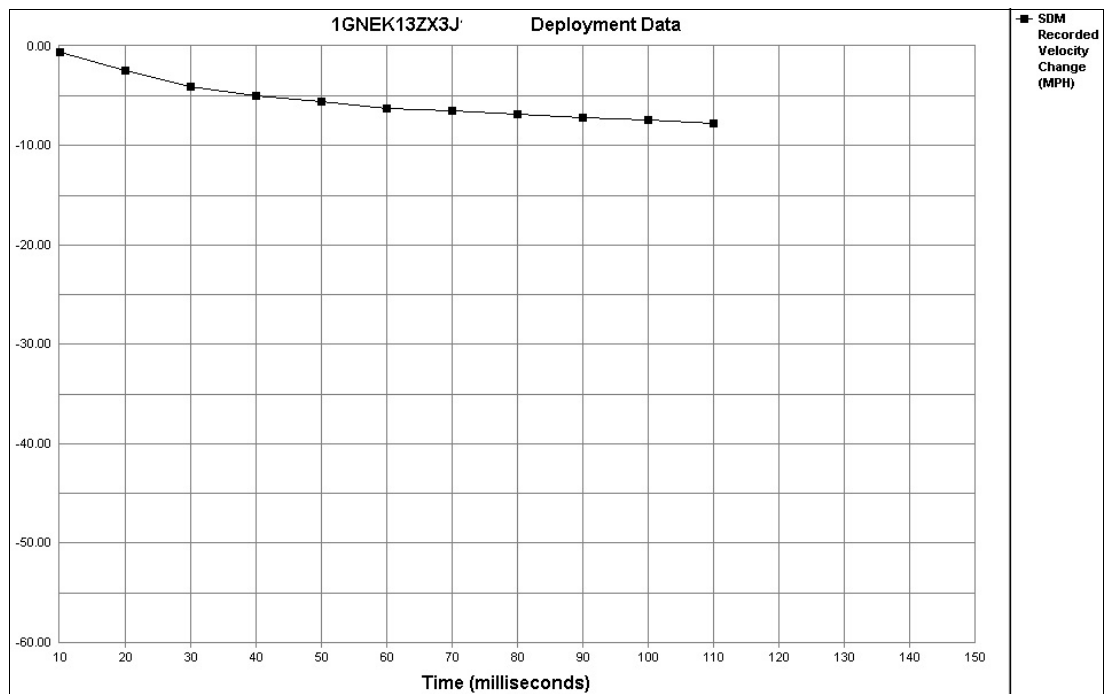
**Figure 35:** The case vehicle sustained a velocity change of approximately 12.5 km.p.h. (7.8 m.p.h.) during the first 110 milliseconds after the algorithm was enabled; maximum velocity change was recorded as 13.0 km.p.h. (8.1 m.p.h.) at 120 milliseconds

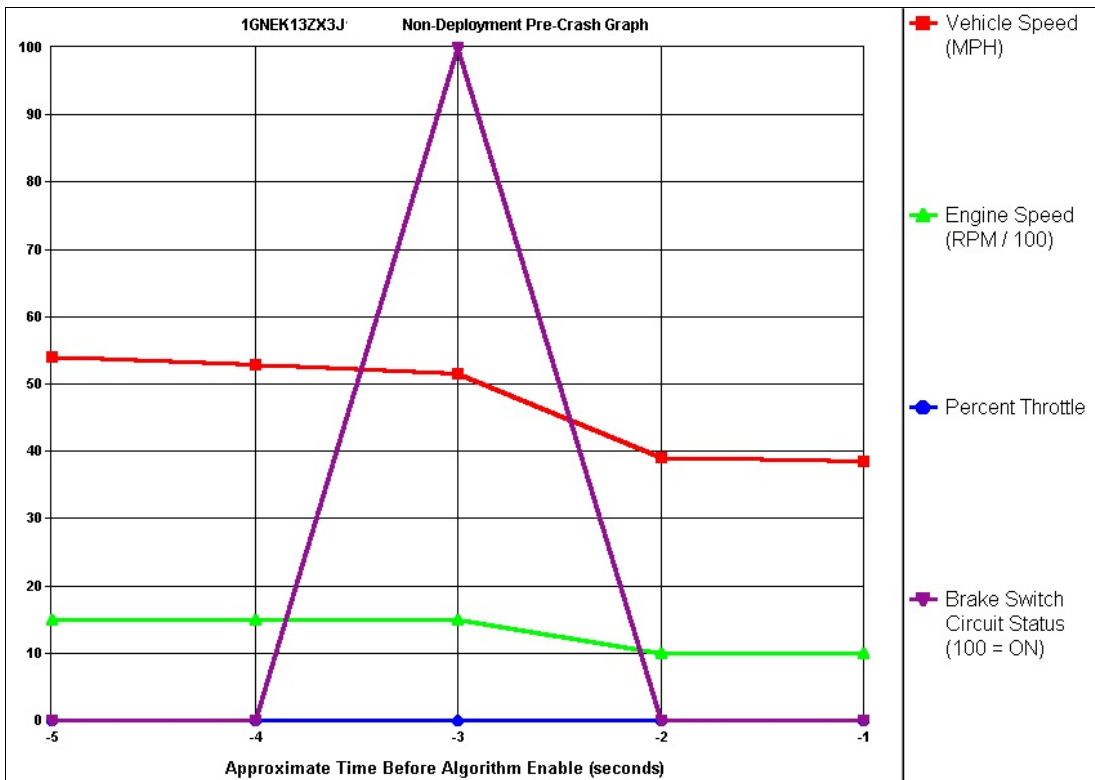
**Figure 37:** Case vehicle's pre-crash speed and brake switch circuit status showing that the vehicle's speed was recorded at 87 km.p.h. (54 m.p.h.), with the brake not activated, at approximately 5 seconds prior to algorithm enable and that the brake had been activated between the 4<sup>th</sup> and 2<sup>nd</sup> recorded sample periods prior to algorithm enable.

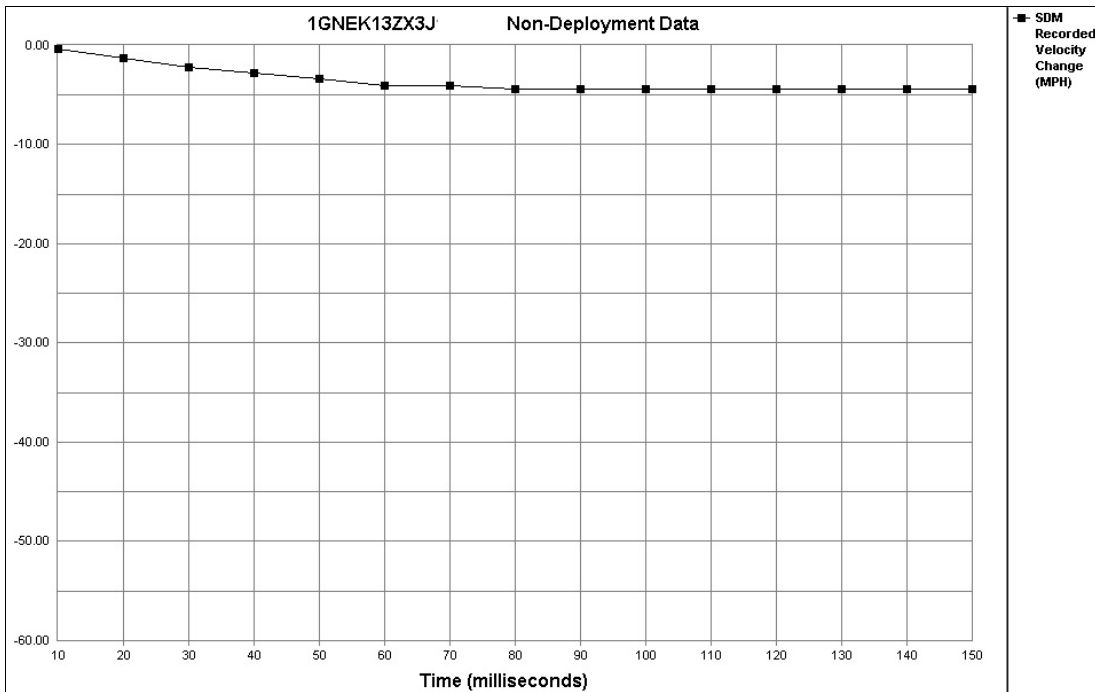
**Figure 38:** The case vehicle sustained a velocity change of approximately 7.0 km.p.h. (4.3 m.p.h.) during the first 150 milliseconds after the algorithm was enabled; maximum velocity change was recorded as 7.1 km.p.h. (4.4 m.p.h.) at 75 milliseconds
