On Site Certified Advanced 208 Complaint Investigation / Vehicle to Vehicle
Dynamic Science, Inc. / Case Number: DS03011
2003 Chevrolet Avalanche K1500
Colorado
March, 2003

Dynamic Science, Inc.
Crash Investigation
Case Number: DS03011

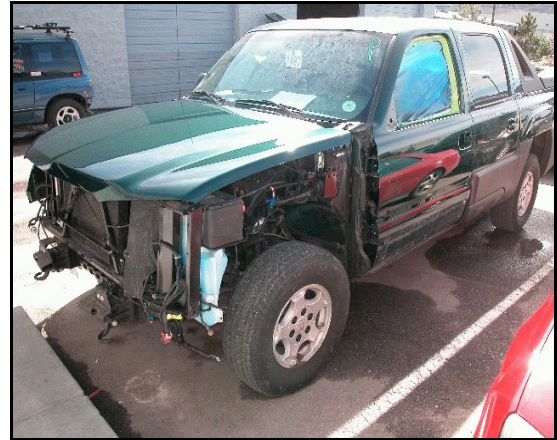
Figure 3. Front left three-quarter view of case vehicle showing vehicle under repair with damaged components removed

The case vehicle was in the process of being repaired so a CDC or crush profile could not be ascertained.

Damage Description: Minor/ Primary Front Left Corner Impact (Highest Delta V):
 Damage noted to front fascia, grille area and the left fender. Front, left side (driver's) window glazing was removed for repairs and found in rear seat area. Glazing did not disintegrate. The left side, rear view mirror was missing. It is probable that this was a result of the initial sideswipe impact.

Minor/Secondary Right Fender Impact: Probable surface abrasions and damage to wheel well area. Damaged components have been removed prior to inspection.

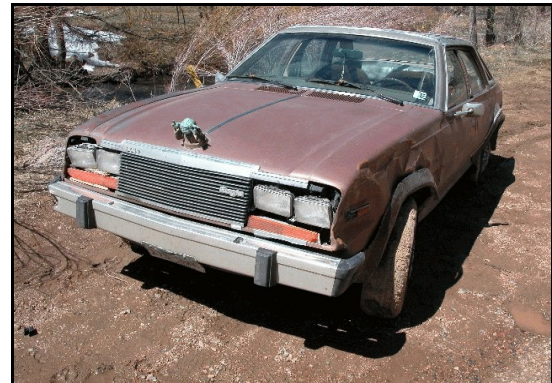
Figure 4. Front left three-quarter view showing left fender damage to other vehicle

Description:	1980 AMC Eagle AWD Four-Door Sedan	
VIN:	A0C355C163404	
Odometer:	Unknown	
Engine:	6 cylinder (258 CID) 4.2 Liter	
Reported Defects:	None Reported	
Cargo:	Unknown	
Damage Description:	<u>Minor/ Left Fender Impact</u> : Minor deformation noted to the left fender and wheel well area.	
CDC:	12FLES6	
Delta V:	Total	Unknown
	Longitudinal	Unknown
	Latitudinal	Unknown
	Energy	Unknown

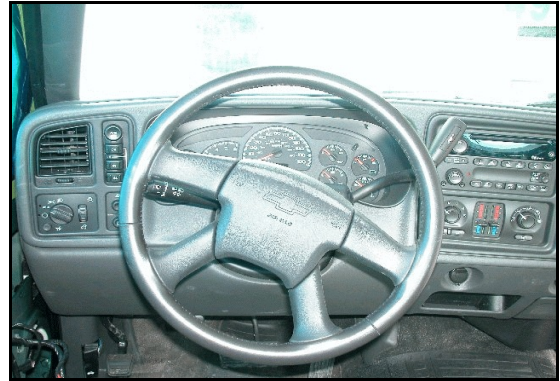
Figure 5. View showing the case vehicle's non-deployed driver's air bag

The case vehicle was equipped with frontal air bags mounted in the steering wheel and mid-mounted in the instrument panel of the front right seat position. The front air bags in the case vehicle did not deploy on impact. The front right passenger air bag includes a “Passenger Sensing System”. The system is designed to automatically switch the air bag on or off based on a passenger’s weight. The system also uses a sensor in the passenger-side seat belt to measure how much tension is exerted by the seat belt when it is being cinched down, another means of determining what may be on the seat.

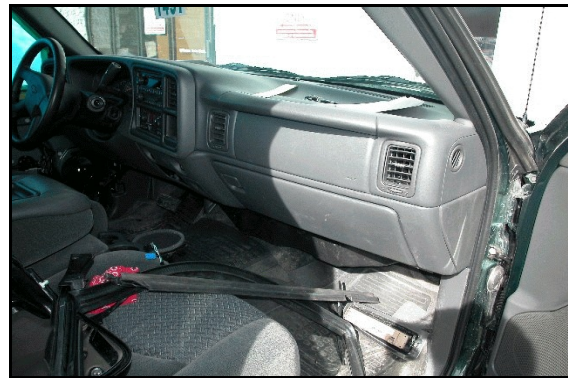
Figure 6. View showing the case vehicle's non-deployed passenger air bag

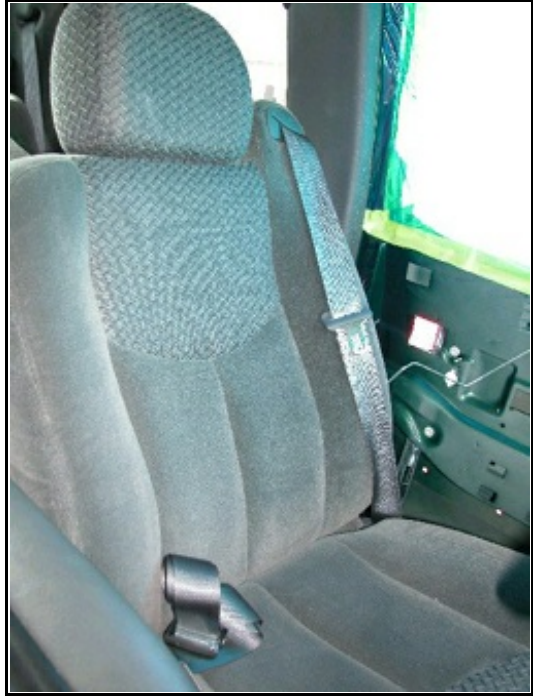
The driver's restraint exhibited evidence of historical use in the form of scratching to the latch plate. There was no evidence of loading. The non-deployment event recorded by SDM reports that the driver's belt switch circuit status was "UNBUCKLED". The front right restraint exhibited evidence of historical use in the form of scratching to the latch plate. There was no evidence of loading to the belt webbing.

Figure 9. Case vehicle driver's seat

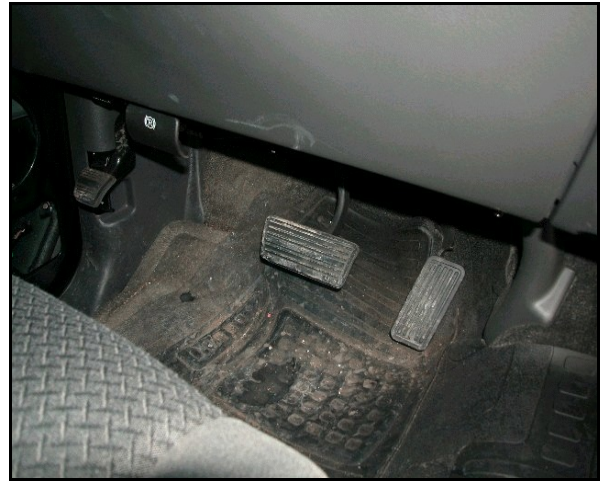
The case vehicle (2003 Chevrolet Avalanche) was void of any intruding components. There were scuff marks noted to the plastic knee bolster cover at the driver's position.

Figure 10. Close-up view showing scuff marks to plastic knee bolster shroud

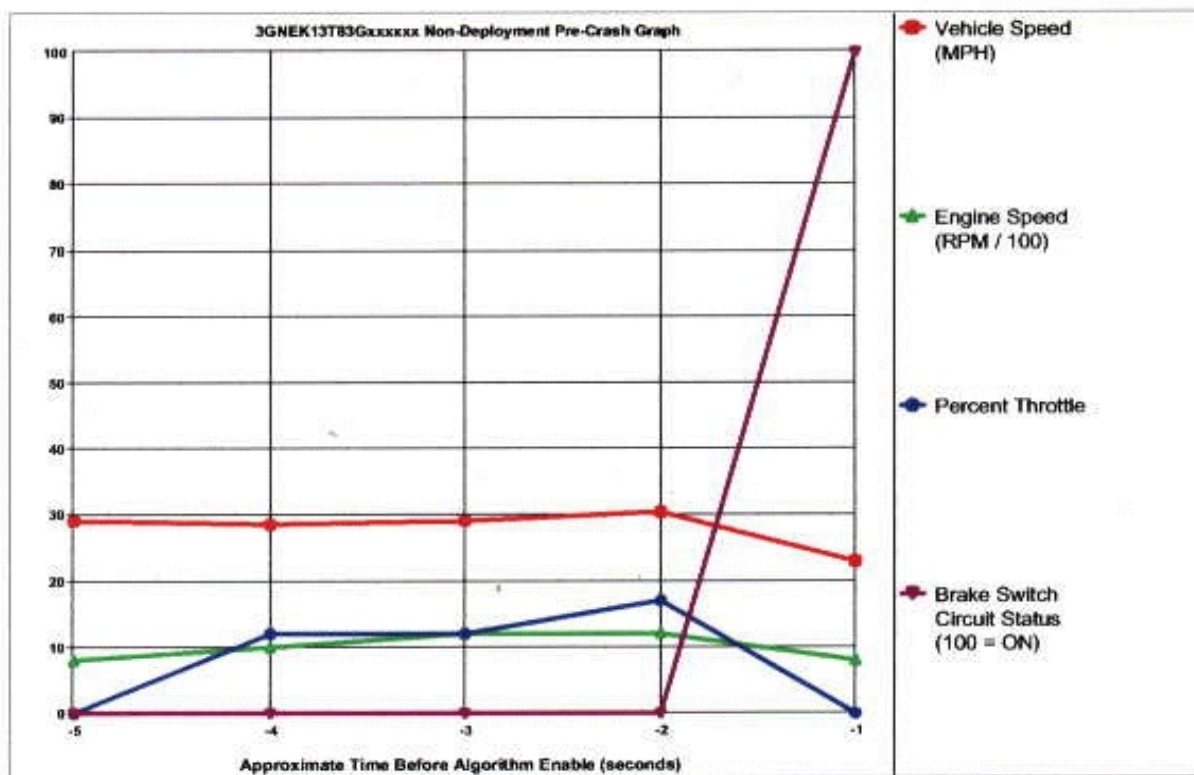
The SDM data indicates that the case vehicle was traveling 37 km/h (23 mph) with the brake switch circuit status on, three seconds prior to algorithm enabled (AE).

Seconds Before AE	Vehicle Speed (MPH)	Engine Speed (RPM)	Percent Throttle	Brake Switch Circuit Status
-5	29	832	0	OFF
-4	29	960	12	OFF
-3	29	1152	12	OFF
-2	30	1216	17	OFF
-1	23	832	0	ON

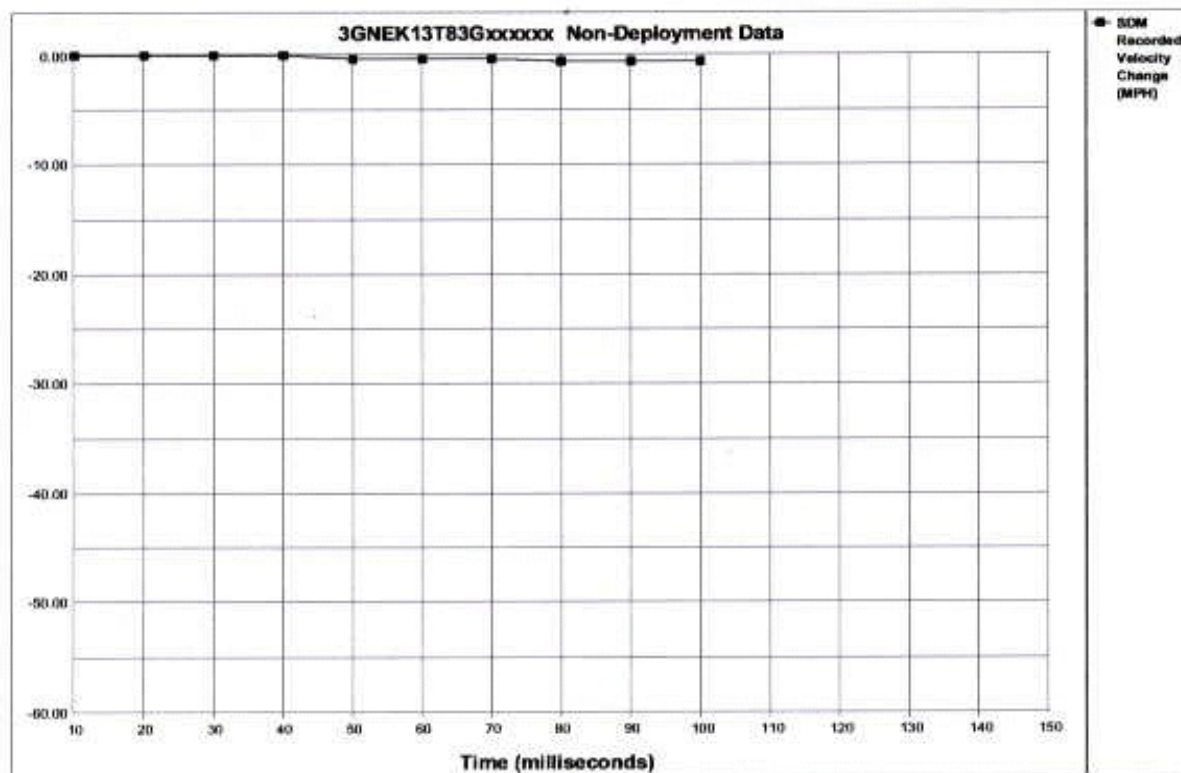
Time (milliseconds)	10	20	30	40	50	60	70	80	90	100	110	120	130	14
Recorded Velocity Change (MPH)	0.00	0.00	0.00	0.00	-0.31	-0.31	-0.31	-0.62	-0.62	-0.62	N/A	N/A	N/A	N
