ON-SITE ADVANCED OCCUPANT PROTECTION SYSTEM INVESTIGATION

CASE NUMBER - IN-03-013
LOCATION - TEXAS
VEHICLE - 2003 LINCOLN NAVIGATOR
CRASH DATE - March 2003

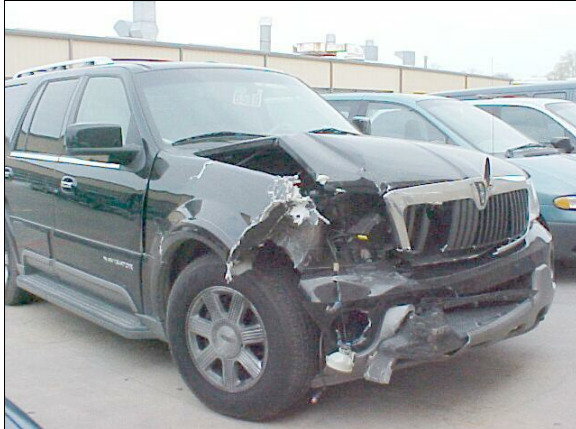
Figure 4: Repair facility photo of case vehicle's frontal damage viewed from right of front, showing damage primarily to front right corner (case photo #16)

Exterior Damage: The case vehicle’s contact with the Pontiac involved the front with the damage distributed on approximately the right half (Figures 4 and 5 above). Direct damage was not measured but, based on the available photographs, it began at the front right bumper corner and extended along the front bumper to the approximate center of the vehicle (Figure 6). Because the vehicle was being repaired, maximum crush was not measured, and it could not be determined if the case vehicle’s wheelbase was altered from the crash. However, measurements of the case vehicle’s wheelbase, track width, and overhangs were in line with manufacturer’s specifications. Based on the repair facility photographs, the case vehicle’s front bumper fascia, grille, hood, right fender, and right headlight, fog light, and turn signal assemblies were directly damaged and crushed rearward. The hood and right fender both sustained induced damage as well.

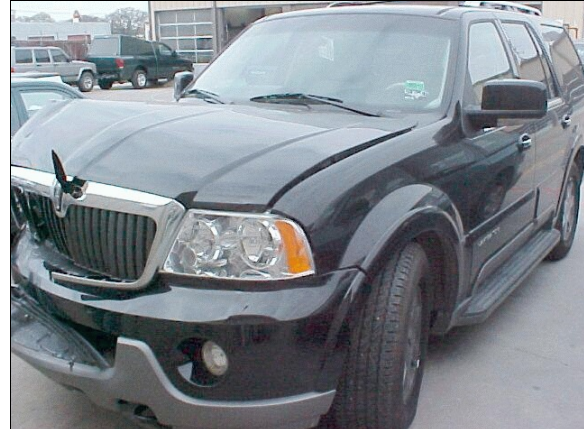
Figure 5: Repair facility photo of case vehicle's frontal damage viewed from left of front, showing that direct damage involved primarily front right half (case photo #10)

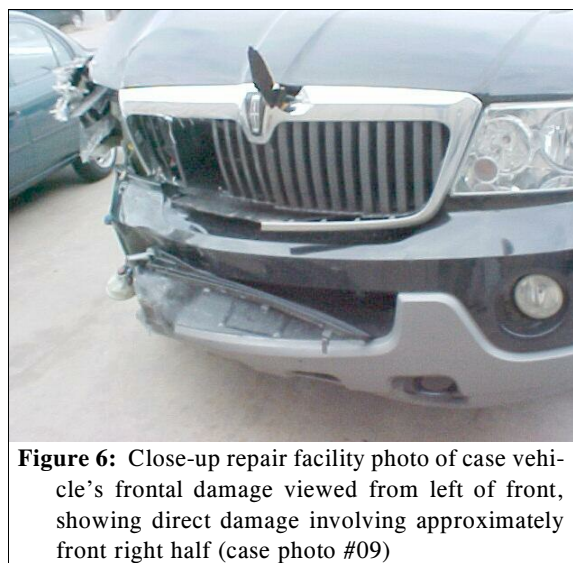
Figure 6: Close-up repair facility photo of case vehicle’s frontal damage viewed from left of front, showing direct damage involving approximately front right half (case photo #09)

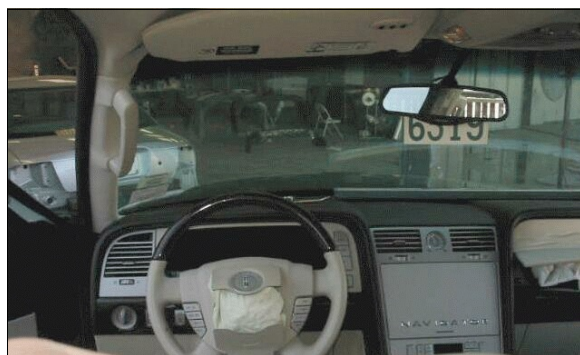
Interior Damage: Inspection of the case vehicle’s interior (**Figures 7 and 8**) revealed that there was no evidence of occupant contact on the interior surfaces of the case vehicle. Furthermore, there was no evidence of intrusion to the case vehicle’s interior, no evidence of compression to the energy absorbing shear capsules in the steering column, and no deformation to the steering wheel rim.

Figure 7: Case vehicle’s driver seating area showing no obvious occupant contact evidence on steering wheel, instrument panel, or greenhouse areas (case photo #20)

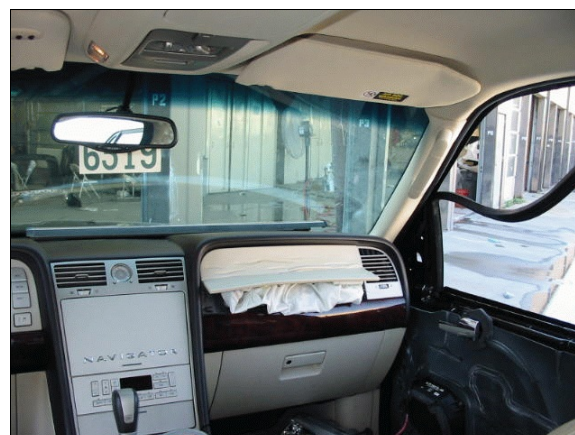
Figure 8: Case vehicle’s front right seating area showing deployed front right air bag and no evidence of occupant contact on instrumental panel, windshield glazing, or greenhouse areas (case photo #26)

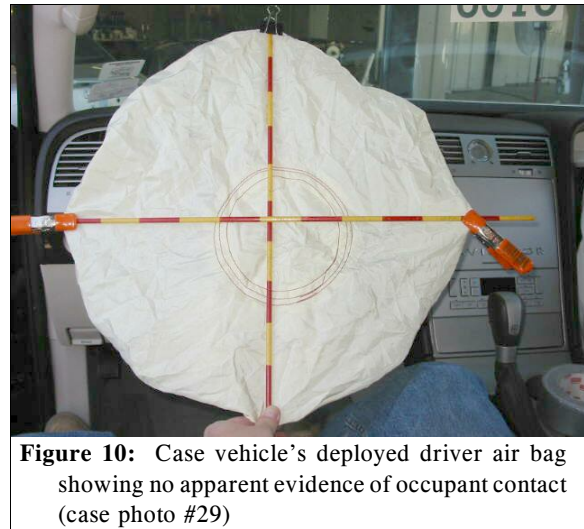
Figure 10: Case vehicle's deployed driver air bag showing no apparent evidence of occupant contact (case photo #29)

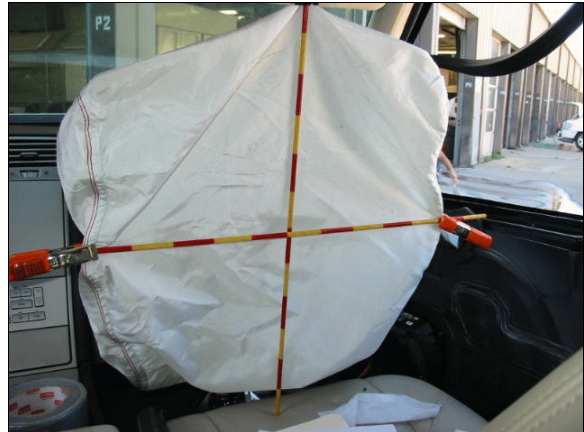
Figure 11: Case vehicle's deployed front right air bag showing no occupant contact evidence (case photo #33)

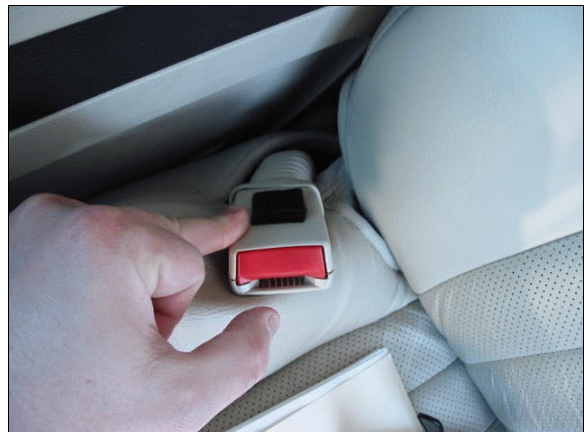
Figure 12: Buckle-mounted pretensioner for case vehicle's driver showing pretensioner actuated (case photo #22)
