**GENERAL DYNAMICS ON-SITE CHILD SAFETY SEAT INVESTIGATION
SCI TECHNICAL SUMMARY REPORT**

CASE NO. CA03-014

VEHICLE – 1993 PONTIAC GRAND AM

CRASH DATE – FEBRUARY 2003

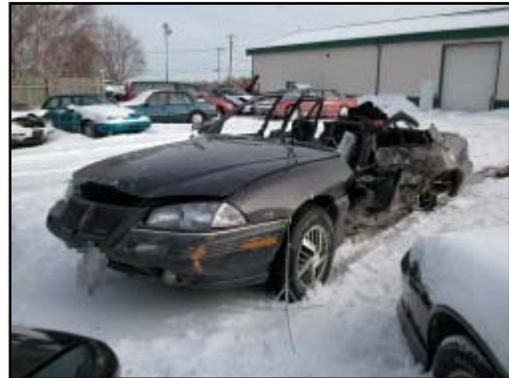
Figure 1. Damaged 1993 Pontiac Grand Am

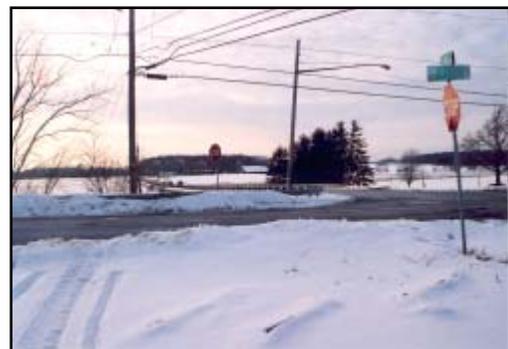
Figure 2. View looking west from the north/south roadway

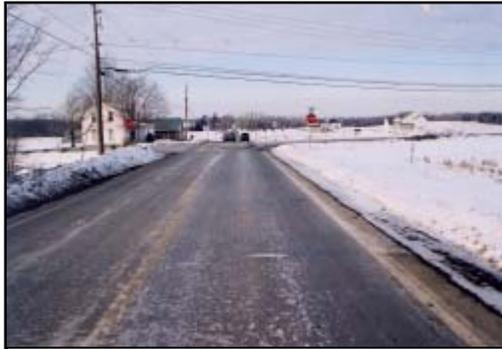
Figure 3. Northbound approach for the Grand Am

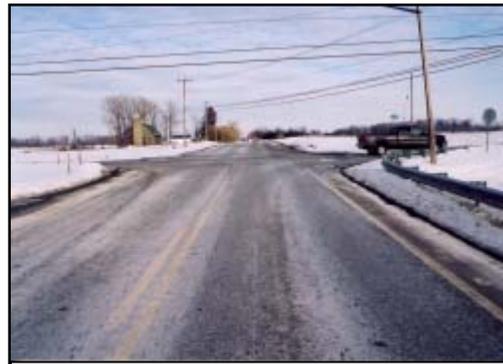
Figure 4. Eastbound approach for the Chevrolet pickup truck

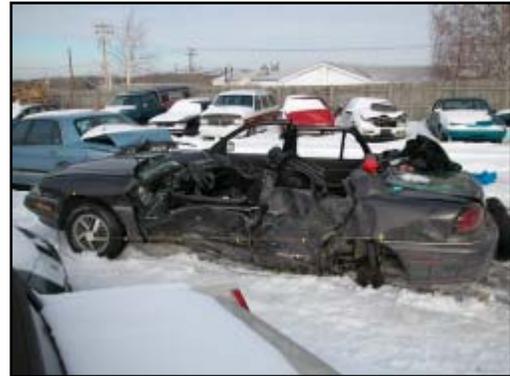
The 1993 Pontiac Grand Am sustained severe left side damage as a result of the impact with the Chevrolet pickup truck (**Figure 5**). The direct contact damage began 2.5 cm (1.0”) forward of the left rear axle and extended 196.9 cm (77.5”) forward along the left side aspect. Both left side doors were crushed laterally and sustained contact abrasions from the bumper of the pickup truck. The left sill was crushed laterally and displaced slightly upward at the forward aspect. The maximum crush was vertically located 34.3 cm (13.5”) below the belt line on the left doors. The combined direct and induced damage began 5.1 cm (2.0”) aft of the left rear axle and extended 274.3 cm (108.0”) forward along the left side aspect. The left side cladding was separated from the exterior door panels. The left rear wheel was sheared from the suspension components. The vehicle also sustained damage from rescue personnel’s extrication of the occupants. All of the pillars were cut and the roof was removed. The rear aspect of the left front door was deformed outward as a result of hydraulic spreaders attempting to open the door. Minor deformation was noted on the rear aspect of the left front fender and left rear quarter panel. The Collision Deformation Classification for the impact with the Chevrolet pickup truck was 10-LPAW-3. Six crush measurements were documented at the mid-door level and were as follows: C1 = 0.0 cm, C2 = 40.0 cm (15.8”), C3 = 45.7 cm (18.0”), C4 = 31.1 cm (12.3”), C5 = 12.4 cm (4.9”), C6 = 0.0 cm.

Figure 5. Left side damage to the Grand Am

The left side cladding was separated from the exterior door panels. The left rear wheel was sheared from the suspension components. The vehicle also sustained damage from rescue personnel’s extrication of the occupants. All of the pillars were cut and the roof was removed. The rear aspect of the left front door was deformed outward as a result of hydraulic spreaders attempting to open the door. Minor deformation was noted on the rear aspect of the left front fender and left rear quarter panel. The Collision Deformation Classification for the impact with the Chevrolet pickup truck was 10-LPAW-3. Six crush measurements were documented at the mid-door level and were as follows: C1 = 0.0 cm, C2 = 40.0 cm (15.8”), C3 = 45.7 cm (18.0”), C4 = 31.1 cm (12.3”), C5 = 12.4 cm (4.9”), C6 = 0.0 cm.

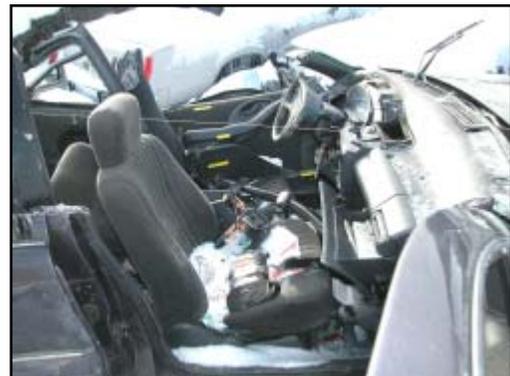
Interior damage to the 1993 Pontiac Grand Am was moderate and attributed to passenger compartment intrusion and occupant contact (**Figure 6**). The left front and left rear doors were jammed shut. The right side doors were opened post-crash by rescue personnel and would not close at the time of the vehicle inspection. The windshield was removed by rescue personnel. The left side glazing disintegrated as a result of the impact with the pickup truck. The backlight and right side glazing was disintegrated, but it was unknown if it was crash-related or due to extrication efforts. The top half of the steering wheel rim was cut by rescue personnel. The interior aspect of the left front door and left front arm rest were deformed as a result of occupant contact. Deformation to the arm rest measured 3.8 cm (1.5”) in length, and was located

Figure 6. View of front seating positions and occupant contacts

15.2 cm (6.0”) forward of the rear aspect of the arm rest and 22.9 cm (9.0”) below the belt line. The driver’s seat back was deflected rearward and laterally as a result of the impact and driver loading. The outboard aspect of the driver’s head restraint was located at the centerline of the vehicle and the top aspect of the seat back was engaged against the right aspect of the CSS. The left instrument panel was deformed as a result of the passenger compartment intrusion.

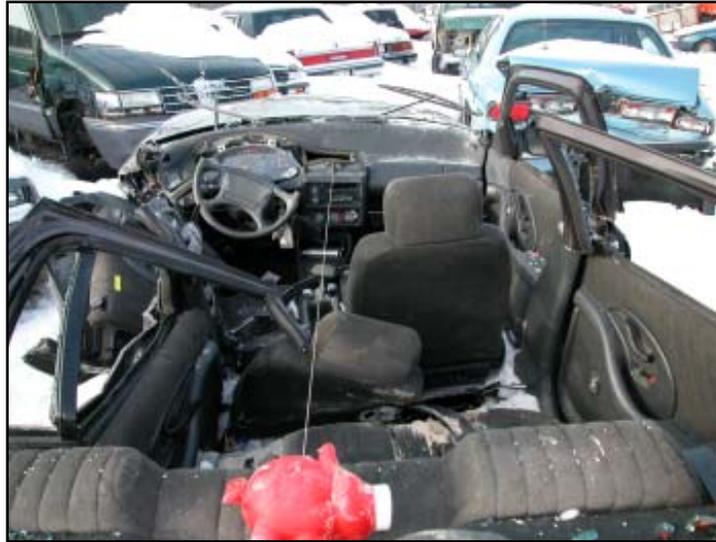
Figure 7. View from rear showing left side intrusions

Multiple intrusions (**Figure 7**) that resulted from the impact were documented as follows:

Position	Intruded Component	Intrusion	Direction
FL	Left front door	24.1 cm (9.5”)	Lateral
FL	Left front door arm rest	26.0 cm (10.3”)	Lateral
FL	Left sill (at B-pillar)	22.9 cm (9.0”)	Lateral
RL	Left B-pillar	34.0 cm (13.4”)	Lateral
RL	Forward aspect of left rear door	39.4 cm (15.5”)	Lateral
RL	Left rear door arm rest	35.6 cm (14.0”)	Lateral
RC	Left front seat back	22.9 cm (9.0”)	Longitudinal
FL	Kick panel	15 – 30 (6 – 11.8”)	Lateral

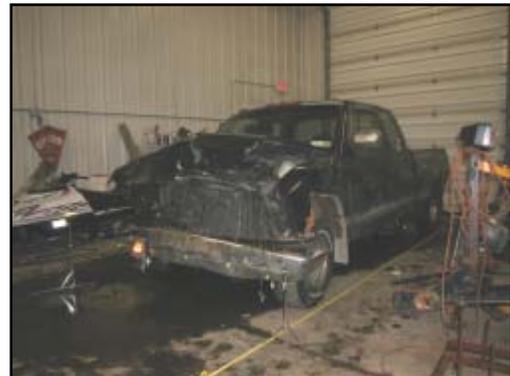
The 1991 Chevrolet Silverado pickup truck sustained moderate frontal damage as a result of the impact with the Grand Am (**Figure 8**). The direct damage began 61.0 cm (24.0”) left of the centerline and extended 152.4 cm (60.0”) laterally across the frontal plane. The combined direct and induced damage involved the entire frontal width of the vehicle. The leading edge of the hood was abraded from direct contact and was buckled rearward. Both head lamps and grille trim were separated. The bumper trim was separated and the bumper was crushed rearward. Both front fenders were buckled rearward. The frontal crush resulted in the reduction of the right wheelbase by 7.9 cm (3.1”). The bumper and front structure sustained lateral end shifting to the left as a result of the Grand Am’s forward momentum during the crash. The left corner was displaced 19.1 cm (7.5”) to the left and the right corner was displaced 30.5 cm (12.0”) to the left. The CDC for the frontal impact with the Grand Am was 01-FDEW-2. The CDC was incremented by 80 to reflect the front end shift to the left, which resulted in a CDC of 81-FDEW-2. Six crush measurements were documented along the front bumper and were as follows: C1 = 33.0 cm (13.0”), C2 = 25.4 cm (10.0”), C3 = 27.9 cm (11.0”), C4 = 27.9 cm (11.0”), C5 = 30.5 cm (12.0”), C6 = 50.8 cm (20.0”).

Figure 8. View of frontal damage to the Chevrolet pickup truck

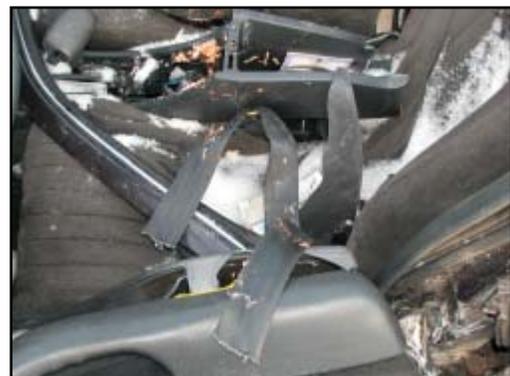
The 1993 Pontiac Grand Am was configured with automatic 3-point, door-mounted, lap and shoulder belts for the front seat positions. Fixed D-rings were present on the door frames and the safety belts were configured with Emergency Locking Retractors (ELR’s) and sewn-on latch plates. The driver’s latch plate was still buckled at the time of the vehicle inspection. Both the lap and shoulder belt webbing had been cut by rescue personnel with the remainder of the webbing retracted into the left front door (**Figure 9**). The length of the cut lap belt measured 23.5 cm (9.3”) from the latch plate and the length of the cut shoulder belt measured 58.4 cm (23.0”) from the latch plate. The right front safety belt was retracted in the right front door and the shoulder belt webbing was cut by rescue personnel during the removal of the roof.

Figure 9. View of cut driver's safety belt

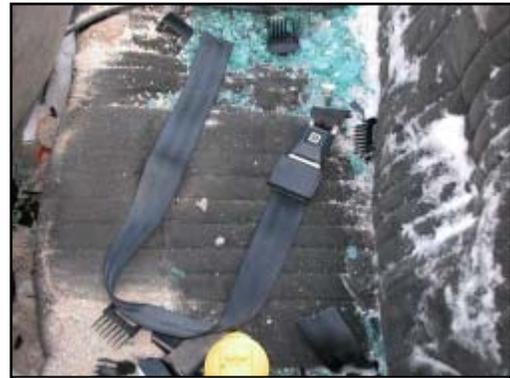
The outboard rear seating positions in the Grand Am were configured with manual 3-point lap and shoulder belts with ELR's and locking latch plates. The rear center position was configured with a lap belt with a locking latch plate. The rear center safety belt was used to secure the forward-facing convertible CSS in the vehicle and was cut by rescue personnel (**Figure 10**). The cut belt webbing measured 85.1 cm (33.5") from the cut line at the locking bar in the latch plate to the end of the webbing. The remaining webbing measured 10.8 cm (4.3") above the seat cushion to the cut point.

Figure 10. View of rear center cut lap belt

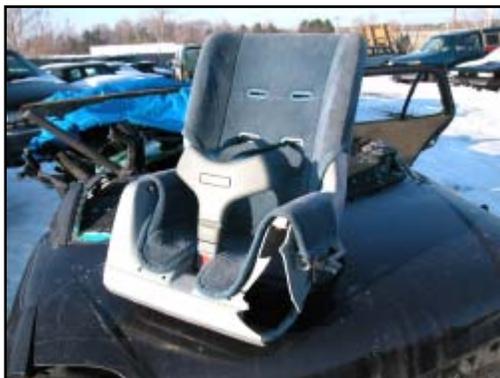
A Fisher-Price Model 9101 convertible CSS was installed in the rear center position of the Grand Am. The CSS did not display a manufacture date and was not configured with a tether or LATCH clips. The CSS was an older model constructed of metal tube framework, a plastic shell and a T-shield (**Figure 11**). The instructions and informational labels present on the rear aspect of the CSS were ripped and partially readable. The CSS label stated that the CSS was designed for children who weighed 18 kg (40 lb) or less and who measured 102 cm (40") or less in height. Six NHTSA recalls were identified for the Fisher-Price Model 9101 CSS with production dates ranging from April 1985 through January 1992.

Figure 11. Fisher-Price Convertible CSS

In the forward facing orientation, the CSS sustained fractures on the front left lower aspect of the plastic shell. The fracture measured 11.1 cm (4.4”) along the bottom edge on the left aspect, 19.1 cm (7.5”) vertically on the left aspect, and extended 7.0 cm (2.8”) along the front face.

The rear aspect of the right lower harness slot exhibited loading evidence from the harness system. The plastic around the perimeter of the harness slot was stressed and discolored on the inboard aspect.

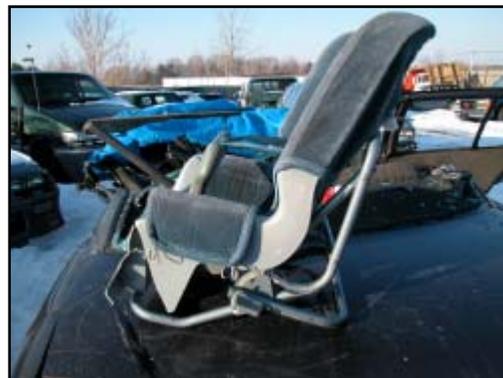
The convertible CSS was configured with a metal kickstand with three available recline positions labeled, "Infant Rear Facing", "Semi-Reclined", and "Upright." At the time of the CSS inspection, the kickstand was positioned in the "Semi-Reclined" position (**Figure 12**).

Figure 12. Left side view of the CSS showing kickstand position

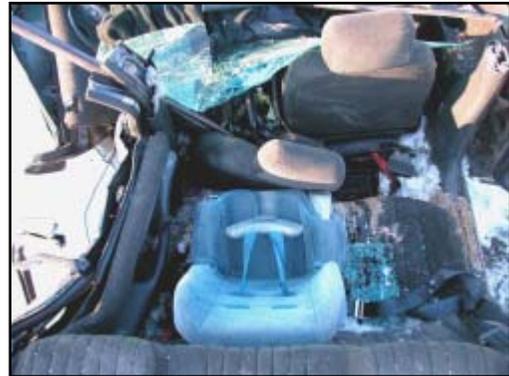
At the time of the vehicle inspection, the CSS was placed on the rear center position of the Grand Am (**Figure 13**). Due to the passenger compartment intrusion, the static distance between the left aspect of the installed CSS and the left rear door arm rest was 9.3 cm (3.6”), assuming the CSS was tightly installed. The static distance from the right aspect of the CSS to the right rear door arm rest was 41.6 cm (16.4”). The rear right aspect of the driver’s seat back was engaged with the front right aspect of the CSS as a result of the driver’s seat back deflection.

Figure 13. View of CSS in the rear center position of the Grand Am
