On Site Advanced Occupant Protection Investigation / Vehicle to Vehicle  
Dynamic Science, Inc. / Case Number: DS03014  
2001 Ford Crown Victoria  
Arizona  
March, 2003

1. Report No. DS03014	2. Government Accession No.	3. Recipient Catalog No.	
4. Title and Subtitle  Advanced Occupant Protection Investigation		5. Report Date October 11, 2004

**Dynamic Science, Inc.  
Crash Investigation  
Case Number: DS03014**

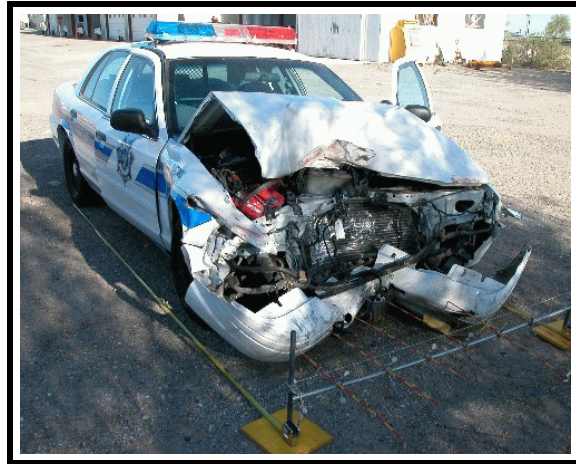
Figure 3. Front right, case vehicle

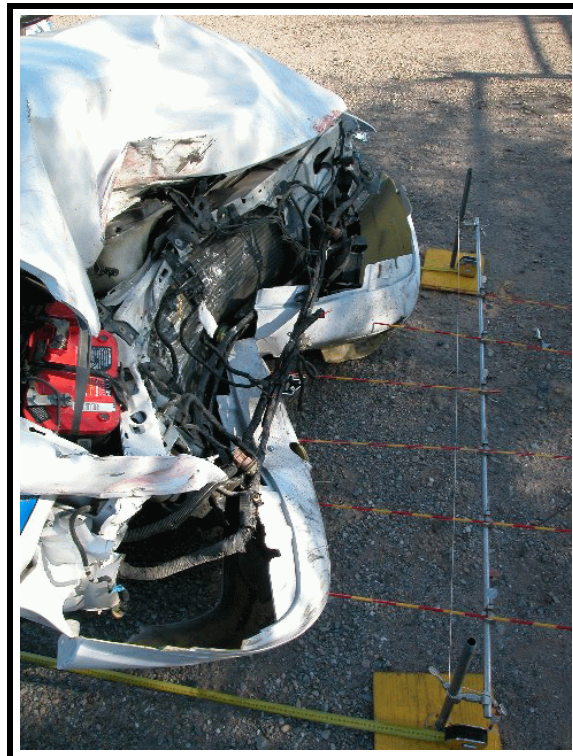
Figure 4. Right side, side view of crush

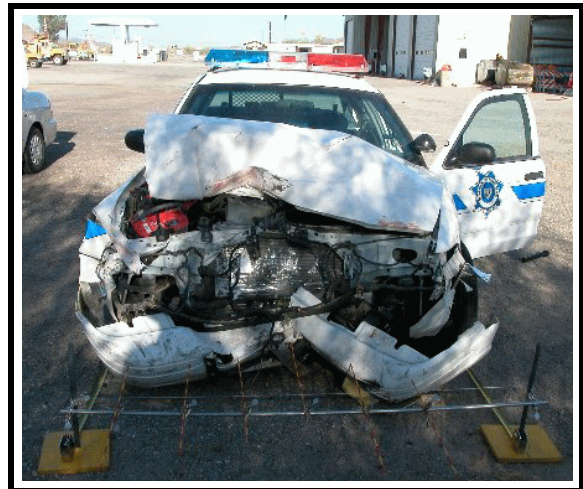
**Figure 7.** Front, case vehicle

Damage Description:	Moderate front end. Damage to bumper, backing bar, grille, hood.	
CDC:	11FDEW2	
Delta V <sup>2</sup> :	Total	42.0 km/h (26.1 mph)
	Longitudinal	-36.4 km/h (-22.6 mph)
	Latitudinal	21.0 km/h (13.0 mph)
	Energy	177,301 joules (130,770 ft lbs)

The Crown Victoria sustained moderate damage to the entire front end. The direct damage started at the front right bumper corner and extended laterally for 131.0 cm (51.5 in). The Crown Victoria underrode the Freightliner which allowed the hood and grille area to sustain direct contact damage. There was damage to the radiator and upper and lower radiator supports. The right front door was jammed shut. Both front fenders sustained inducted buckling. Six crush measurements were taken along the bumper face and were as follows: C1=2.0 cm (0.8 in), C2=25.0 cm (9.8 in), C3=61.0 cm (24.0 in), C4=42.0 cm (16.5 in), C5=51.0 cm (20.0 in), C6=15.0 cm (5.9 in).

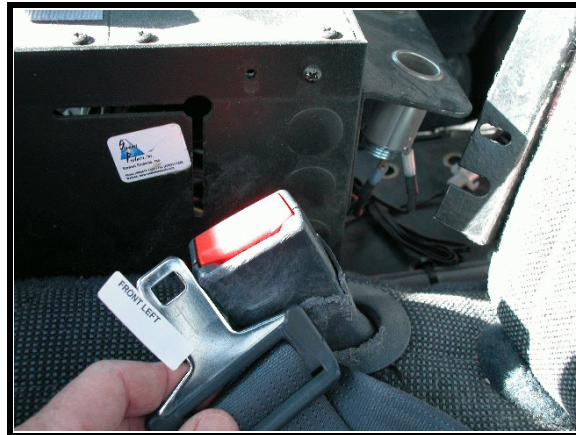
Figure 8. Driver's seat belt

The Crown Victoria was configured with manual 3-point lap and shoulder belts with sliding latch plates for both front seat positions. The front seat restraints were configured with adjustable shoulder belt anchorages. Both anchorages were adjusted to the full down position. Both front seat belts were equipped with pretensioners. The retractors were located in the lower B pillars. The driver's seat belt pretensioner did actuate during the crash.

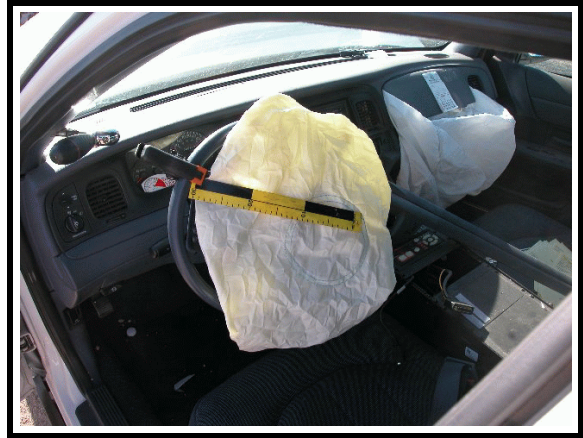
Figure 10. Driver's air bag

The case vehicle was equipped with a driver's air bag and a front right passenger's air bag. The driver's steering wheel mounted air bag was circular and measured 50.0 cm (19.7 in) in diameter. It was equipped with two tethers and two vent ports. The vent ports were at the 11 and 1 o'clock positions. The single module cover opened in a "U" configuration. There were no indications of damage or contact to either the air bag or the module cover. The front right passenger's mid mounted air bag was rectangular and measured 42.0 cm (16.5 in) wide from seam to seam and 56.0 cm (22.0 in) high. There was a single vent port on the left side. The single flap module cover opened vertically. On the face of the air bag was cover-related scuffing. The module cover did not sustain any damage or contact.

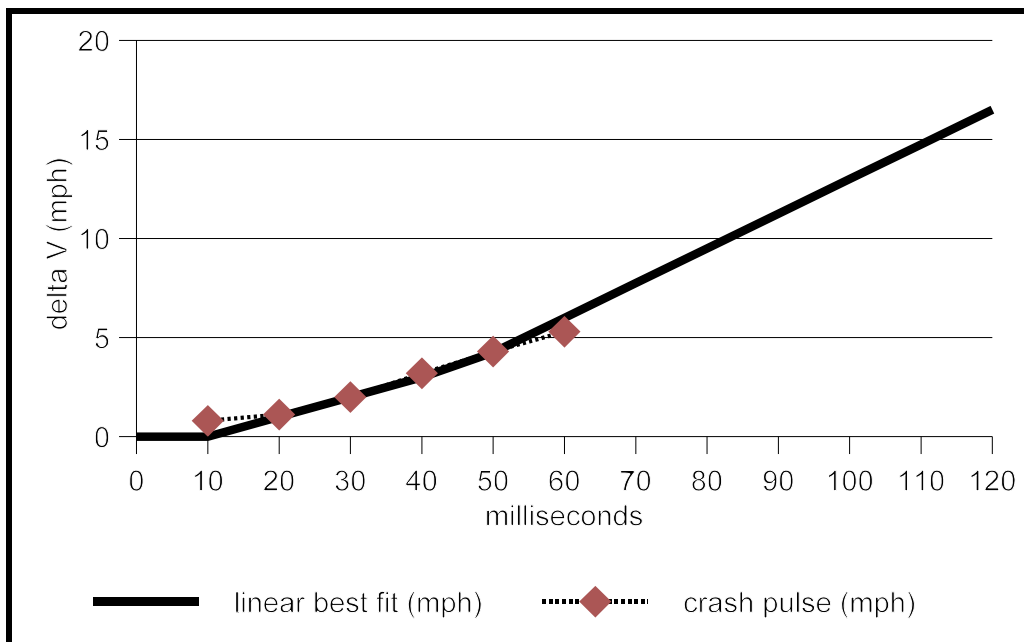
**Figure 12.** Linear best fit projection

The downloaded data indicates a cumulative longitudinal delta V of 8.5 km/h (-5.3 mph) at the 56.8 ms mark. The results are low and incomplete. It appears that the power was interrupted to the RCM during the recording of data and a partial recording occurred. This is shown as “no data” in the data table and is not plotted on the graph of acceleration. When some portion of the acceleration data is not recorded, the delta V during that time is not calculated. A delta V is calculated for the points that are valid but the partial delta V calculated will underestimate the actual event total delta V.

A linear best fit projection indicated a trend that would have put the delta v at 26.5 km/h (16.5 mph) at the 120 ms mark. This projection is essentially an approximation that indicates that the delta V had an upward trend when the recording stopped.

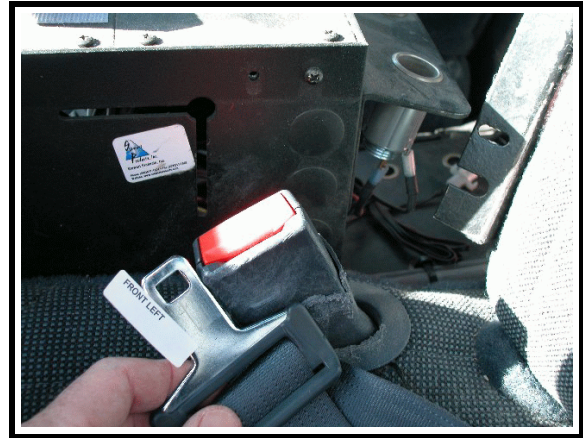
**Figure 13.** Driver's seat belt latch

There is some conflicting information regarding the status of the passenger pretensioner and the second stage deployment times. Both front seat positions of the case vehicle were equipped with seat belt pretensioners. The retractors are located in the lower B pillars. It appears that the driver's seat belt pretensioner fired and the passenger's did not, which is consistent with no passenger seated in the front right seat. The system status indicator in the Vetronix report indicated a "fire" for the passenger pretensioner. There are times given for second stage deployment, but the system status indicates "no fire" for both sides.

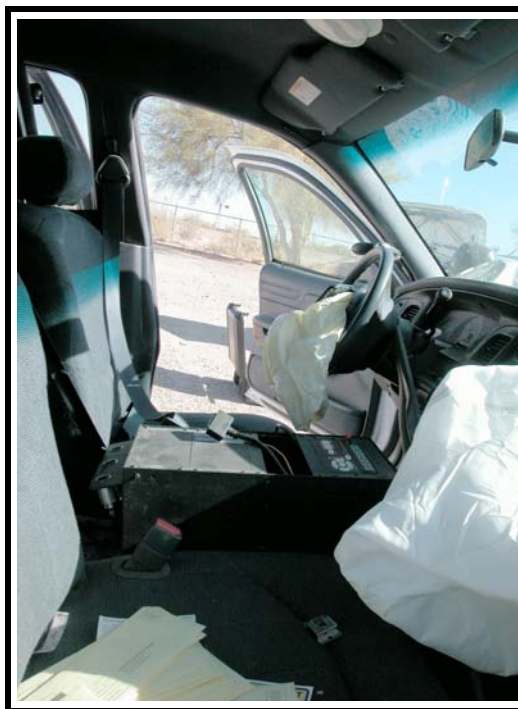
Figure 15. Driver's seated area

The 29-year-old male driver of the case vehicle was seated in a normal, upright fashion on the fabric covered bucket seat. The seat had been adjusted to the rear most track position. The seat back was slightly reclined. The driver was wearing the available 3-point lap and shoulder belt. The manual shoulder belt upper anchorage was in the full down position. The front seat belts were equipped with B-pillar mounted pretensioners and emergency locking retractors. The driver was wearing his protective vest. The driver was involved in a turning maneuver. His left hand was below his right. His right foot was on the accelerator, his left was on the floor. At impact, the front air bags deployed and the outboard seat belt pretensioners actuated. The driver responded to the 11 o'clock direction of force by exhibiting a slightly left of forward trajectory and loading the pretensioned and locked manual restraint system—causing a contusion on the left side of his chest and the lumbar and thoracic strains. The driver's face likely contacted the deployed air bag, but there were no indications of any contact to the air bag. The driver did sustain a burn/abrasion to the top of his left hand that was likely caused by the deploying driver's air bag flinging his hand into the door side panel. He was able to exit the vehicle on his own. He refused treatment at the scene but did seek medical treatment three hours after the crash.
