ODI Potential Air Bag Failure Investigation / Vehicle to Object
Dynamic Science, Inc. / Case Number: DS03022
2002 Honda Civic
Texas
April, 2003

1. Report No. DS03022	2. Government Accession No.	3. Recipient Catalog No.	
4. Title and Subtitle ODI Potential Air Bag Failure Investigation		5. Report Date May 22, 2004

Dynamic Science, Inc.
Crash Investigation
Case Number: DS03022

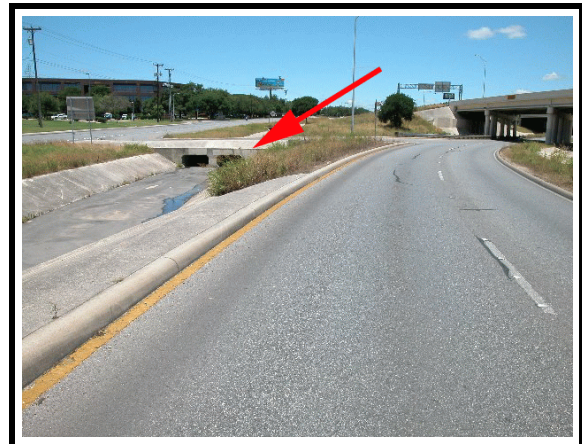
Figure 1. Area of road departure. Impact is marked with red arrow.

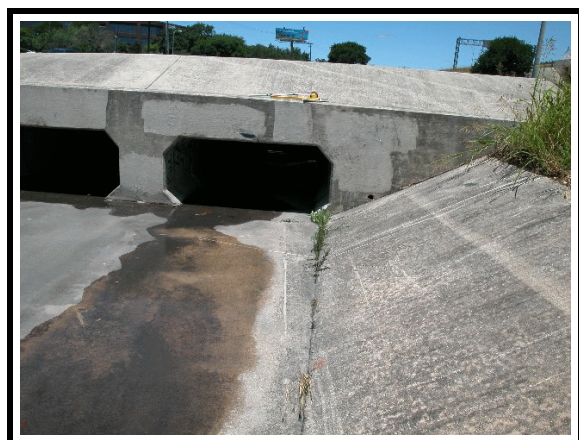
Figure 2. Area of impact

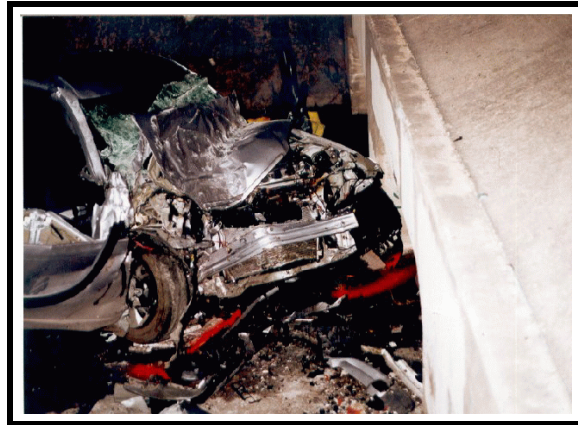
Figure 3. Case vehicle at final rest

The case vehicle rotated clockwise after impact and came to rest in the culvert facing northeast. Both occupants were fatally injured. They were extricated from the vehicle by paramedics and firefighters while at the scene.

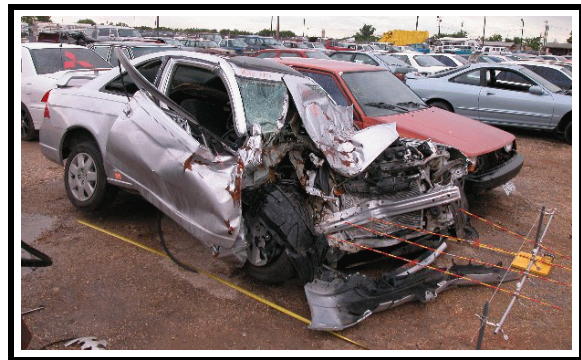
Figure 4. Front right, case vehicle

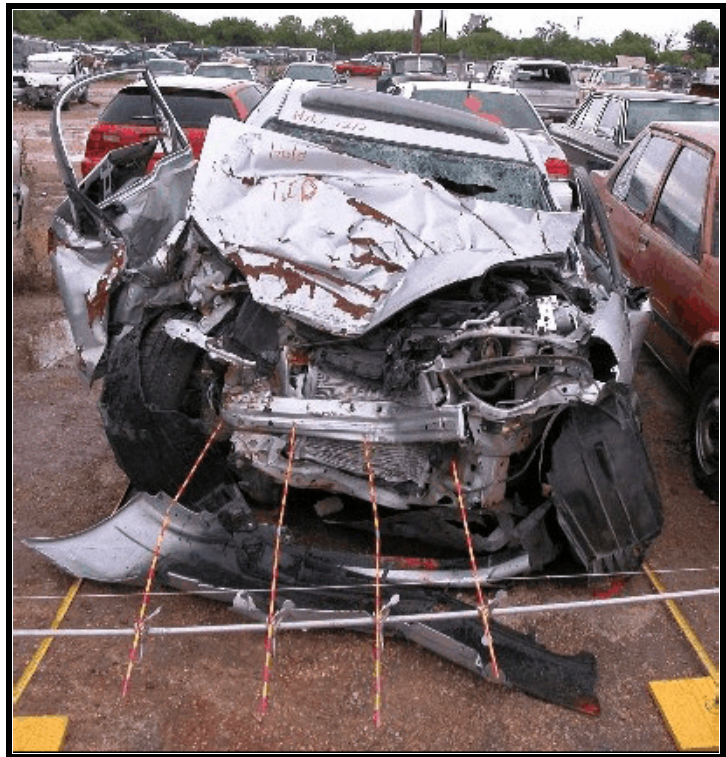
Damage Description:	Major front end damage. Vehicle towed from the scene.		
CDC:	12FZEW6		
Delta V:	Total	84.0 km/h (52.2 mph)	
	Longitudinal	-84.0 km/h (-52.2 mph)	
	Latitudinal	0 km/h (0 mph)	
	Energy	338,575 joules (249,720 ft-lbs)

The frontal impact with concrete support structure resulted in severe front end damage to the 2002 Honda Civic. The damaged components for this impact included the bumper fascia and reinforcement bar, upper and lower radiator supports, and hood. There was vertically displaced crease that began at the front right of the hood and extended diagonally to the rear left of the hood that was a result of the vehicle pitching into the top of the open concrete structure. The direct damage to the end plane began at the front right bumper corner and extended 59.0 cm (23.2 in) laterally. The residual crush measured along the bumper reinforcement bar was as follows: C1=3.0 cm (14.2 in), C2=100.0 cm (39.3 in), C3=108.0 cm (42.5 in), C4=111.0 cm (43.7 in). The maximum crush was located at C4. The principle direction of force was within the 12 o'clock sector and was an estimated 000 degrees. Both front wheels sustained rim damage and were flattened by the impact. Both front tires were physically restricted. The wheelbase was shortened by 58.0 cm (22.8 in) on the right side and by 2.0 cm (0.8 in) on the left. The right front door was likely jammed shut and later pried open by rescue personnel.

Figure 5. Front view, 2002 Honda Civic

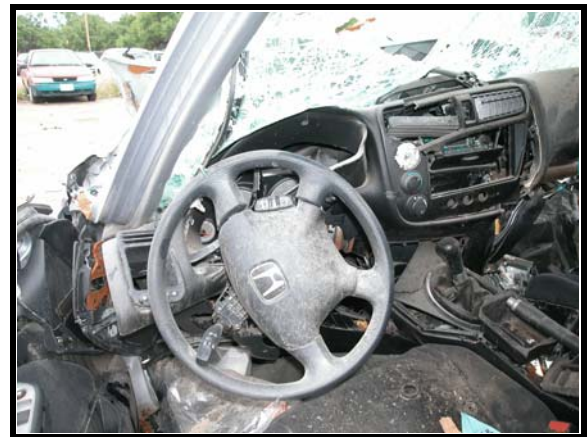
Interior damage to the Civic was severe and attributed to occupant contact and passenger compartment intrusion. The entire windshield was fractured from impact forces. The glazing at the left front and right front doors was disintegrated. There was steering wheel, instrument panel, and toe pan longitudinal intrusion to the front left seating area. The maximum intrusion came from the steering wheel. The steering wheel rim was not deformed, but steering column had broken loose so the steering column could be moved up and down 7.6-12.7 cm (3.0-5.0 in). It was shifted to the left at the time of the inspection. There was deformation to the knee bolsters on both sides of the steering wheel. The front right passenger, although restrained by the manual belt system, loaded the lower instrument panel with both knees. There was instrument panel, toe pan, and A-pillar longitudinal intrusion to the front right seating area. The maximum intrusion was to the toe pan and measured 40.0 cm (15.7 in). There was also vertical intrusion through the bottom right side floor due to vehicle body buckling. There were significant contacts to the right instrument panel. The rear view mirror was knocked off.

Figure 6. Overview of interior damage, left to right

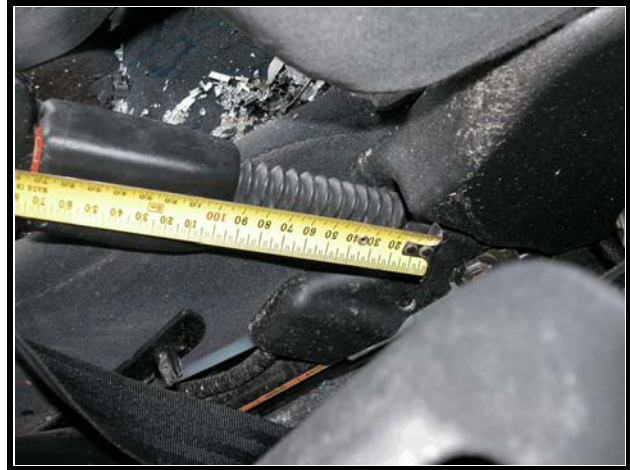
The Civic was configured with manual continuous loop 3-point lap and shoulder belts for both front positions and all three rear seat positions. All the seat belts were equipped with sliding latch plates. The driver's seat belt was equipped with an emergency locking retractor. The front right passenger's seat belt and all three rear seat belts were equipped with switchable retractors (retractors that can be changed from an emergency locking retractor to an automatic locking retractor to assist in securing child seats). The driver's seat belt was not in use at the time of the crash. The front right passenger was properly restrained by the manual belt system. At impact, this occupant loaded the seat belt and caused heavy abrasions to the webbing near the latch. Additionally, rescue personnel cut the belt at both the lap and shoulder levels. The seat belt pretensioners were located in the driver and passenger side lower B-pillars and the front seat inner seat belt buckles. The pretensioners did not actuate.

Figure 7. Front right seat belt with no pretensioner compression

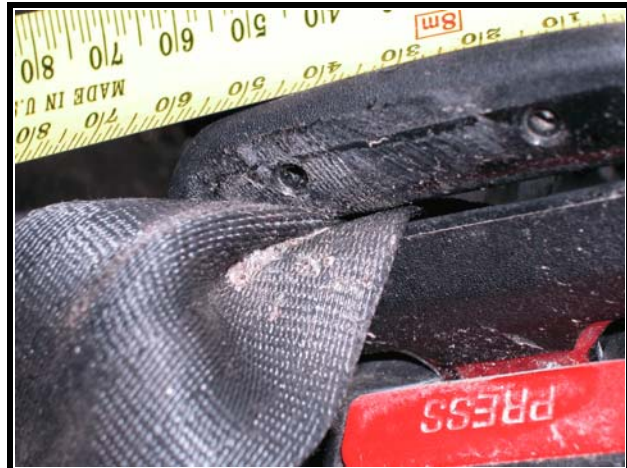
Figure 8. Loading to front right seat belt at latch

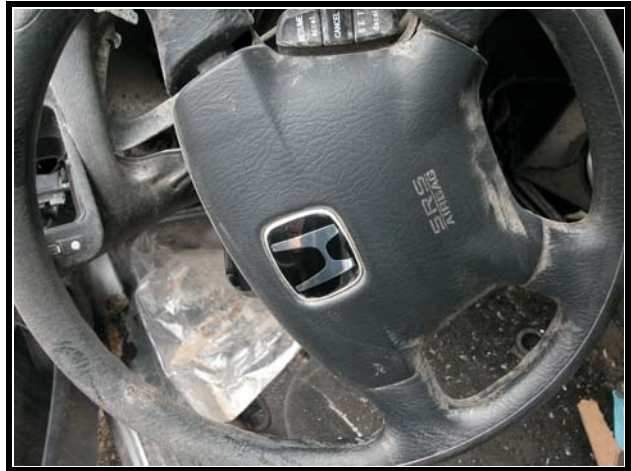
Figure 9. Non-deployment of driver's air bag

There were no air bag deployments and neither front seat belt pretensioner actuated. The reason for this is not known. There was some discussion that the pitch/roll angle of the vehicle at impact may have influenced the sensor, but Honda indicated to NHTSA that this should not be a factor. As indicated earlier, the vehicle was purchased new and has been in the possession of its original owners since that time. There were no indications of any prior crashes or repairs.

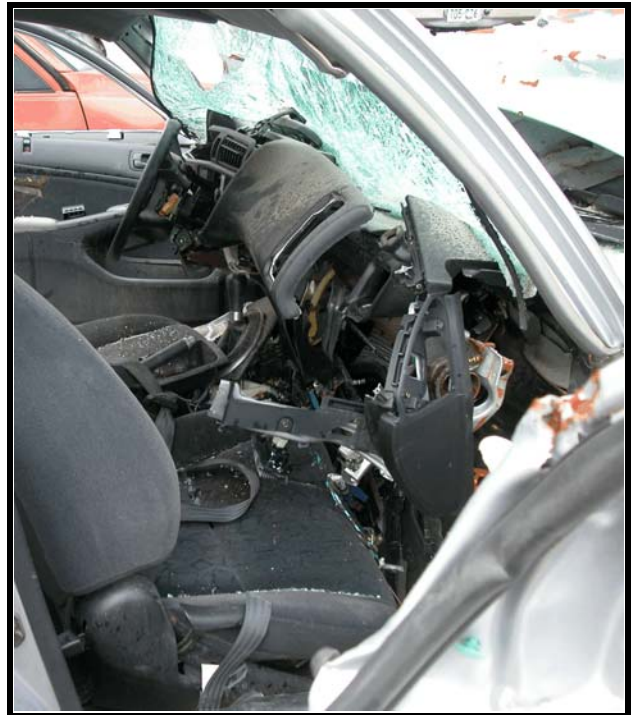
Figure 10. Non-deployment of front right passenger's air bag.

The most likely reason would appear to be related to the sudden loss of battery power at impact. The initial point of impact was on the right corner and involved the right front impact sensor. The battery was located on the right side, just above the sensor area. Both were damaged during the crash.

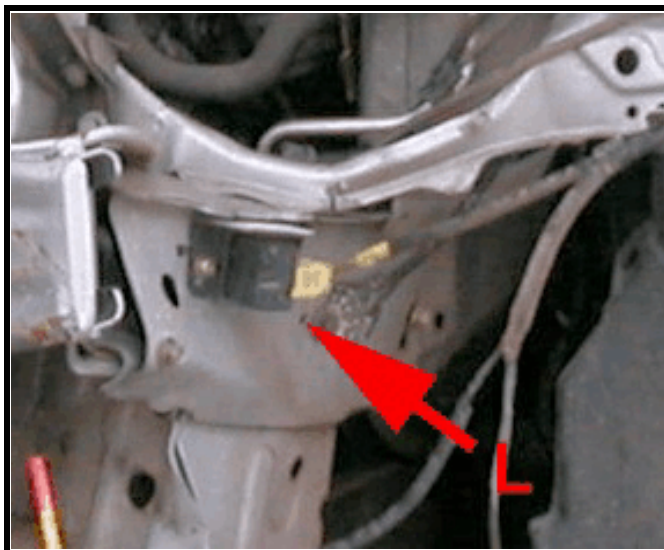
Figure 11. Left front impact sensor

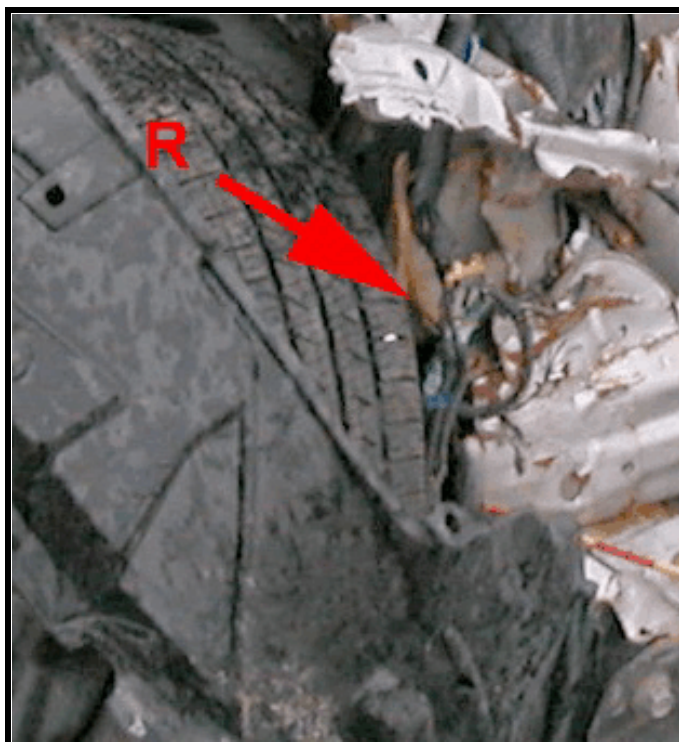
Figure 12. Right front impact sensor

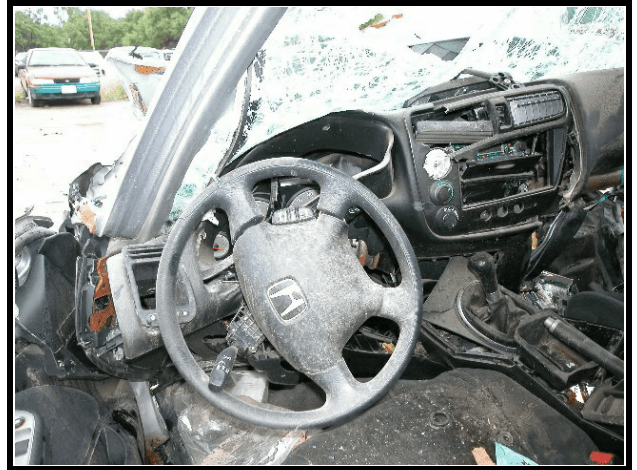
The 26-year-old male driver was sitting in a forward facing position on the fabric covered bucket seat. The seat had been adjusted to between the forward most and middle track position. The seat back was slightly reclined. He was not restrained. He was likely leaning somewhat to the left due to the roll position of the Civic prior to impact. He was wearing a white shirt, blue jeans, and brown shoes. A wrist watch was present on the left wrist. At impact, he pitched forward in response to the 0 degree direction of force. His chest and abdomen engaged the steering wheel/rim causing minor abrasions. Both knees engaged the lower instrument panel/knee bolster. Abrasions were found on the right knee from this contact and the right femur was fractured. The driver's head and torso were already leaning slightly to the left prior to the impact, but pitched sharply in the 11 o'clock direction as the vehicle fully engaged the concrete wall on the right side and began a sharp clockwise rotation. The driver's face (lower) engaged the top of the steering wheel. His face and head continued past this point and engaged the left A pillar and left side of the windshield. The A pillar contacts likely caused the head and upper facial bone fractures while the steering wheel rim contact likely caused the lower facial bones. The driver's left hand came off the steering wheel. The forearm area engaged the left side of the instrument panel causing a radius/ulna fracture.

Figure 13. Driver's seated position

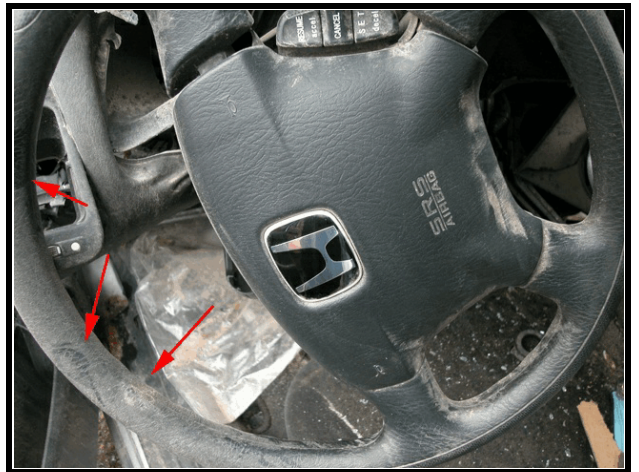
Figure 14. Scuffs to top of steering wheel

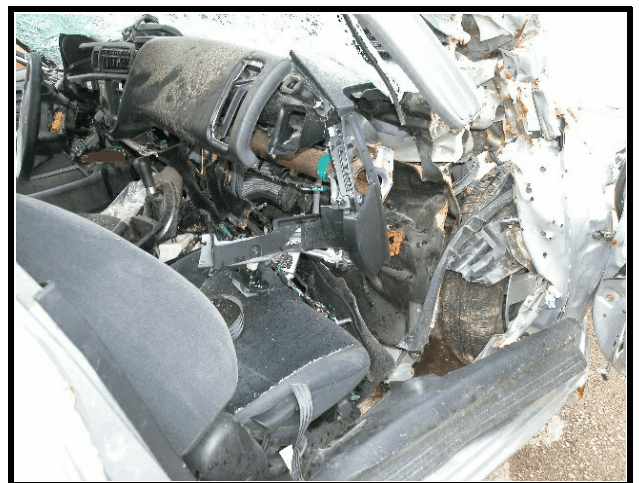
The 30-year-old male front right passenger was sitting in a forward facing position on the fabric covered bucket seat. The seat had been adjusted to between the forward most and middle track position. The seat back was slightly reclined. He was wearing the available lap and shoulder belt. He was likely leaning somewhat to the left due to the roll position of the Civic prior to impact. He was wearing a short sleeve grey sweat top, a white T shirt, blue jeans, and brown shoes. At impact, he pitched forward and engaged the lap and shoulder belt. He sustained abdominal abrasions at the umbilicus level from contact with the lap belt and right upper chest/shoulder abrasions from contact with the torso belt. The loading to the abdomen from the lap belt also caused a superficial splenic laceration. Both of this occupant's lower legs engaged the intruding right lower instrument panel, resulting in a tibia/fibula fracture to the right leg, right leg abrasions, and

Figure 15. Front right occupant seated position

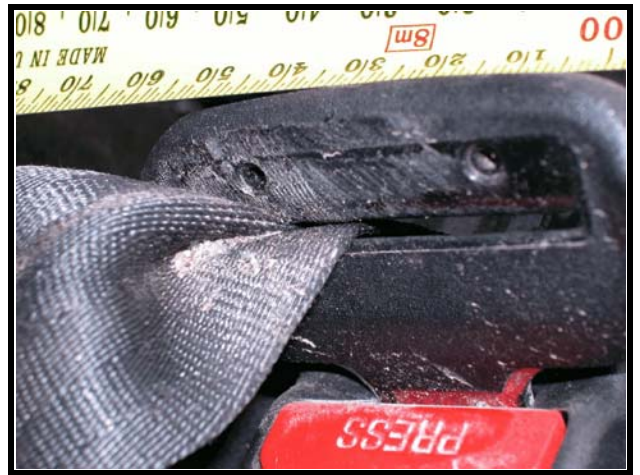
Figure 16. Loading to front right seat belt at latch
