Advanced Occupant Protection System Investigation / Vehicle vs. Concrete Wall
Dynamic Science, Inc. / Case Number: DS03026
2003 Honda Accord EX Four-Door Sedan
Texas
May, 2003

1. Report No. DS03026		2. Government Accession No.		3. Recipient Catalog No.	
4. Title and Subtitle Advanced Occupant Protection System Investigation				5. Report Date September 17, 2005

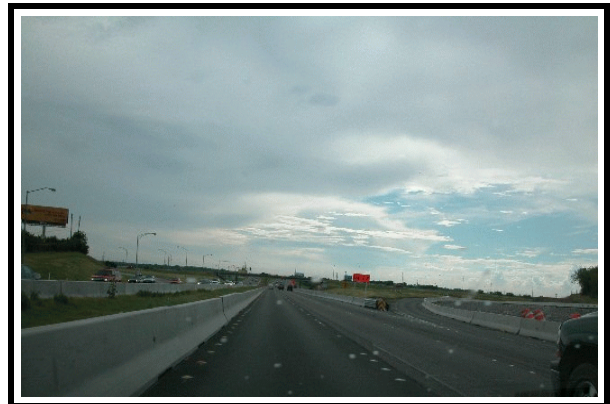
This single vehicle crash occurred during a weekday night in May, 2003 at 2250 hours. It was dark at the time of the crash and the roadway was not illuminated. The weather was cloudy and the concrete surfaced roadway was wet. The crash occurred on the left side (south roadside) concrete jersey barrier of an interstate roadway. The interstate highway consists of three west/eastbound travel lanes that are bordered by concrete jersey barriers. A center median (grass, bordered by concrete jersey barriers) delineates the west and eastbound travel lanes and was under construction at the time of the crash. There were no traffic controls present and the posted speed limit was 97 km/h (60 mph).

Figure 1. View showing case vehicle's pre-impact travel lane and area of impact

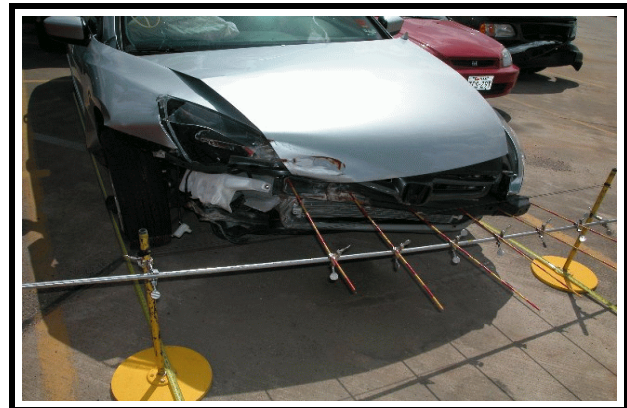
Figure 2. Exterior view showing frontal deformation to case vehicle.

Damage Description: Moderate/Primary Frontal Impact: Longitudinal displacement of the front bumper with maximum crush of 17.9 cm (7 in.) located at the front, right bumper corner. Damaged components included the front bumper and fascia cover, hood, grille, upper/lower radiator supports, both fenders, right front tire/wheel and the laminated windshield glazing was cracked.

C-measurements: Six equidistant crush measurements were documented at the bumper and above bumper levels and the averaged crush profile is as follows: C₁= 12.0 cm (4.7 in), C₂=0 cm (0 in), C₃=6.0 cm (2.4 in), C₄=10.0 cm (3.9 in), C₅=18.0 cm (7.0 in), C₆= 16.0 cm (6.3 in).

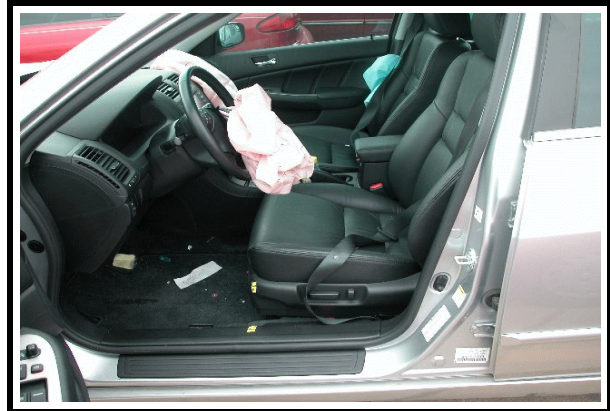
The driver's manual restraint system consisted of a continuous loop three-point seat integrated lap and shoulder safety belt with a free sliding latch plate and an adjustable shoulder belt upper anchorage that was in the upper most position. The driver's lap and shoulder belt exhibited evidence of historical usage in the fashion of striations and scratching to the latch plate. In addition, there was evidence of loading to the shoulder belt webbing in the form of minor stretching.

Figure 3. View of driver's position showing deployed air bag and spooled out lap and shoulder restraint (pretensioner actuation)

Both front seats are equipped with pretensioners (Automatic Tensioning System) which activated and were observed to locked in a spooled out (used) position. The pretensioners will be discussed with more detail under the Frontal Air Bag System section.

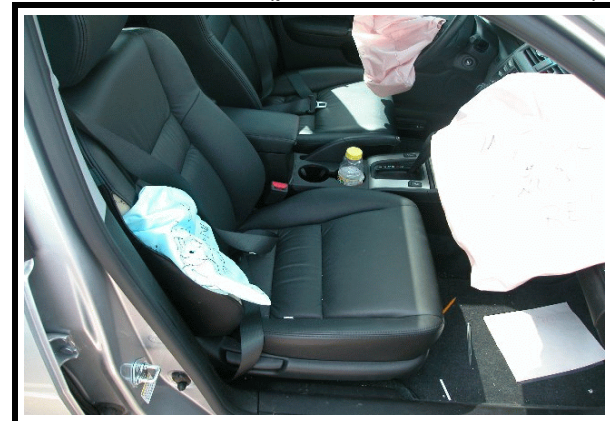
The front, right seat was also equipped with a continuous loop three-point seat integrated lap and shoulder safety belt with a free sliding latch plate and an adjustable shoulder belt upper anchorage that was in the upper most position. The latch plate showed evidence of historical usage in the form of striations and surface scratching. The shoulder belt webbing exhibited evidence of minor load induced stretching.

Figure 4. View of front right position showing deployed front and side air bags along with spooled lap and shoulder restraint (pretensioner actuation)

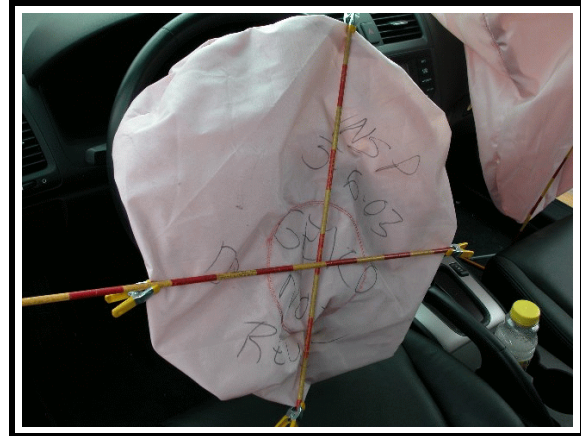
Figure 5. View showing deployed driver's air bag

The driver and front right passenger air bags deployed on impact with the retaining cement wall. The driver's air bag module was located in the center hub of the steering wheel rim and had two module cover flaps. The upper flap measured 12.0 cm (4.7 in) wide by 8.0 cm (3.1 in) high. The lower flap measured 12.0 cm (4.7 in) wide by 6.0 cm (2.4 in) high. There was no contact evidence on any of the module cover flaps. The diameter of the air bag measured 49.0 cm (19.3 in) in its deflated state. There were two vent ports, located at the 1 and 11 o'clock positions respectively, and two tethers. There was no evidence of occupant contact to the air bag. There was evidence of module cover flap transfer on the middle right of the face of the air bag and to the upper half of the back of the air bag. The driver's air bag had a maximum post deflated excursion of 28.0 cm (11.0 in). The front right passenger air bag was a top mount design located in the right aspect of the instrument panel. The two symmetrical rectangular module cover flaps each measured 23.0 cm (9.1 in) wide by 5.0 cm (2.0 in) high. There was module cover flap transfer to the mid-face of the air bag. The deflated air bag measured 42.0 cm (16.5 in) wide by 68.0 cm (26.7 in) high. The air bag had two vent ports and no tethers. The ports were at the 2 and 10 o'clock positions. The air bag had a maximum deflated excursion of 66.0 cm (26.0 in).

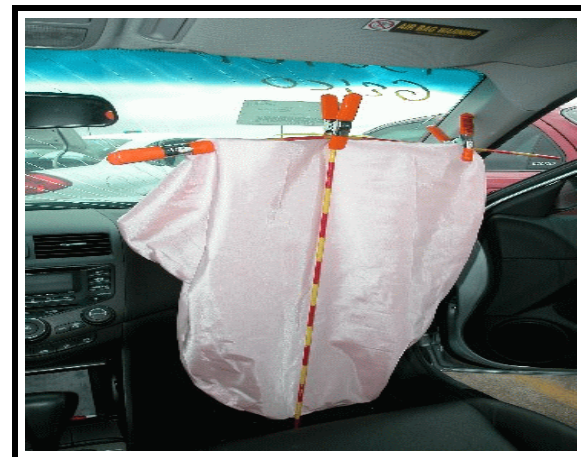
Figure 6. View showing deployed front, right passenger air bag

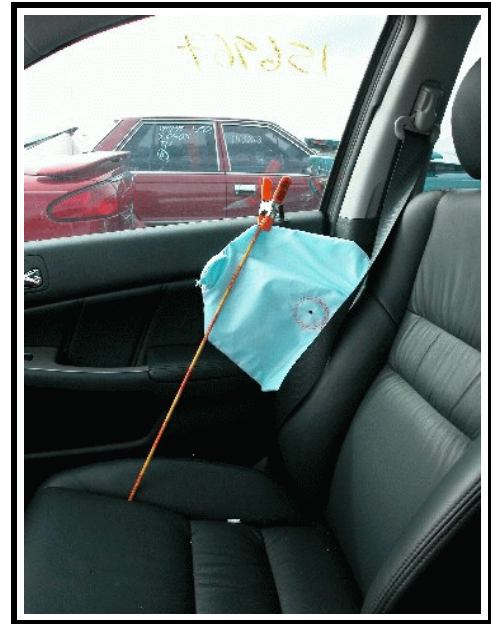
The vehicle was also equipped with a driver's and front right passenger side air bags mounted in the outboard padding of the seat backs. The driver's side air bag did not deploy; the front right passenger's side air bag did deploy during the impact with the wall. The front right passenger's side air bag was square shaped and measured 31.0 cm (12.2 in) wide by 32.0 cm (12.5 in) wide. The side air bag had a single sewn tether and a single vent port. There was no evidence of any occupant contact to the side air bag.

Figure 7. View showing deployed right side thoracic air bag

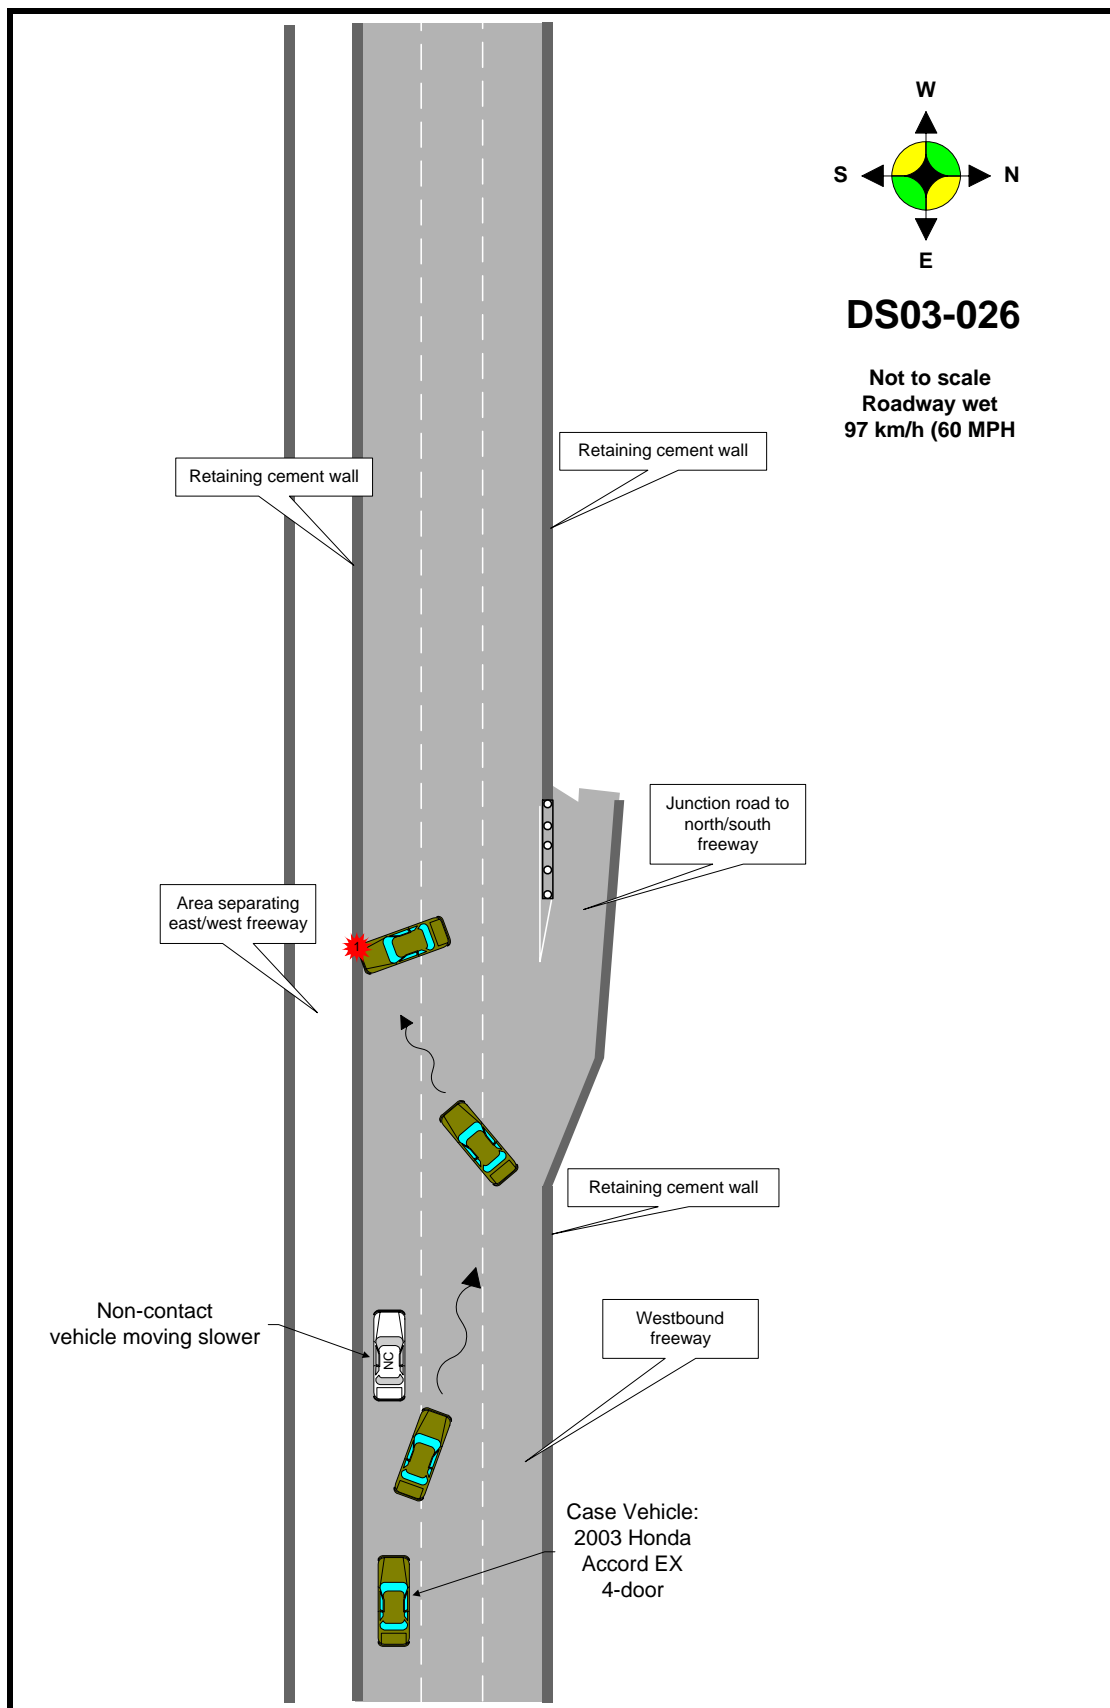
Attachment 1. Scene Diagram

As the case vehicle closed in on the slower moving westbound vehicles, the driver of the case vehicle applied the brakes and the tires lost traction on the wet, concrete roadway surface. The driver applied a right steering input as the case vehicle traversed the 2nd and 1st travel lanes. The driver then applied a left counter steering input, in an attempt to correct the vehicle. In response to the left steering application the case vehicle initiated a counterclockwise rotation, traversing the three westbound travel lanes before impacting the south roadside jersey barrier with its frontal plane (01FZEW1).
