### REMOTE CHILD AIR BAG-RELATED FATALITY INVESTIGATION

CASE NUMBER - IN-03-026  
LOCATION - Texas  
VEHICLE - 1997 CHEVROLET LUMINA LS  
CRASH DATE - June 2001

Submitted:  
February 4, 2005  
Revised:  
February 19, 2007

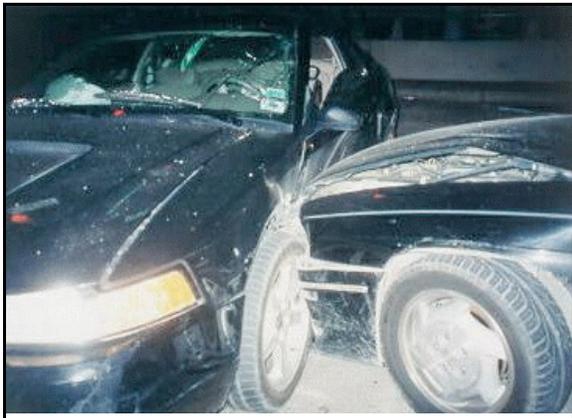
The case vehicle sustained relatively minor impact damage across the entire front, heavier on the left. The modest damage on the two vehicles and their close proximity at final rest indicate a relatively low-speed impact (**Figures 1 and 2**), which suggests that the case vehicle driver braked prior to impact.

The available photos do not fully illustrate of the case vehicle's damage. The front left area of the bumper and the left front fender were crushed rearward against the left front tire (**Figure 1**), causing wheel restriction. The left headlamp/turn signal assembly was shattered, but the right headlamp was intact (**Figure 2**). The engine hood was buckled slightly upward on the left. The windshield had a large hole in the right-center area (**Figures 3 and 4**). There was no other glazing damage. Except for the restriction of the left front wheel/tire, there was no damage to the wheels or tires.

**Figure 1:** Case vehicle's front against other vehicle's left side at final rest, showing case vehicle's left front corner area (case photo #20)

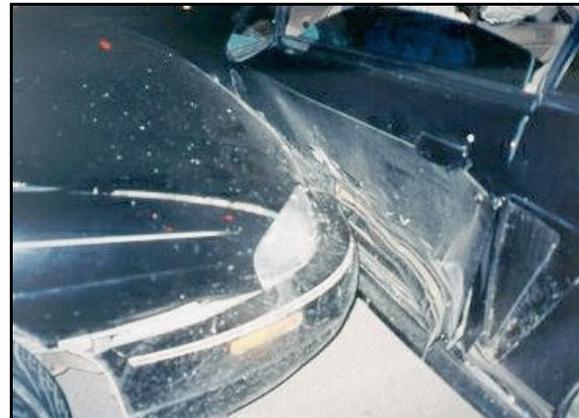
**Figure 2:** Case vehicle's front against other vehicle's left side at final rest, showing case vehicle's right front corner area (case photo #19)

The Mustang sustained direct contact damage along the lower edge of the driver's door, the left lower A-pillar, the left front fender and the left front wheel/tire assembly. The available photos do not enable a full appreciation of the damage (**Figures 1 and 2**). The lower edge of the door was crushed inward along its entire width. The lower left A-pillar was crushed inward and the left edge of the windshield was cracked. The rearward portion of the left fender was crushed inward and there was direct contact to the left front tire, but no wheel or tire damage is visible. The driver and front right passenger air bags deployed. Other than the cracked windshield, there was no glazing damage.

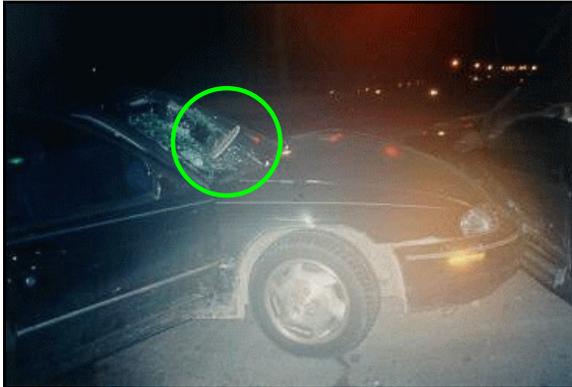
**Figure 3:** Case vehicle at final rest; note, passenger air bag module cover flap projecting through hole in windshield (case photo #06)

The front right passenger's air bag was located in the top of the instrument panel on the right (**Figure 5**). The available photographs do not provide close-up views of the passenger's air bag and there is no knowledge as to the post-deployment condition of the module flap or the air bag. The photos do not show any obvious damage or evidence of occupant contact on the passenger's air bag fabric. The module cover flap consisted of a single panel that was not attached anywhere around its perimeter but had a tether strap (**Figure 6**). It seems apparent that, when the front right passenger air bag deployed, the cover flap struck and fractured the windshield. At final rest, the cover flap was projecting through the large hole in the windshield (**Figures 3 and 4**).

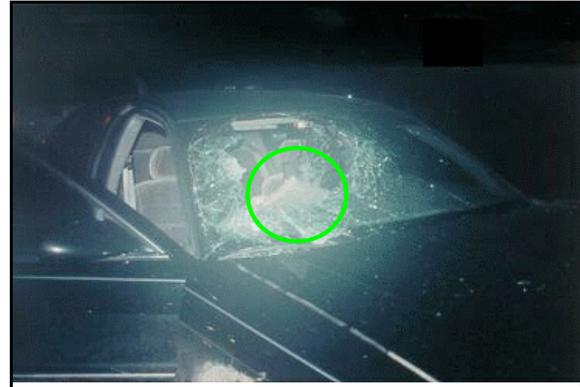
**Figure 4:** Case vehicle at final rest; note, large hole in windshield with passenger air bag module cover flap projecting through (case photo #07)

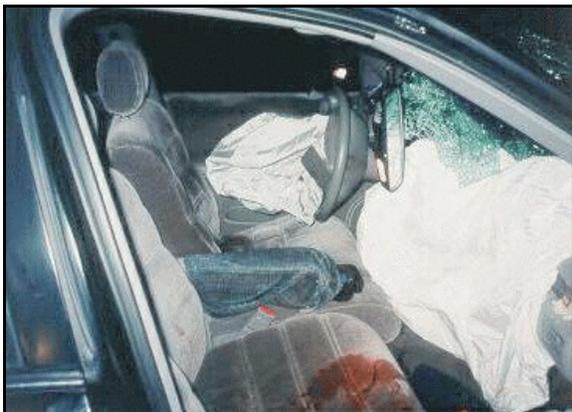
The case vehicle was equipped with driver and front right passenger air bags, both of which deployed as a result of the collision. The driver's air bag was mounted in the steering wheel hub. The available photos do not provide close-up views of the driver's air bag. This contractor was not able to discover any information concerning the post-deployment condition of the module cover flaps or the air bag. The photos do not show any obvious damage or evidence of occupant contact on the driver's air bag fabric (**Figure 5**).

**Figure 5:** Case vehicle's front seat row, showing deployed air bags, fractured windshield and blood on the front right seat cushion (case photo #08)

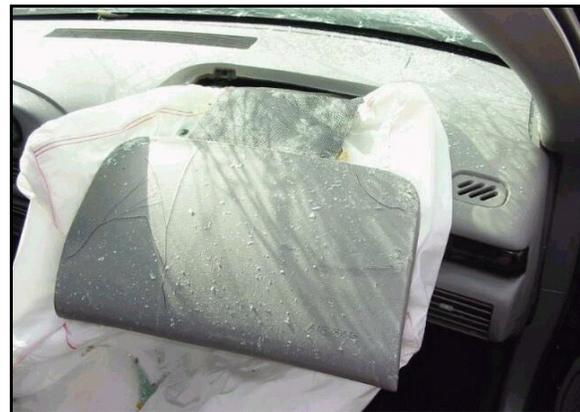
**Figure 6:** Exemplar front right passenger air bag cover flap, showing tethered installation NOT THE CASE VEHICLE (case photo #28)

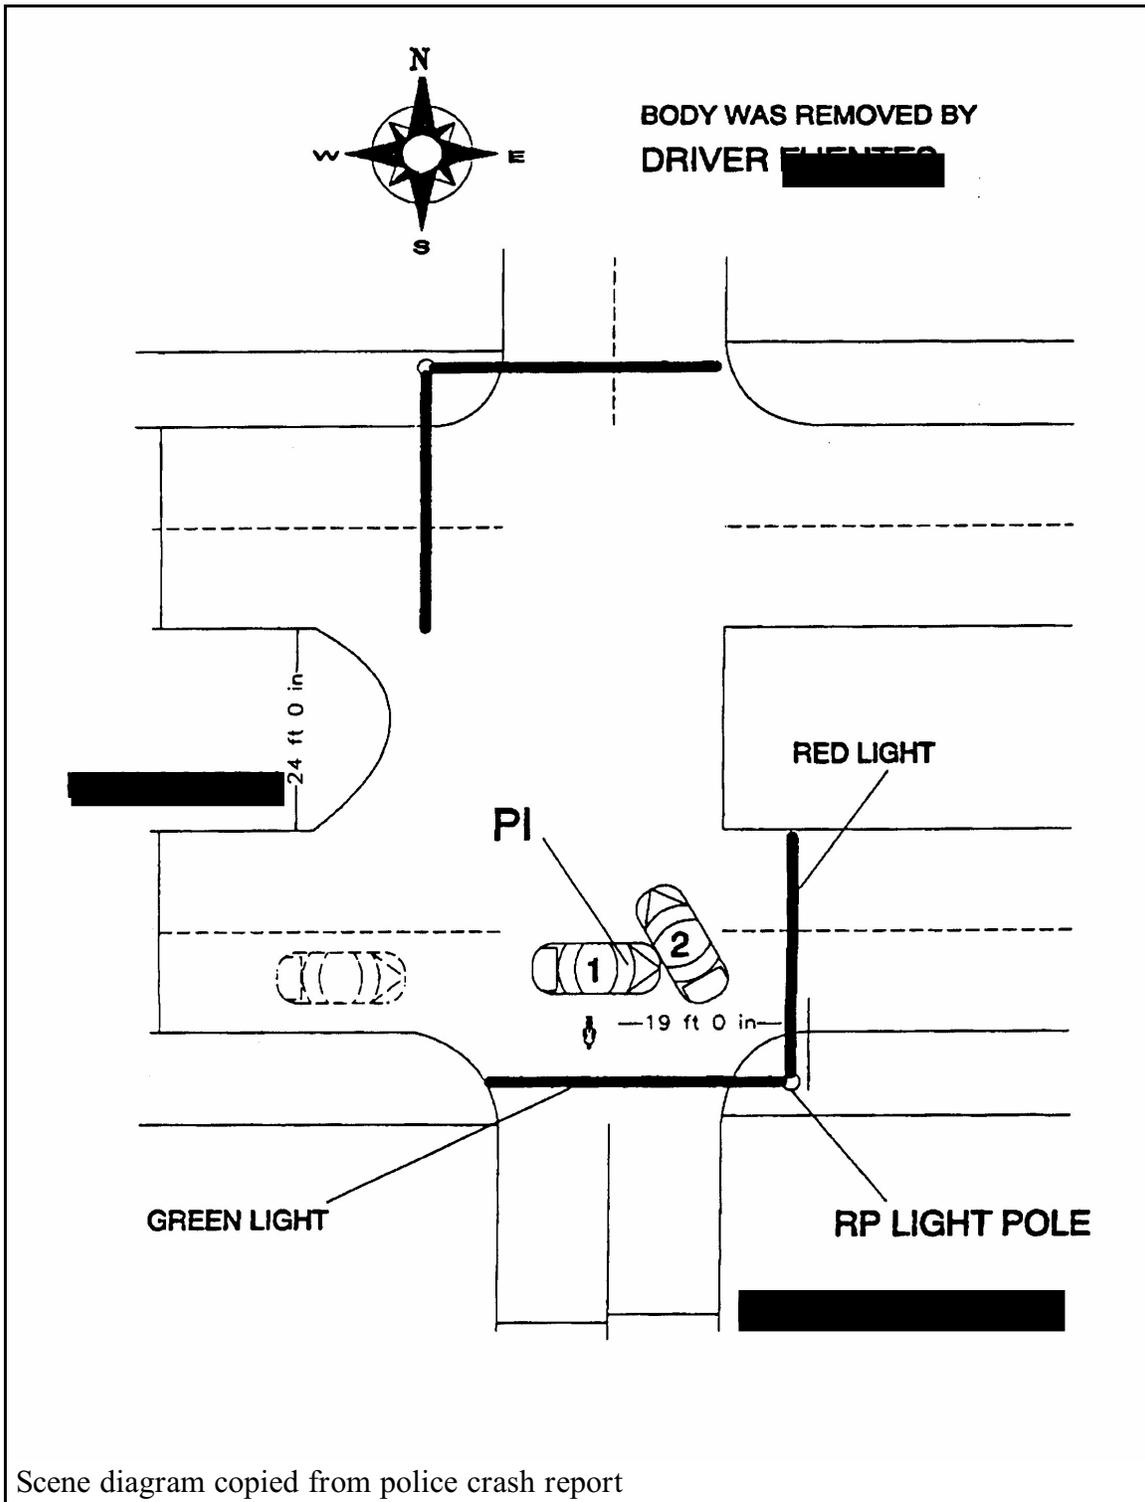
Note: The depiction of a body on the pavement shows the position of the fatal victim after she was removed from the case vehicle.
