Side Air Bag Investigation / Vehicle to Vehicle
Dynamic Science, Inc. / Case Number: DS03027
1999 BMW 328i
Colorado
June, 2003

Technical Report Documentation Page

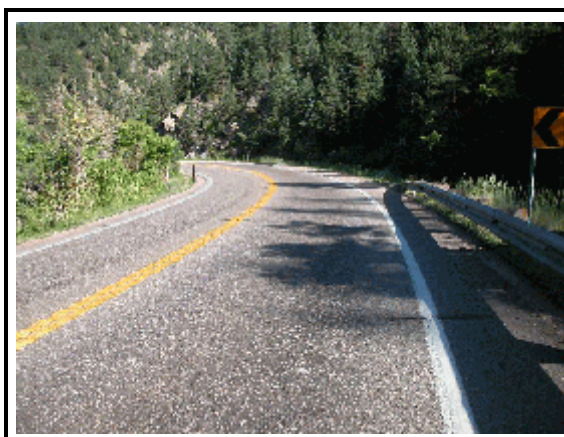
This single vehicle crash occurred in June, 2003 at 0100 hours in a mountainous area of Colorado. The crash occurred off-road. The north/south asphalt roadway approaching the roadway departure is two-way, curved to the left, and has a positive 2.5% grade. The curve had a radius of 55.4 m (182.0 ft) and a critical speed of 67.4 km/h (41.9 mph)¹. The roadway was wet. It was dark at the time of the crash and there were no streetlights available. To the right of the roadway is a dirt shoulder followed by a grass/dirt embankment with a 37% downgrade. The speed limit is 64 km/h (40 mph).

Figure 1. Approach to area of road departure/off road impact (south)

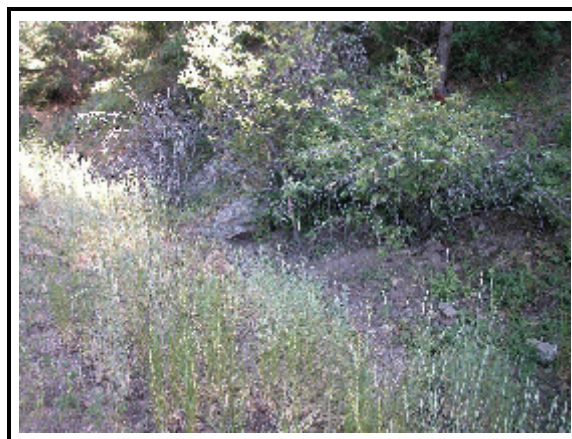
Figure 2. Impact area/final rest

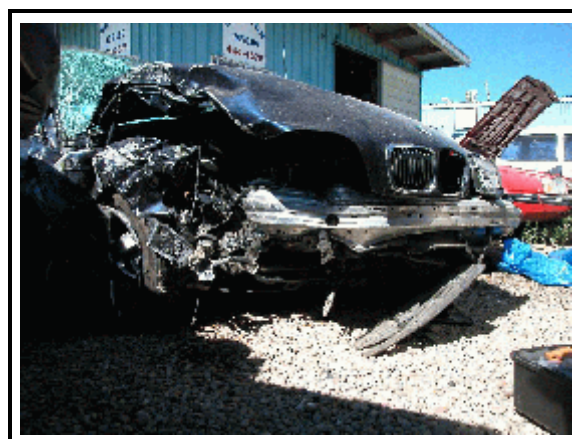
As the vehicle entered the curve, the driver lost control. The case vehicle began to yaw in a counterclockwise direction and slid off the roadway onto a grass shoulder. The vehicle continued on for 14.2 m (46.5 ft) and traveled down an embankment. The case vehicle had rotated 30-40 degrees by this time. The case vehicle struck a large boulder with its front right end (01FREE6).

Figure 3. Front right, case vehicle

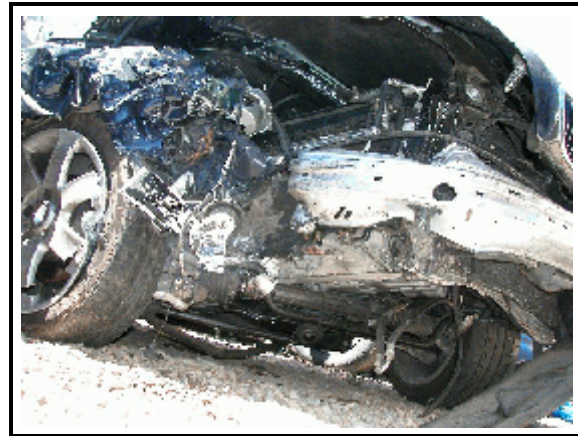
The case vehicle sustained direct contact damage from the first impact that began at the front right bumper corner and extended 36.0 cm (14.2 in) along the front. The residual crush measured on the bumper reinforcement bar was as follows: C1=0 cm (0 in), C2=0 cm (0 in), C3=0 cm (0 in), C4=44.0 cm (17.3 in). The maximum crush was into the pocket beyond the end of the bumper corner and measured 118 cm (46.4 in). The right side wheelbase was shortened by 69.0 cm (27.2 in). There was minor contact damage to the right passenger area from contact with a tree/bushes. There was intrusion into the passenger compartment from the initial impact through the right instrument panel, right toe pan, and right A pillar.

Figure 6. Front right, case vehicle (impact 1)

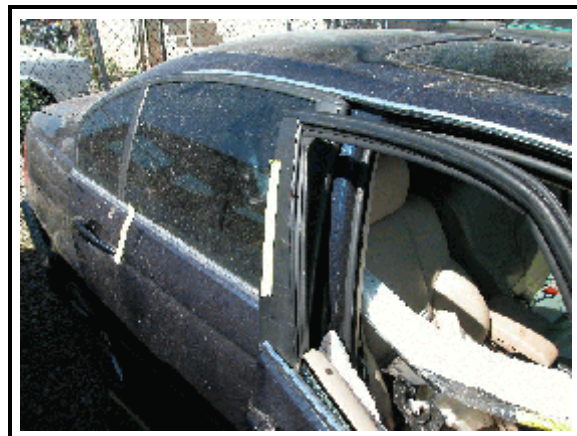
After the impact with the boulder, the case vehicle rotated counterclockwise and contacted a small tree/bush with its right side (03RPAW2).

Figure 5. Right side of vehicle (impact 2)

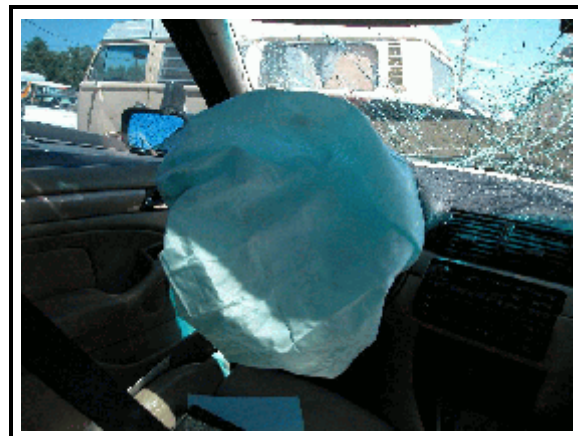
Figure 8. Driver's air bag

The driver's air bag module had a roughly triangular configuration and was located in the center hub of the steering wheel rim and had a single cover flap. There was no contact evidence on the cover flap. The diameter of the air bag measured 45.0 cm (17.7 in) in its deflated state. There was a single vent port located at the 12 o'clock position. There were no tethers. There were four vertical and three horizontal folds on the air bag face. There were no indications of any occupant contacts.

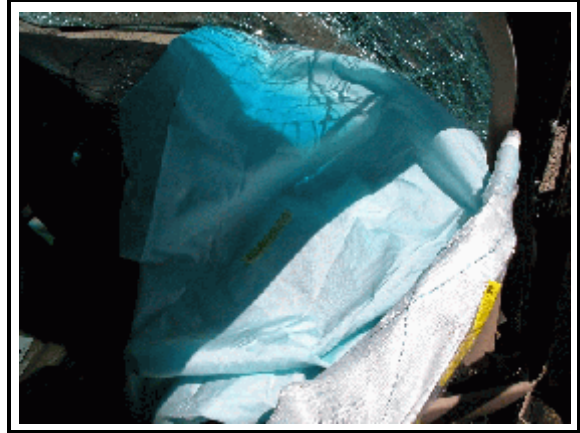
Figure 9. Front right passenger air bag

The front right passenger air bag was a top mount design located in the right aspect of the instrument panel. The rectangular module cover measured 44.0 cm (17.3 in) wide by 19.0 cm (7.5 in) high. It was held in place by two 13.0 cm (5.1 in) long nylon straps on the back side and two 15.0 cm (5.9 in) long nylon straps on the front side. The deflated rectangular air bag measured 52.0 cm (20.5 in) wide by 60.0 cm (23.6 in) high. There were two vent ports and two tethers. The ports were at the 3 and 9 o'clock positions.

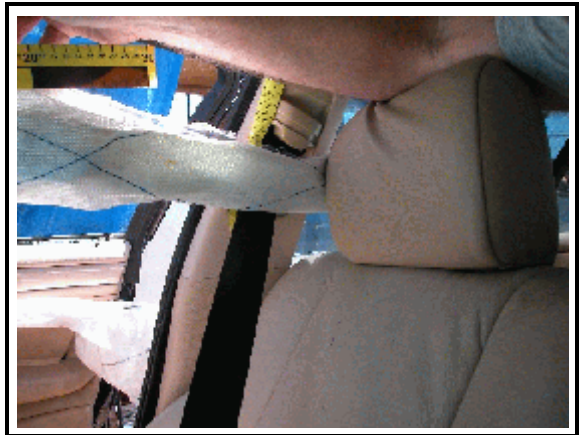
Figure 10. Right ITS (contact evidence to structure and B pillar)

The ITS was roof rail mounted. The ITS was 94.0 cm (37.0 in) in length. It was connected to the vehicle by a 16.0 cm (6.3 in) tether on the front and a 21.0 cm (8.3 in) in the rear. There was make-up contact evidence found 49.0 cm (19.3 in) from the front end.

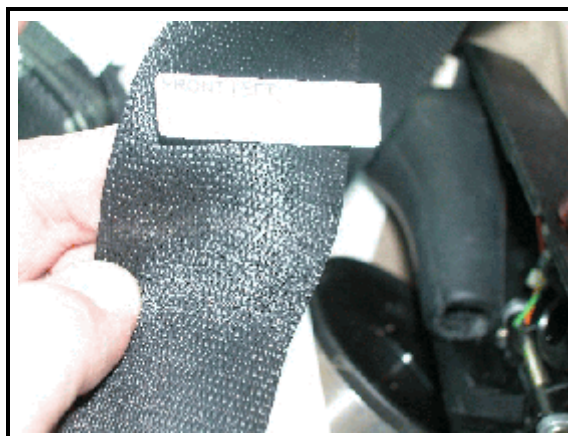
Figure 12. Loading evidence on front left seat belt

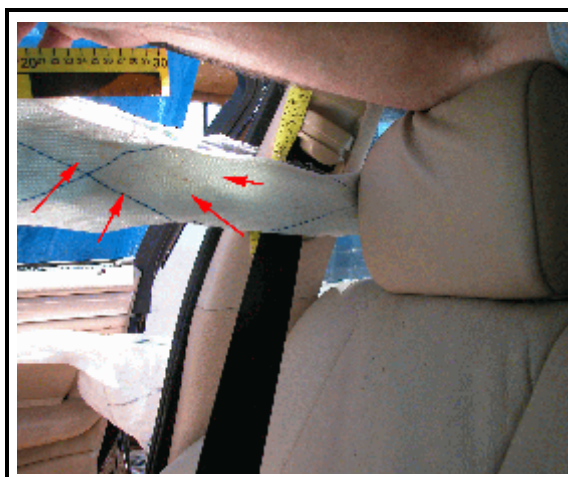
Interior damage to the 1999 BMW 328i was moderate and attributed to occupant contact and passenger compartment intrusion. The windshield was fractured from impact forces. There was longitudinal intrusion into the front right seating area from the toe pan, right instrument panel, and A pillar. The glove compartment door was dislodged. The right door was deformed outward due to occupant contact and the impact along the frame. There were make up contacts to the right side ITS and the B pillar.

Figure 13. Make-up contacts to ITS and B pillar

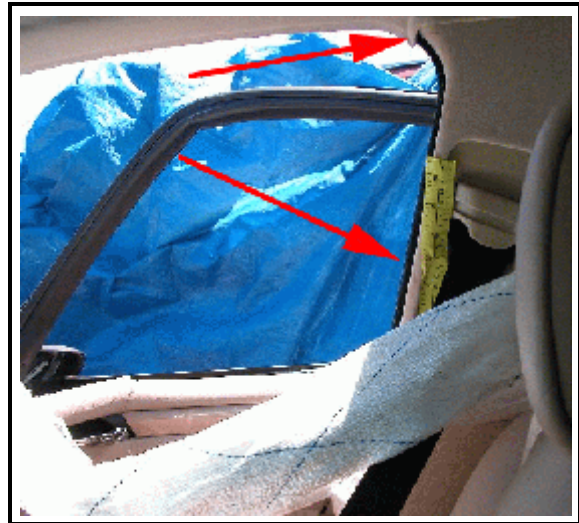
Figure 14. Make up contacts to B pillar

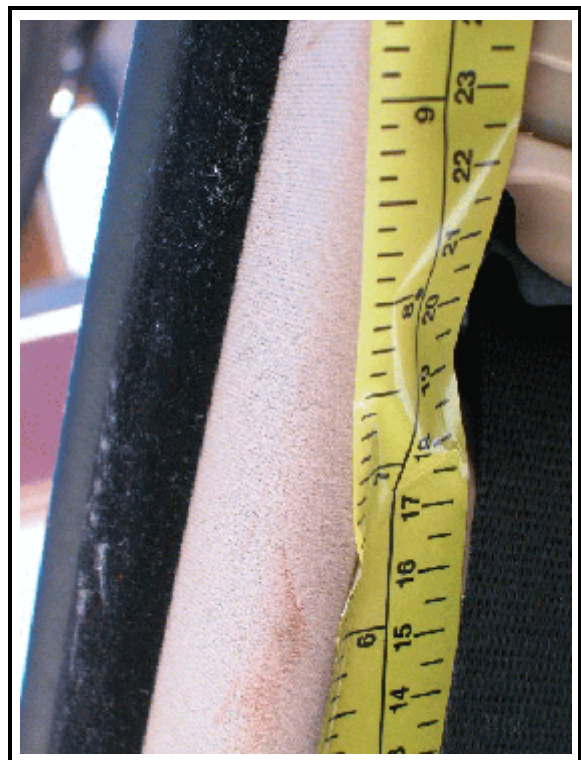
Figure 15. Close up of contact to middle of B pillar

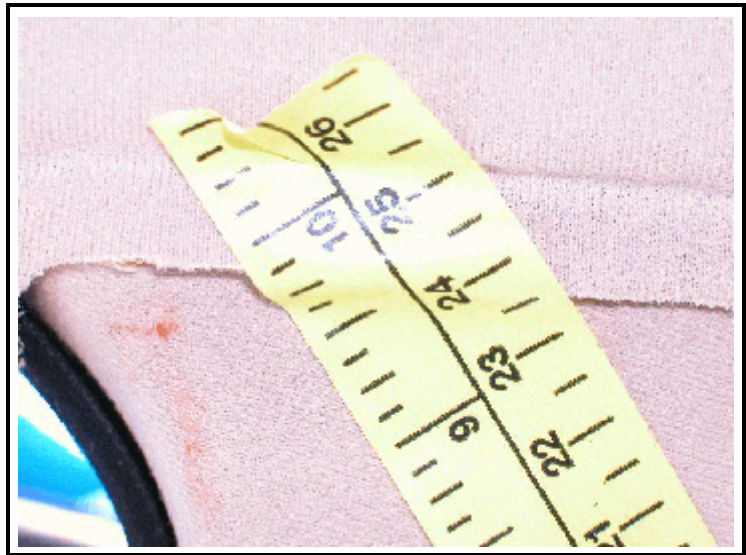
Figure 16. Close up of contact to top of B pillar
