REMOTE AIR BAG DEPLOYMENT REPORT

CASE NUMBER - IN-03-027
LOCATION - Texas
VEHICLE - 1995 FORD CONTOUR GL
CRASH DATE - April 2001

1. <i>Report No.</i> IN-03-027		2. <i>Government Accession No.</i>		3. <i>Recipient's Catalog No.</i>	
4. <i>Title and Subtitle</i> Remote Child Air Bag-Related Fatality Investigation Vehicle - 1995 Ford Contour GL Location - Texas			5. <i>Report Date:</i> December 10, 2004

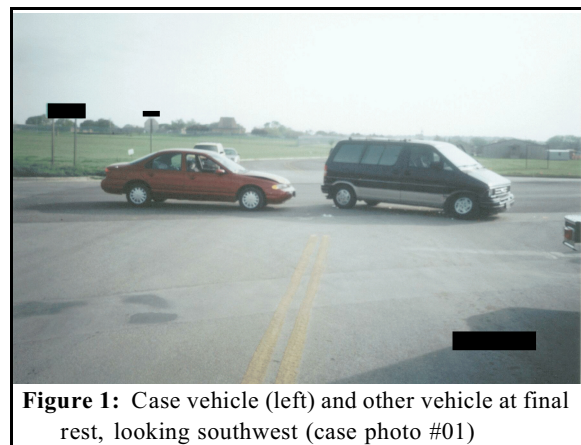
The front of the case vehicle impacted the right front portion of the other vehicle, causing the case vehicle's driver and front right passenger air bags to deploy. The case vehicle rotated a few degrees clockwise and came to rest a short distance from the point of impact, within the intersection, heading approximately north. The other vehicle rotated approximately 60 degrees counterclockwise while sliding in a northwesterly direction and came to rest within the intersection heading north (**Figures 1 and 6**).

Figure 1: Case vehicle (left) and other vehicle at final rest, looking southwest (case photo #01)

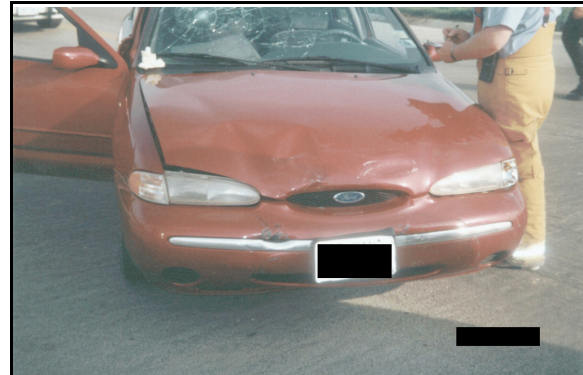
The case vehicle sustained light crushing and abrading from direct contact involving the left three-quarters of the front (**Figures 2 and 3**). The damage was primarily at the center of the bumper and on the leading edge of the hood, extending to the front left bumper corner, with minor induced damage and displacement of the hood. Both headlamp/turn signal assemblies were intact. Based on the collision configuration and the damage to the other vehicle, this was probably an impact that involved substantial force despite the apparently minor damage. The case vehicle's energy absorbing bumper structures and frame accommodated this force with only slight exterior damage evident. There was extensive cracking of the windshield in the right and center (**Figure 4**). This cracking was certainly a result of the front right occupant impacting the windshield, but the vehicle-to-vehicle crash forces probably contributed to the magnitude of the windshield damage. None of the case vehicle's tires were deflated or restricted, and there was no glazing damage other than the windshield.

Figure 2: Case vehicle's front at final rest (case photo #04)

The CDC for the case vehicle was estimated from photographs as **12-FYEW-1 (350)**. The WinSMASH reconstruction program, damage only algorithm based on the photo-estimated CDCs for the two vehicles, was used on the single impact. The total, longitudinal and lateral delta-Vs for the case vehicle are, respectively: 14.0 km.p.h. [8.7 m.p.h.], -13.8 km.p.h. [-8.6 m.p.h.] and + 2.4 km.p.h. [+ 1.5 m.p.h.]. This is a borderline reconstruction and the results appear a little low but essentially reasonable. This was a crash of low severity (14-23 km.p.h. [9-14 m.p.h]) for the case vehicle.

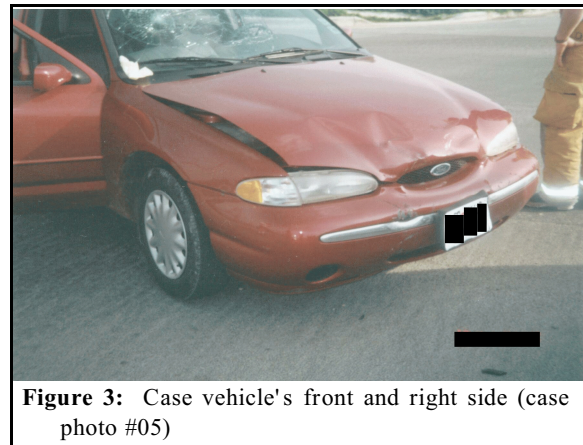
Figure 3: Case vehicle's front and right side (case photo #05)

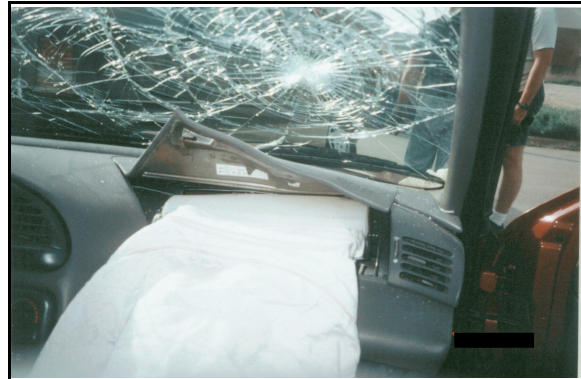
shape and condition after the deployment are not known. The leading edge of the air bag module cover flap is bent and distorted, probably as a result of contacting the front right passenger (Figures 4 and 5). The right edge of the cover flap appears to be bent slightly downward while the left edge has been bent upward. This contractor speculates that the center and right of the cover flap contacted the front right occupant such that the inflating air bag was prevented from expanding straight out. This caused the air bag to press against and deform the left side of the cover flap as the air bag expanded to full inflation. There are no obvious areas of damage or contact evidence visible in the limited views of the air bag fabric.

Figure 4: Case vehicle's front right air bag, cover flap and cracked windshield (case photo #07)

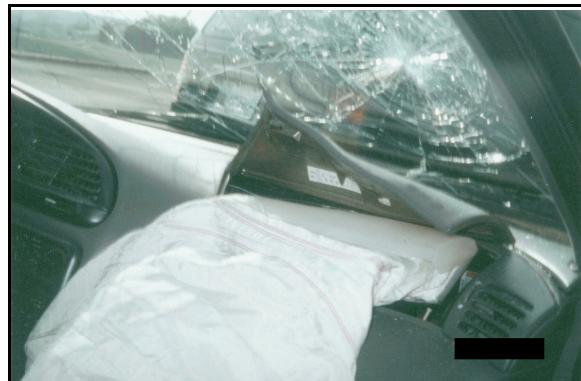
Figure 5: Front right air bag and cover flap, view from right (case photo #10)

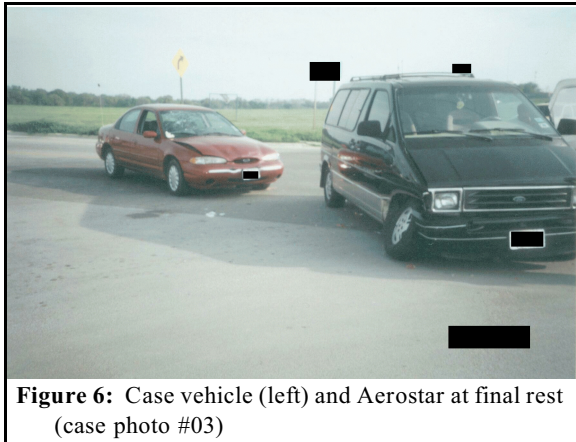
Figure 6: Case vehicle (left) and Aerostar at final rest (case photo #03)

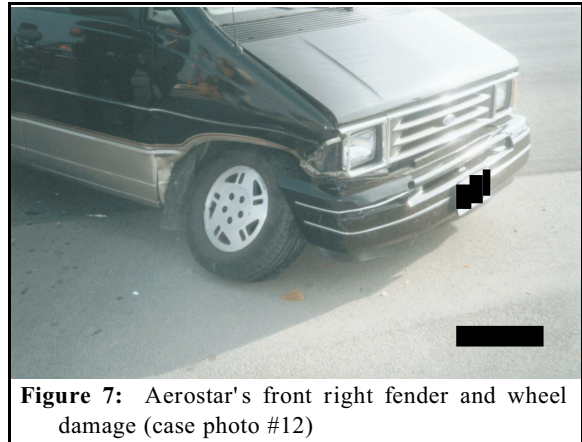
Figure 7: Aerostar's front right fender and wheel damage (case photo #12)

The Aerostar sustained direct contact damage in the right front area, from the right A-pillar forward to the bumper corner. The fender was crushed inward along the edges of the wheel well and there was direct contact to the wheel/tire assembly. The right front suspension components and/or axle were probably damaged, with the top of the wheel tilted inward approximately 20 degrees off vertical. The portion of the front bumper cover that wraps around to the right side showed light abrading and the turn signal lens was broken, but the right headlamp was intact. It appears that none of the other wheels/tires sustained any damage and no glazing damage is visible in the available photos.

The CDC for the Aerostar was estimated from photographs as **03-RFEW-3 (80)**. The WinSMASH reconstruction program, damage only algorithm based on the photo-estimated CDCs for the two vehicles, was used on the single impact. The total, longitudinal and lateral delta-Vs for the Aerostar are, respectively: 12.0 km.p.h. [7.5 m.p.h.], -2.1 km.p.h. [-1.3 m.p.h.] and -11.8 km.p.h. [-7.3 m.p.h.]. This is a borderline reconstruction and the results appear a little low but essentially reasonable. This was a crash of low severity (14-23 km.p.h. [9-14 m.p.h]) for the Aerostar.

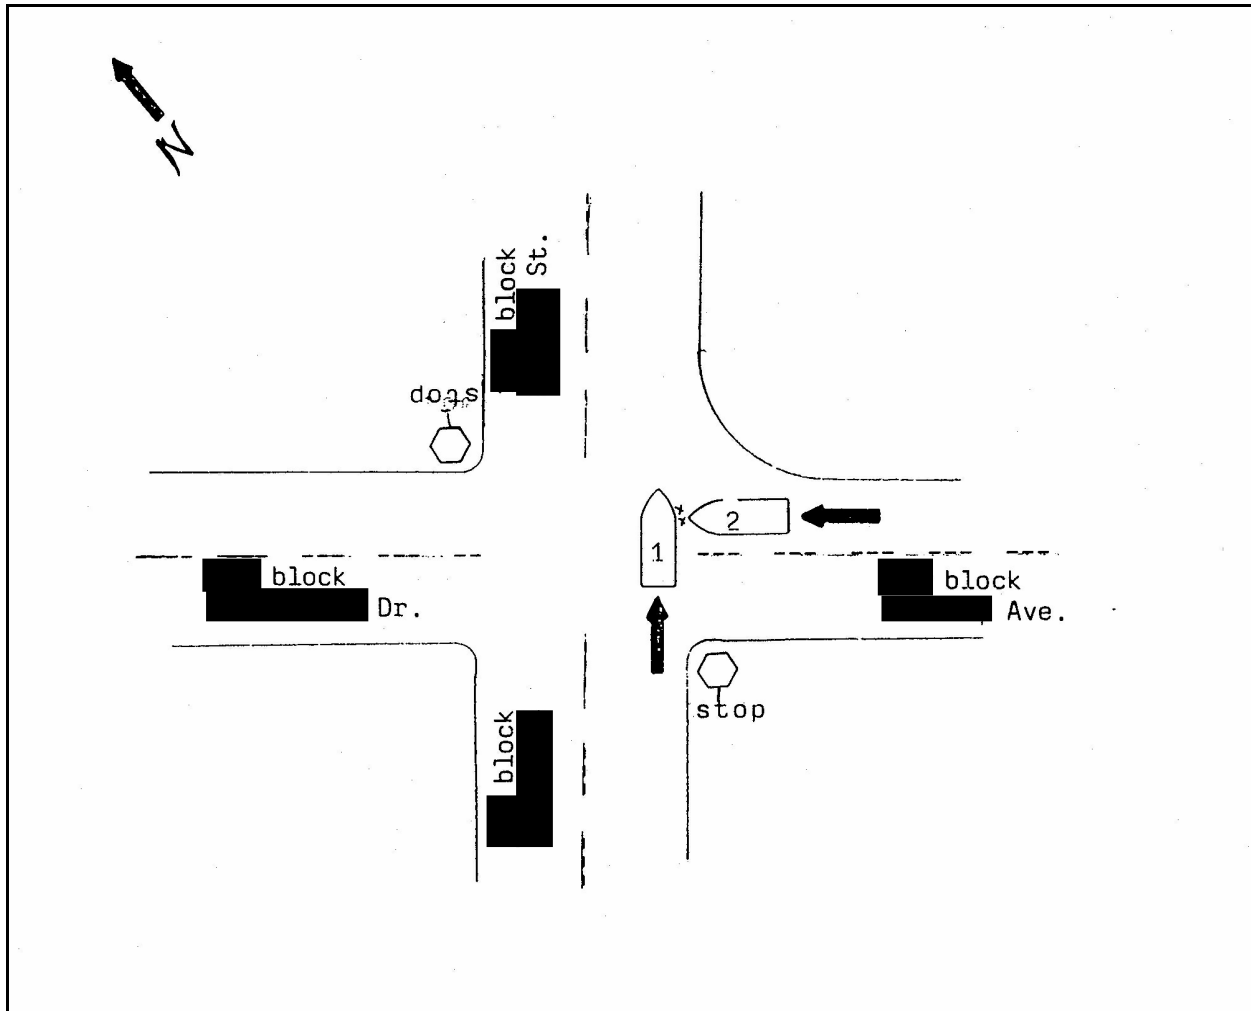
Copied from police crash report. Vehicle #2 in this drawing is the case vehicle.
