On Site Hybrid Vehicle Investigation / Vehicle to Vehicle
Dynamic Science, Inc. / Case Number: DS03029
2003 Honda Civic Hybrid
California
June, 2003

1. Report No. DS03029	2. Government Accession No.		3. Recipient Catalog No.	
4. Title and Subtitle On Site Hybrid Vehicle Investigation			5. Report Date

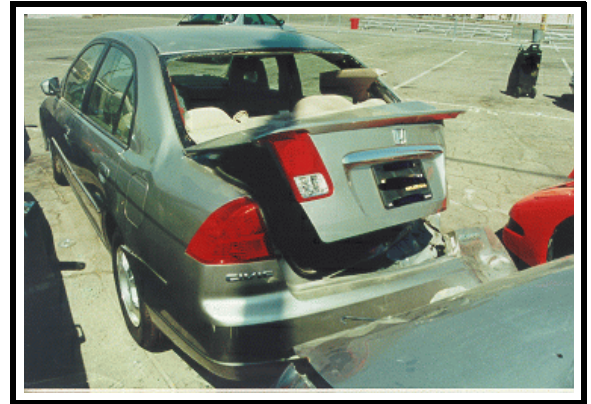
The left front of the other vehicle struck the right rear of the case vehicle (06BREW2). The total velocity change as calculated by the missing vehicle algorithm of WinSmash collision model was 15.0 km/h (9.3 mph). The longitudinal and lateral delta V components were 15.0 km/h (9.3 mph) and 0 km/h (0 mph), respectively.

Figure 2. Left rear of case vehicle

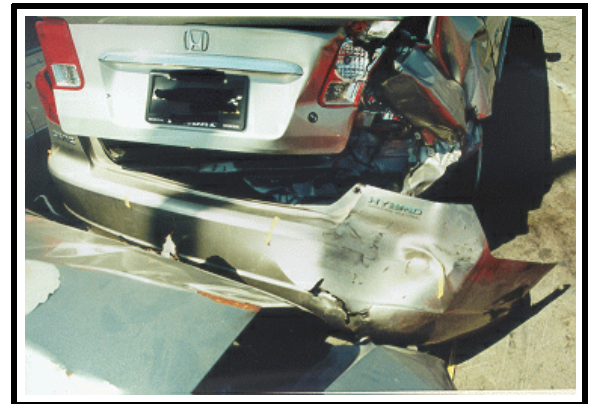
Figure 3. Right rear bumper corner

The case vehicle sustained 43.0 cm (16.9 in) of direct contact damage across the back end beginning at the right rear bumper corner. The residual crush measured along the bumper was as follows: C1=0 cm (0 in), C2=0 cm (0 in), C3=1.0 cm (0.4 in), C4=26.0 cm (10.2 in). The C4 measurement was averaged with the crush found to the frame. The maximum crush was located at C4. The principle direction of force was within the 6 o'clock sector and was an estimated 180 degrees. The damaged components for this impact included the bumper fascia and reinforcement bar, the trunk lid, and the right rear quarter panel. The wheelbase retained its pre-crash dimensions.

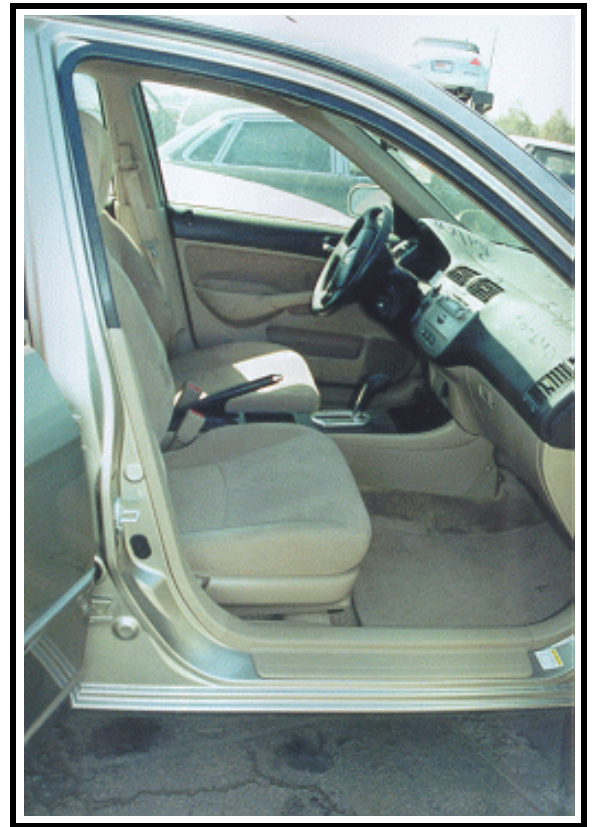
Figure 4. Interior view from right side

Interior damage to the Civic was almost non-existent. There was some light scuffing to the driver's head restraint that suggested a possible head contact. The backlight was disintegrated to impact forces.

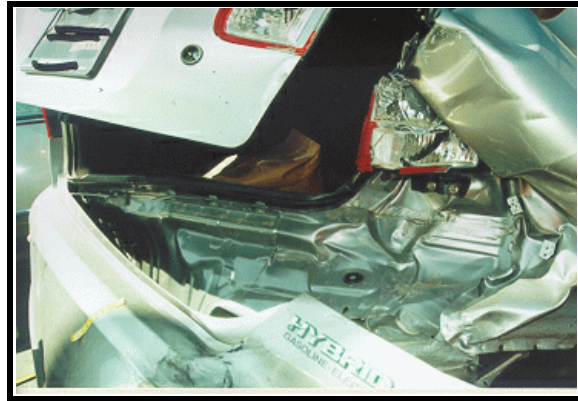
Damage Description: Moderate rear end damage. Backlight disintegrated. Vehicle towed from the scene. Declared a total loss by insurance company.

Figure 5. Right rear corner

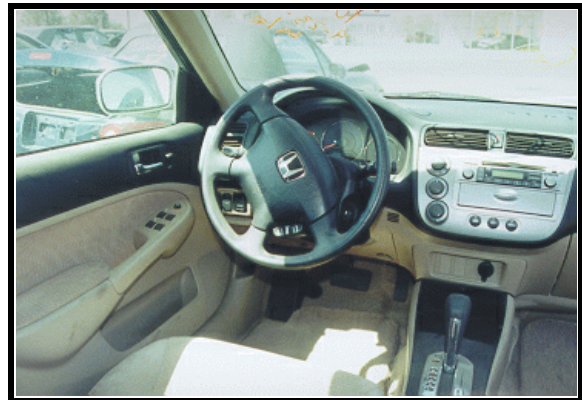
The Honda Civic was equipped with frontal air bags for the driver and front right passenger positions. The driver's air bag was housed in the steering wheel hub. The front right passenger's air bag was housed on top of the instrument panel. The front seats were also equipped side air bags that were housed in the seat backs. The front right passenger seat back was equipped with an occupant position detection system that can prevent a side air bag deployment if someone is leaning into the air bag deployment path. A dashboard warning light illuminates to alert the driver if the side air bag has been deactivated. There were no air bag deployments. The front seat belts were equipped with both buckle and B pillar pretensioners. There was no pretensioner actuation. See overview of system on the following page.

Figure 6. Driver's air bag/module

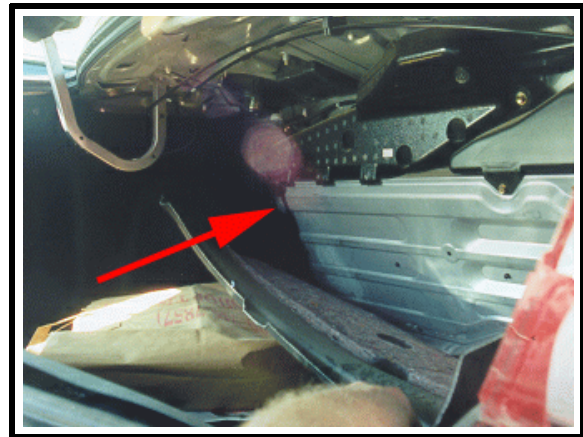
- There were no indications of electrolyte spillage from the propulsion battery.
- There was no movement of the battery module.
- The electrical isolation test could not be conducted. There were no indications of any arcing, fire, or component meltdown. See Attachment 2 for discussion of electrical isolation test.

Figure 9. Battery pack, undamaged

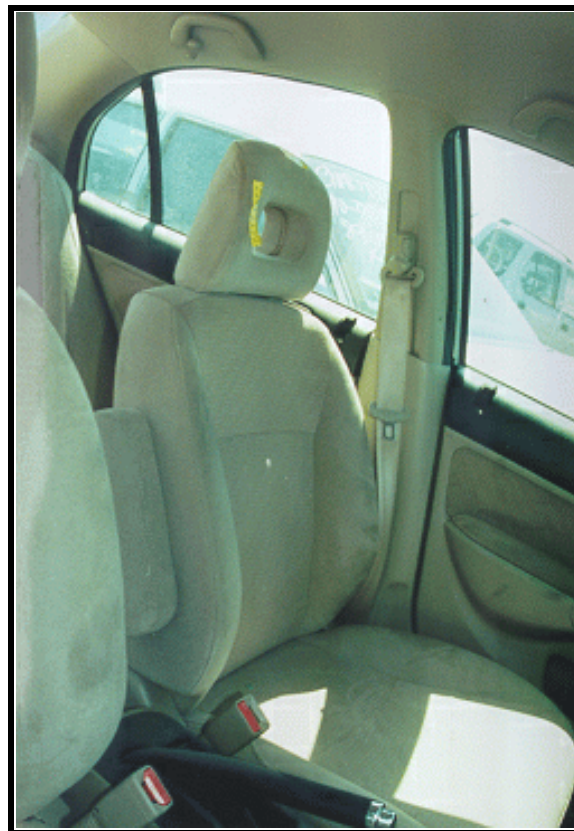
At impact, the driver responded to the 6 o'clock direction of force by moving rearward engaging the seat back and the head restraint. There were scuffs found on the head rest but these many have been related to usage. The driver did not sustain any injuries. He was able to exit the vehicle under his own.

Figure 10. Driver's seated position
