**GENERAL DYNAMICS ON-SITE ADVANCED OCCUPANT PROTECTION SYSTEM
(AOPS) INVESTIGATION
SCI TECHNICAL SUMMARY REPORT**

CASE NO. CA03-030

VEHICLE – 2001 VOLVO S40

CRASH DATE – MAY 2003

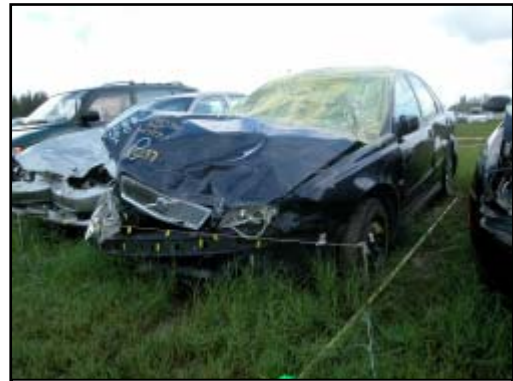
Figure 1. Damaged 2001 Volvo S40

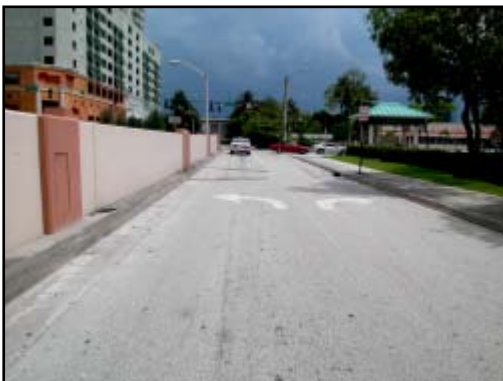
The driver of the 2001 Volvo S40 was operating the vehicle southbound on the service road on approach to the four-leg intersection (**Figure 2**). It was not known what phase the overhead traffic signal was in as the Volvo approached the intersection. The driver of the 2003 Buick Century was operating the vehicle westbound on the inboard lane of the four-lane roadway (**Figure 3**). As the Century approached the intersection, the overhead traffic signal changed to the red phase. The driver of the Century did not realize the traffic signal had changed and continued into the intersection. The driver stated to police that he was distracted because he was looking for a particular address. As the traffic signal was in the green phase for the Volvo S40, the driver of the Volvo proceeded into the intersection but did not detect the approaching Buick Century traveling through the intersection. There was no evidence at the scene to support pre-crash braking from either vehicle.

Figure 2. Southbound approach for the Volvo S40

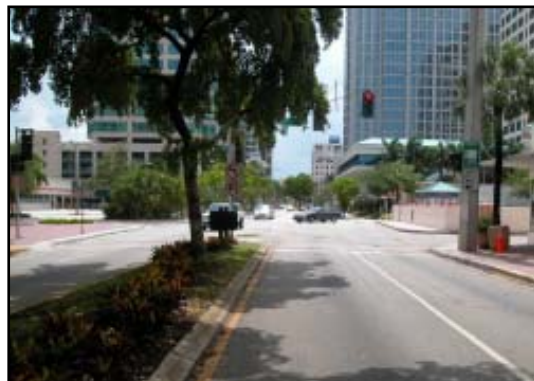
Figure 3. Westbound approach for the Buick Century

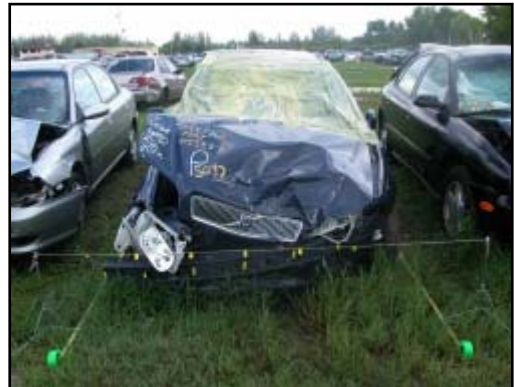
The 2001 Volvo S40 sustained moderate frontal damage (**Figure 4**) as a result of the initial impact with the Buick Century. The direct damage abrasions and paint transfers began at the front left corner and extended laterally across the entire width of the bumper fascia. The direct damage across the leading edge of the hood began at the left front corner, extended 94 cm (37”), and terminated 27 cm (10.5”) right of the centerline. The direct contact on the bumper fascia included abrasions and paint transfers and measured 140 cm (55.0”) across the entire width of the fascia. The entire bumper fascia was separated. The bumper beam was crushed rearward, and deflected to the right and downward at the right front corner. The hood was displaced and buckled to the right and slightly rearward. The left front fender was deflected inward at the front aspect. Six crush measurements were documented across the front bumper beam and were as follows: C1 = 18 cm (7”), C2 = 16 cm (6.3”), C3 = 13 cm (4.5”), C4 = 11 cm (4.3”), C5 = 15 cm (5.8”), C6 = 11 cm (4.1”). The Collision Deformation Classification (CDC) for the frontal impact to the S40 was 10-FYEW-1.

Figure 4. Frontal view of damaged Volvo S40

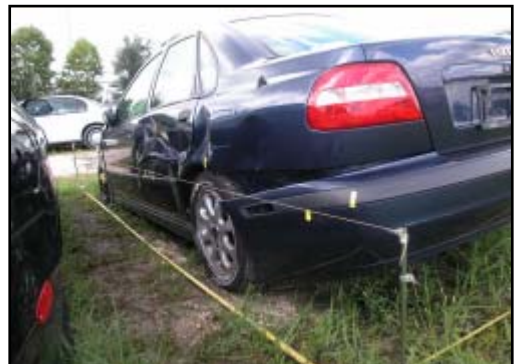
The sideslap impact to the Volvo S40 resulted in minor damage (**Figure 5**) to the left side aspect of the vehicle. The original information obtained during the SCI inspection was later revised. The field investigation overemphasized the length of the direct and induced damage by including damage incurred during the initial impact. The revised direct damage and Field L began approximately 125 cm (50”) rear of the left front axle and continued rearward

Figure 5. View of left side damage to the Volvo S40

along the entire length of the vehicle for a distance of approximately 225 cm (88"). A semi-circular abrasion began 6 cm (2.5") forward of the rear edge of the left front door and extended 71 cm (28") rearward, 15 cm (6") below the beltline. Paint transfers from the Century were present along the entire length of the left aspect of the S40. An area of deformation was also located on the left rear door area at the location of the semi-circular abrasion. The maximum lateral crush was located approximately 130 cm (51.2") aft of the left front axle on the left rear door and measured 6.0 cm (2.4") in depth. The revised CDC for the sideslap event was 09-LZEW-1. Six crush measurements were documented along the left side of the Volvo and were estimated to be as follows: C1 = 6 cm (2.4"), C2 = 6 cm (2.4"), C3 = 5 cm (3"), C4 = 3 cm (1"), C5 = 5 cm (3"), C6 = 2 cm (0.8").

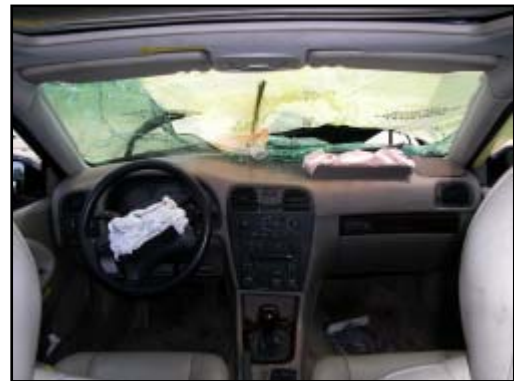
The 2001 Volvo S40 sustained minor interior damage as a result of the impacts with the Buick Century. All of the doors on the Volvo were operational. The side and rear glazing did not sustain damage, however, the windshield fractured as a result of crash forces. Post-crash, the windshield sagged under hot temperature conditions. The fractured laminate could not support the weight of the windshield due to the heat-sag, which caused a large portion of the windshield to separate and fall onto the instrument panel and deployed front right passenger air bag (**Figure 6**). There was no passenger compartment intrusion. Two scuff marks (**Figure 7**) were present on the left front interior door panel from occupant contact. One scuff mark measured 8.9 cm (3.5") in length and 5.1 cm (2.0") in height and was located at the rear aspect of the door handle and 7.6 cm (3.0") below the beltline, possibly from the driver's left arm. A second scuff mark was located on the forward face of the armrest, 3.8 cm (1.5") below the top aspect of the electronic window controls, possibly from the driver's left leg. The scuff mark measured 12.7 cm (5.0") in length and 7.6 cm (3.0") in height. An area of abrasion was located on the headliner at the aft edge of the driver's sun visor. The abrasion began 8.9 cm (3.5") left of the centerline and 20.3 cm (8.0") aft of the windshield header. The abrasion measured 6.4 cm (2.5") in length and 10.2 cm (4.0") in width. A dark transfer was also present on the front left corner of the interior sunroof sliding cover. The transfer measured 13.3 cm (5.3") in length and 8.9 cm (3.5") in width, and was located 21.6 cm (8.5") left of the centerline and 8.9 cm (3.5") from the leading edge of

Figure 6. View of holed windshield

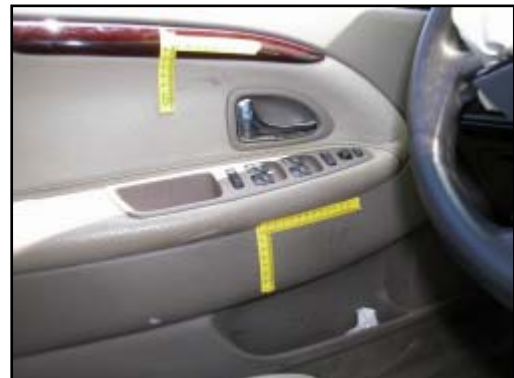
Figure 7. View of scuff marks on driver's door

the cover, from possible post-crash handling. The front center armrest on the top aspect of the center console was slightly displaced to the right from probable occupant loading.

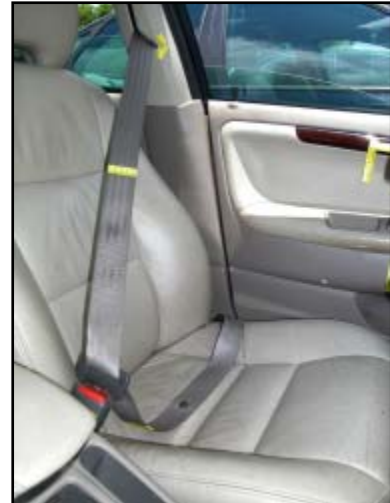
The 2001 Volvo S40 was equipped with manual 3-point lap and shoulder belts for each seating position. The driver's safety belt was configured with continuous loop webbing, a sliding latch plate, and a belt-sensitive, emergency locking retractor. The remaining safety belts were configured with continuous-loop webbing, a sliding latch plate, and belt-sensitive switchable ELR/Automatic Locking Retractors (ALR). The front safety belts were also configured with automatic height adjusters for the shoulder belts. Both height adjusters exhibited a small notch on the forward aspect, although they appeared to have resulted from historical use. The driver's safety belt webbing (**Figure 8**) exhibited stretch marks that began 48.3 cm (19.0") above the anchor and extended 42.5 cm (16.8") along the webbing. The latch plate cover exhibited minor abrasions from engagement against the safety belt webbing and the latch plate showed abrasions consistent with historical use.

Figure 8. View of driver's safety belt

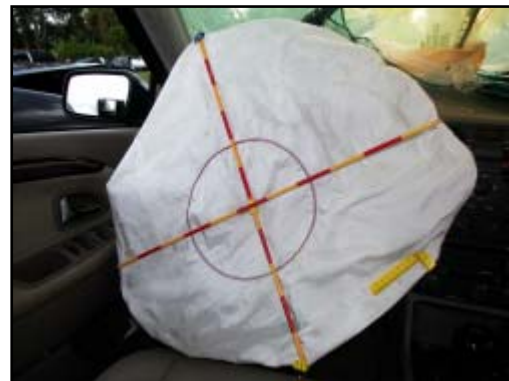
The 2001 Volvo S40 was equipped with an AOPS that included dual-stage frontal air bags, safety belt pretensioners, and a Side Impact Protection System (SIPS), which included side impact air bags and inflatable side curtains. The driver's air bag (**Figure 9**) deployed from the center of the steering wheel hub as a result of the initial impact with the Buick Century. The air bag module was configured with symmetrical H-configuration cover flaps that measured 5.1 cm (2.0") in height and 16.5 cm (6.5") in width. The air bag measured 66.0 cm (26.0") in diameter and was vented by one circular port located at the 12 o'clock sector of the air bag. The vent port measured 2.5 cm (1.0") in diameter and was located 19.1 cm (7.5") from the circumferential seam. A faint green/blue transfer was present on the lower right quadrant of the face of the air bag. The transfer was located 17.8 cm (7.0") below the horizontal centerline and 14.0 cm (5.5") to the right of the vertical centerline. The transfer measured 7.6 cm (3.0") in length and 5.1 cm (2.0") in width. The air bag was tethered by four internal straps that measured 6.4 cm (2.5") in width and were located at the 12, 3, 6, and 9 o'clock positions.

Figure 9. Deployed driver's air bag

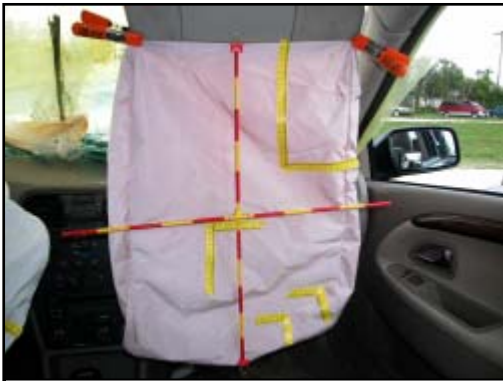
The front right passenger's air bag deployed from a top-mount module. The module was configured with symmetrical H-configuration cover flaps that measured 31.8 cm (12.5") in width and 5.1 cm (2.0") in height. The air bag (**Figure 10**) measured 35.6 cm (14.0") in width and 55.9

cm (22.0") in height. The air bag was vented by two circular ports located at the 3 and 9 o'clock positions of the air bag. The vent ports measured 3.8 cm (2.5") in diameter and were located 22.9 cm (9.0") forward of the face of the air bag. The face of the front right passenger's air bag exhibited three white transfers (**Figure 11**), although the source was not known and the front right passenger's seat was unoccupied at the time of the crash. The first transfer began 2.5 cm (1.0") left of the vertical centerline and 2.5 cm (1.0") below the horizontal centerline, measured 5.1 cm (2.0") in length, and extended at a downward angle to the right. The second transfer began 3.8 cm (1.5") to the right of the vertical centerline, 17.8 cm (7.0") below the horizontal centerline, and measured 3.8 cm (1.5") in width. The third transfer was located 14.0 cm (5.5") below the horizontal centerline, 10.2 cm (4.0") right of the vertical centerline, and measured 3.8 cm (1.5") in width.

The top right corner of the front right passenger's air bag was torn as a result of engagement with the damaged windshield, which had collapsed post-crash. Minor tears and abrasions were present

Figure 10. Deployed front right passenger's air bag

on the top right corner of the air bag face, which extended to the right side panel. The top aspect of the air bag sustained abrasions and minor tears as a result of contact with the fractured windshield.

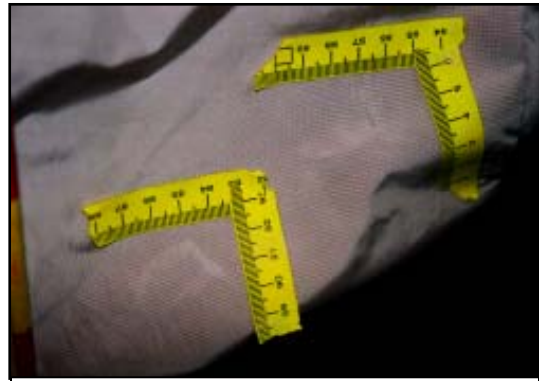
Figure 11. Close-up of white transfers on the front right passenger's air bag

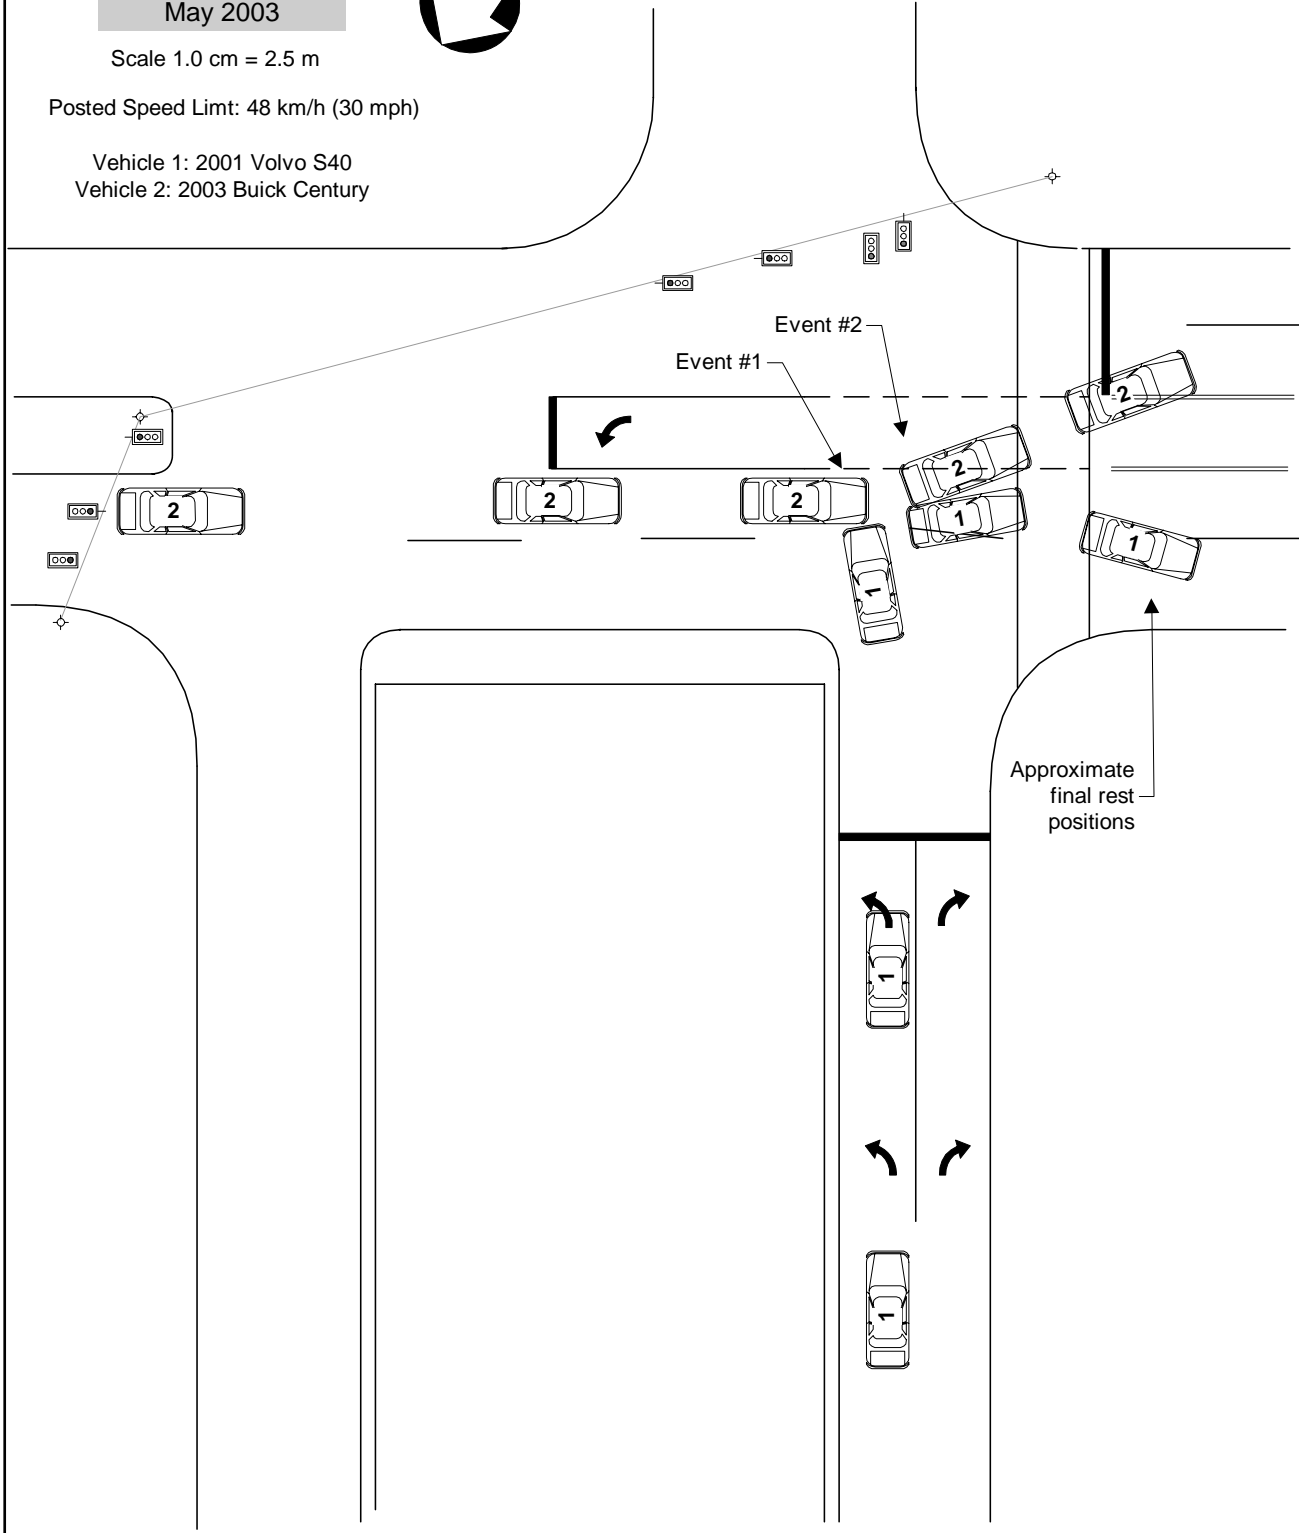
Figure 12. Scene schematic

The front of the Volvo S40 struck the right side of the Buick Century. The impact was sufficient to deploy the frontal air bag system in the Volvo S40. The Missing Vehicle algorithm of the WinSMASH program computed a total delta-V of 25 km/h (15.5 mph) for the Volvo S40 based on the Volvo's documented frontal crush profile and a total delta-V of 21 km/h (13 mph) for the Buick Century. The forward motion of the Century across the frontal plane of the S40 resulted in the rapid clockwise (CW) rotation of the S40 in the intersection and a slight counterclockwise

(CCW) deflection of the Century. The left rear of the S40 subsequently impacted the right side of the Century in a sideslap configuration. The Missing Vehicle algorithm of the WinSMASH program computed a delta-V for the Volvo of 12 km/h (7.5 mph) as a result of the sideslap. The sideslap event was not severe enough to warrant deployment of the SIPS system in the Volvo S40. The vehicles came to rest in the intersection, although the exact positions of final rest were not reported.
