On Site Child Safety Seat Investigation / Vehicle to Vehicle
Dynamic Science, Inc. / Case Number: DS03031
1995 Ford Windstar
Arizona
August, 2003

1. Report No. DS03031	2. Government Accession No.		3. Recipient Catalog No.	
4. Title and Subtitle On Site Child Safety Seat Investigation			5. Report Date June 15, 2004

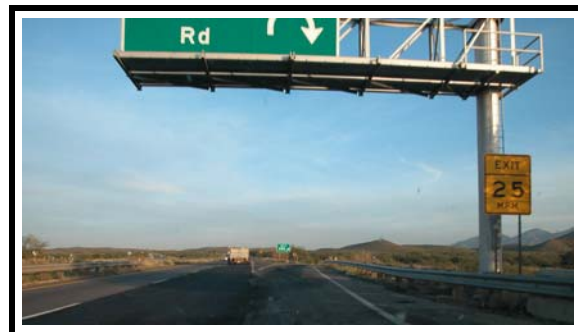
Figure 1. Area of impact (SE)

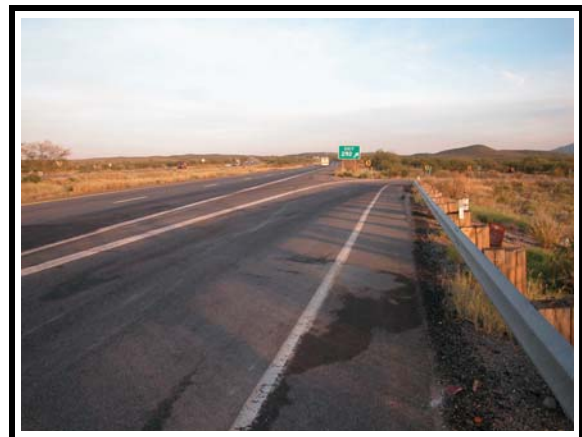
Figure 2. Area of final rest (SE).

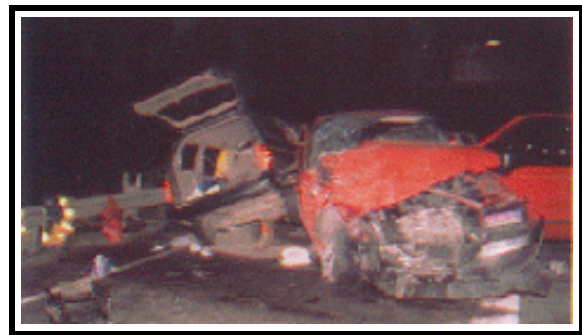
Figure 3. Final rest (NW)

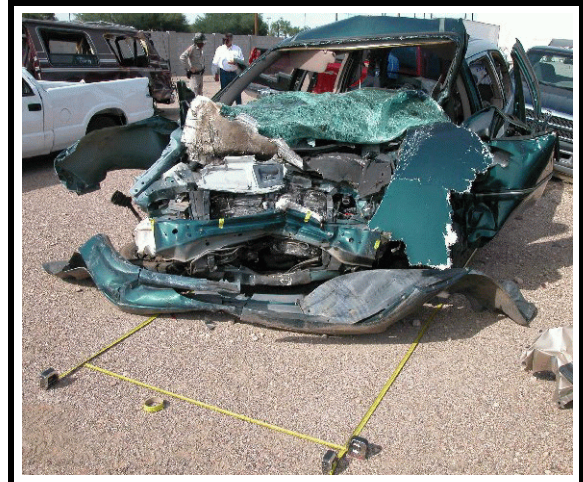
Figure 4. Front left, case vehicle

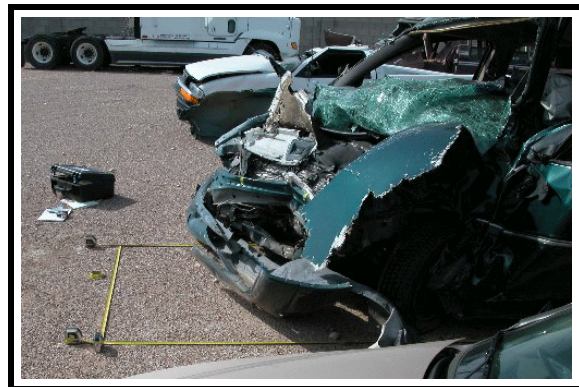
Figure 5. Left side, case vehicle

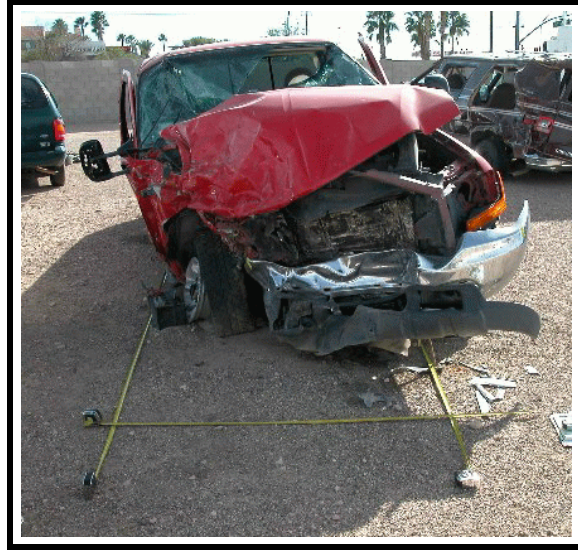
Figure 6. Front, other vehicle

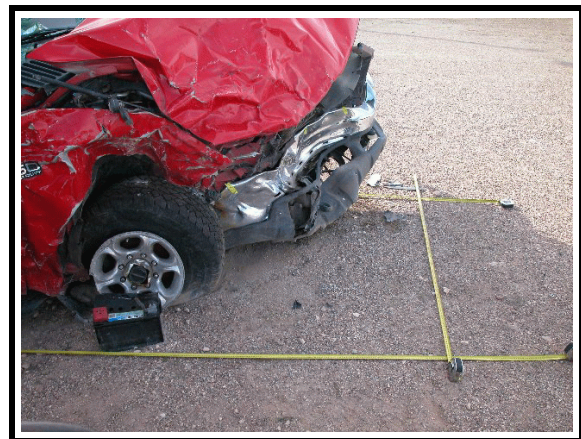
Figure 7. Right side, other vehicle

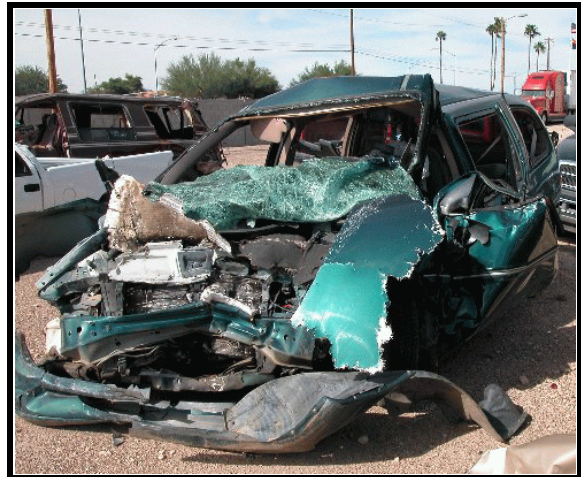
The frontal impact with the Ford pickup resulted in major frontal damage to the 1995 Ford Windstar. The direct damage began at the front left corner and extended across the entire front end. The front bumper fascia was broken away. The upper and lower radiator supports and metal bumper backing bar were crushed rearward. The left front wheel was displaced rearward and the left wheelbase was shortened by 82 cm (32 in). The front right wheel was dislodged and separated from the axle. Four crush measurements were taken along the metal bumper backing bar and were as follows: C1=114 cm (45 in), C2=115 cm (45 in), C3=83 cm (33 in), C4=62 cm (24 in).

Figure 8. Front left, Ford Windstar

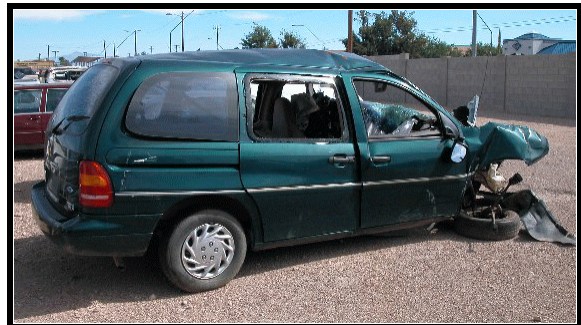
Figure 9. Right side, Ford Windstar

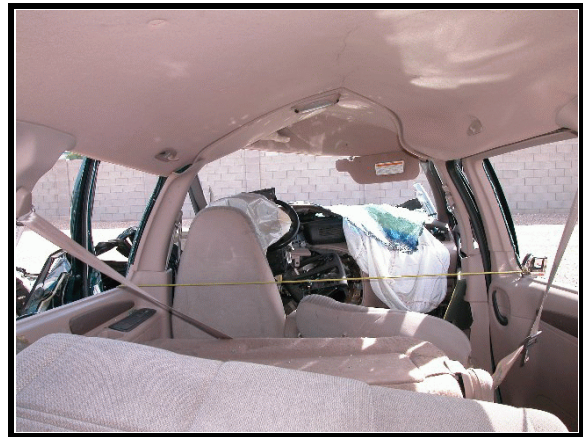
Interior damage to the 1995 Ford Windstar was extensive and attributed to occupant contact and passenger compartment intrusion. The entire windshield was fractured from impact forces. The right and left side glazing was disintegrated. The entire instrument panel and toe pan were intruded rearward. There was extensive knee contact damage to the left lower instrument panel. The bottom of the steering wheel was deformed upward from occupant contact. The steering column was rotated upward. Both front doors and the right rear door were jammed shut.

Figure 10. Overview of Ford Windstar interior

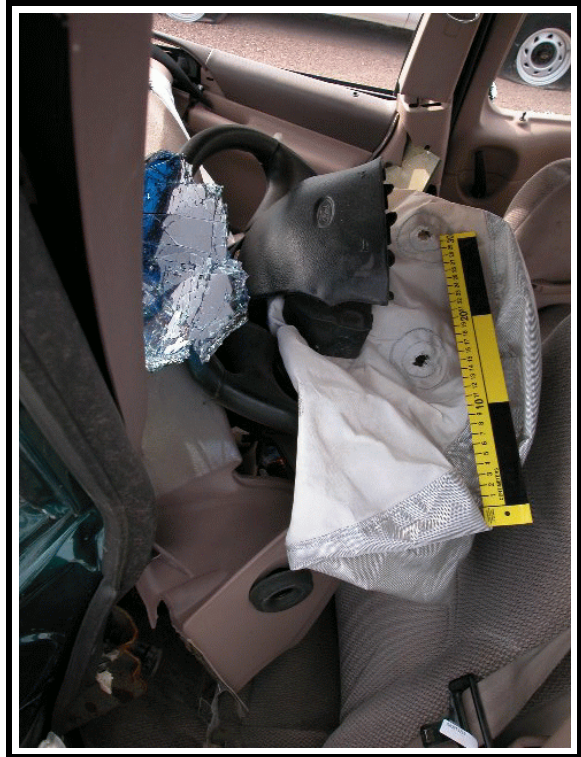
The 1995 Ford Windstar was equipped with frontal air bags for the driver and front right passenger positions that deployed as a result of the frontal impact with the other vehicle. The driver's air bag was housed in the steering wheel hub with symmetrical H-configuration module cover flaps. The top flap measured 30.0 cm (11.8 in) wide by 13.0 cm (5.1 in) high. The lower flap measured 30.0 cm (11.8 in) wide by 10.0 cm (3.9 in) high. The driver's air bag was circular in shape and measured 60.0 cm (23.6 in) in diameter in its deflated state. The air bag was vented by two circular ports that were located at the 11 and 1 o'clock positions on the rear aspect. The air bag was tethered by a single internal strap. The air bag face had seven vertical folds that were 7.0 cm (2.75 in) apart from one another. There were no visible contacts or damage to the air bag or the module covers.

Figure 11. Driver's air bag, top view

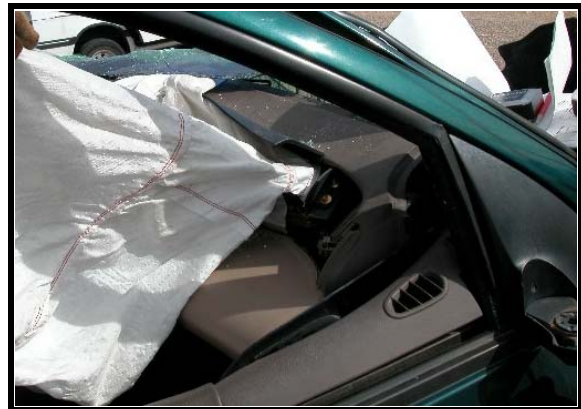
The front right passenger's air bag was housed in the mid instrument panel with a single cover flap. The flap measured 34.0 cm (13.8 in) wide by 12.0 cm (4.7 in) high. The front right passenger's air bag was vaguely rectangular in shape and measured 50.0 cm (19.7 in) high by 66.0 cm (25.9 in) wide. The bag was internally vented and there were no tethers. There was no contacts or damage to the air bag or the module cover.

Figure 12. Side view of front right passenger's air bag

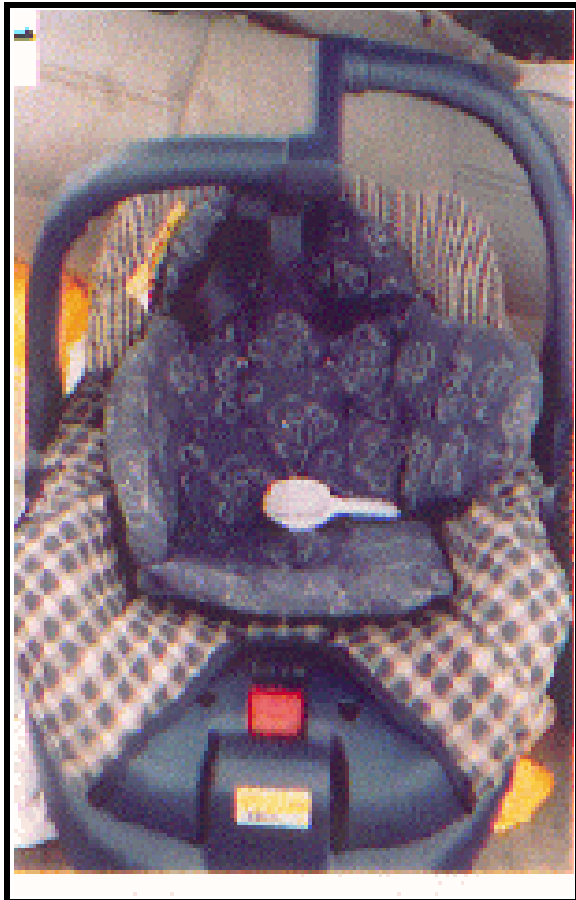
The second row left seat was occupied by a 4-month-old male (03) who was seated in an Evenflo Discovery rear facing infant safety seat (ISS), model #33161356P1 with a manufacture date of 04/04/03. The seat was designed to be used in a rear facing fashion for infants weighing between 2-9 kg (5-20 lbs). Police photos show that the child was restrained using the 3-point harness. The investigating officer indicated that the seat was properly anchored to the case vehicle using the available lap and shoulder belt. This does not appear to be the case. The left rear seat position was equipped with an emergency locking retractor, which would have necessitated the use of a locking clip. There are no indications that a locking clip was used.

Figure 14. Police photo of infant safety seat

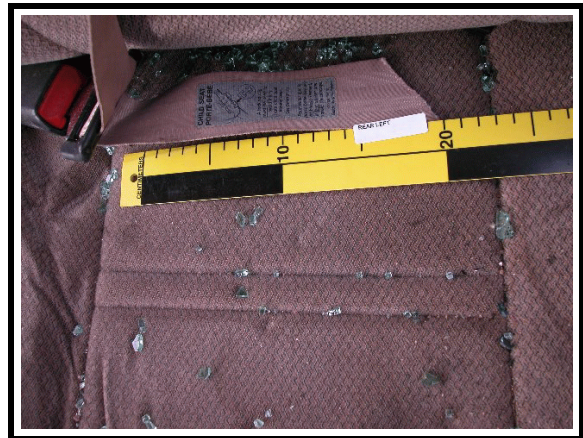
Figure 15. Second row left seat position, shows belt cut by EMS personnel

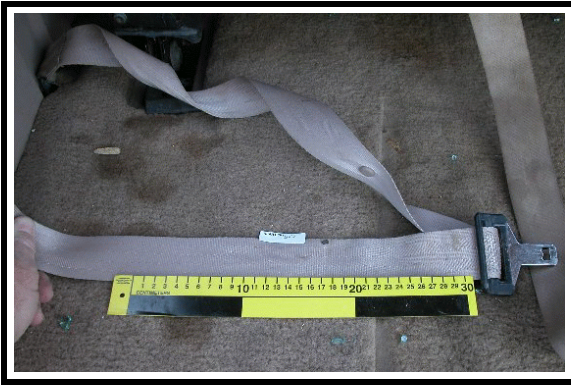
There were indications of loading to the child seat harness, the lap and shoulder belt routing guide on the right side of the child seat, to the lap and shoulder belt itself, and to the D pillar lap and shoulder attachment. Both sides of the tray shield mounting fractured and came free during the crash.

Figure 17. Loading to lap and shoulder belt, left side, third row

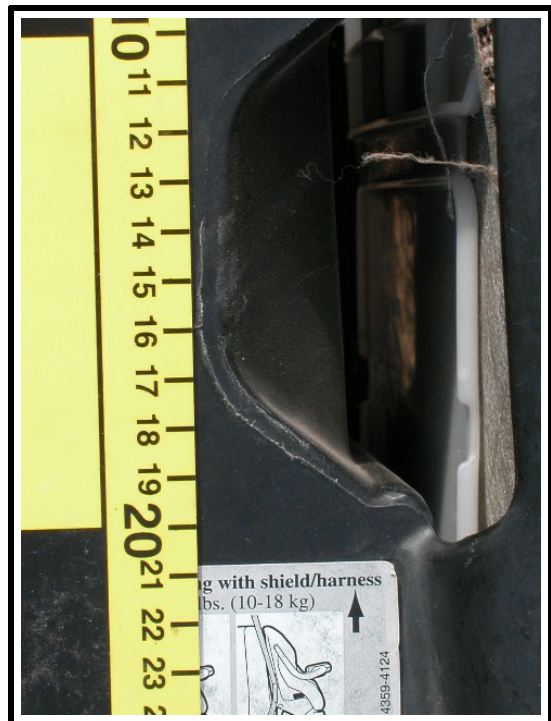
Figure 19. Loading marks to right side of Cosco seat

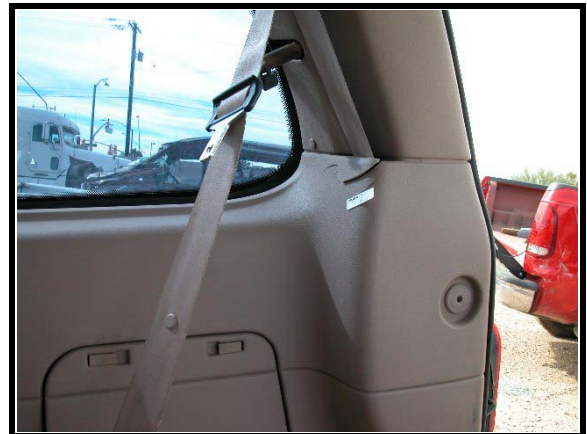
The third row right seat was occupied by the other 2-year-old female. The child was seated in a Graco Century 1500 STE convertible car seat. The manufacturer recommends that the seat be used in the rear facing mode until children weigh at least 9 kg (20 lbs) and are one year of age. For children over 10 kg (22 lbs), the car seat should be used in the forward facing until the child reaches 20 kg (40 lbs). In this case the seat was being used as a forward facing toddler seat. The seat was anchored to the vehicle using the available lap and shoulder belt. The child seat harness was routed through the top slots. The third row right rear seat position was equipped with an emergency locking retractor, which would have necessitated the use of a locking clip. There are no indications that a locking clip was used. There were indications of loading to the lap and shoulder belt itself and to the D pillar lap and shoulder attachment.

Figure 21. Cracks in D pillar from seat belt loading (third row right)

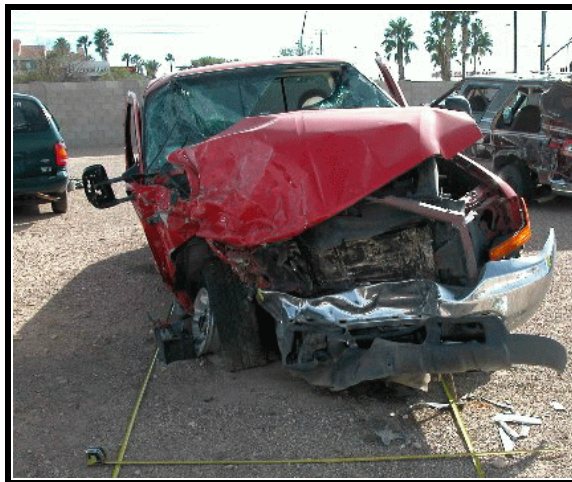
Figure 22. Front right, Ford F250

The 1999 Ford F250 pickup sustained major frontal damage as a result of the impact with the Ford Windstar. Damage began at the front right corner and extended 114.0 cm (44.8 in) laterally across the bumper. The front end was shifted 62.0 cm (24.4 in) to the left. The right front wheel was displaced rearward and the right wheelbase was shortened by 23.0 cm (9.1 in). The left wheelbase was shorted by 7.0 cm (2.8 in). Six crush measurements were taken along the bumper and were as follows: C1=11.0 cm (4.3 in), C2=6.0 cm (2 in), C3=27.0 cm (11 in), C4=48.0 cm (19 in), C5=58.0 cm (23 in), C6=80.0 cm (31 in).

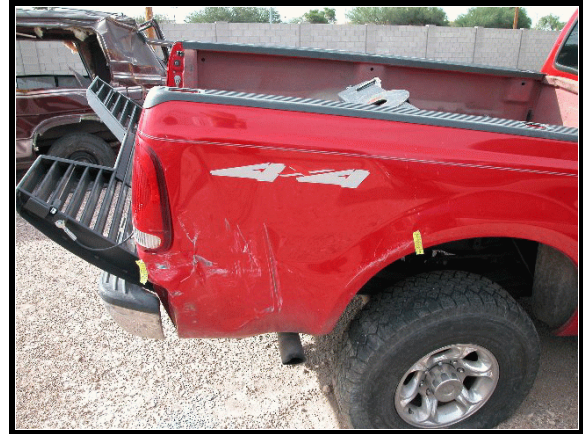
After impact, both vehicles rotated in a counterclockwise direction. There was a second, side slap type impact between the right rear of the Windstar (03RBEW1) and the right rear side of the F250 (09RBEW1). Both vehicles came to rest side by side on the off ramp area with the case vehicle facing west and the other vehicle facing east.

Figure 23. Impact 2, right rear

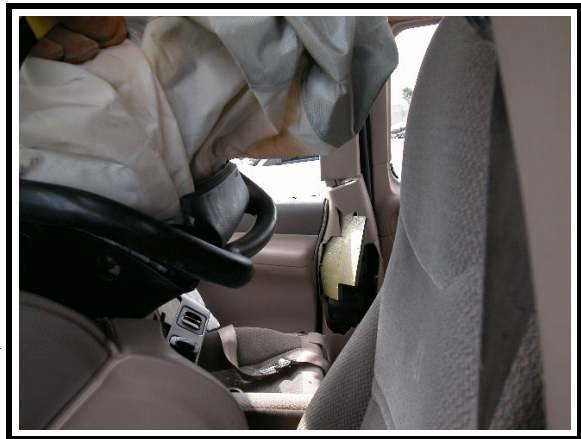
The 29-year-old female driver of the case vehicle was seated in a forward facing fashion on a fabric covered bucket seat. The seat track position is not known. She was not using the available 3-point lap and shoulder belt. A steering wheel hub mounted frontal air bag was available. At impact, the driver responded to the 11 o'clock direction of force by pitching forward sharply and over-loading the deployed driver's air bag. Her abdomen compressed and deformed the lower steering wheel rim. This action likely caused the aortic transection, mesentery lacerations, liver and bladder lacerations. Her torso engaged the middle and top of the steering wheel. This caused the lung

Figure 25. Deformation to bottom of steering wheel rim

pivot point. The driver's head pitched forward, hyper-flexing over the steering wheel. This movement likely caused the pons-medullary junction laceration and the cervical fractures. Both of the driver's knees struck the lower instrument panel, indirectly causing bilateral femur fractures and a left pelvis fracture.

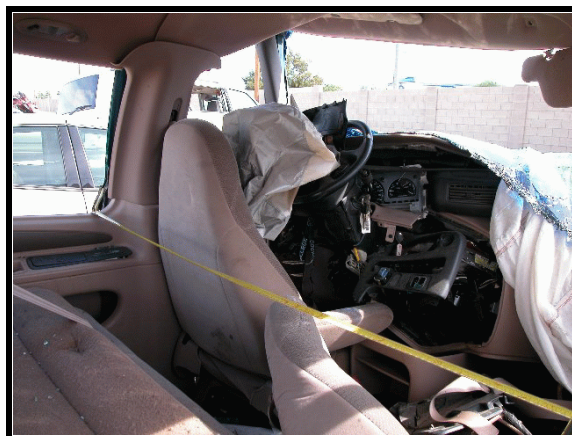
Figure 26. Driver's position

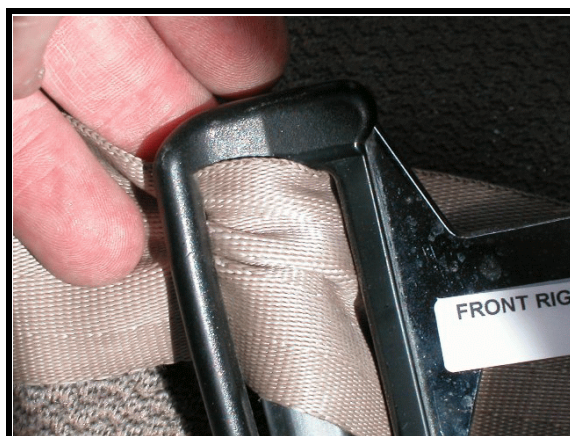
Figure 27. Webbing locked into front right passenger seat belt latch

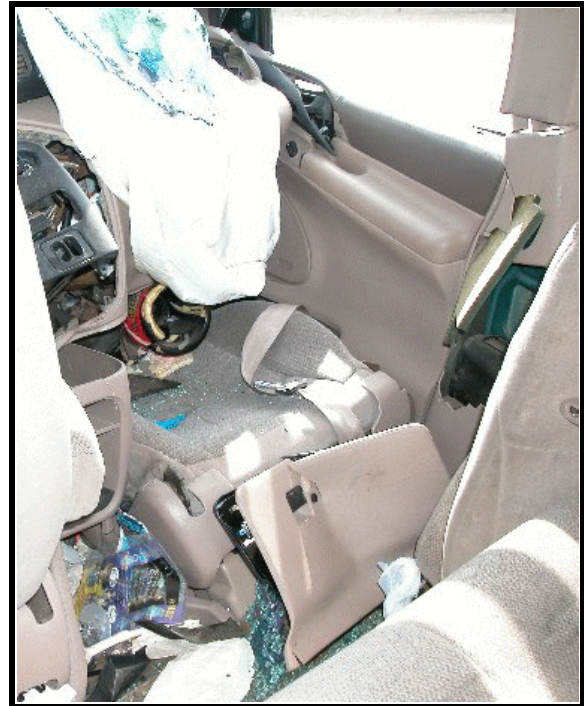
Figure 28. Front right seat position. Shows air bag and contact to glove compartment.

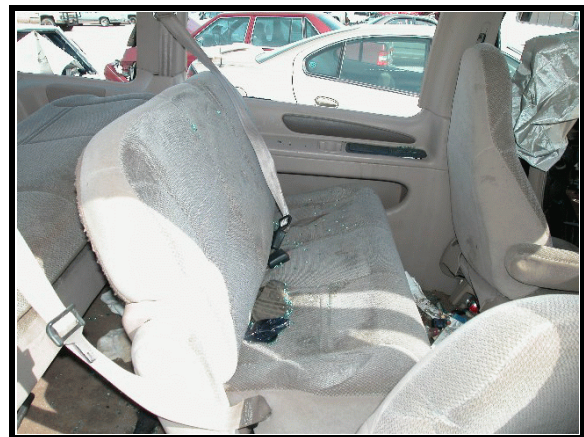
Figure 29. Second row (Occupants 3 and 4)

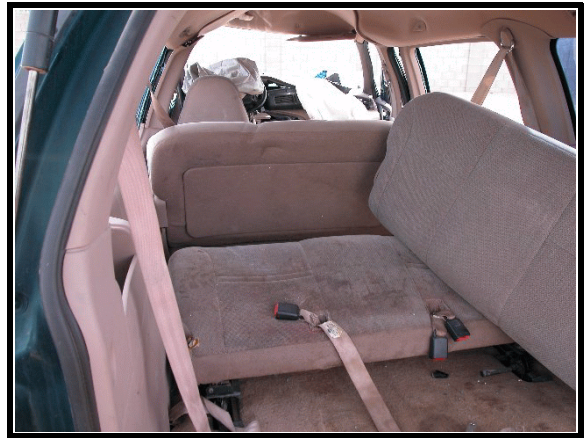
Figure 30. Third row (Occupants 5, 6, and possibly 7)
