GENERAL DYNAMICS ON-SITE ADVANCED OCCUPANT PROTECTION SYSTEM (AOPS) INVESTIGATION SCI TECHNICAL SUMMARY REPORT

CASE NO. CA03-032

VEHICLE – 2001 FORD CROWN VICTORIA POLICE INTERCEPTOR

CRASH DATE – MAY 2003

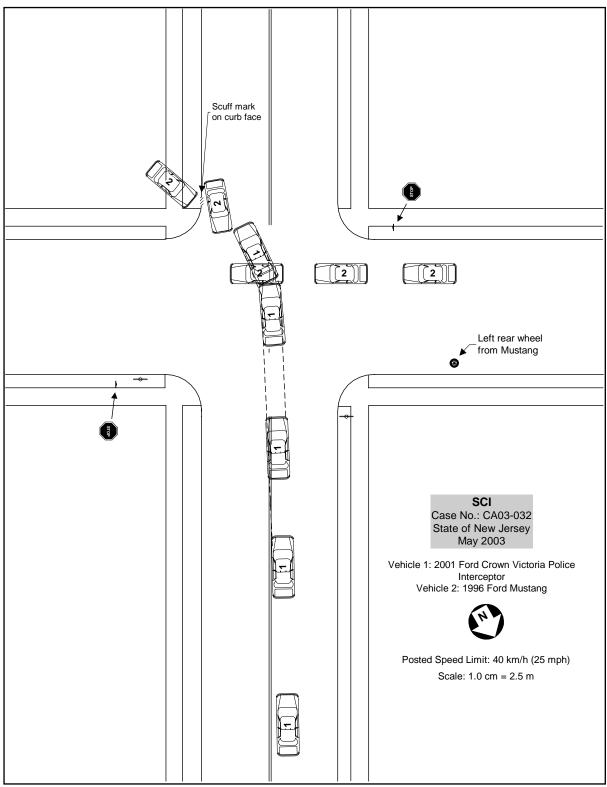
Figure 15. Scene schematic

concrete sidewalks and private residences. The posted speed limit for both roadways was 40 km/h (25 mph). The scene schematic is included as Figure 15 of this report.

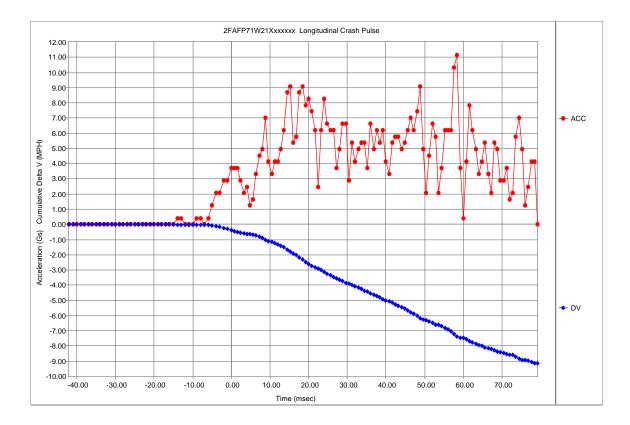
System Status At Deployment

Ford Part Number Prefix	1W7A
Number Of Active Faults	0
Driver Seat Belt Buckle	Unbuckled
Passenger Seat Belt Buckle	Unbuckled
Driver Seat Track In Forward Position	Yes
Occupant Classification Status Value	Dual Stage
Unbelted Stage 1	Fire
Unbelted Stage 2	No Fire
Belted Stage 1	No Fire
Belted Stage 2	No Fire
Driver Pretensioner	Fire
Passenger Pretensioner	Fire

Parameter	Driver	Passenger
Pretensioner Time (milliseconds)	NONE	NONE
First Stage Time (milliseconds)	28.8	28.8
Second Stage Time (milliseconds)	128.8	128.8
