ON-SITE ADULT AIR BAG-RELATED FATALITY INVESTIGATION

CASE NUMBER - IN-03-033
LOCATION - MISSOURI
VEHICLE - 1997 FORD EXPLORER XL
CRASH DATE - July 2003

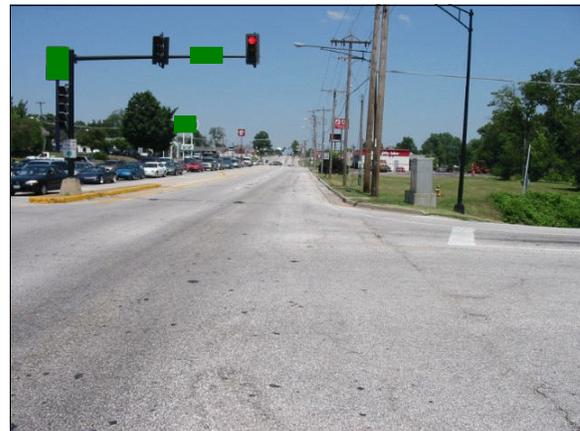
Figure 1: Case vehicle's northward travel path in outside northbound lane toward impact location with utility pole on east roadside (case photo #04)

The shoulders were improved (i.e., concrete rain gutter) but their width was not measured. The trafficway was bordered by barrier curbs. The northern and southern roadways were separated on both the northern and southern legs of the intersection by unprotected, raised, concrete medians (**Figures 1** and **2** above). On the southern leg of the intersection, pavement markings consisted of a solid white lane line and the left-hand turn lane was separated from the through lanes by a solid white lane line. Furthermore, the median curb and the raised, paved median was painted yellow. In addition, no edge lines were present for the northern roadway (**Figure 3**); although, a curving white edge line was present for the westward intersecting roadway (**Figure 2** above and **Figure 3**). The coefficient of friction was not estimated.

Traffic controls consisted of multiple on-colors, pre-timed, vertically mounted traffic control signals located on the northern leg of the intersection, hanging from the arm of a pole mounted in the median (**Figure 1** above). In addition, there was a regulatory **LEFT TURN YIELD ON GREEN** sign (Manual on Uniform Traffic Control Devices, R10-12) fastened on the median signal pole (**Figure 1** above). The statutory speed limit was 48 km.p.h. (30 m.p.h.). No regulatory speed limit sign was posted near the crash site. At the time of the crash the light condition was daylight, the atmospheric condition was clear, and the roadway pavement was dry. Given the time of day and the proximity of the crash scene to an interstate entrance/exit, the Traffic density was most likely heavy, and the site of the crash was urban commercial; see **CRASH DIAGRAM** at end.

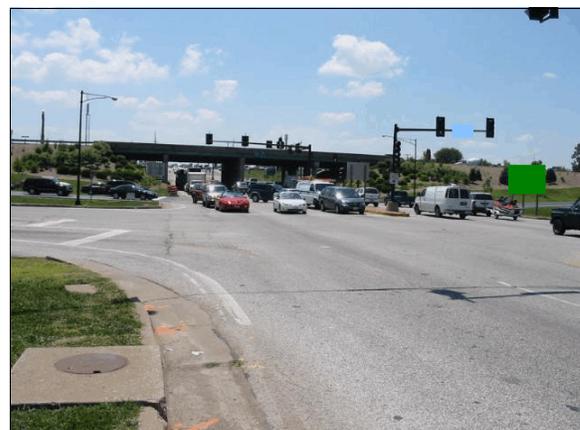
Figure 2: Southward view of case vehicle's northern travel path from northeast corner of intersection, just southwest of impact location (case photo #09)

southern leg, through the intersection, toward the northern leg (**Figure 2** above). As a result, it cannot be determined whether the narrowing of the outside lane played a role in this crash.

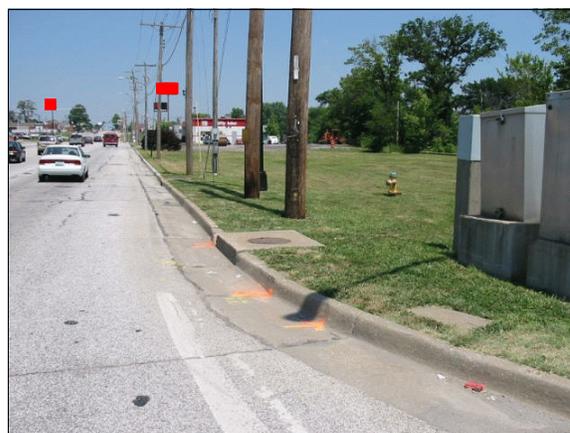
Figure 3: Case vehicle's travel path off roadway toward wooden utility pole (case photo #05)

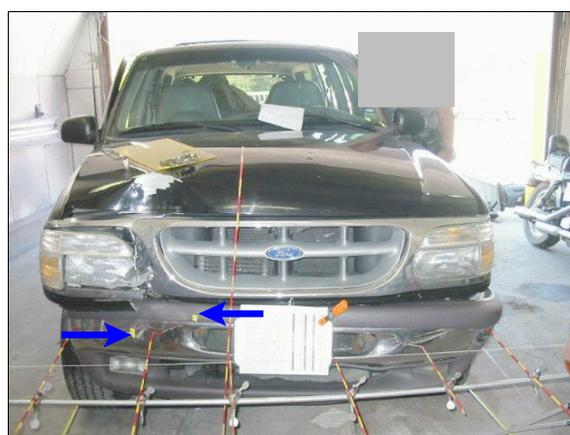
Figure 4: Case vehicle's frontal damage with contour gauge set at bumper level; Note: yellow tape (arrows) shows location and direct damage width of pole impact (case photo #10)

Crash: The front right (**Figure 4**) of the case vehicle impacted a large wooden utility pole

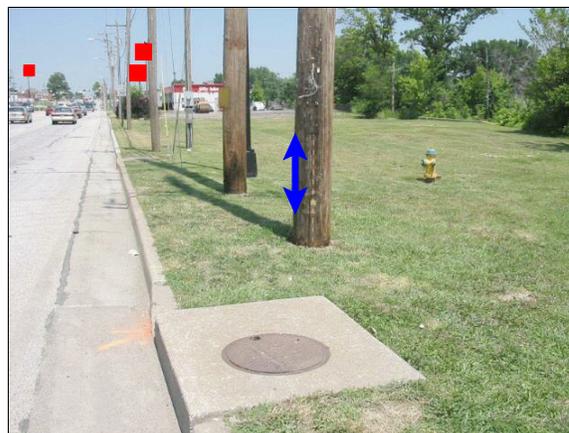
(Figure 5), causing the case vehicle's driver and front right passenger supplemental restraints (air bags) to deploy.

Figure 5: Case vehicle's travel path on east shoulder toward point of impact with wooden utility pole; Note: arrow indicates location of damage on pole (case photo #06)

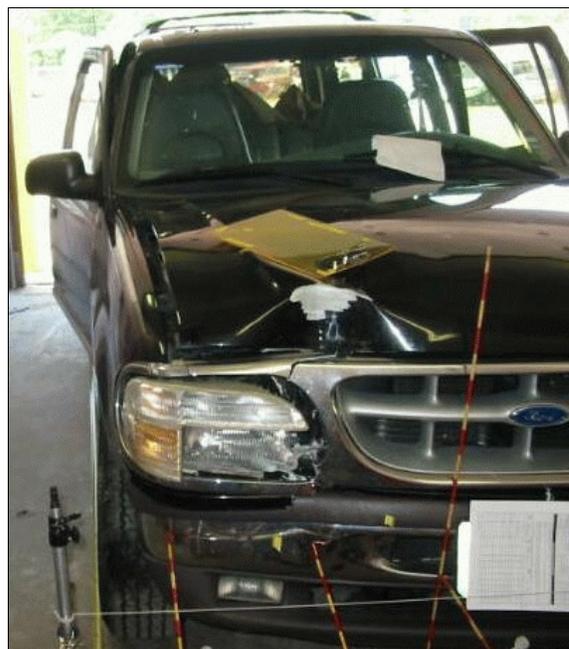
Figure 6: Case vehicle's front right damage from impact with utility pole viewed along right side (case photo #21)

damage distributed on approximately the front right portion (Figure 6 above). Direct damage began 24 centimeters (9.4 inches) inward from the front right bumper corner and extended 21 centimeters (8.3 inches) to the left along the front bumper. Residual maximum crush was measured as 17 centimeters (6.7 inches) at C₆ (Figure 7). The table below shows the case vehicle’s crush profile.

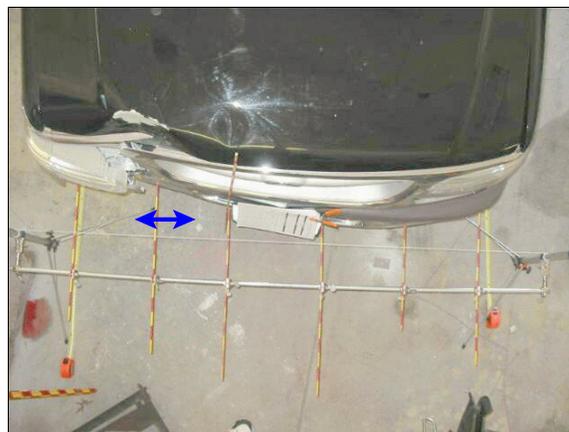
Figure 7: Overhead view of case vehicle’s frontal damage with contour gauge present at bumper level; arrow indicates location of pole impact (case photo #22)

The wheelbase on the case vehicle’s left side was extended at most 1 centimeter (0.4 inches) while the right side was shortened approximately 3 centimeters (1.2 inches). The case vehicle’s front bumper fascia, grille, hood, and right head lamp assembly were directly damaged and crushed rearward. The right headlight and turn signal assemblies sustained induced damage as well as both the right and left fenders. No obvious induced damage or remote buckling was noted to the remainder of the case vehicle’s exterior.

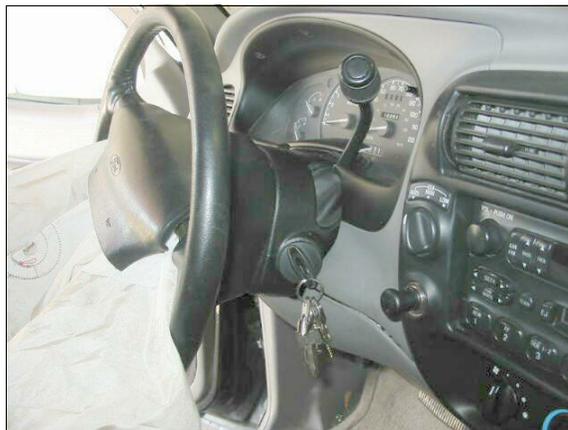
Interior Damage: Inspection of the case vehicle's interior revealed loading to the steering column and approximately 1 centimeter (0.4 inches) of deformation to the top half of the steering wheel rim. Furthermore, the column was driven forward, approximately 5 centimeters (2.0 inches), into the left instrument panel (**Figure 8**). The windshield-mounted rearview mirror was cracked and broken off the windshield, and there were stress fractures to the right windshield's glazing from the collision (**Figure 9**). There was no other evidence of occupant contact on the interior surfaces of the case vehicle (**Figure 10** and **Figure 11** below). Finally, there was no evidence of intrusion to the case vehicle's interior, and it could not be determined if there was compression to the energy absorbing steering column device.

Figure 8: Case vehicle's slightly deformed steering wheel rim and loaded steering column; Note: steering column driven forward against left instrument panel (case photo #38)

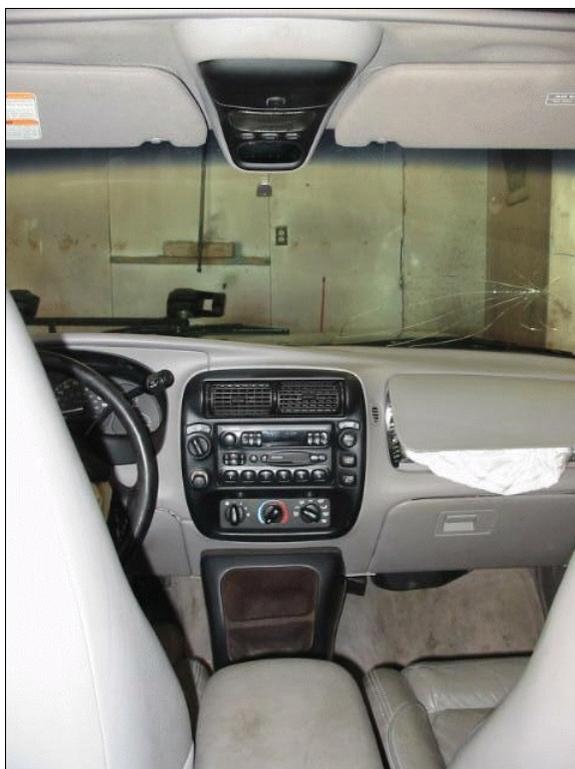
Figure 9: Case vehicle's center and right instrument panel and greenhouse areas showing no obvious evidence of occupant contact and crack to right windshield's glazing (case photo #40)

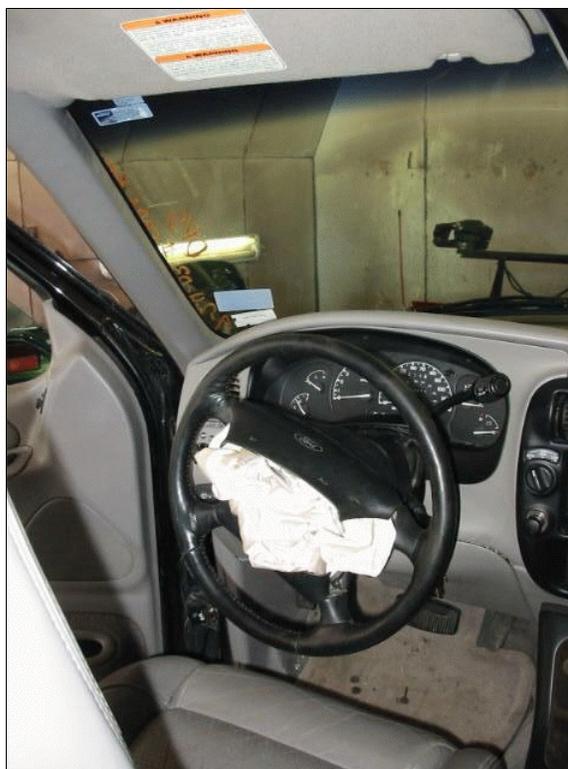
Figure 10: Case vehicle's driver seating area showing deployed driver air bag and no obvious contact evidence to greenhouse area or right side of driver's knee bolster (case photo #25)

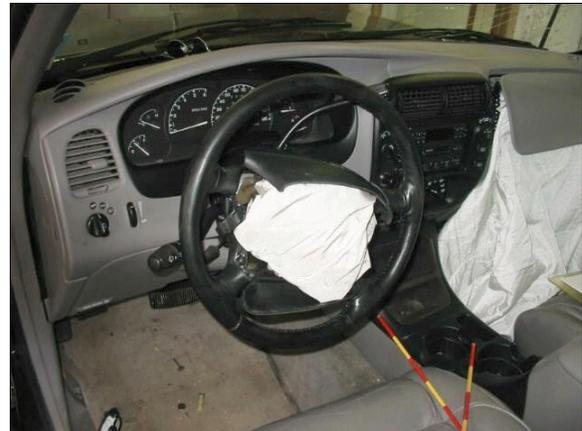
Figure 11: Case vehicle's driver seating area showing deployed frontal air bags, driver's toe pan area, and left instrument panel; Note: no obvious contact evidence present (case photo #26)

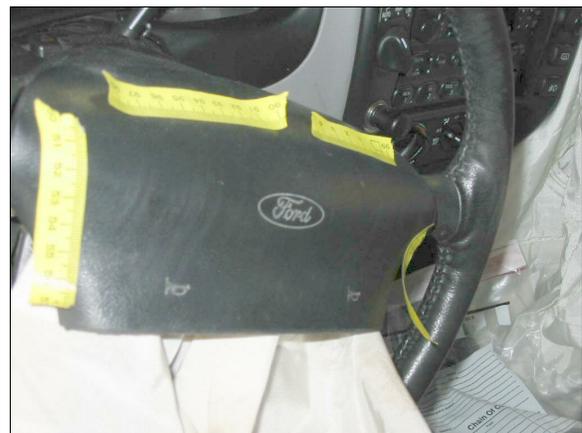
Figure 12: Vertically oriented scuffs on case vehicle driver air bag module's top cover flap (case photo #34)

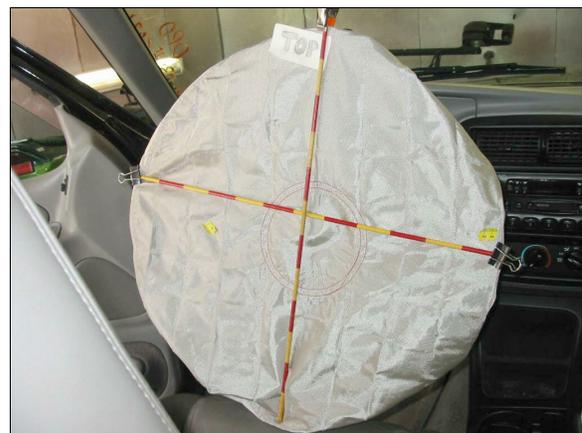
Figure 13: Case vehicle's deployed driver air bag showing (i.e., yellow tape) blood spots near 3 o'clock position and between center and 9 o'clock position (case photo #27)

evidence on the air bag's fabric; although, there were a couple of very small blood spots on the front surface of the air bag (**Figure 13** above) and one spot on the back surface (**Figure 14**).

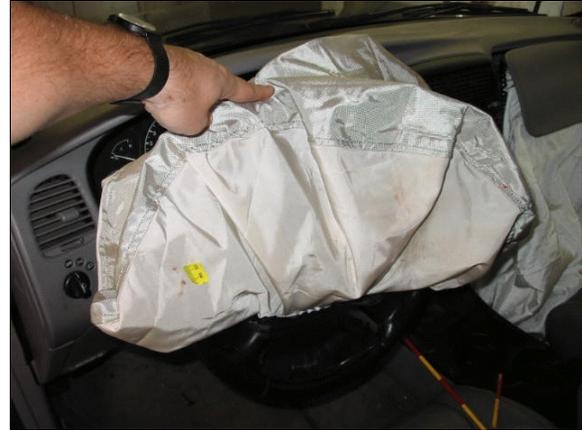
Figure 14: Blood spot on back surface of case vehicle's deployed driver air bag (case photo #31)

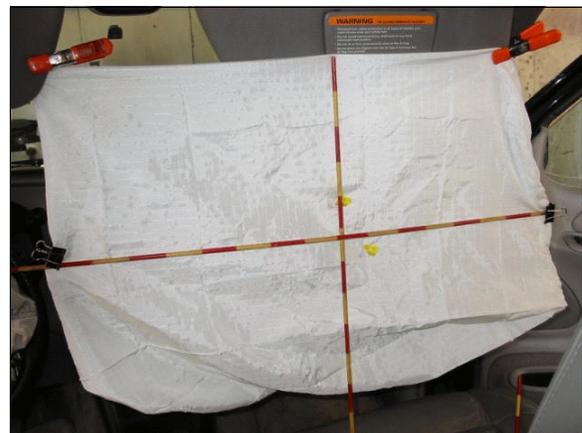
The front right passenger's air bag was located in the middle of the instrument panel. There was a single, essentially rectangular, modular cover flap. The cover flap was made of a medium thickness vinyl but thicker than the vinyl on the driver's module. The flap's dimensions were 37 centimeters (14.6 inches) at the lower horizontal seam and 17.5 centimeters (6.9 inches) along both vertical seams. The profile of the case vehicle's instrument panel was flush with the leading edge of the cover flap. An inspection of the front right air bag module's cover flap and the air bag's fabric revealed that the cover flap opened at the designated tear points, and there was no evidence of damage during the deployment to the air bag or the cover flap. The front right passenger's air bag was designed without any tethers. The front right air bag had two vent ports, approximately 5 centimeters (2.0 inches) in diameter, located at the 9:30 and 2:30 clock positions. The deployed front right air bag was rectangular with a height of approximately 62 centimeters (24.4 inches) and a width of approximately 85 centimeters (33.5 inches). An inspection of the front right passenger's air bag fabric revealed two small blood stains on the front surface of the front right air bag's fabric, just to the right of the bag's center (**Figure 15**).

Figure 15: Front surface of case vehicle's deployed front right passenger air bag showing blood spots near bag's center (case photo #44)
