**ON-SITE CHILD SAFETY SEAT INVESTIGATION
CENTURY SMART MOVE SE CONVERTIBEL CHILD SAFETY SEAT
GENERAL DYNAMICS CASE NO: CA03-033**

**VEHICLE – 1990 TOYOTA 4 RUNNER
LOCATION - COLORADO
CRASH DATE – JUNE 2003**

Contract No. DTNH22-01-C-17002

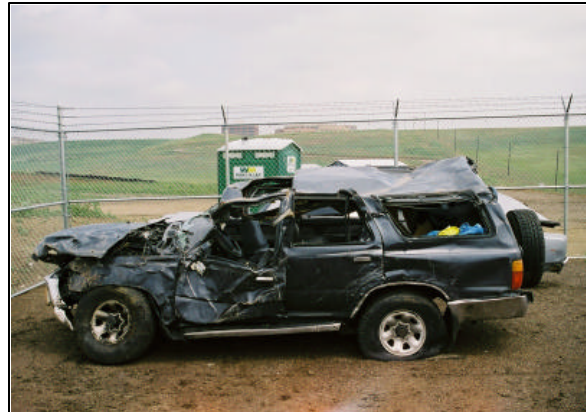
This on-site investigation focused on the installation and performance of a Century Smart Move SE convertible child safety seat (CSS) that was installed in a forward facing mode in the right rear position of a 1990 Toyota 4 Runner sport utility vehicle, **Figure 1**. The Toyota sustained severe damage to the greenhouse (volume above the belt line) as the result of high speed rollover crash. The CSS was occupied by a 2-year old male child. The child sustained only minor facial abrasions and a wrist contusion. The 22 year old restrained male driver and 22 year old restrained female front right passenger sustained serious injuries and were admitted to a trauma center for treatment. A secondary focus of the investigation was a tread separation of the Toyota's left rear tire that contributed to the driver's loss of control and subsequent crash.

Figure 1: Left side view of the Toyota 4 Runner.

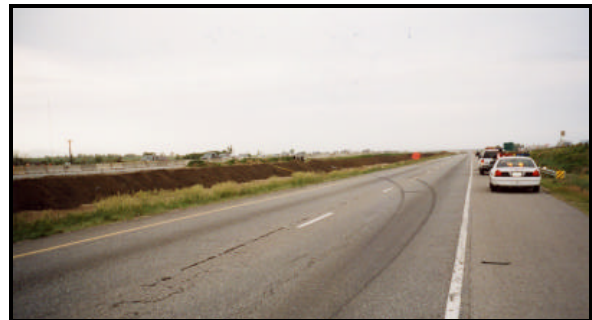
Inspection of the crash scene identified two yaw marks that began in the outboard (right) lane. The marks were attributed to the right side tires of the Toyota. The front right yaw mark measured 50 m (165 ft) in length. The length of the rear right yaw mark measured 40 m (130 ft).

Figure 4 is an on-scene police photograph of the yaw marks looking along the Toyota's northwestward trajectory. At the end of the yaw marks, the Toyota initiated an untripped right side leading rollover. There were no pavement gouges at the end of the yaw marks normally associated to a tripped rollover. The area of first touchdown was located 9 m (30 ft) northwest of the end of the yaw marks on the inboard road shoulder, **Figure 5**. The touchdown zone was identified by a series of small gouges and abrasions dispersed over a 2.4 m x 0.9 m (8.0 ft x 3.0 ft) area. This contact was attributed to the right roof rail and roof area of the Toyota. Two 1.5 m (5.0 ft) long abrasion marks, located on the inboard shoulder 14 m (45 ft) beyond the end of the yaw marks, denote the point where the Toyota entered the median. An area measuring 1.2 m x 5.5 m (4.0 ft x 18.0 ft) located 42.7 m (140.0 ft) beyond the end of the yaw marks was documented during the police investigation as the second point of (significant) impact by the Toyota. The vehicle then vaulted over the 2.4 m (8.0 ft) berm of construction materials. A review of the on-scene police photographs depicted that the berm remained undisturbed throughout the area of the Toyota's trajectory indicative that the vehicle did not significantly contact the berm. The Toyota came to rest on its left side facing south, **Figure 6**. The final rest of the vehicle was located 20 m (230 ft) northwest of the end of the yaw marks and 23 m (74 ft) west of the northbound lanes. Reconstruction of the rollover indicated the Toyota completed 2-3/4 revolutions (11 quarter turns) during the event. A schematic of the crash sequence is attached to the end of this narrative report, **Figure 20**.

Figure 4: Northwest view of the yaw marks.

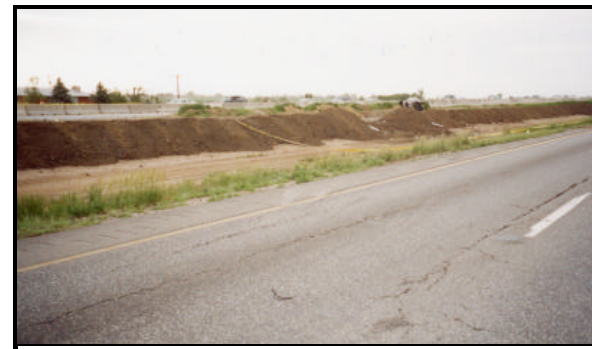
Figure 5: View of the area of first touchdown

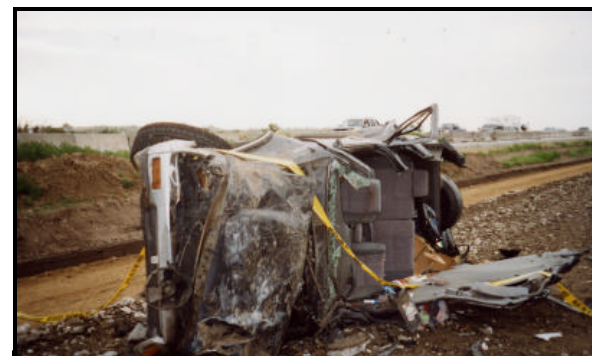
Figure 6: View of the final rest position of the Toyota.

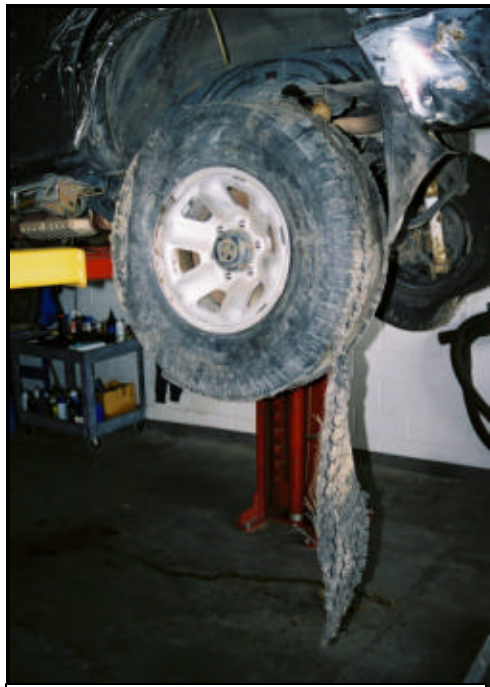
The left rear tire sustained a 90 percent tread separation immediately prior to the crash. Witness reported that the tread instantly separated. Examination of the left rear wheel well did not yield evidence that the tire tread impacted the inner fender of the truck in a repetitive manner. The majority of the separated tread was recovered by the police investigators from the crash site.

Figure 7 is a view of the left rear tire. The tire was deflated at the time of the inspection; however, the tire bead was still seated. **Figure 8** is a view of the recovered tread. The tread section measured 229 cm (90 in) in length. The depth of the tread was a consistent 9.5 mm (12/32) across its face. Examination of the tread and tire casing indicated the tread appeared to have separated between the steel plies.

Figure 7: View of the left rear tire.

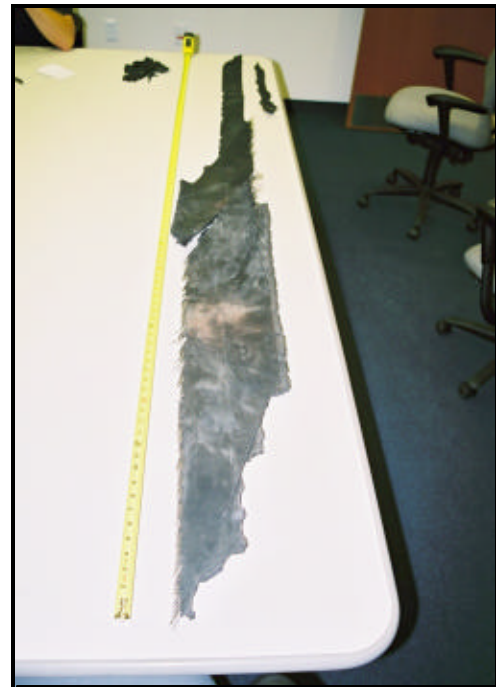
Figure 8: View of the recovered tire tread.

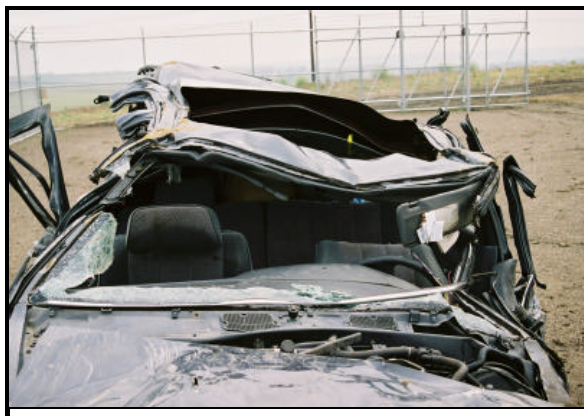
Figures 9 through 11 are the views of the Toyota's left side, greenhouse and right side, respectively. The vehicle sustained damage consistent with a 2 3/4 revolution (11 quarter turn) lateral rollover crash event. The primary vehicle damage was to the forward aspect of the roof resultant to its impact with the ground. The right A-, B-, and C-pillars, and the left A-, and B-pillars deformed vertically and were displaced laterally to the right. The residual vertical deformation at the left A-pillar measured 23 cm (9 in). It should be noted that the dynamic vertical deformation would have been greater than the static post-crash intrusion due to the effects of restitution. Inspection of the left aspect of the instrument panel (IP) identified a region of direct contact between the windshield header and top surface of the instrument panel and steering wheel rim. Additionally, during impact with the ground, the left A-pillar buckled and deformed inboard. The deformed roof and pillar impacted and fractured the left aspect of the instrument panel. The windshield was fractured and completely displaced from its mounting. The backlight and all side glazings disintegrated in the event and the sunroof separated. The left front, left rear, and right rear doors were jammed shut due to deformation. The right front door remained closed during the crash and was operational. The Collision Deformation Classification (CDC) of the damage was 00-TDDO-4. The left A-pillar and the right A- through D-pillars were cut during the extrication of the occupants.

Figure 9: Front view of the deformed greenhouse.

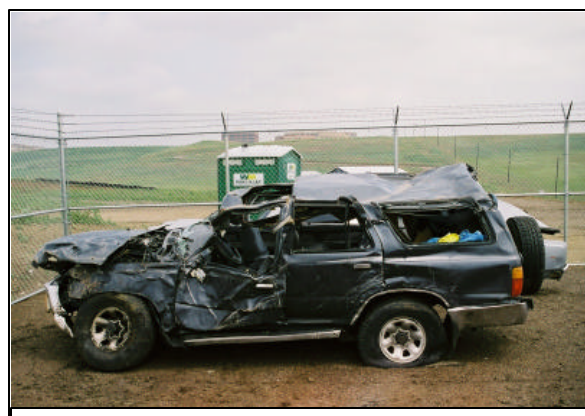
Figure 10: Left side view of the Toyota 4 Runner.

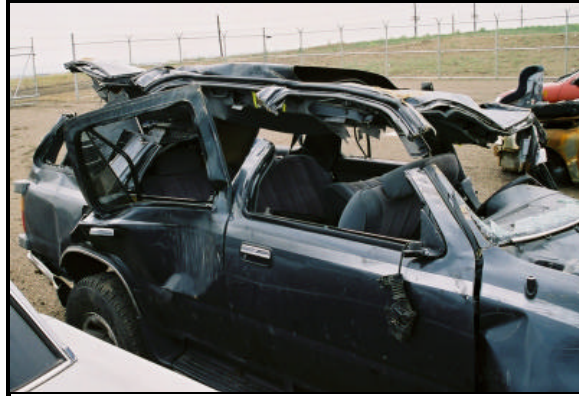
Figure 11: Right side view.

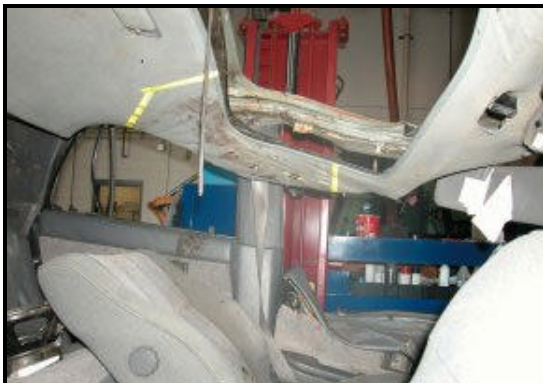
measuring 53 cm x 30 cm (21 in x 12 in) was located 38.1 cm (15.0 in) rearward of the header. This contact resulted in the driver's left scapula and left rib fractures. **Figure 12** is a view of the contact area above the driver's position.

Figure 12: Driver's contact.

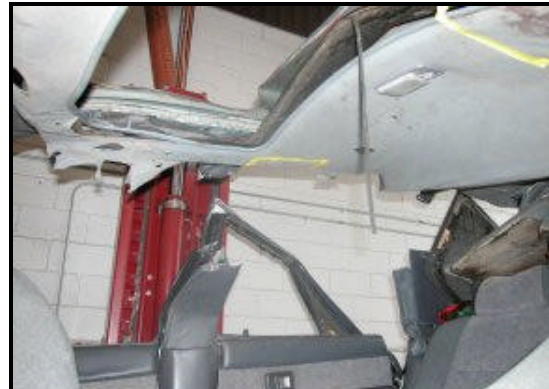
The front right seat was in the full forward position and the seat back was folded forward. Reportedly, the seat had been moved prior to the SCI inspection. The seat back recline mechanism was damaged and would not engage; the seat back return spring would cause the seat to fold completely forward. The recline mechanism was probably damaged in the rollover due to the loading of the front right occupant during inverted ground contact. A 15.0 cm x 14.0 cm (6.0 in x 5.5 in) contact, **Figure 13**, to the right side rail/headliner junction was identified above the right front position. The contact was located 66 cm (26 in) rearward of the header and attributed to the right shoulder of the occupant. This contact resulted in her right clavicle fracture.

Figure 13: Front right passenger contact.

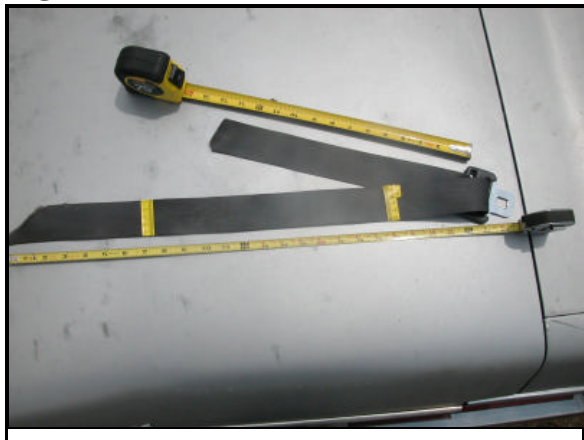
The rear right restraint was cut in order to extricate the child while he was still restrained within the child safety seat. A 102 cm (40 in) section of webbing was found in the rear right position. This webbing section was threaded through the lightweight locking latch plate that was still inserted into the inboard buckle at the time of the inspection. The restraint's outboard floor anchor was located under the rear seat cushion. The webbing was attached to the anchor and then passed through the seat bight forming the continuous loop. The webbing was cut 16.5 cm (6.5 in) above the seat bight during the extrication. **Figure 14** is a view of the cut webbing section. A crease in the webbing identified the at crash location of the latch plate. The latch plate was located 38 cm (15 in) from the end of the webbing section. This section of webbing was used to restrain the child seat during the crash. Load evidence was located 19.1 cm (7.5 in) and 49.5 cm (19.5 in) from the end of the section. This evidence was consistent with an interaction with the forward facing belt path of the CSS. The width of the tunnel forming the belt path measured 33 cm (13 in) consistent with the separation of the loading marks on the belt, **Figure 15**.

Figure 14: View of the webbing section/belt path interaction.

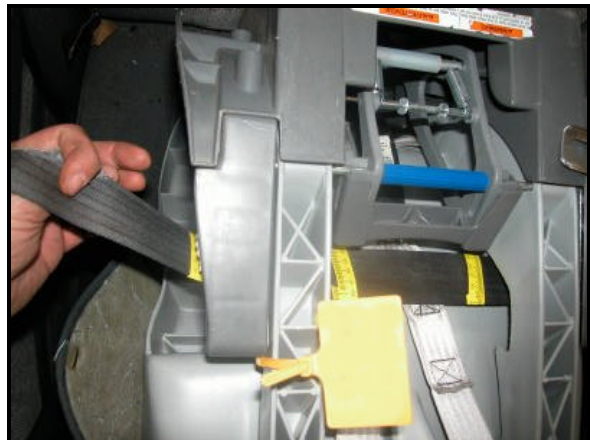
Figure 15: View of the rear right cut webbing section.

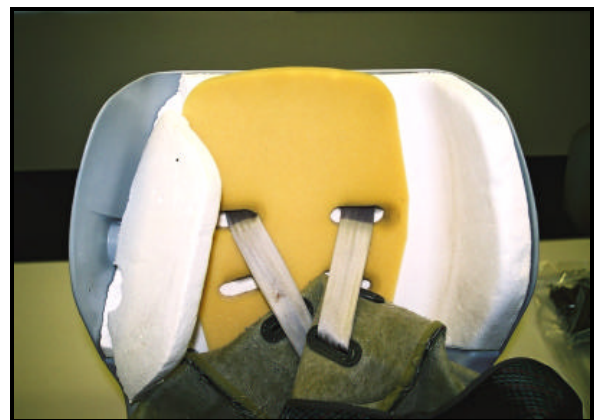
Examination of the child seat involved removing the cloth seat cover and inspecting the shell. Removing the seat cover revealed fracture damage to the Styrofoam absorber overlying the upper right aspect of the shell. **Figure 17** is a view of the fractured Styrofoam. **Figure 18** is a view of the shell with the Styrofoam removed. Inspection revealed three areas of stress marks to the plastic shell denoted by the arrows in the figure. During the crash sequence the deformed roof impacted the upper right wing of the shell. This contact fractured the Styrofoam absorber and caused the stress marks within the CSS shell. The shell was not fractured. Although the shell of the CSS was contacted by the intruding roof, the child remained protected during the rollover crash through the use of the 5-point harness.

Figure 17: View of the Styrofoam fracture.

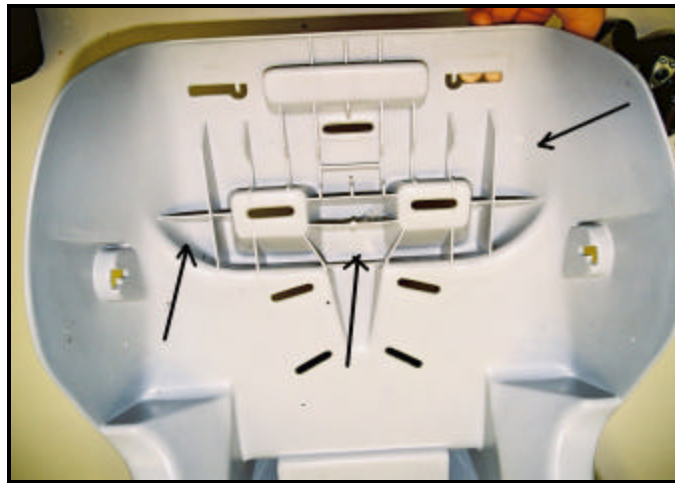
Figure 18: View of the upper aspect of the CSS shell and the stress marks.

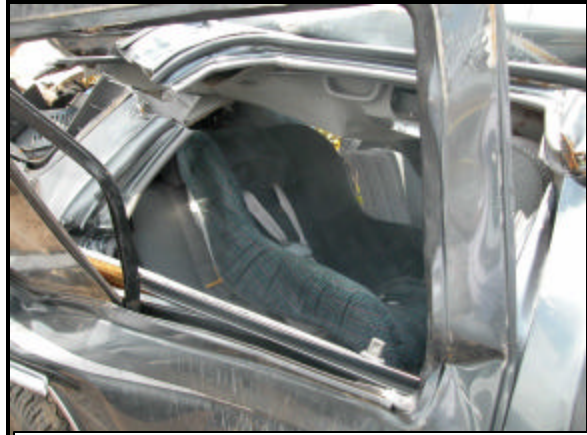
The 2 year old male was restrained by the 5-point harness of a convertible child safety seat buckled in the rear right position of the 4 Runner. **Figure 19** is a view of the reconstructed seat position. As the vehicle went through the dynamics of the rollover, the child loaded the harness straps of the safety seat with his shoulders. The harness straps of the CSS and design of the shell protected the child as he rode down the forces of the crash. During the event, the vehicle’s roof crushed down and impacted the right upper aspect of the shell. This contact was evidenced by the fractured Styrofoam absorber overlying the shell. During the event, the right rear window glazing disintegrated and the flying glass was a possible source of the child’s facial abrasions.

Figure 19: View of the CSS in the rear right position.
