TRANSPORTATION RESEARCH CENTER

ON-SITE CHILD SAFETY SEAT INVESTIGATION

CASE NUMBER - IN-03-034
LOCATION - INDIANA
VEHICLE - 1988 CHRYSLER LEBARON
CRASH DATE - March 2003

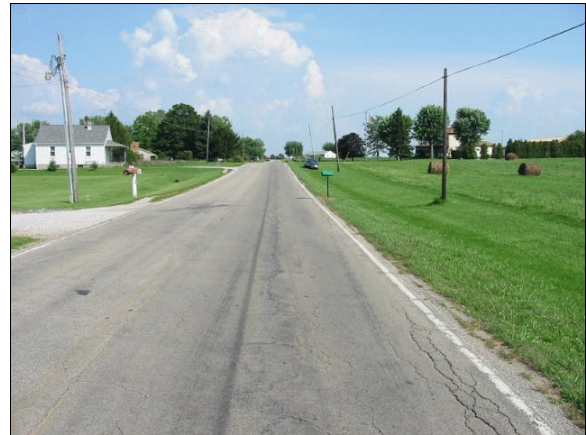
Figure 1: Case vehicle's southeasterly travel path in southeastbound lane approaching hill crest; Note: vehicle ran-off-road to right and driver overcorrected upon re-entry (case photo #01)

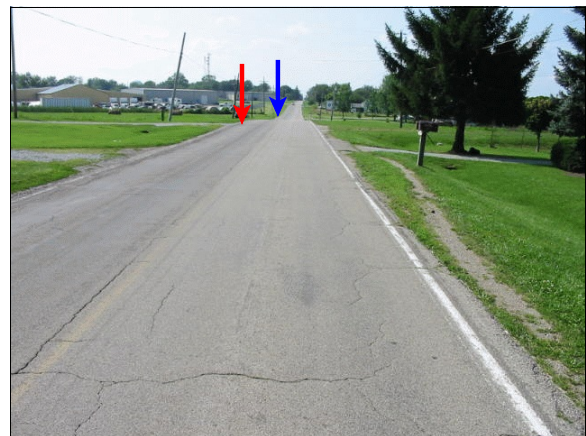
Figure 2: Dodge pickup's northwesterly travel path in northwestbound lane approaching hill crest; Note: arrows indicate approximate location of hill crest (red) and sag (blue)—further to northwest (case photo #05)

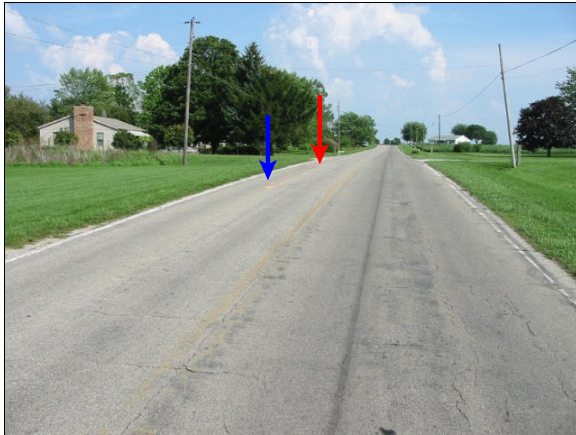
Figure 3: Case vehicle's east-southeasterly travel path, near hill crest, across centerline; Note: arrows indicate beginning (blue) of straight line yaw mark and approximate point of impact (red) with Dodge pickup (case photo #01b)

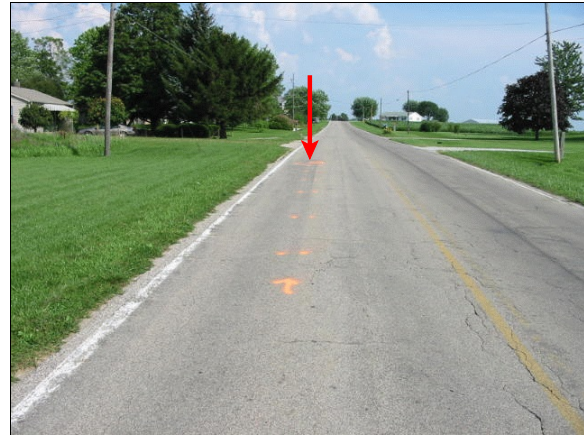
Figure 4: Case vehicle's straight line yaw mark in northwestbound lane; Note: arrow indicates approximate point of impact near hill crest (case photo #02)

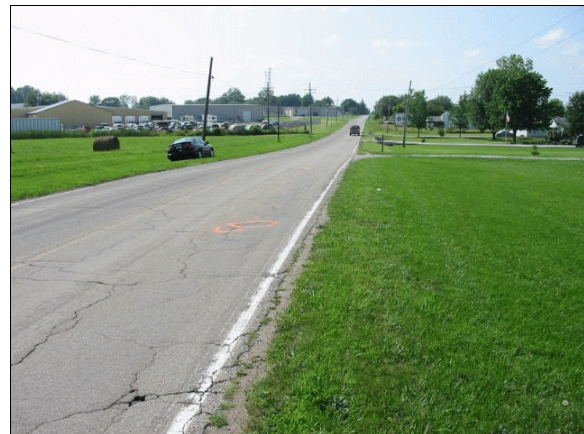
Figure 5: West-northwesterly view from northeast roadside, near hill crest, showing impact location between case vehicle and Dodge pickup (case photo #04)

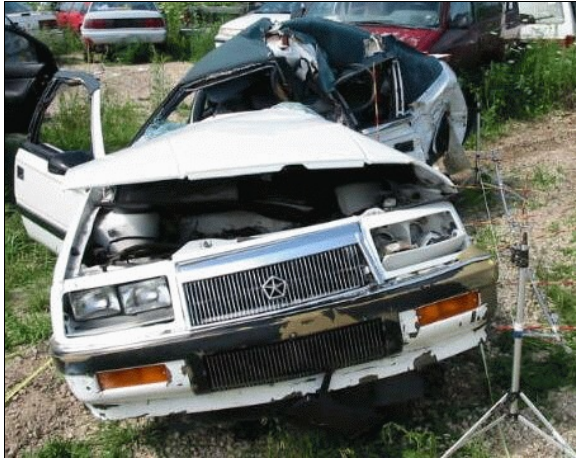
Crash: The left side (**Figure 6**) of the case vehicle was impacted by the front left corner of the Dodge (**Figure 7**). The case vehicle was equipped with automatic, two-point, shoulder belts and manual, two-point, lap belts. No supplemental restraint systems (air bags) were available.

Figure 6: Case vehicle's left side impact viewed from front showing leftward shift (case photo #08a)

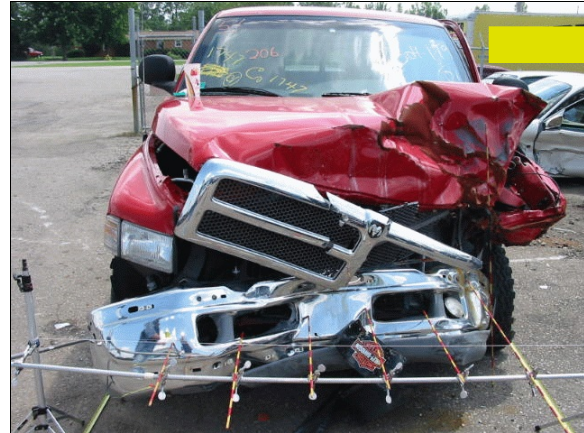
Figure 7: Dodge pickup's frontal damage from impact with case vehicle left side; Note: greatest crush occurred at front left corner (case photo #59)

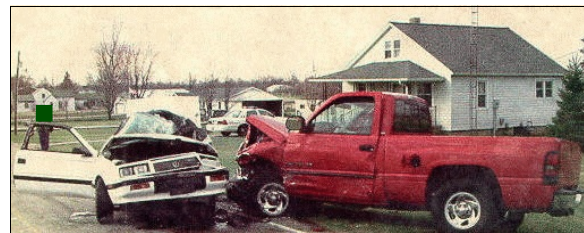
Figure 8: Newspaper photograph of final rest positions of case vehicle (left) and Dodge pickup (right); Note: tire yaw mark near case vehicle's right front door (case photo #00)

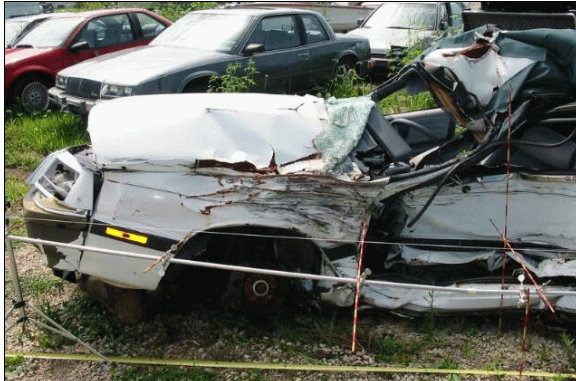
Figure 9: Case vehicle's left side damage forward of left "B"-pillar with contour gauge set above sill level; Note: initial contact with Dodge began forward of front axle (case photo #12)

Exterior Damage: The case vehicle's initial contact with the Dodge involved the left side with the damage distributed almost along the entire side (Figures 9 and 10). Direct damage began at the left front bumper corner and extended 351 centimeters (138.2 inches) along the left side, ending 33 centimeters (13.0 inches) behind the left rear axle (Figure 11). Crush was measured both at the sill and above the sill, and positions C₂ and C₃ required averaging (Figure 12). The residual average maximum crush was measured as 67 centimeters (26.4 inches) at C₃. The actual

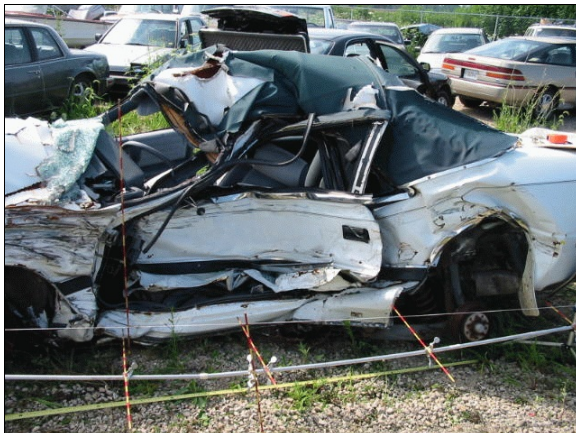
Figure 10: Case vehicle's left side damage from left "A"-pillar rearward with contour gauge set at sill level (case photo #13)

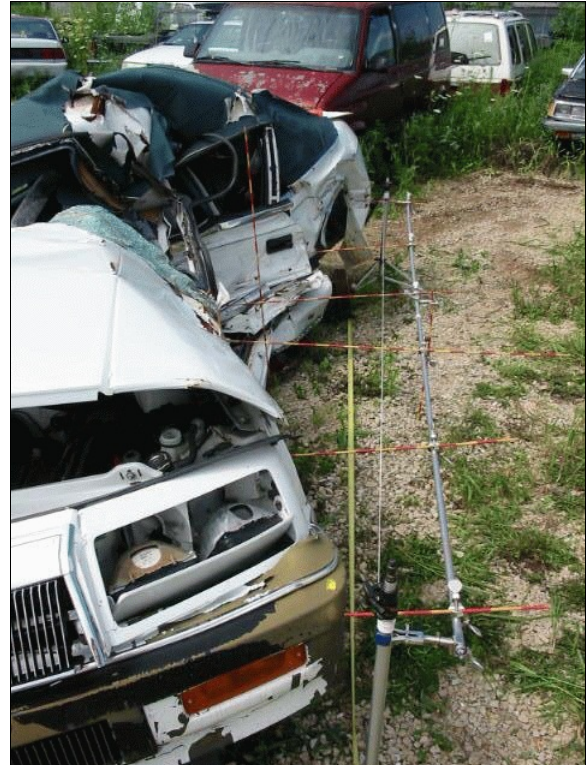
Figure 11: Reference line view from front of case vehicle's left side damage with contour gauge set above sill level (case photo #10)

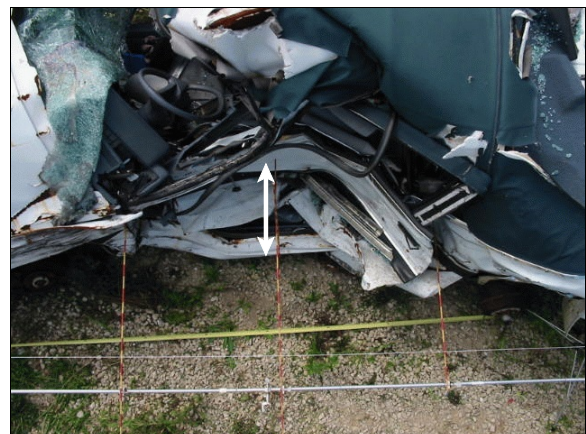
Figure 12: Overhead view of case vehicle's left side damage and crush pocket on driver's door; Note: arrows indicate difference between crush at sill and crush above sill level (case photo #22)

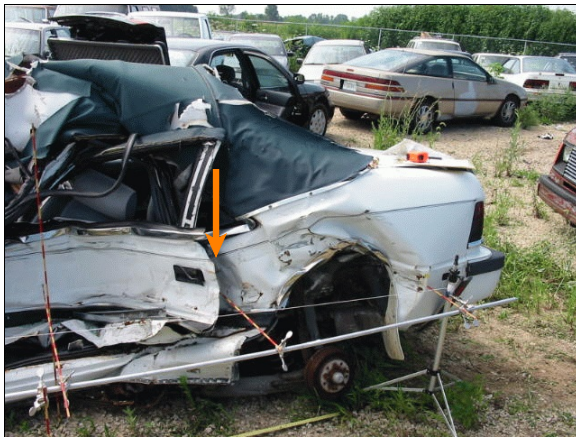
Figure 13: Case vehicle’s left side damage from left “A”-pillar rearward with contour gauge set above sill level; Note: arrow indicates door latch failure (case photo #16)

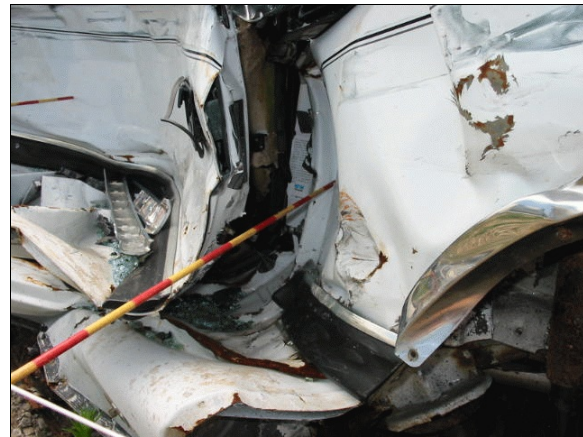
Figure 14: Close-up of door latch failure on case vehicle’s driver door (case photo #24)

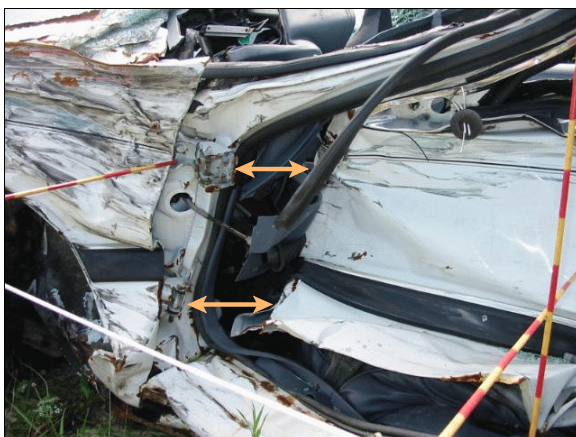
Figure 15: Close-up of door hinge failure (arrows) on case vehicle’s driver door (case photo #25)

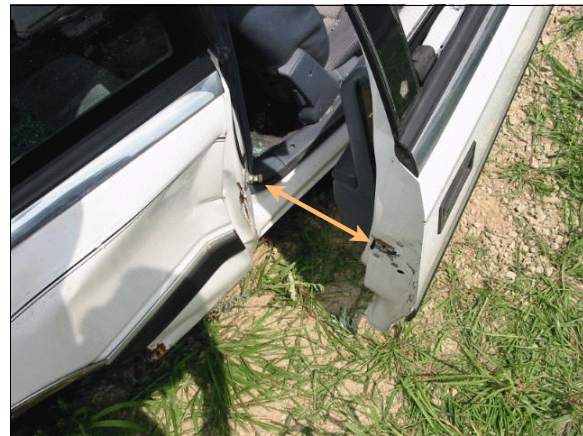
Figure 16: Overhead view of case vehicle’s right front door which was pried open (arrows) by rescue personnel (case photo #29)

turn signal assemblies, the hood, the roof, the truck, and the left “B” and “C”-pillars. Remote buckling was also found on the hood and roof. Furthermore, the right front door was pried open by rescue personnel (Figure 16 above), and the case vehicle’s right quarter panel was damaged at the storage facility.

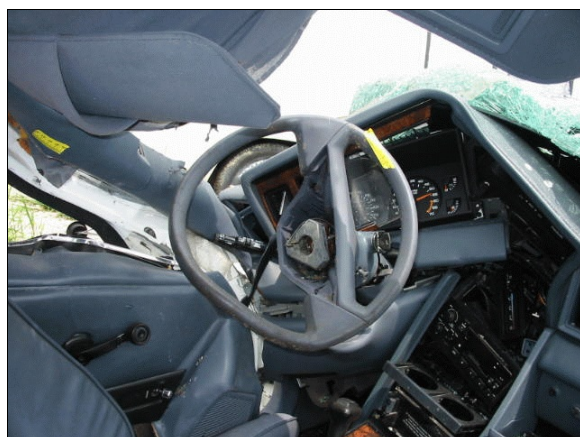
Figure 17: Case vehicle’s driver seating area showing extensive intrusion and contact evidence on steering wheel rim and left “A”-pillar; Note: top of rim is toward 9 o’clock position and plastic cover for wheel hub is absent (case photo #32)

Vehicle Interior: Inspection of the case vehicle’s interior revealed contact evidence on the steering wheel rim (i.e., hair and blood—Figures 17 and 18), hub (i.e., blood—Figure 19 below), left “A”-pillar (i.e., hair and a scuff mark—Figure 17 and Figure 20 below), and on the left door armrest and interior door’s surface (i.e., scuff—Figure 20 below). The steering wheel hub and left “A”-

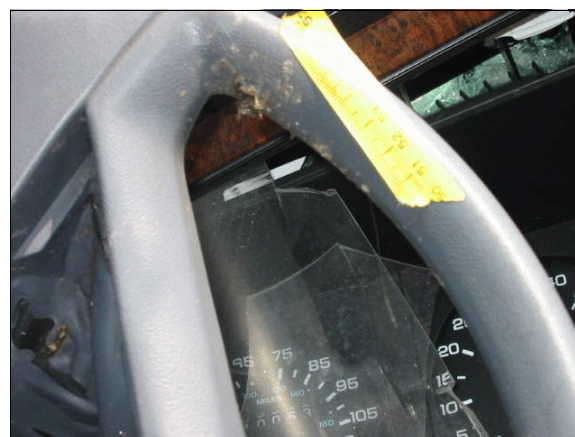
Figure 18: Close-up of contact evidence on case vehicle’s deformed steering wheel rim (case photo #37)

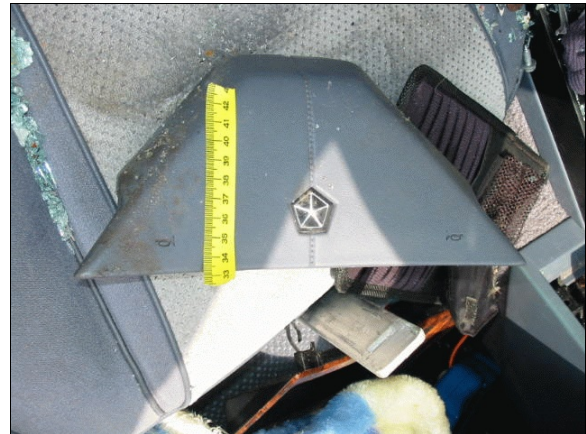
Figure 19: Overhead view of plastic piece that covered case vehicle's steering wheel hub showing evidence of occupant contact (case photo #42)

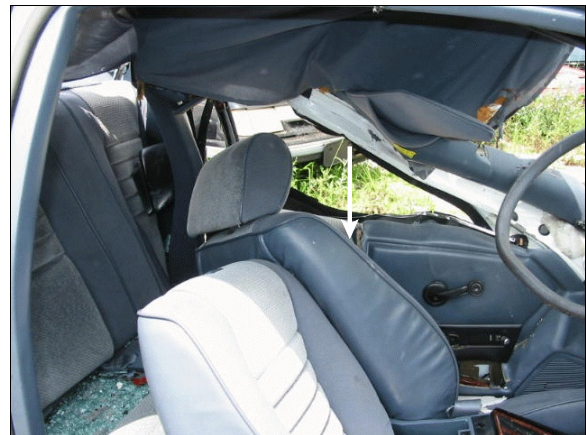
Figure 20: Case vehicle's front seating area viewed from right showing twisted driver's seat, distorted steering wheel rim, contact to left "A"-pillar, and hidden (arrow) contact to side door panel; Note: front right head restraint missing (case photo #45)

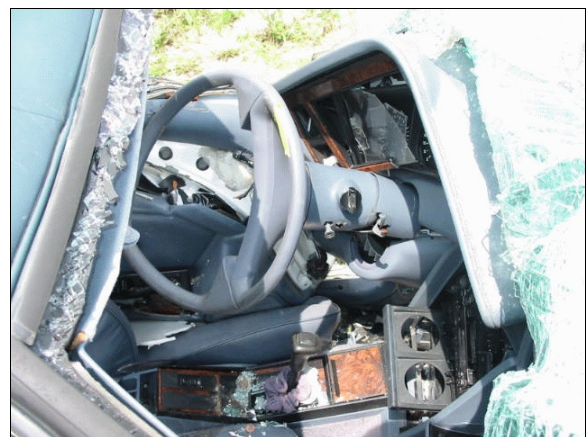
Figure 21: Overhead view of case vehicle's steering column and center console; Note: damage to steering column, steering wheel rim and hub, holed windshield's glazing, and intrusion of driver's seat onto center console (case photo #36)

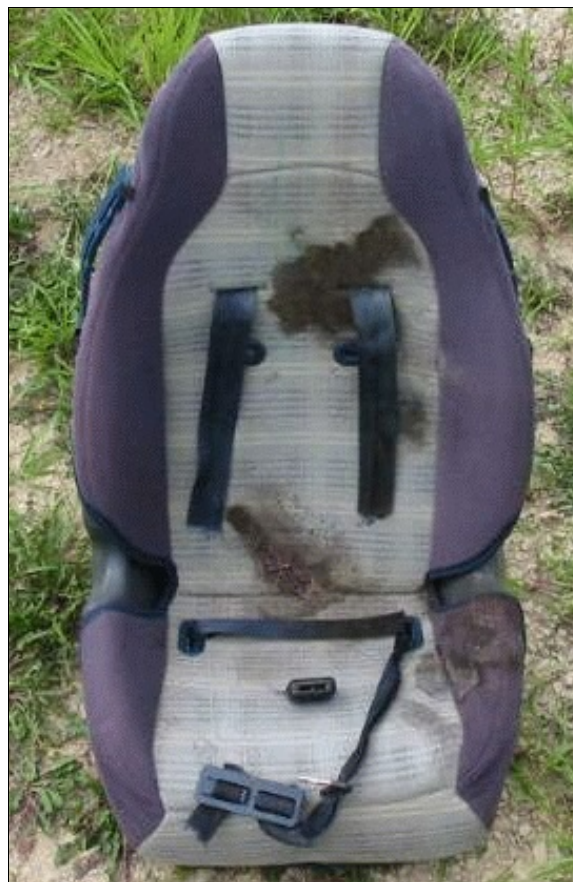
Figure 22: Frontal view of Cosco forward-facing, high-back, combination child seat-configured with five-point harness, used by case vehicle's front right passenger showing harness straps cut by rescue personnel (case photo #47)

Based on the vehicle inspection, the case vehicle's front right passenger was restrained by the child seat's five-point harness (**Figures 22 and 23** above). The forward-facing child safety seat was secured by the available, active, two-point, lap belt (**Figure 27**) with an **ELR** retractor. The child safety seat was not secured by the non-motorized, passive, two-point, shoulder belt. Furthermore, the passive shoulder belt was not secured to the door frame (**Figure 28**). A "heavy duty locking clip" was not used, yet according to the responding police officers, the child seat was "fairly snug". The inspection of the front right passenger's seat belt system showed that the child seat was still secured by the vehicle's lap belt.

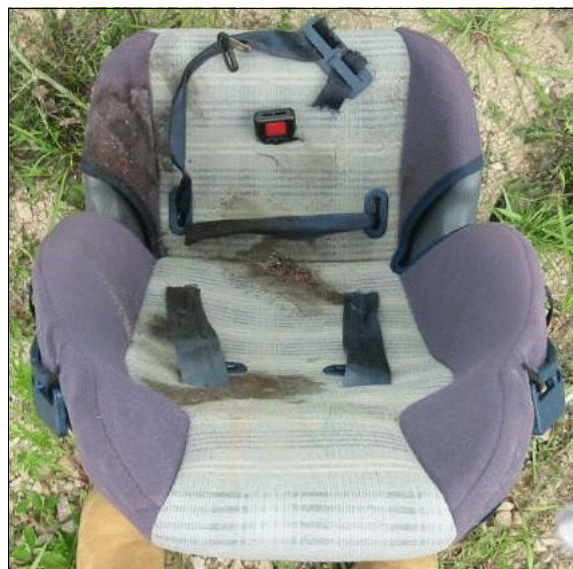
Figure 23: Overhead view from back of Cosco child safety seat used by case vehicle's front right passenger; Note: harness straps cut by rescue personnel (case photo #48)

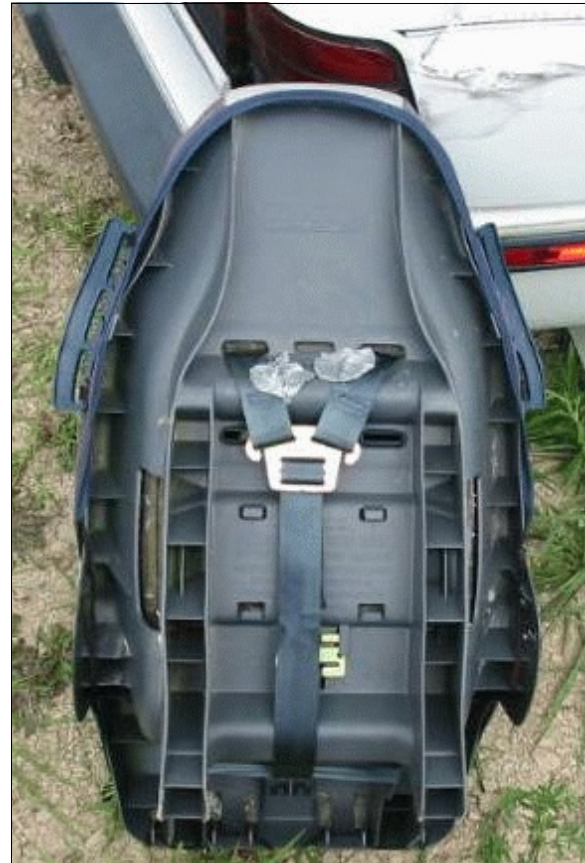
inspection of the child safety seat revealed no apparent damage or fractures to the shell (**Figure 24**). In addition, no damage or fractures were noted along the seat's path for the vehicle's safety belt (**Figure 25**). There was a manufacturers label affixed to the bottom right side of the forward-facing child seat giving the child seat's **height and weight limitations** [i.e., weight: between 10 and 18 kilograms (20-40 pounds), and height: less than 101.6 centimeters (40 inches)–when used with the internal five-point harness; **OR** weight: between 13.6 and 36.3 kilograms (30-80 pounds), and height: between 94.0 and 129.5 centimeters (37-51 inches)–when used without the internal five-point harness as a belt-positioning booster seat]. This label was not dated (**Figure 26**). The manufacturer's instructions for this child safety seat were not available on the back of the seat at the time of this contractor's inspection.

Figure 24: Back surface of Cosco child safety seat showing harness straps positioned through upper slots and no apparent damage to child seat; Note: locking clip secured on seat back (case photo #55)

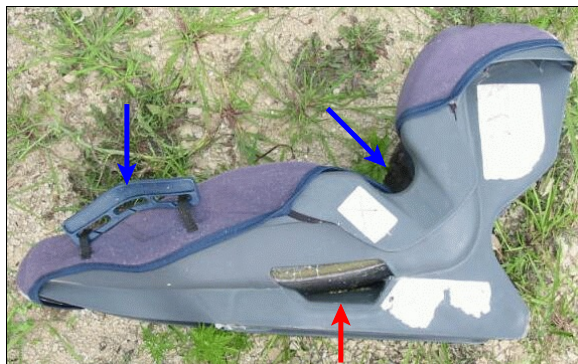
Figure 25: Overhead view of Cosco child safety seat's right side showing locations for securing vehicle's safety belts when seat used as forward-facing seat (red arrow) with harness straps or as belt-positioning booster seat (blue arrows) without harness straps (case photo #50)

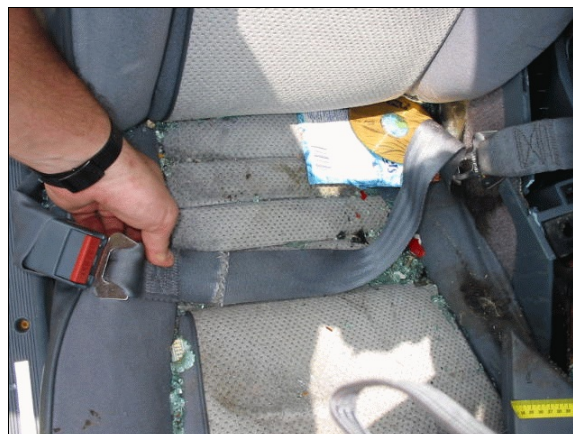
Figure 27: Overhead view of case vehicle's manual, front right lap belt which was used to secure Cosco child safety seat used by front right passenger (case photo #46)

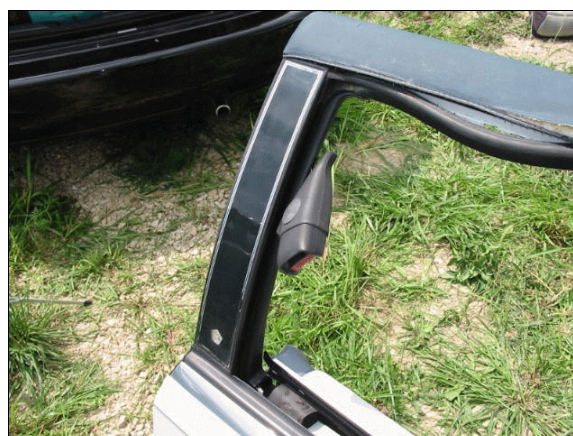
Figure 28: Case vehicle's right front door showing door-mounted buckle for non-motorized front right shoulder belt (case photo #46a)

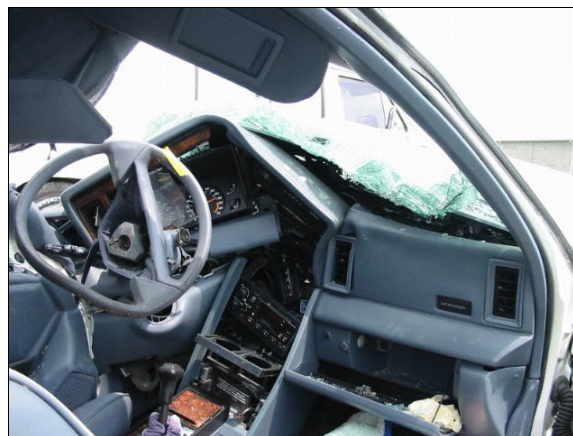
(Figure 29). Otherwise, there was no apparent evidence of this occupant's contact found to the vehicle's interior. The exact posture of the front right passenger at final rest is unknown. She was unable to exit the case vehicle because of her injuries.

Figure 29: Case vehicle's front right passenger seating area showing extensive intrusion to instrument panel and contact to steering wheel rim; Note: no apparent evidence of occupant contact to either center or right instrument panels (case photo #33)

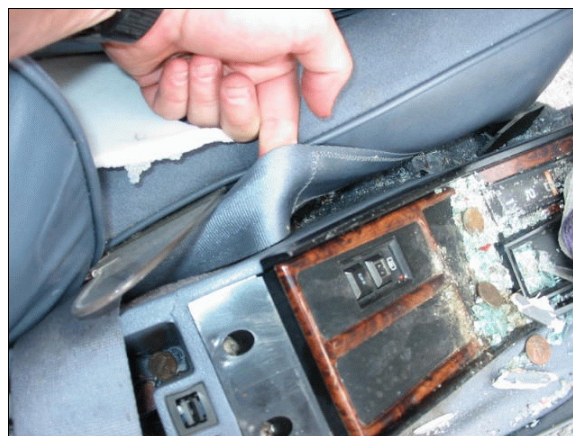
Figure 30: Webbing from case vehicle driver's automatic, shoulder belt showing webbing lodged between intruded driver seat and center console, indicating webbing not in use at time of crash (case photo #44)

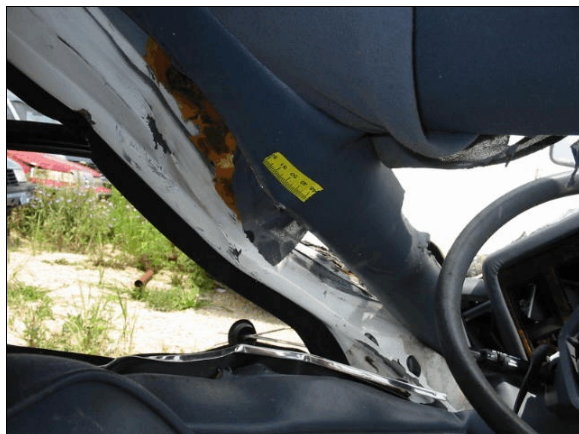
Figure 31: Contact evidence along case vehicle's left "A"-pillar deposited by case vehicle's driver (case photo #38)

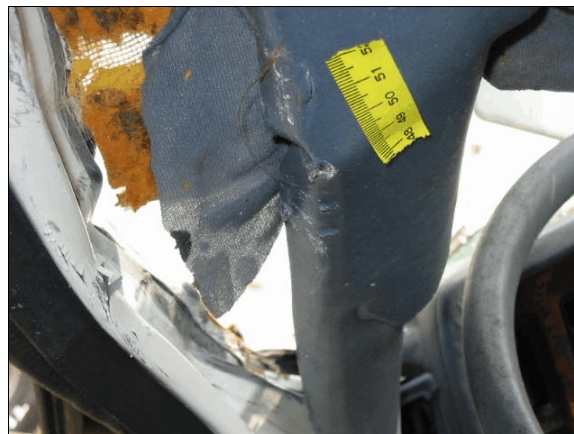
Figure 32: Close-up of contact evidence on case vehicle's left "A"-pillar deposited by case vehicle's driver; Note: hair on "A"-pillar (case photo #39)

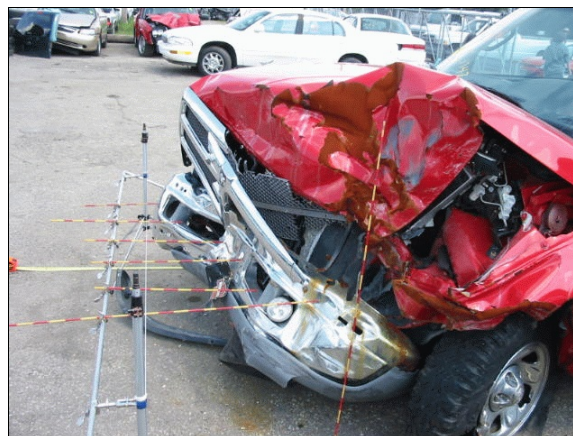
Figure 33: Reference line view from left with contour gauge at bumper level showing Dodge’s oblique crush profile and damaged and restricted left front tire (case photo #62)

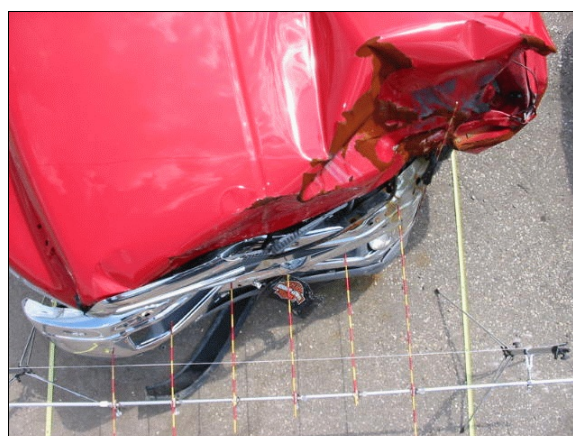
Figure 34: Overhead view of Dodge pickup’s frontal damage with contour gauge set at bumper level (case photo #69)

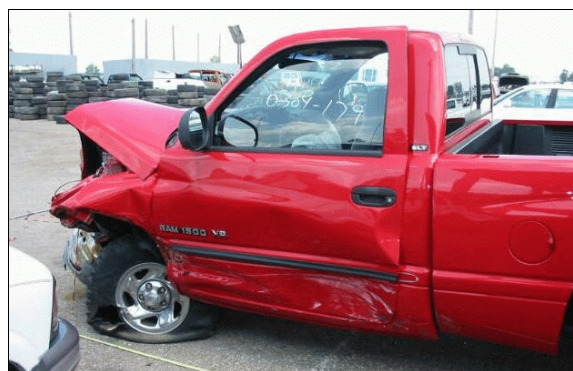
Figure 35: Dodge pickup’s side slap damage from left front of case vehicle; Note: damaged, deflated left front tire and induced damage (rearward movement) to driver’s door from frontal impact (case photo #63)
